REPAIR, EVALUATION, MAINTENANCE, AND
REHABILITATION RESEARCH PROGRAM

TECHNICAL REPORT REMR-C.T-3

GEOTECHNICAL ASPECTS OF ROCK EROSION
IN EMERGENCY SPILLWAY CHANNELS

Christopher P. Cameron, Kerry D. Cato,
Colin C. McAneny, James H. May

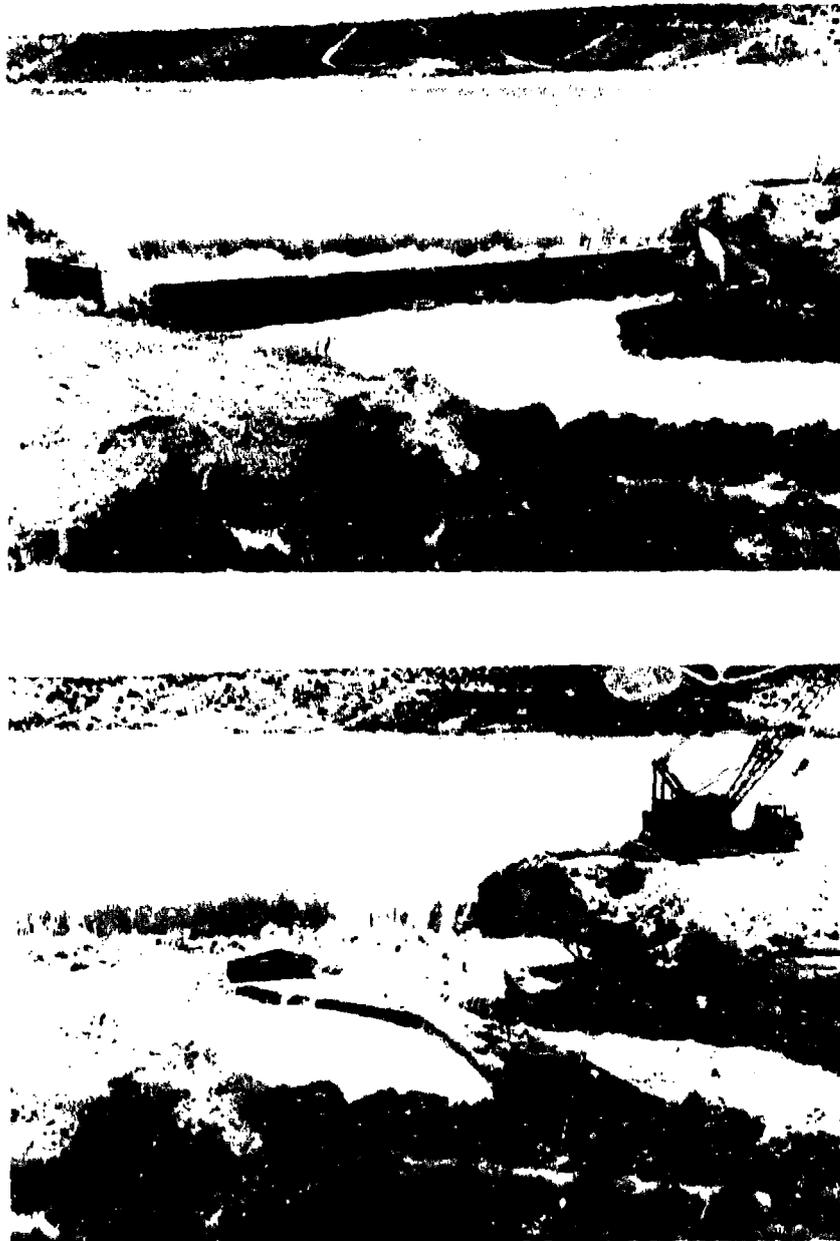
Figure 36. Excessive channel erosion and headcutting caused failure of the DMAD emergency spillway and catastrophic release of the reservoir waters

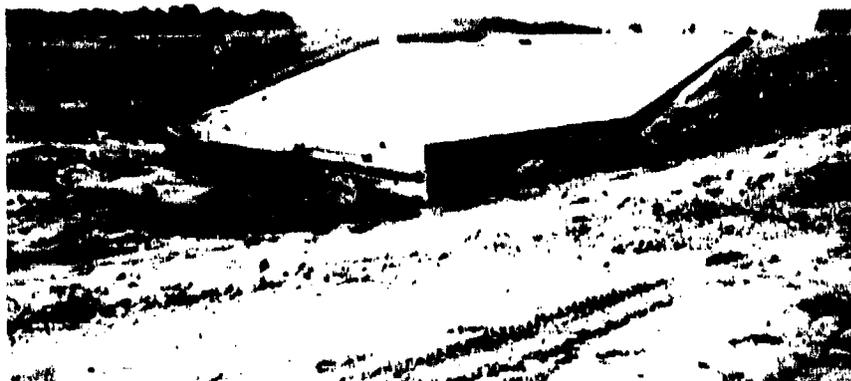
Figure 38. Remedial construction at Grapevine project. Energy will be dissipated in deep, large-volume plunge pool beneath extended concrete apron

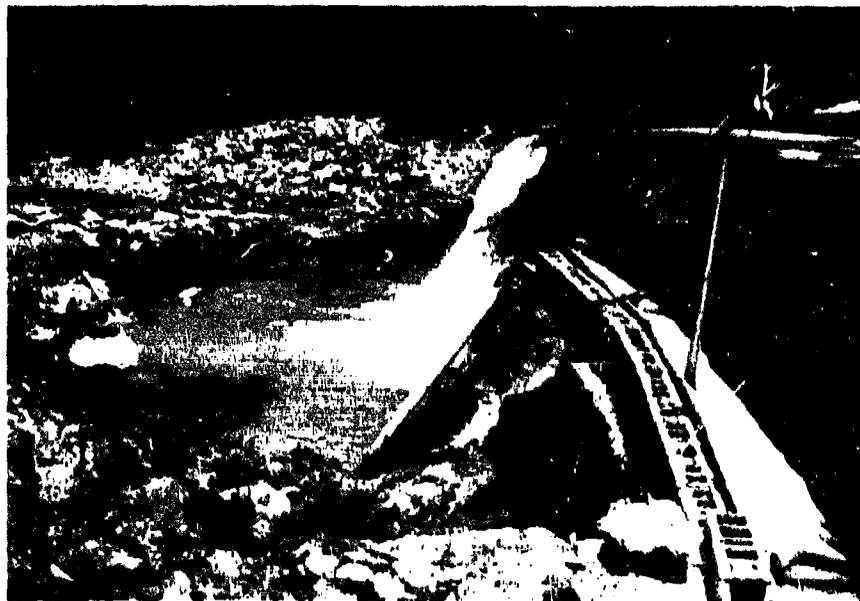
Figure 41. A 30-ft waterfall now occupies the site of the failed downstream spillway apron at a private reservoir on Johnny's Creek near Fort Payne, Alabama. Excessive scour undercut the concrete structure during an estimated 100-year storm in the summer of 1985

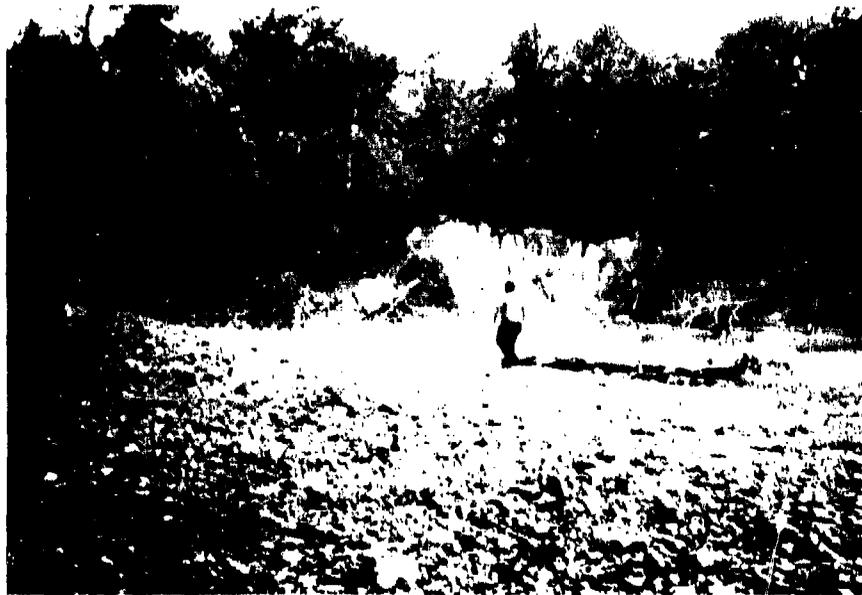
Figure 45. Gravel fan formed by spillway overflow at Wister Dam (SWT) Tulsa District. Formation forced flow against outer channel bank causing bank erosion

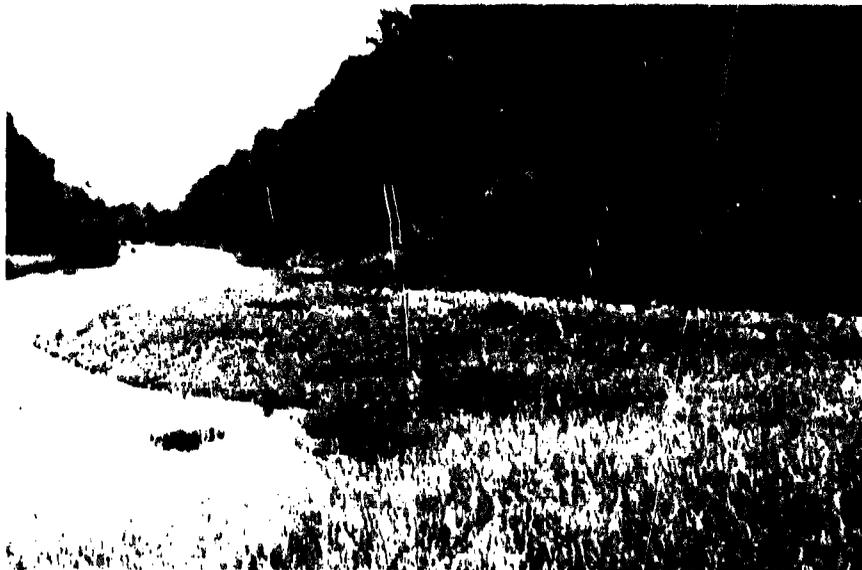
Figure 46. Fan formed in French Creek, Union City project, by deposition of eroded emergency spillway rocks. Creek sedimentation has impacted downstream fish populations

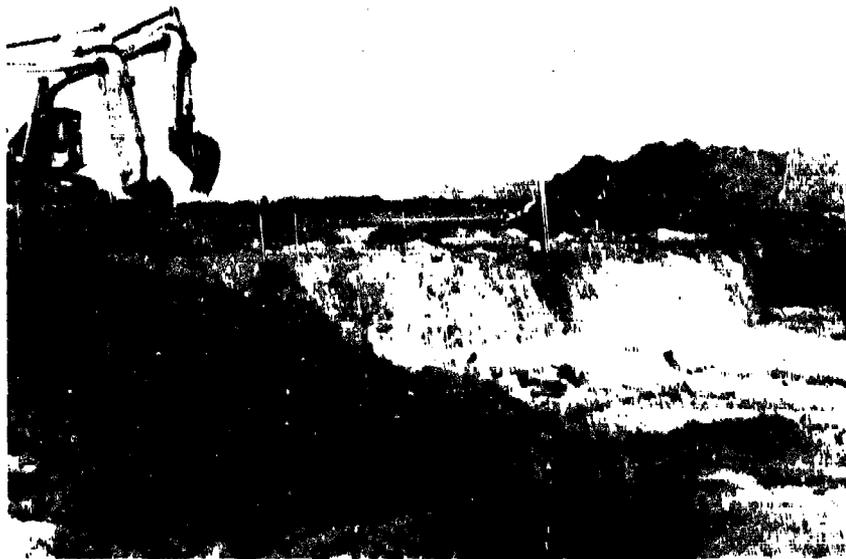
Figure 47. Intentional breaching of spillway at Gunnison Bend Reservoir, Utah, during 1983 flood

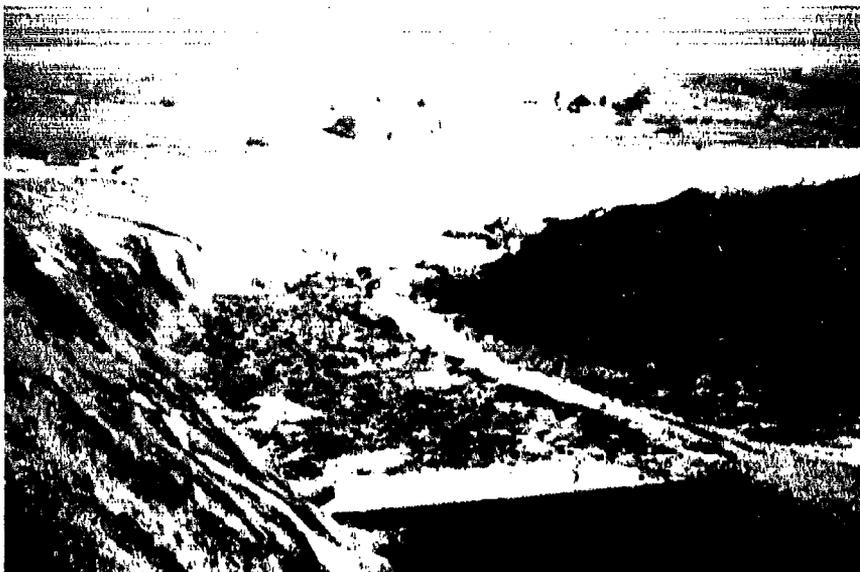
Figure B1. Downstream view of eroded Black Butte spillway following 1983 overflow. The spillway floor is composed of basaltic and pyroclastic materials. The reinforced-concrete spillway weir is in foreground. The linear structure, right center, is a road used to haul materials for remedial dam work several years before overflow
