SPILLWAY MODIFICATION GRAPEVINE LAKE TEXAS (U) ARMY
ENGINEER DISTRICT FORT WORTH TX A J MARR JUN 86

**FINAL
FOUNDATION
REPORT**

**SPILLWAY MODIFICATION
GRAPEVINE LAKE, TEXAS**

JUNE 1986

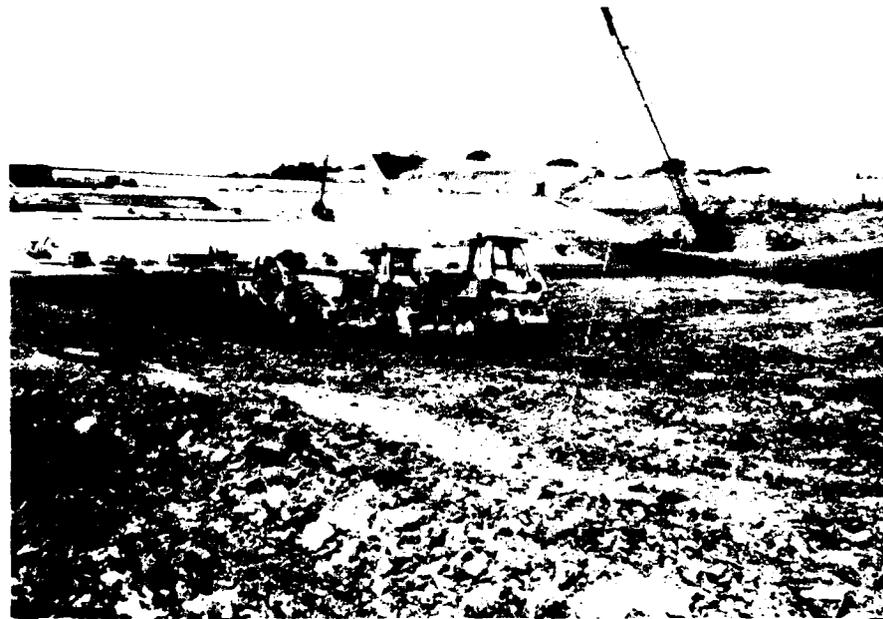
Fig. 4 - Neat-line excavation is accomplished with Gradall equipped with straight-edged bucket

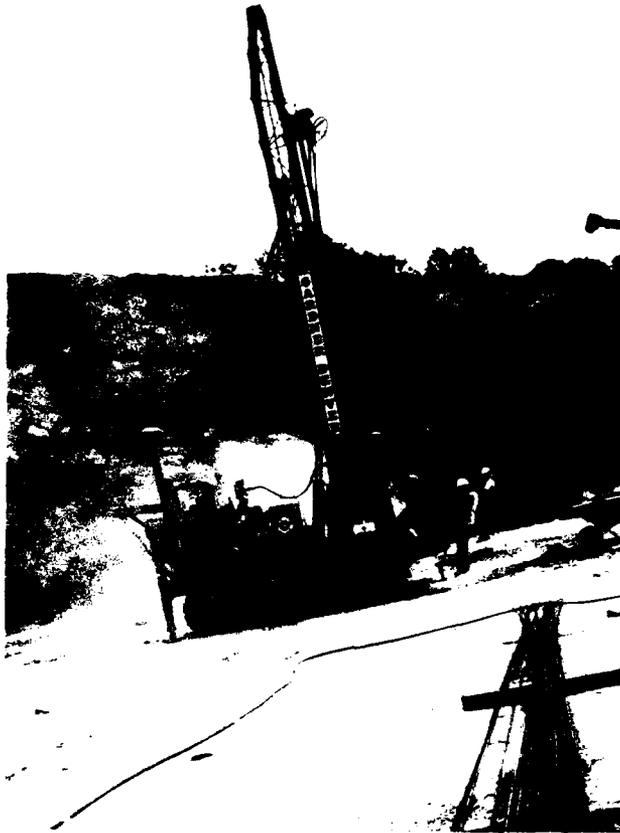
2. Equipment. The 6-inch diameter holes for the foundation anchors were drilled using a Gardner-Denver RDC-16B track-mounted pneumatic drill, shown on Figure 7. Two types of bits were used for drilling: The majority of drilling was done using a 5 $\frac{1}{2}$ -inch drag bit in the soft shales, clays and sandstones; and, a 6-inch Varel Tri-cone rock-bit was used to penetrate the moderately hard to hard sandstone layers which were encountered. The anchors consisted of No. 11 rebar bent in an L-shape. The grout mixture placed around the anchors was mixed at a commercial off-site batch plant and delivered in ready-mix trucks. (See Figure 9) The grout was dumped into a hopper attached to a side-winder pump and subsequently pumped into the holes through a 1 $\frac{1}{4}$ -inch ID flexible hose.

Fig. 7 - Anchor holes being drilled with track-mounted pneumatic drill

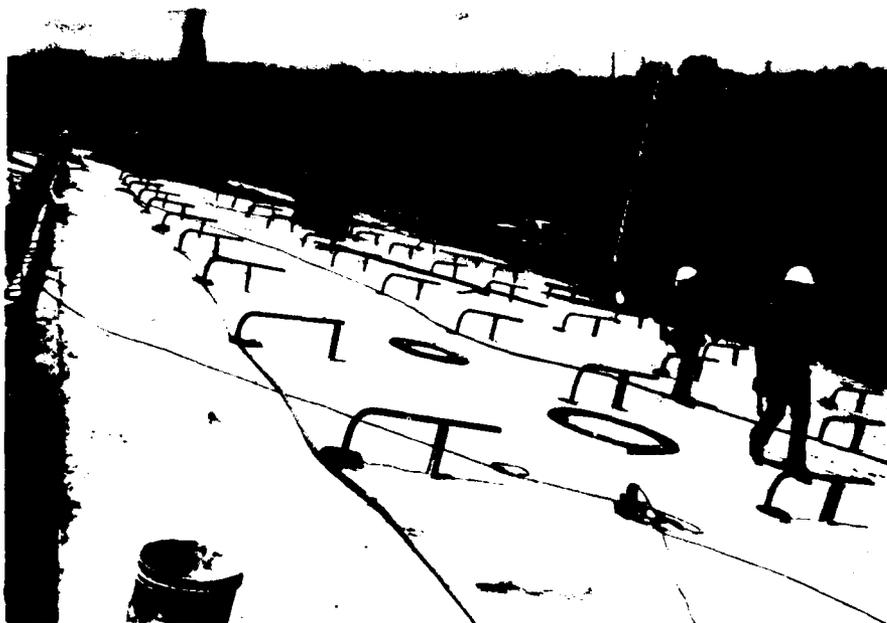
Fig. 8 - Anchor bars in place and ready for grouting

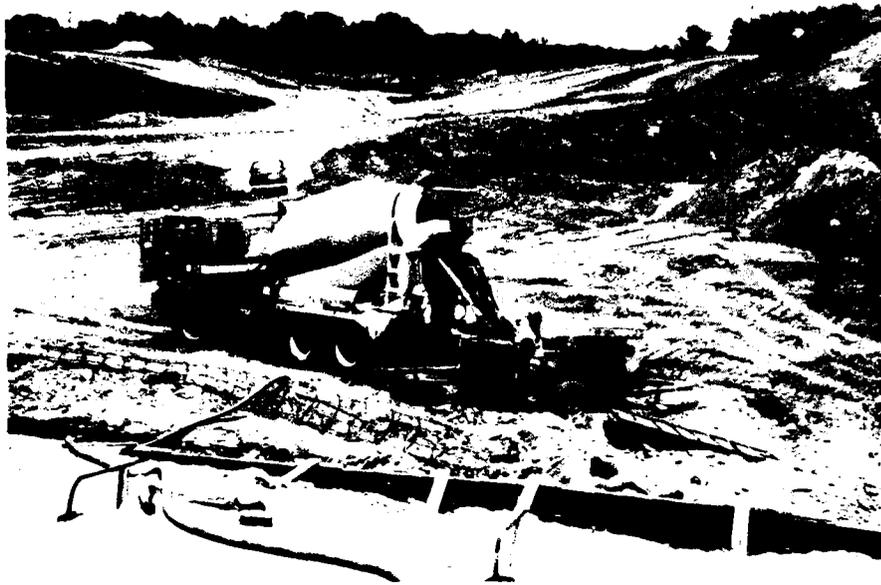
Fig.9 - Grout arrives at site and is dumped into hopper and pumped to hole locations

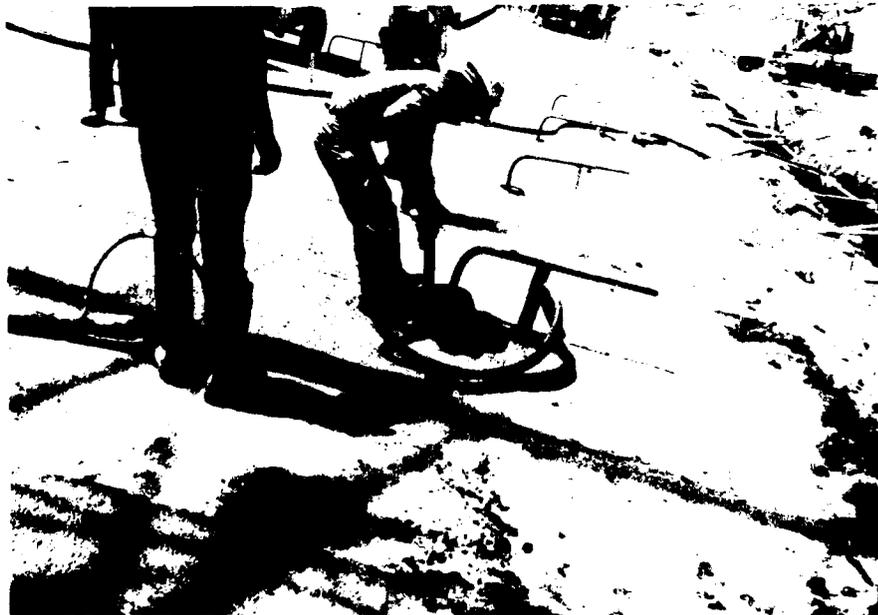
Fig.10 - Grout being placed in bottom of hole through 1½-inch ID flexible rubber hose

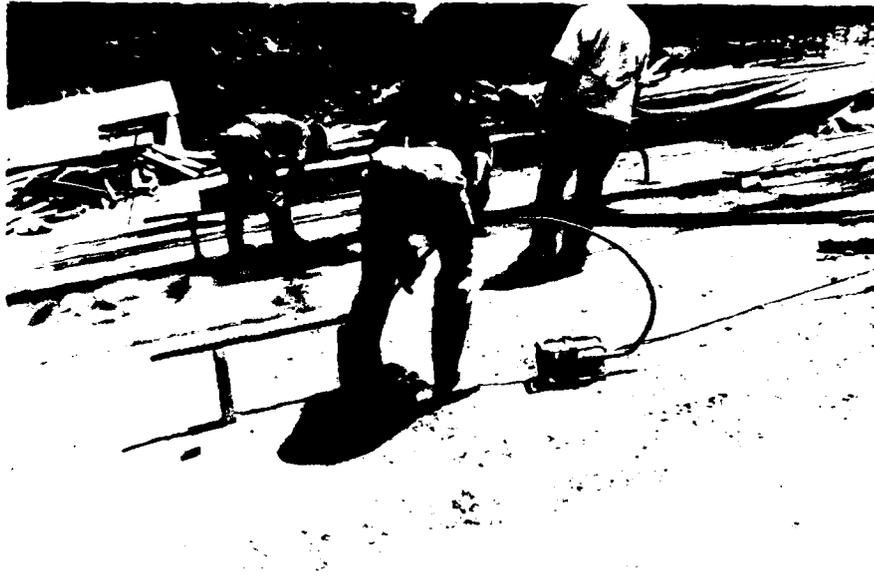
Fig.11 - Grout being vibrated in the hole

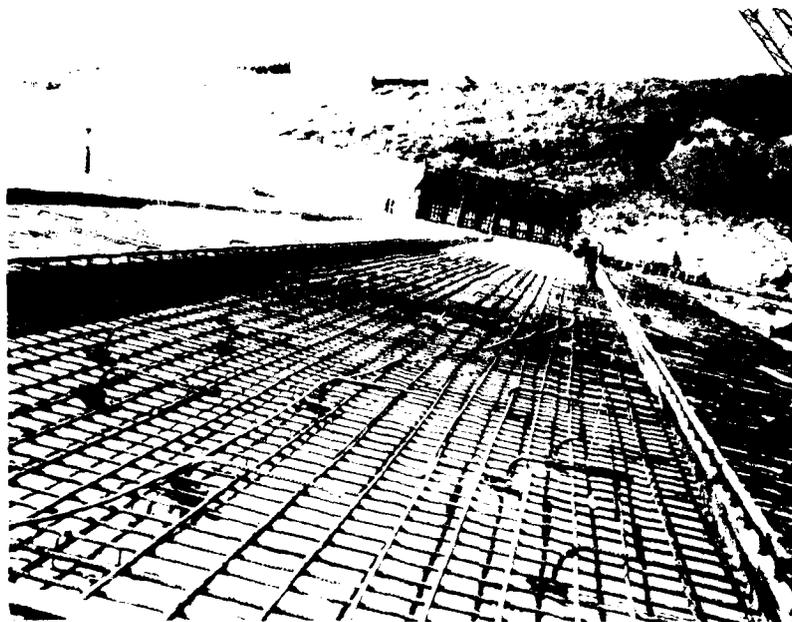
Fig.12 - Anchor bars and steel in place ready for concrete
