THE MAINTENANCE AND OPERATION OF A SMALL WIND GENERATOR IN THE MARINE ENVIRONMENT

WARREN HEERLEIN

U.S. COAST GUARD RESEARCH AND DEVELOPMENT CENTER
AVERY POINT, GROTON, CONNECTICUT 06340-6096

FINAL REPORT
July 1986

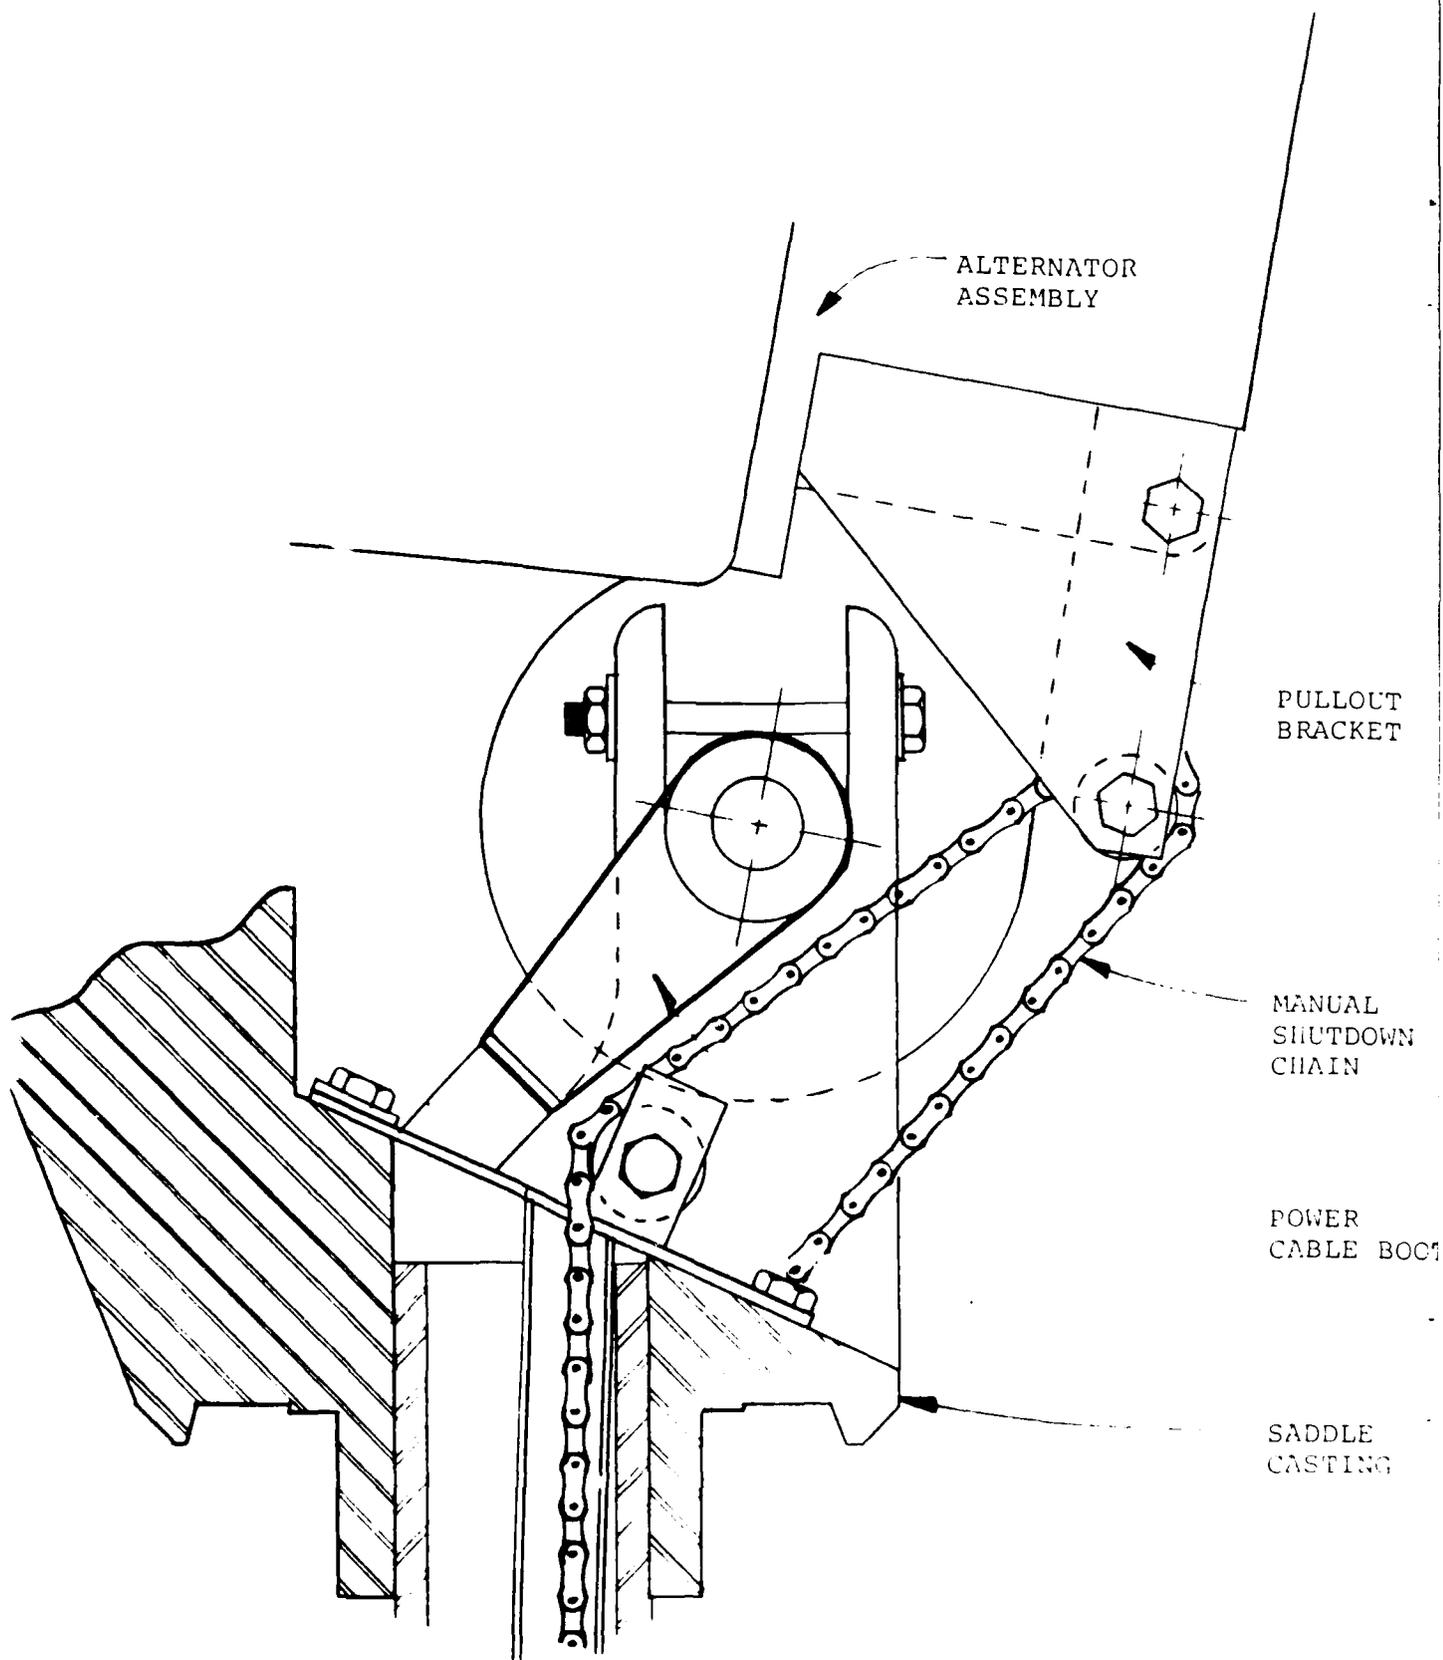
FIGURE 10. MANUAL STOWING ASSEMBLY

The manual stowing assembly was noticed to have evident rusting. APL hand greased the chain but did not replace it with a new chain supplied by North Wind, (see Figure 10).

The manual stowing chain that was observed to be rusting has failed. Repair work is dangerous until the wind machine can be manually feathered. The HR2 continued to produce power while repairs were planned.

The manual stowing chain was repaired by USCG personnel.

The second weakest link in terms of maintenance is the continual failure of the manual stowing mechanism. This device is subject to full marine environmental stresses. Left unused for long periods of time it often fails when it is needed the most. The Coast Guard replaced the North Wind plastic coated wire rope with 1/4-inch stainless steel wire with a 6100 pound rating. Thimbles were employed at all turns. Since this change was made no failures have been experienced.

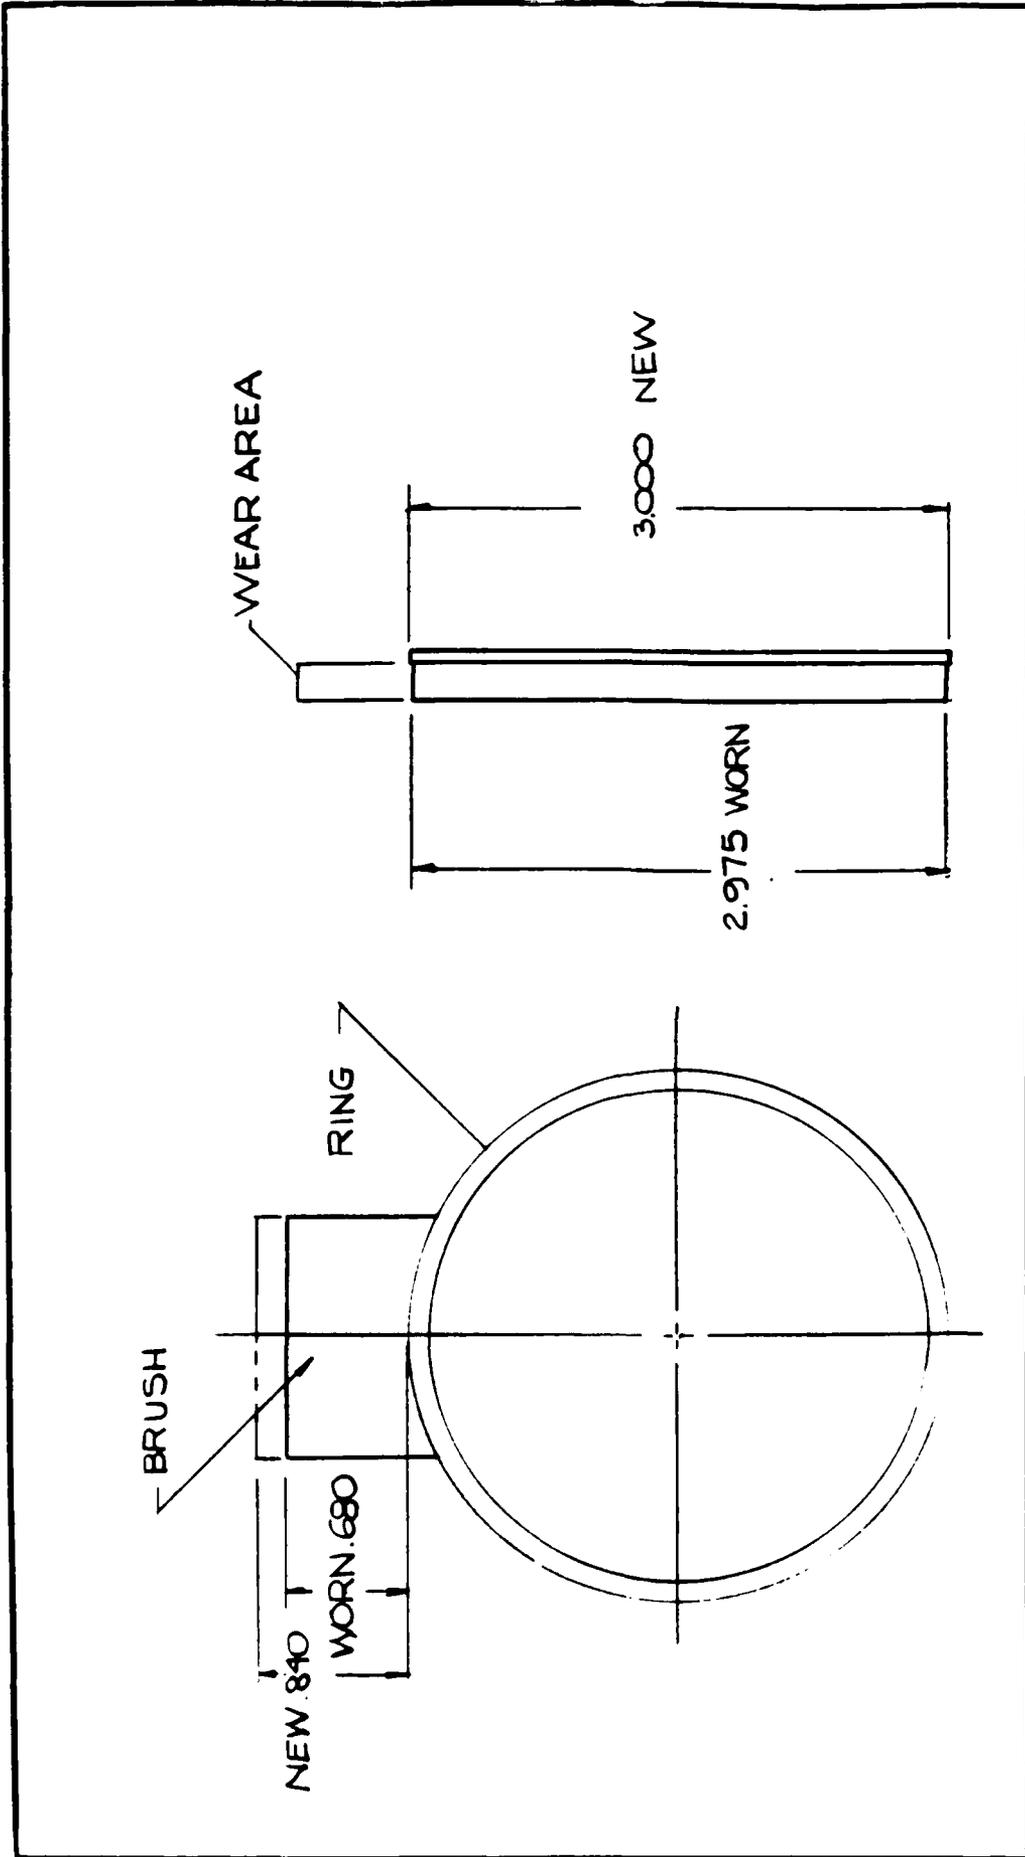
FIGURE 12. HR2 SLIP RING WEAR

From its installation in October 1981 to the time of this report, June 1986, the HR2 experienced four major failures. Two of these failures (RCD, May 1984 and field coil, January 1986) can be traced to the manufacturer's original design. The two other failures (brush/rings September 1982 and May 1984) are of a more serious nature because they reflect on the design limits of the machine. From all observations, the weakest "link" in the HR2's design is the two sets of brushes and rings (field and yaw). The yaw brushes and rings allow the positive, negative, and field current to run down the tower length and then be translated 90 degrees at the tower top. They are not subject to the large number of revolutions that are seen by the field brush and ring assembly on the main shaft, but affected by wind direction only. Based on our data, we conclude that barring catastrophic failure such as was experienced in May 1984 this yaw brush/ring assembly will survive for a full year without service. The field brush reliability for a one year service interval cannot be stated with such certainty. The initial set of brushes put in the machine apparently began to fail after nine months and power output was nil by eleven months. The second set of brushes ran for 16 months with at least two months of no-load (higher RPM) operation. When they were removed for the rebuild in August of 1985, they measured just within specification at 0.680 inches, (see Figure 12). They may survive one year of operation.

SLIP RING WEAR

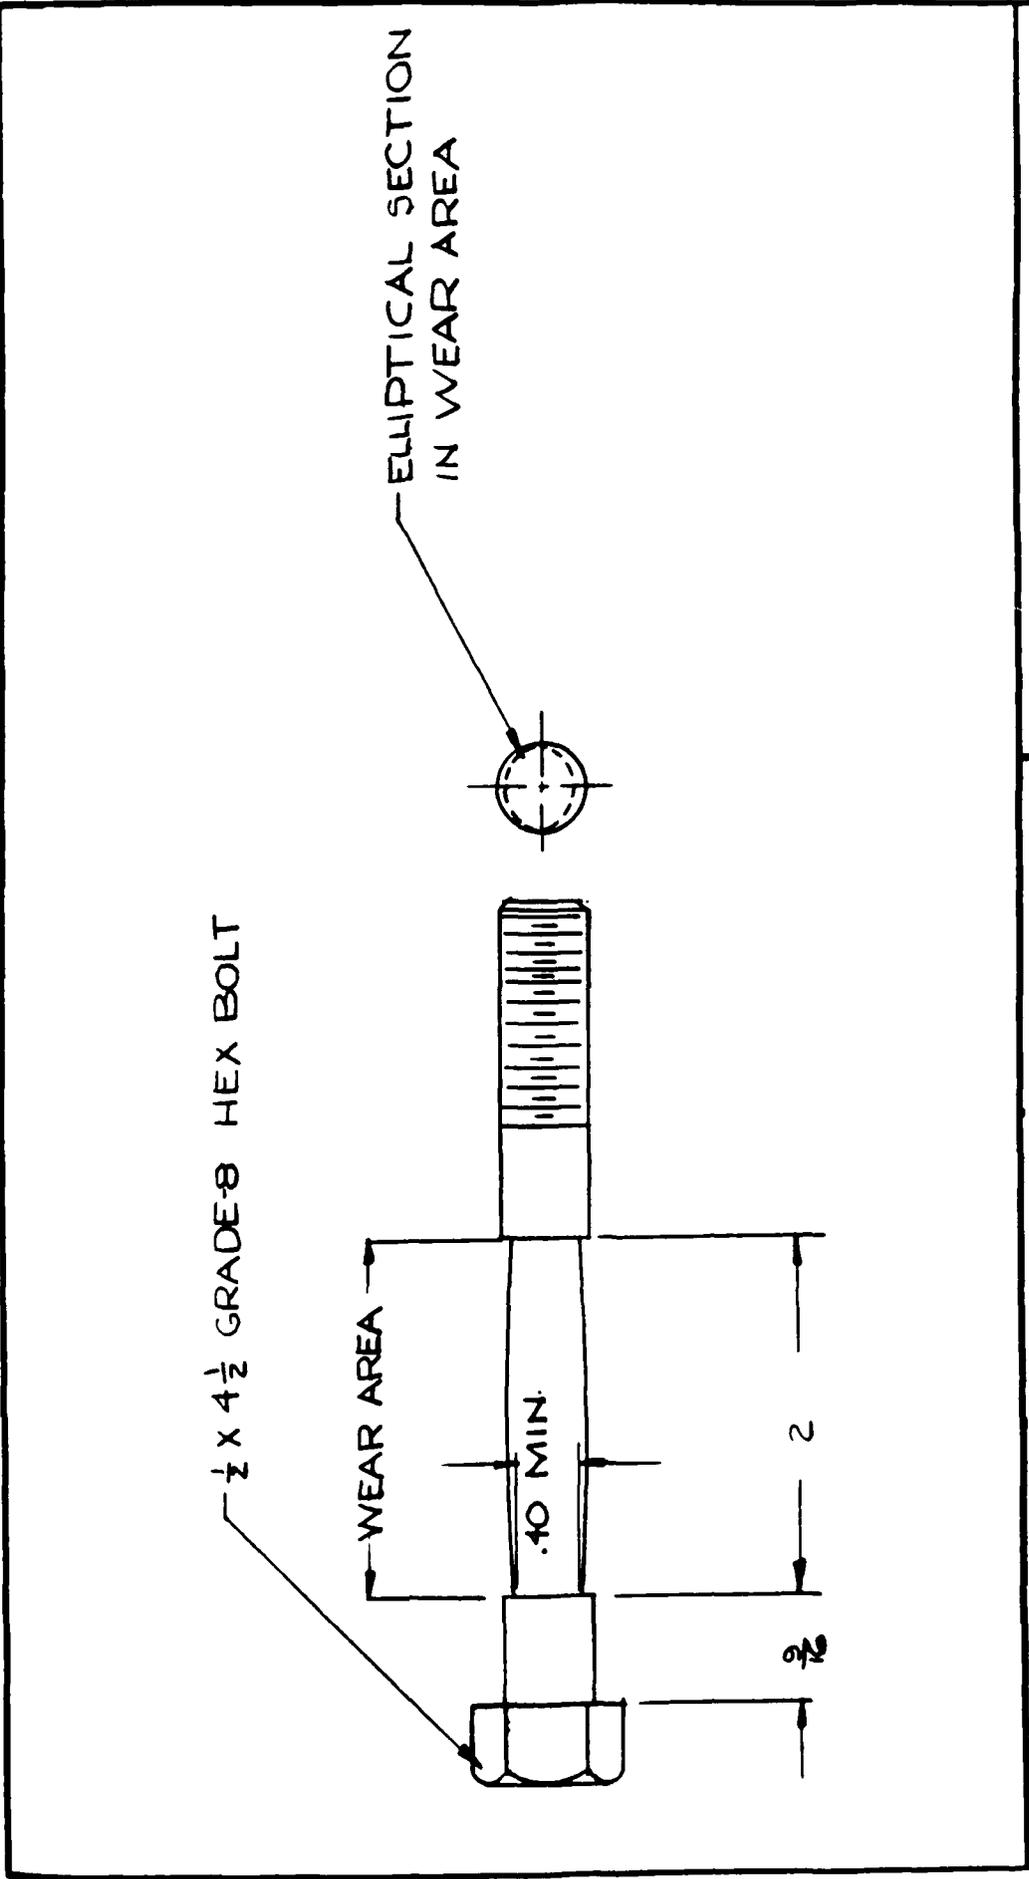
FIGURE 13. HR2 VARCS MOUNTING BOLT WEAR

The VARC's assembly performed according to design, but as was pointed out in the performance section, may reduce the output of the HR2 more than the manufacturer designed it to. The 1/2-inch steel bolt that pins the VARC shaft in place showed extreme wear on its outer surfaces, (see Figure 13). The bolt could have failed (broken) within a short period of time and this would have left the HR2 in a stowed position with no reactive force to push it back down. Power output would have been interrupted. North Wind has upgraded this bolt to 5/8-inch steel grade 8, and it will become an annual replacement item.
