STAGE I AND II PLATFORM STRENGTH EVALUATION OFFSHORE

PANAMA CITY FLORIDA (U) BARNETT AND CASBARIAN INC

METAIRIE LA FEB 81 CHES/NAUFAC-FPO-8331A

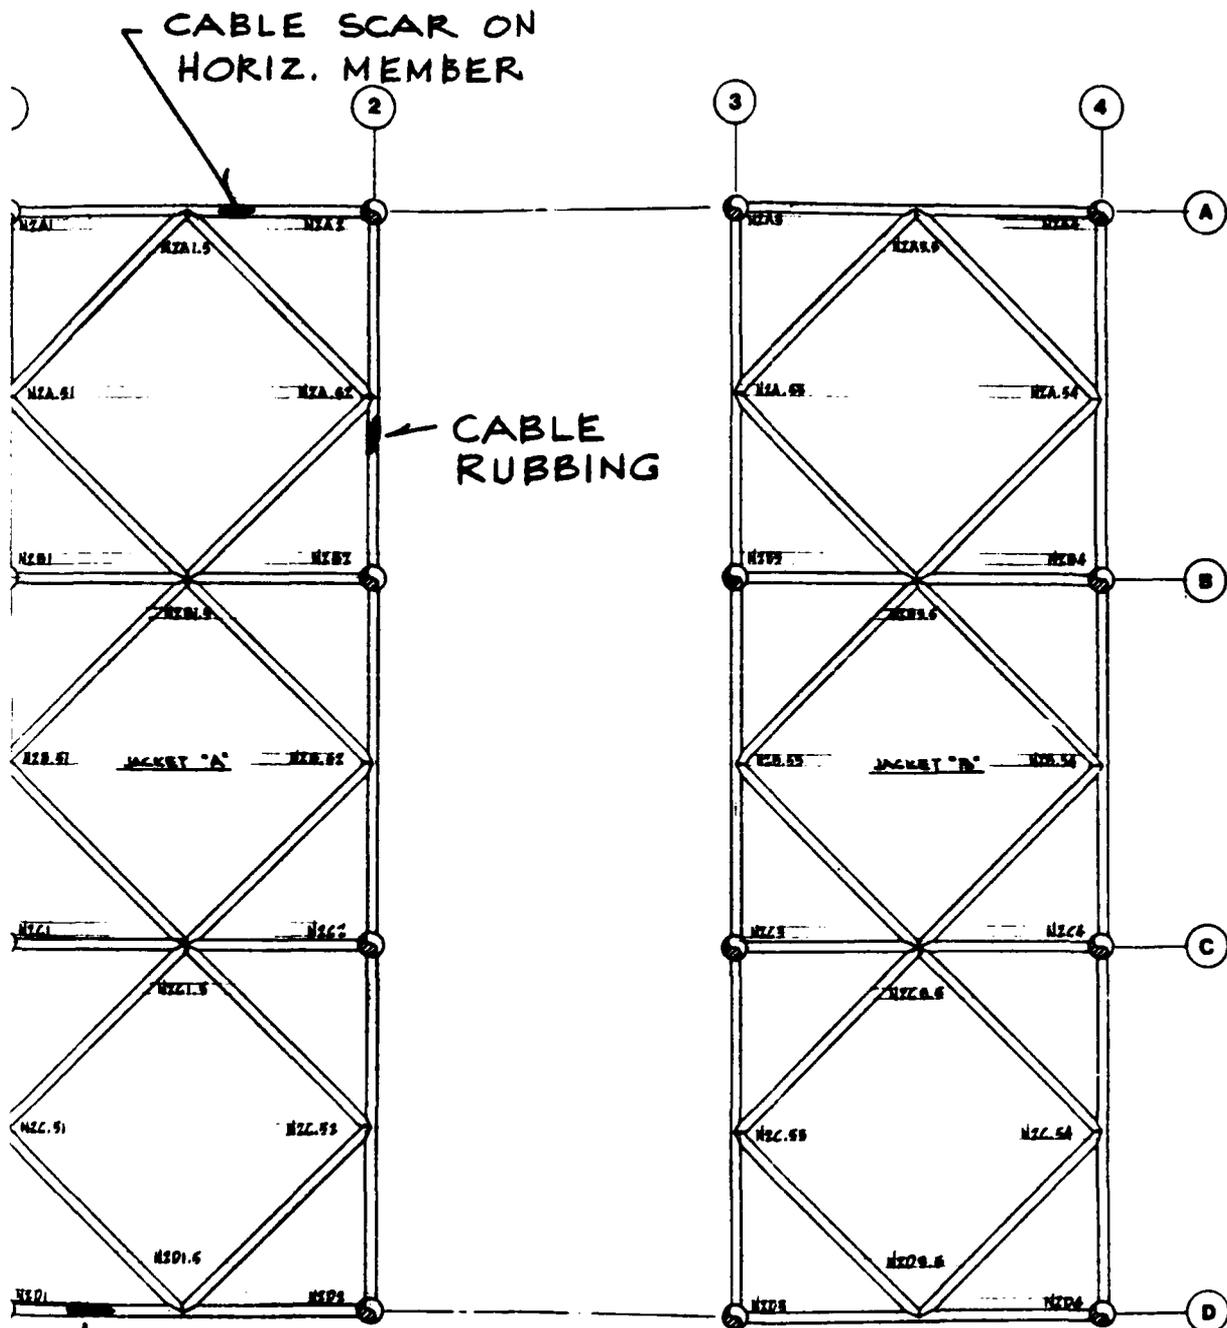
PIPE FLATTENED
 1/2" TO 2" DEEP LEVEL "2"
 2' LONG.

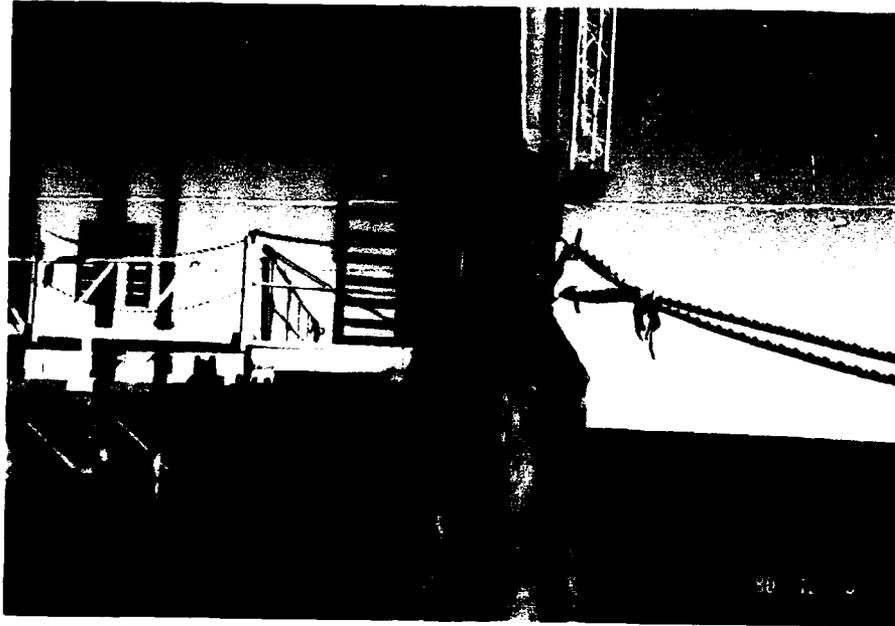
Fig. 2.1.11

Above, Leg D-1, where severe corrosion covers the area just above the monel. The boat bumper is rusted and distorted by collisions and the timber pad has dropped away.

Below, Leg A-3 base metal loss at the +10 feet level is 1/4 inch deep in the area circled.

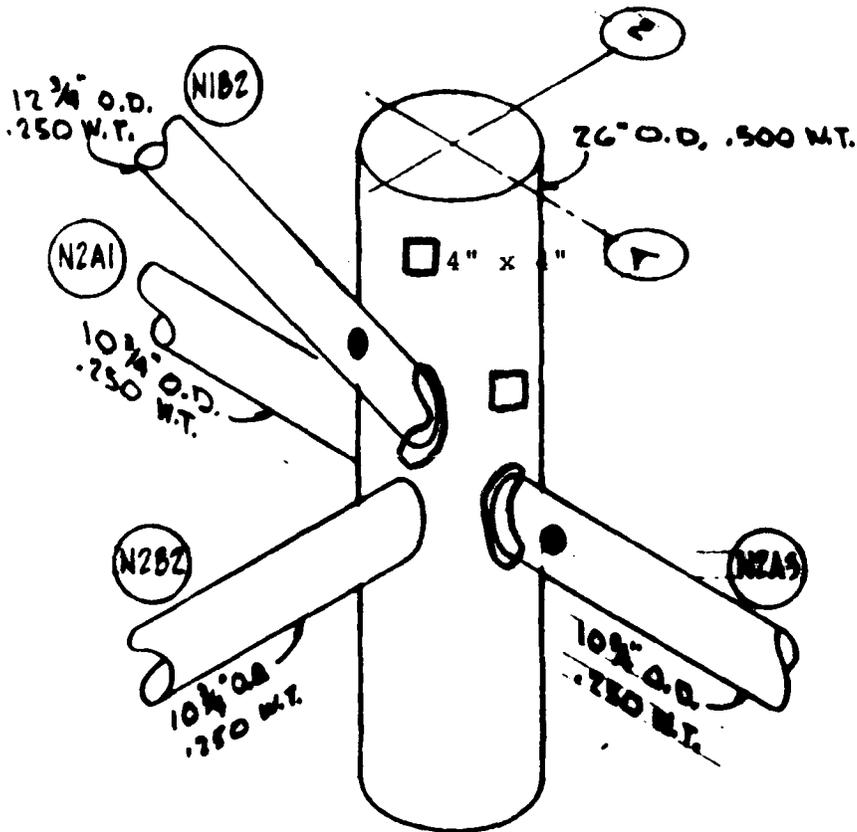
NOTE: Diver reports that he was unable to detect damage noted above prior to water blasting, due to marine growth.

CP 657
Bio-Fouling 1"
 N2A2 to N1B2 - Large pits on
 brace at 5:00.
 Holes in brace at 9:00.
