FAILURE ANALYSIS OF COMPOSITE STRUCTURE MATERIALS

Brian Smith
Ray Grove
Boeing Military Airplane Company
P.O. Box 3707 MS 73-43
Seattle, WA 98124

May 1987

Final Report for Period of 1 October 1985 to 31 August 1986

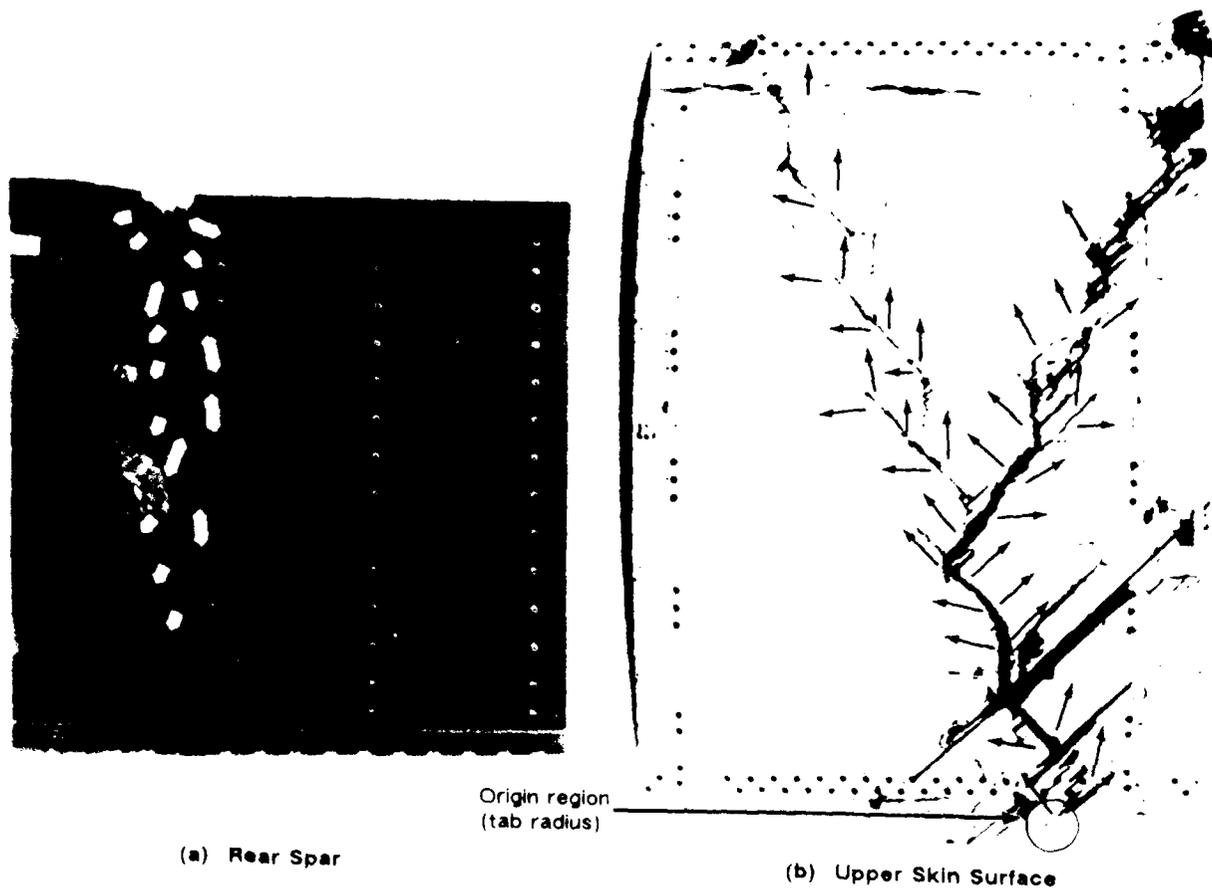
Figure 97. JVX Wing Test Box Crack Mapping Results

At this point the question of the sequence of failure between the upper skin and the rear spar was asked. Experience with fracture analysis of large composite structures indicated that smaller, well defined origin regions tend to initiate at lower overall strain levels at locations such as notches or holes and therefore exhibit less damage at the origin zone. The larger, ill defined origin zones tend to be indicative of overload, or rather, high overall strain fractures (with extensive damage) and are often not

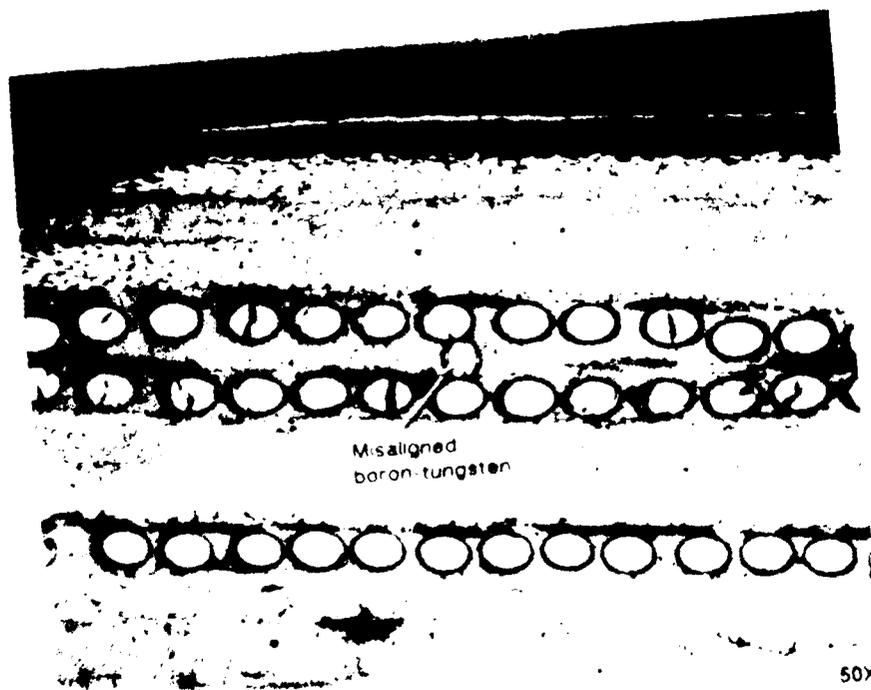
Figure 104. Cross Section Illustrating Boron Fiber Misalignment Resulting in Resin-Rich Adjacent Regions

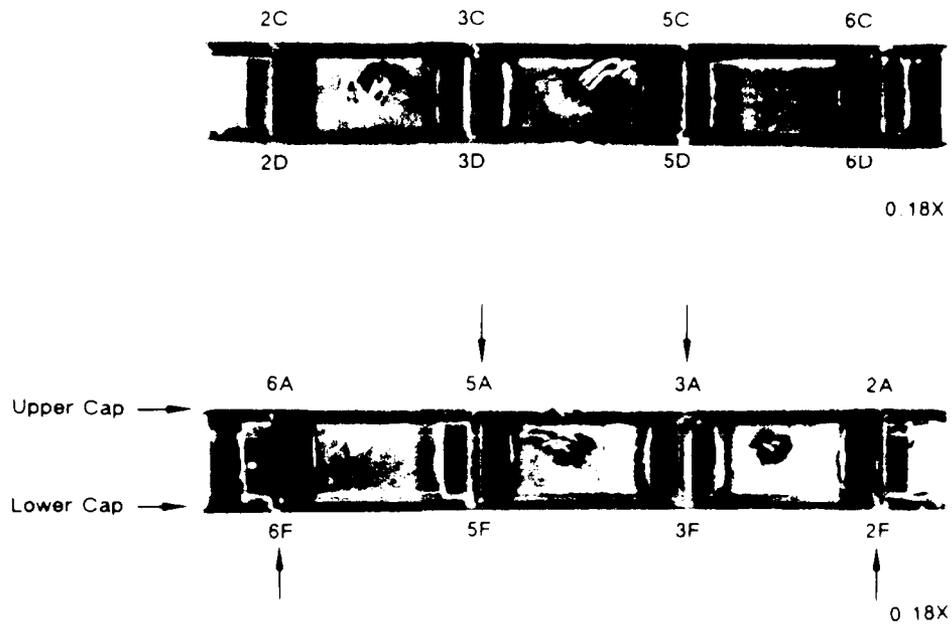
Figure 108. CFRP I-Beam in the As-Received Condition
