AN INVESTIGATION OF MICROBIOLOGICALLY MEDIATED CORROSION OF COPPER-NICKEL  
PIPING SYSTEMS SELECTIVELY TREATED WITH FERROUS SULFATE

Patricia Wagner<sup>1</sup>, Brenda Little<sup>1</sup>, and Louis Janus<sup>2</sup>

<sup>1</sup>Naval Ocean Research and Development Activity  
NSTL, Mississippi 39529-5004

<sup>2</sup>Chemistry Laboratory, Ingalls Shipbuilding  
Pascagoula, Mississippi 39567

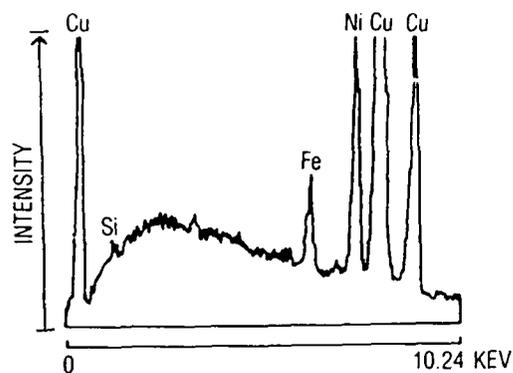
The EDAX spectra of the pipe surfaces were essentially identical despite the varying initial treatments. Pipe surfaces were predominantly copper, nickel, and iron. A sample spectrum is shown in Figure 2. Over the 8-month exposure period, all surfaces exposed to Pascagoula River water accumulated silica, phosphorus, sulfur, chlorine, potassium, and calcium (Fig. 3). Pipes 2 and 3 did show a temporary increase in surface Fe immediately after batch treatment. However, this increase was not evident at the next sample collection after two weeks.

Figure 2. Representative EDAX spectrum of pipe surfaces after initial treatments

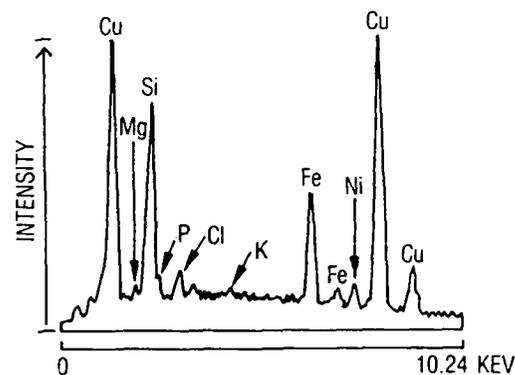
Figure 3. Representative EDAX spectrum of pipe surfaces after 6 month exposure period
