CONDITION SURVEY OF LOCK NO. 2 MONONGAHELA RIVER

G. S. Wong, R. L. Stowe, J. C. Anvin, & G. J. ...
Structures Laboratory

August 1988
Final Report

DEPARTMENT OF THE ARMY
US Army Engineer District, Pittsburgh
Pittsburgh, Pennsylvania 15222-4136

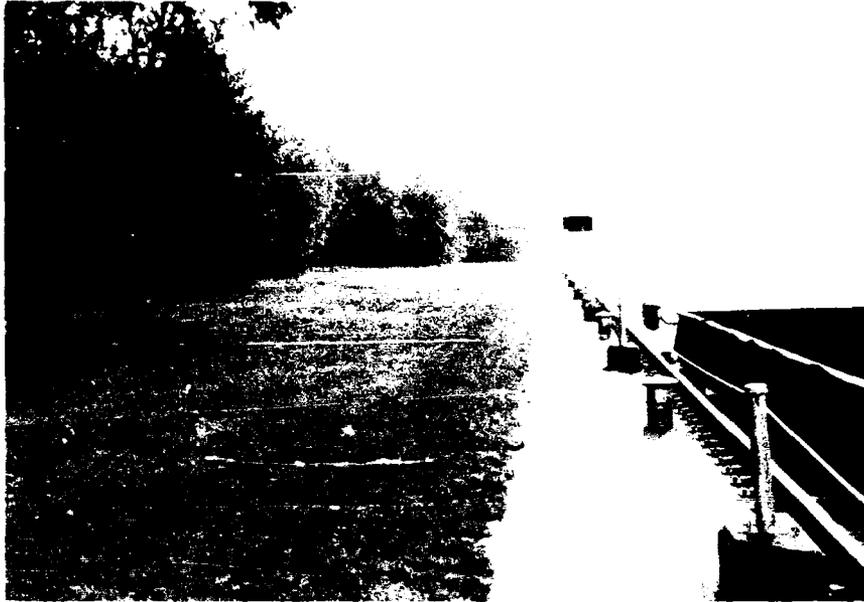
Figure 1. Grassed area behind upper guide wall

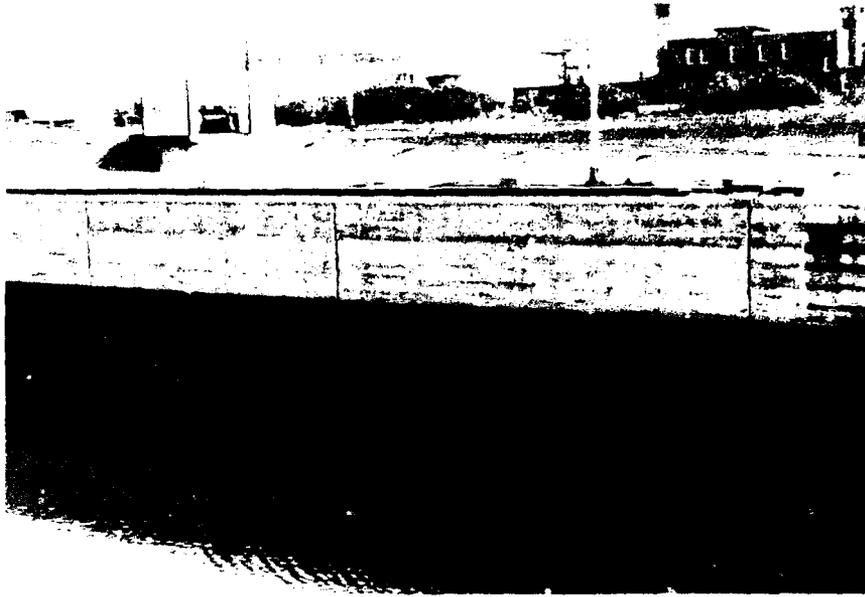
12. River face. The surface is generally in good condition. Below the upper pool elevation there is some minor spalling of the monolith joints. Surface above the upper pool shows 20 percent exposed aggregate and small joint spalls (Figure 2).

Figure 2. River face of the land wall, large chamber

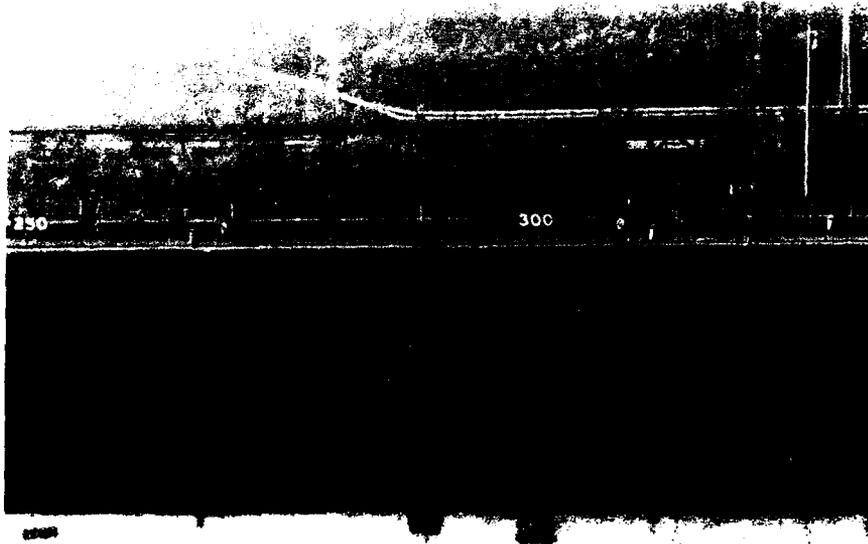
16. Land face. The concrete above upper pool elevation is in good condition. The concrete below the upper pool elevation contained approximately 5 percent severely scaled concrete and approximately 30 percent lightly-scaled concrete. Severe spalling was present along the monolith joints (Figure 5).

Figure 5. Severe spalling along monolith joints in land face of middle wall

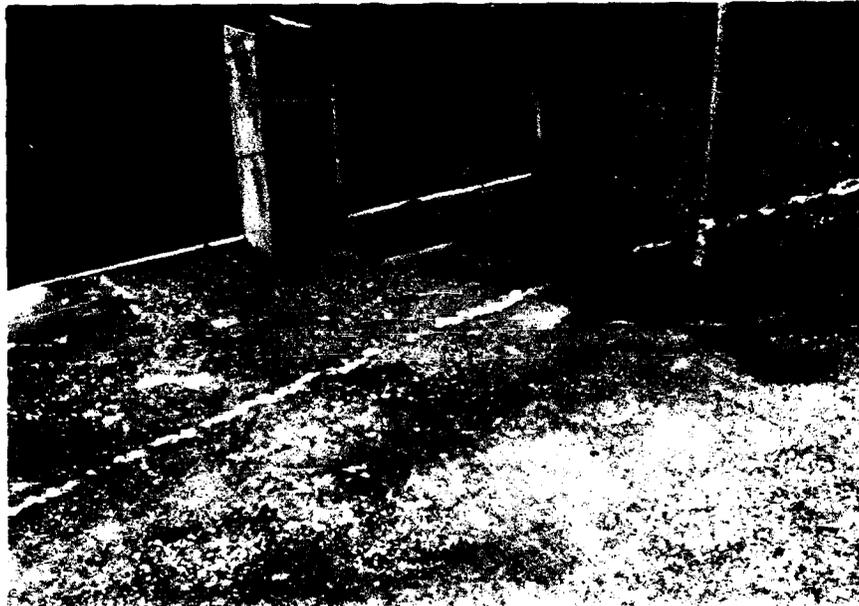
Photograph A17. Cracking near gate recess monolith R-12 of river wall

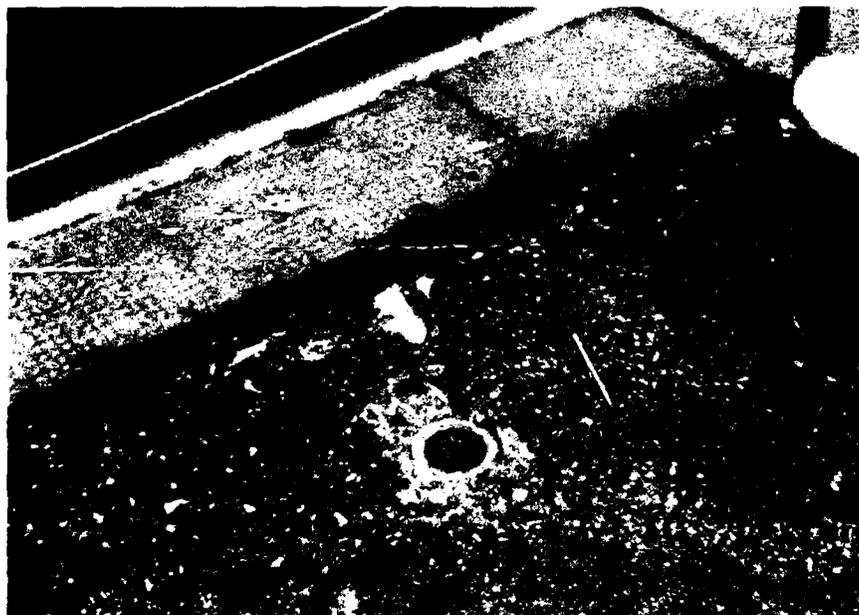
Photograph A18. Top of monolith R-13 river wall near upper gate recess

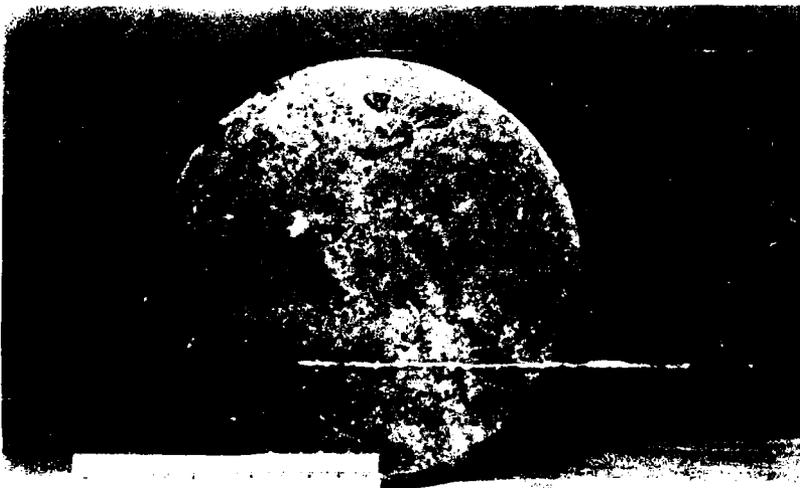
Photograph C3. Surface concrete at L-1. The surface concrete is in good condition

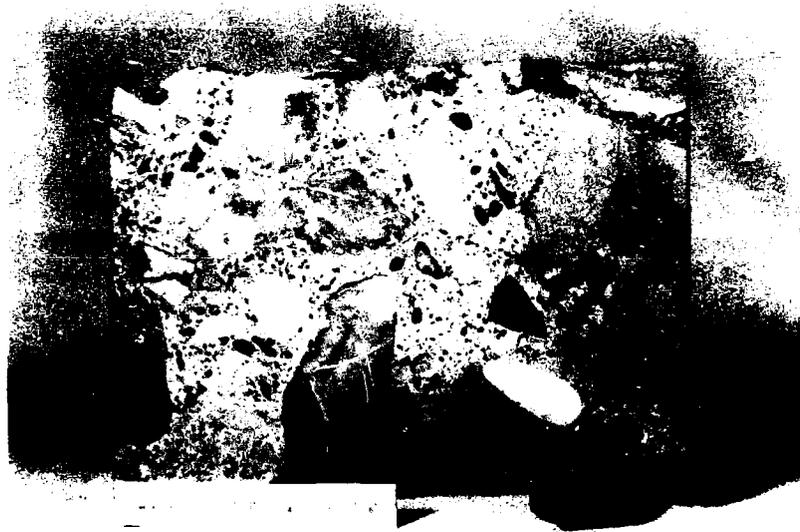
Photograph C4. Concrete from R-4. Hairline cracks are through coarse aggregate and paste. Note the reaction rim around the aggregate at the bottom center. The texture of this aggregate is crystalline dolomite with a matrix of fine-grained calcite
