DTIC FILE COPY TECHNICAL REPORT GL-88-9

# RETROGRESSIVE FAILURES IN SAND DEPOSITS OF THE MISSISSIPPI RIVER

EMPIRICAL EVIDENCE IN SUPPORT OF THE  
HYPOTHESIZED FAILURE MECHANISM AND  
DEVELOPMENT OF THE LEVEE SAFETY  
FLOW SLIDE MONITORING SYSTEM

PART II: CASE HISTORY OF THE CELOTEX BATTURE AND LEVEE FAILURE OF  
30 JULY 1985

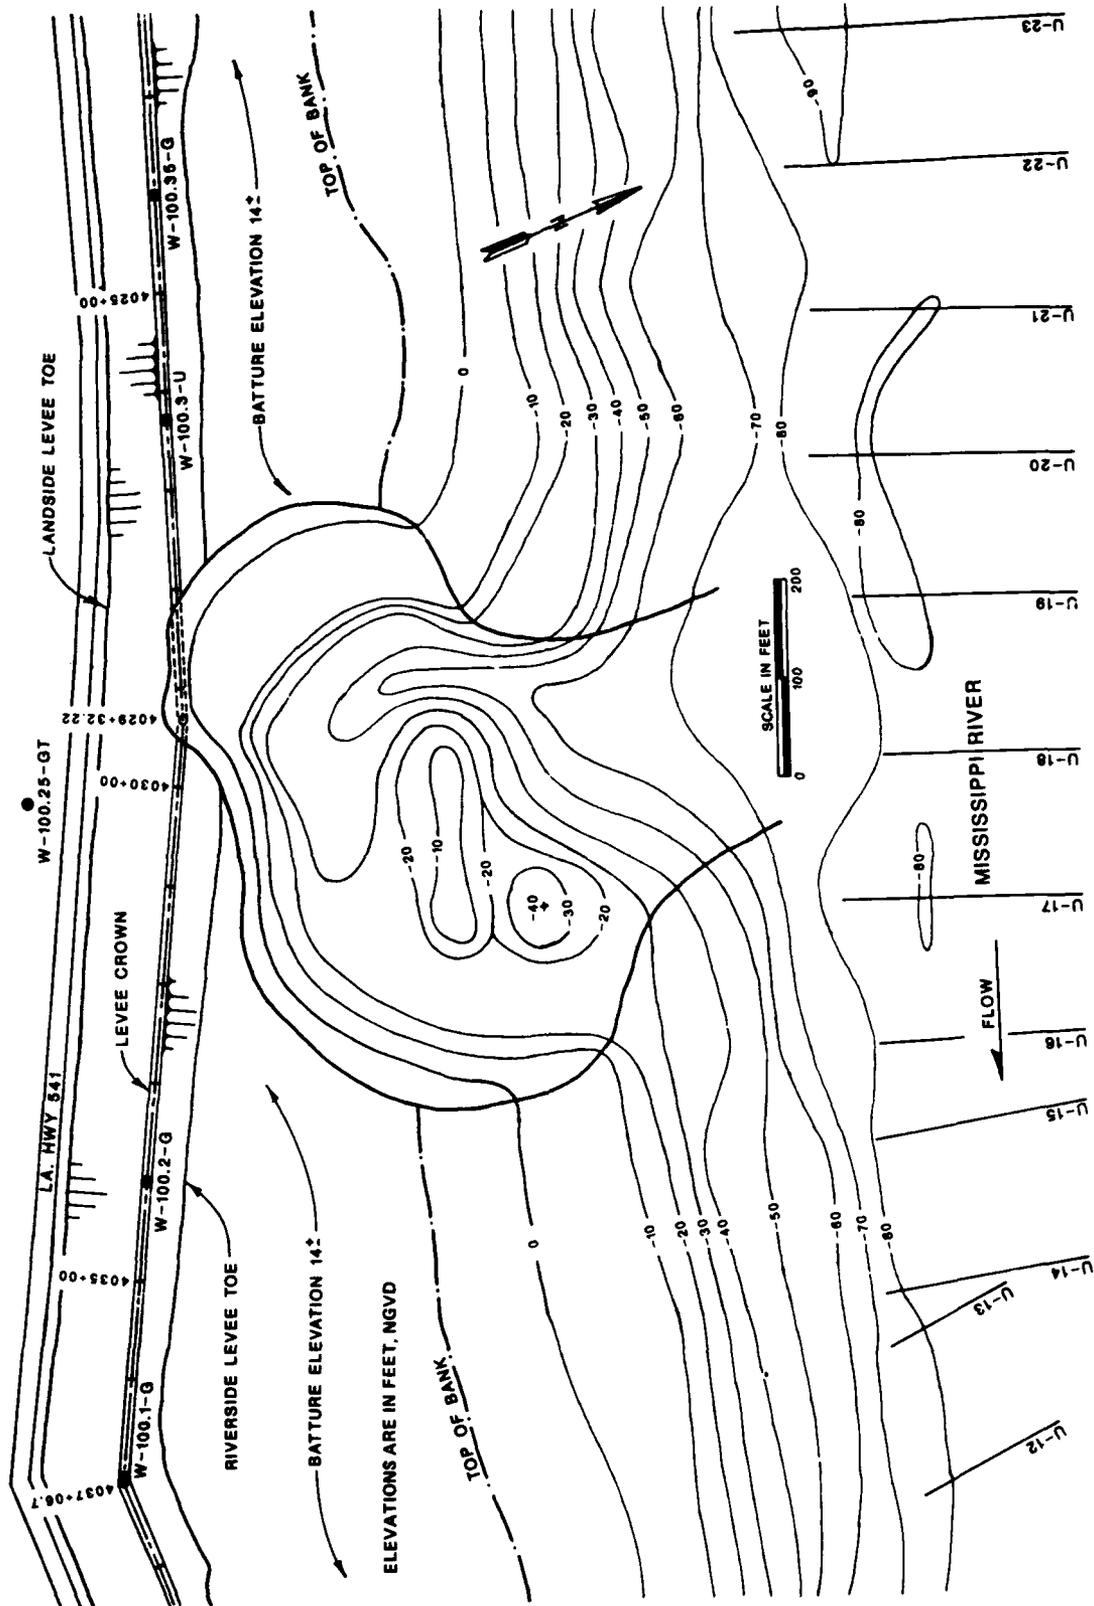
Figure 5. Contour map of the Celotex batture and levee failure

10. The author employed the Fathometer surveys and the boring information within the failure area to produce the contour map shown in Figure 5. Sections are plotted in Figure 6. Three-dimensional microcomputer images of the failure are given in Figures 7 and 8. The plan and sections of the failure reveal the bottleneck plan view and relatively flat bottom slopes typical of a flow slide. The line of borings taken between Greenville Bend revetment ranges U-18 and U-19 for the purposes of determining if overburden remained in the scar proved to be a fortuitous accident with respect to their position in revealing some important aspects of the failure's appearance as well as suggesting a sequence of events to be addressed later. This circumstance emphasizes the need that surveys of future flow slides be done in greater detail so that quality contour views can be constructed. Survey range lines should never be more than 100 ft apart and should extend to the thalweg. Portions of failures above water should also be surveyed after the fashion necessitated by the repair method for Celotex. The surveys should be initiated as close to the failure event as practicable even if the failure is only to be graded and revetted or even if the failure is in unrevetted bank. Such quality physical pictures of flow failures are now especially important data to help eliminate any doubts about predictions of potential batter loss included in the flow slide bank monitoring system to be discussed in the next part of this report. Simple microcomputer software is available to draw contour maps and three-dimensional views which can be rotated and sectioned at will.

15. In studying the plan and sections of Figures 5 and 6, respectively, the author conjectures as to a possible sequence of events. From the plan view of Figure 5, the failure has the appearance of dual lobes with a main body of the more symmetrical nature of a flow slide and a lobe in the landward, upstream portion (upper right portion of the plan view) which represents the involvement of the levee section and has the U-shape of a typical shear failure. A line of borings was logically taken straight out riverward from the center of the levee slide between revetment ranges U-18 and U-19 to investigate the presence of overburden material remaining in the failure scar. Those borings coupled with the Fathometer surveys of ranges U-18 and U-19 indicate that a narrow trench considerably deeper than the remainder of the failure existed along the line of borings. It would appear likely that the overburden material encountered lay only in that trench as indicated in the section of Figure 6. The other evidence of probable overburden remaining in the scar is the mound shown in Figures 5 and 6 between revetment ranges U-17 and U-18 which may have been a top stratum chunk which broke away but was not carried out into the river. From the section of Figure 6 for range U-17, it is shown that the "depression" to the riverward side of the chunk is in conformance with the general "bowl" elevation of the failure. The computer images of Figures 7 and 8 make this more evident. It is feasible that, at some time during the progress of the main failure, scour conditions also triggered a deeper additional outflowing which may be evidenced by the trench between ranges U-18 and U-19. That secondary flow may have produced instability in the top stratum and levee resulting in a shear failure and the movement

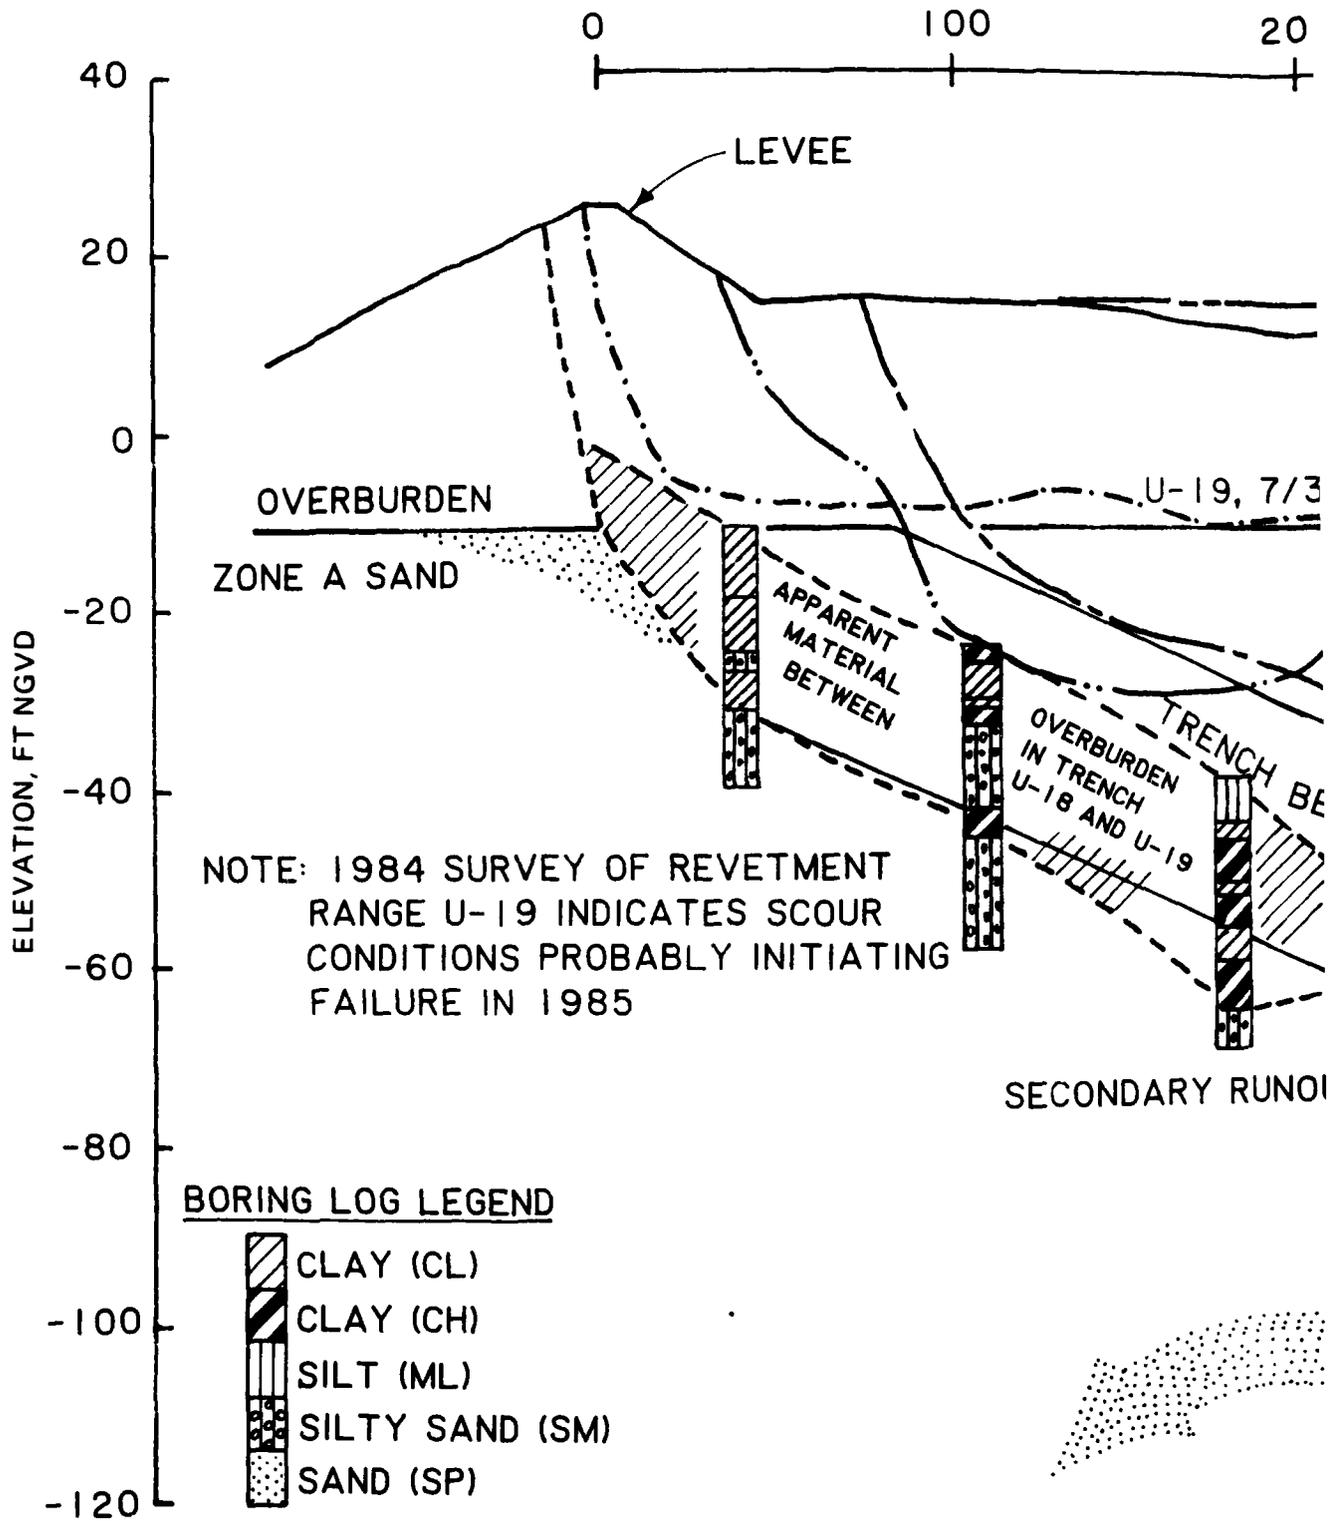
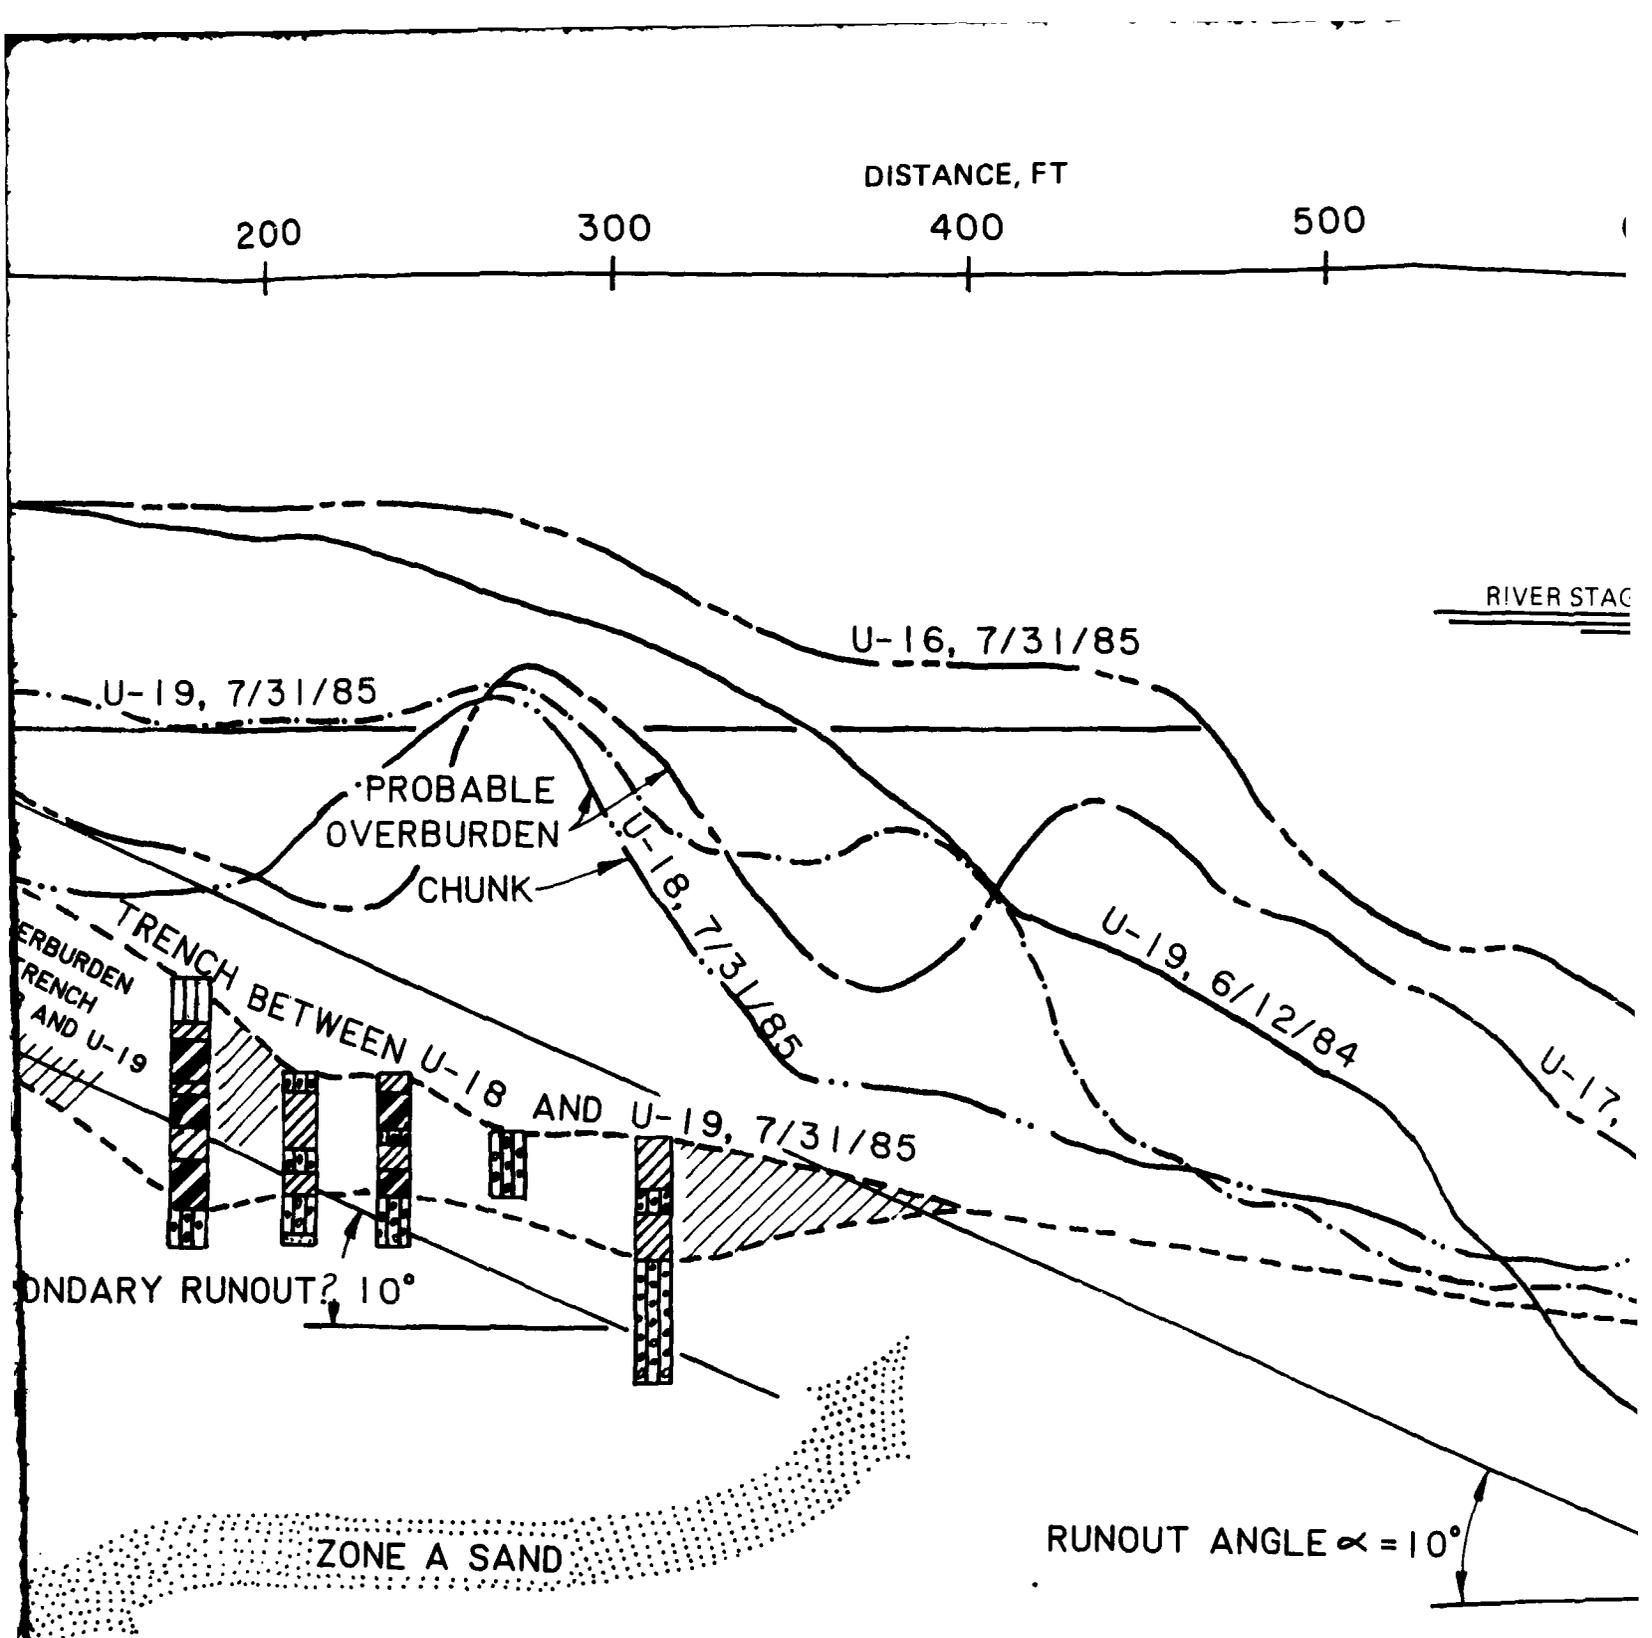
Figure 6. Cross sections of the Celotex failure

22. Turning back to the sections of the Celotex failure of Figure 6, two important observations are as follows:

- a. Assuming that the scour which triggered the failure in 1985 was similar to that seen in the 1984 survey at revetment range U-19, the projection of a 10-deg runout angle from that trench closely conforms to the extent of batture loss. It must be remembered that the runout angle is a sand failure parameter so that projection of the angle is up to the base of the overburden. A failure slope in the overburden can conservatively be taken as 45 deg, i.e., treating the overburden as a clay failing in unconsolidated, undrained shear ( $Q$  strength,  $Q = 0$ ). This overburden failure slope will usually be conservative with respect to batture loss because it has been commonly observed that overburden scarps in flow slides are nearly vertical in a significant upper portion. There is no mystery behind the near vertical upper portion of overburden scarps because tension cracks of considerable depth would form as a section of overburden is undercut and cantilevered by the outflow of underlying sand. The thinner the overburden, the more likely the scarp will be near vertical. Secondary mass instability in the overburden is always possible depending on its strength profile and the presence of any bank loadings such as the levee.

- b. The trench of the Celotex failure between revetment ranges U-18 and U-19 presents an intriguing possibility. A 10-deg runout angle also fits the average bottom slope of the trench. This may represent a "clean" runout as previously postulated during which there was resedimentation in the area of the scour which triggered it and some scour modification.

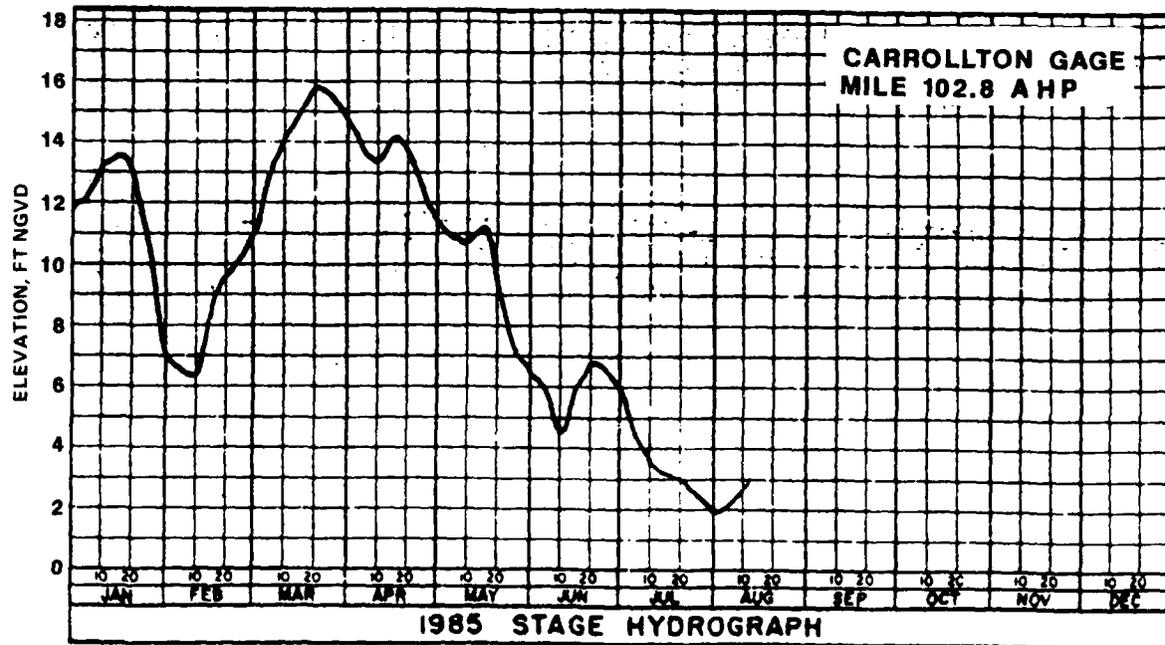
Figure 10. 1985 Mississippi River stage through the period of the Celotex failure

12. The stage hydrograph for the Mississippi River based on the Carrollton gage (about 2.5 miles upstream of the failure location) is shown in Figure 10. On the day of the failure (30 July), the river had reached its lowest stage of the period at about el 2.0. The construction sequence for the batture and levee restoration given previously in paragraph 9 states that the river was on the rise during repair operations. The river had been on the fall prior to the failure since about 21 June at an average rate of only about 0.1 ft per day. Years ago, in the LMVD Potamology Investigations studies, seepage gradients in sands and silty sands resulting from such rates of falling stage were dismissed as playing a role in the general case of instability of Mississippi Riverbanks (Clough 1966) as well as in triggering of flow failure (US Army Engineer Waterways Experiment Station (USAEWES) 1950).

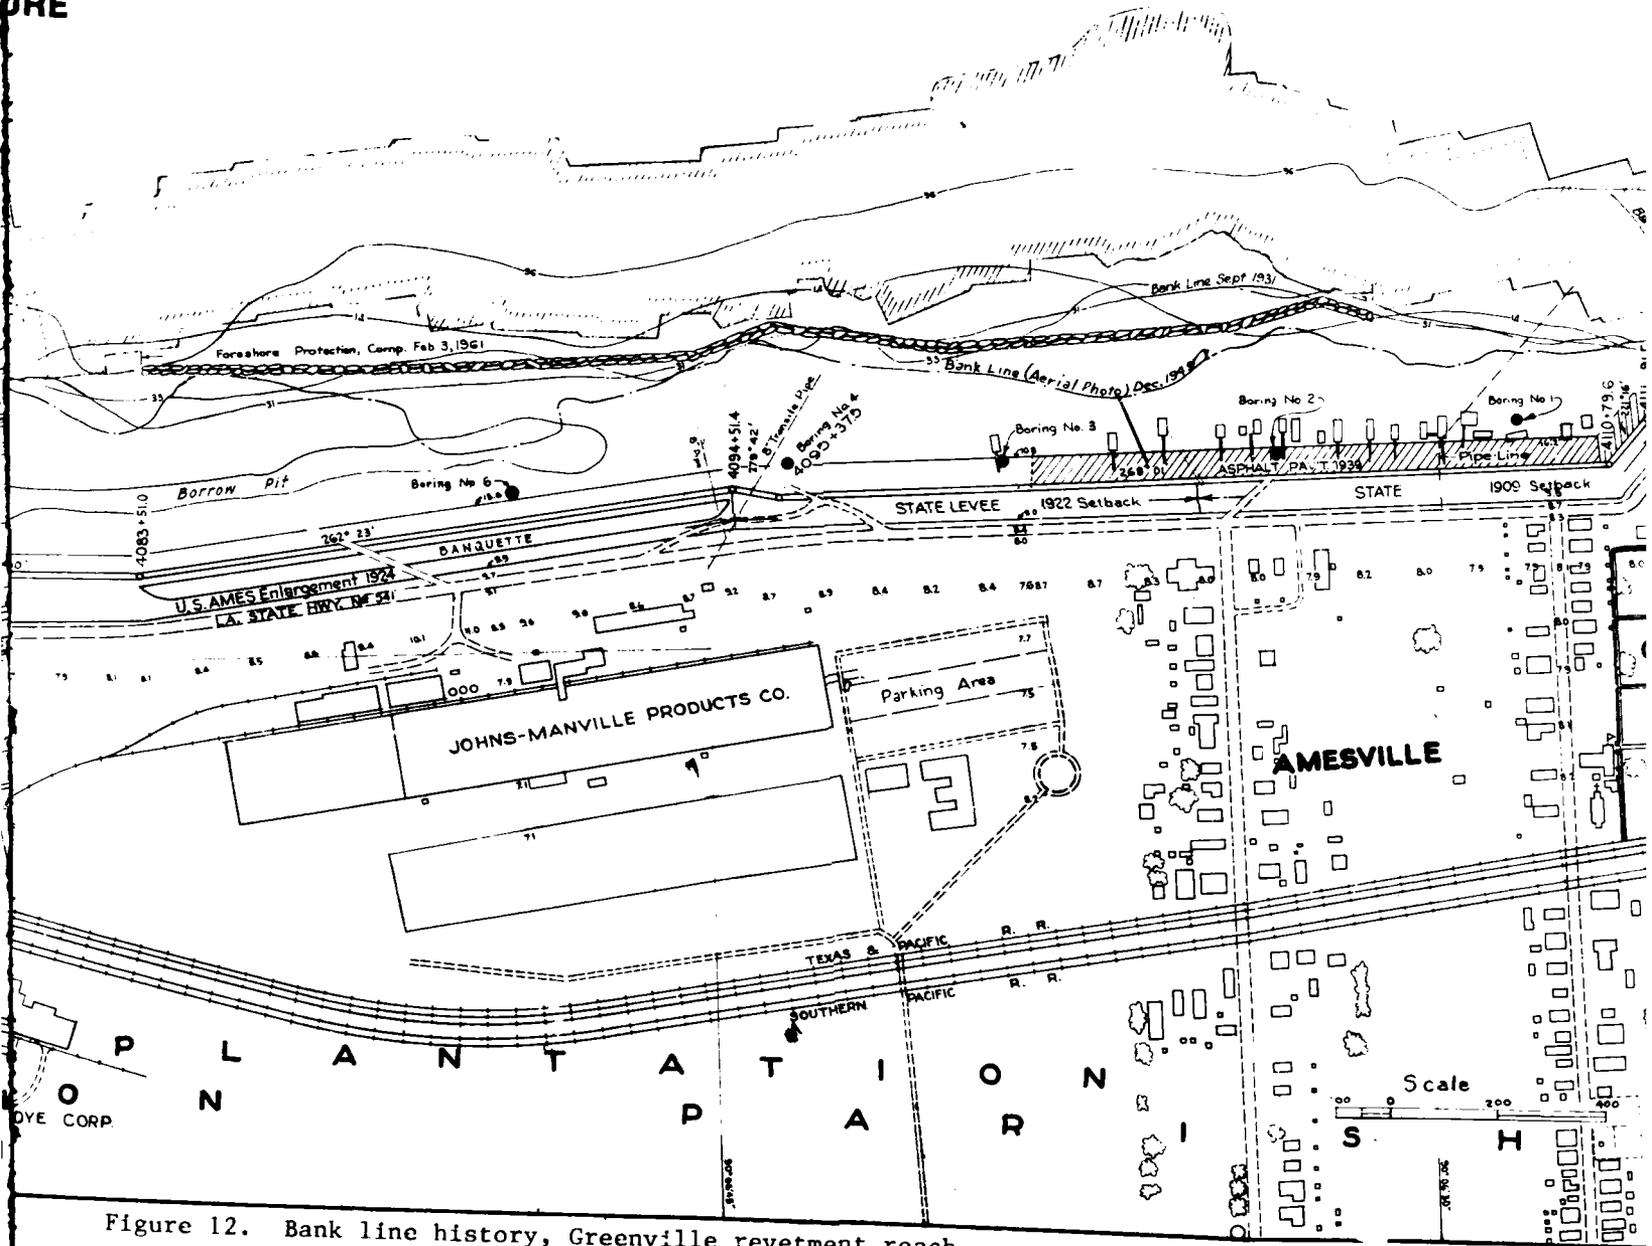
Figure 12. Bank line history, Greenville revetment reach

16. The history of the bank line along Greenville Bend revetment reach is shown in Figure 12 (file map, New Orleans District). The bank line in 1949 was determined from aerial photos. Earlier bank lines were established by ground surveys. The most apparent observation is that a major bank failure area existed in 1896 precisely at the Celotex location. In addition, looking downstream, other scallops are seen in the bank line over the years. In 1901, 1909, and 1922, setbacks were constructed in front of Amesville, LA, and the old General Alcohol Co. indicating the severity of bank losses during those times. A major failure highly likely to have been a flow slide because of the proportions of the batture loss is indicated in the 1900 bank line in front of the alcohol company complex. The 1973-1975 Mississippi River hydrographic survey shows a scour pool at this location. There is reason to believe that the bank loss patterns indicated by the old bank line data can be expected in the future all along the abandoned channel/point bar reach. The aerial photographs given as Figure 3 were taken in 1977 during an extremely low water period. Although small and difficult to see in the photographs, a scallop did exist at the Celotex failure location at that time. Other larger scallops are evident in Figure 3 in the downstream direction in various places in the point bar deposit. Of particular concern to the author is the very sharply defined scallop seen in the photograph just in front of the down stream end of the long, narrow complex of the Johns-Manville Co. (upper center of photo). The location corresponds to revetment ranges D-2 to D-3. Given the much smaller scallop preexistent at the Celotex site, this larger scallop demands special attention since the overburden is very thin, and no more batture than at Celotex protects the levee.

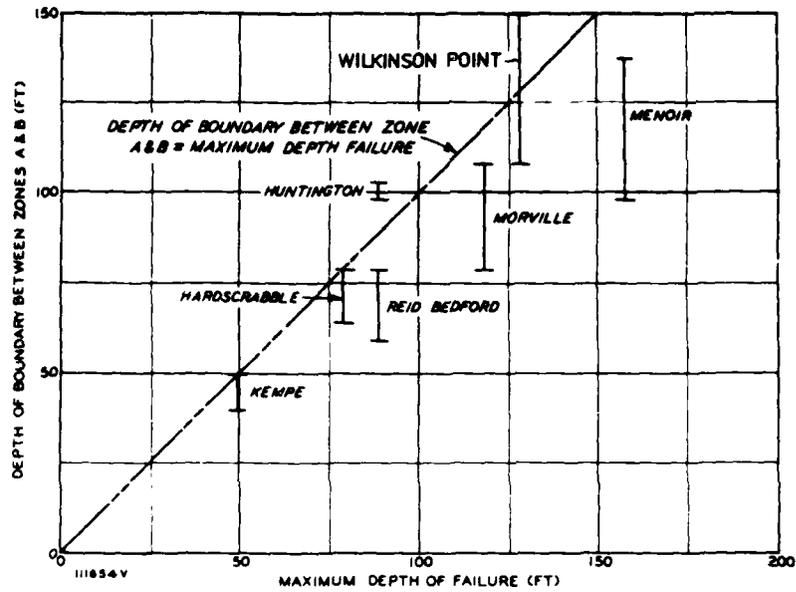
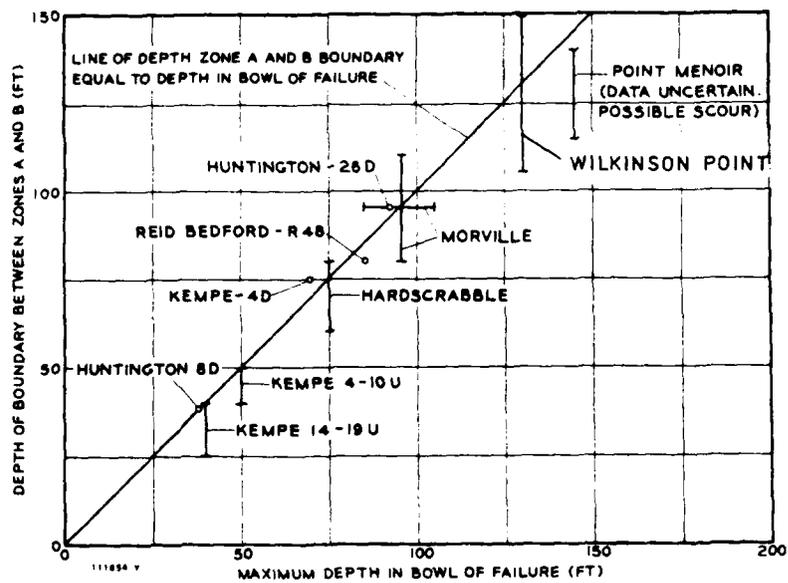
Figure 16. Depth of failure versus depth to Zones A and B boundary (from Potamology Investigations Report 12-5)

Report 12-5. Where Figure 16 shows that some failures extended into Zone B sands, two directions of reasoning arise:

- a. Scour conditions within the failures removed the additional sand below the Zone A/Zone B interface.
- b. The retrogressive mechanism also occurs in Zone B sands.

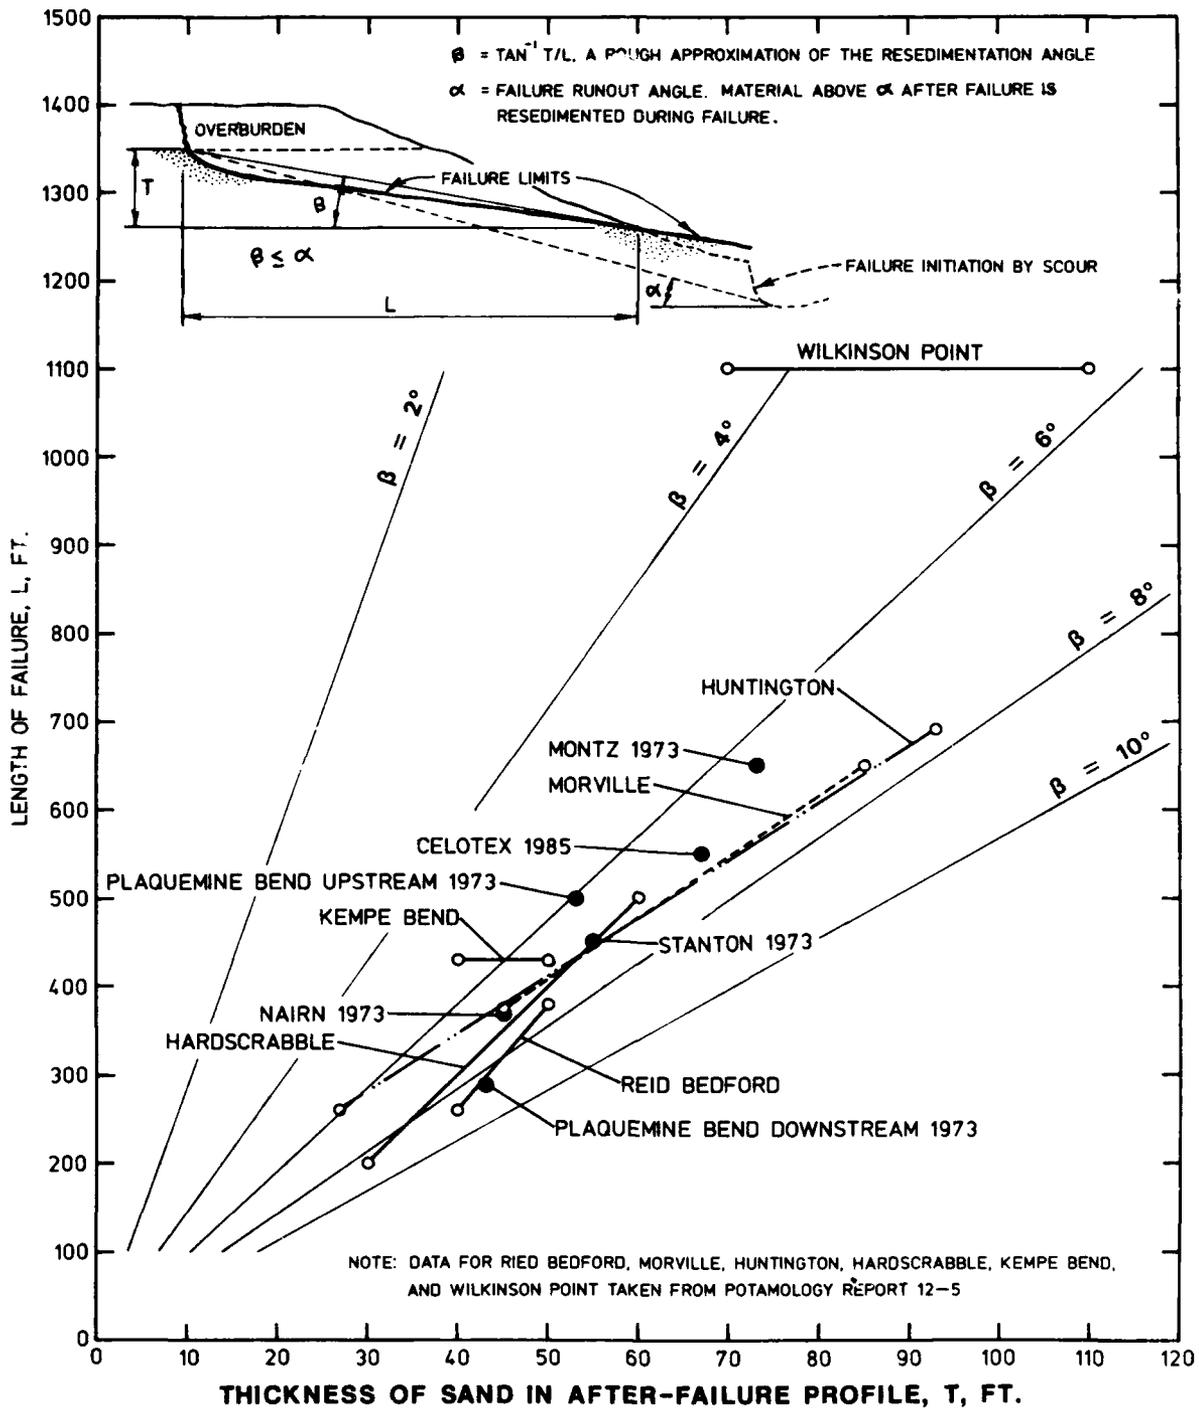
Figure 17. Estimation of a maximum value of runout angle  $\alpha$  from empirical values of resedimentation angle  $\beta$

21. The data of Figure 15 are plotted with data from the 1973 flow slides below Baton Rouge and the Celotex data in Figure 17. The parameters plotted in Figure 17 are explained in the inset on the figure. In keeping with the mechanism of failure illustrated in Figure 14, the beta angle,  $\beta$ , of Figure 17 is the approximate average slope of the resedimented material after failure. Note that in order for this to be true, the failure slope in the overburden must be relatively vertical as has been observed to be generally the case. If no major scour develops within the failure which removes material in excess of that involved in the retrogression mechanism,  $\beta$  must be less than or equal to the runout angle. If the failure proceeded with just the perfect assistance of scour such that every grain of sand raining off the retrogressing face and every piece of overburden were removed from the scar, then  $\beta$  would equal  $\alpha$ . In that special case, there would have been no resedimentation of any of the sand raining off the retrogressing face. It can be deduced from the sections of typical failures of record that with few exceptions some resedimentation does occur, and  $\beta$  is less than  $\alpha$ . This is because projections of the average  $\beta$  just do not conform to the concept of the scour pool/trench as the initiation point of failure. In other words, the projection of the average bottom slope of a typical failure would intersect the river bottom well out into the river and pass well above and beyond the scour pool/trench. The value of Figure 17 lies in the suggestion of a maximum

value for  $\beta$  and, therefore, a possible maximum value for  $\alpha$ . The author selects the maximum implied value of  $\alpha$  from Figure 17 to be 9 or 10 deg, say 10 deg, taken from the initiating point of scour. This is a valuable implication. However, does that 10-deg runout angle represent a maximum of a wide-ranging variable, or can it be taken as a representative value for all failures below Baton Rouge? It would be logical that a representative value is feasible because the range in Zone A gradations is not a broad one.
