AEFA Project No. 87-25

### EVALUATION OF THE IMPROVED OV-1D ANTI-ICING SYSTEM

April 1988  
Final Report

AVIATION ENGINEERING FLIGHT ACTIVITY  
Edwards Air Force Base, California 93523-5000

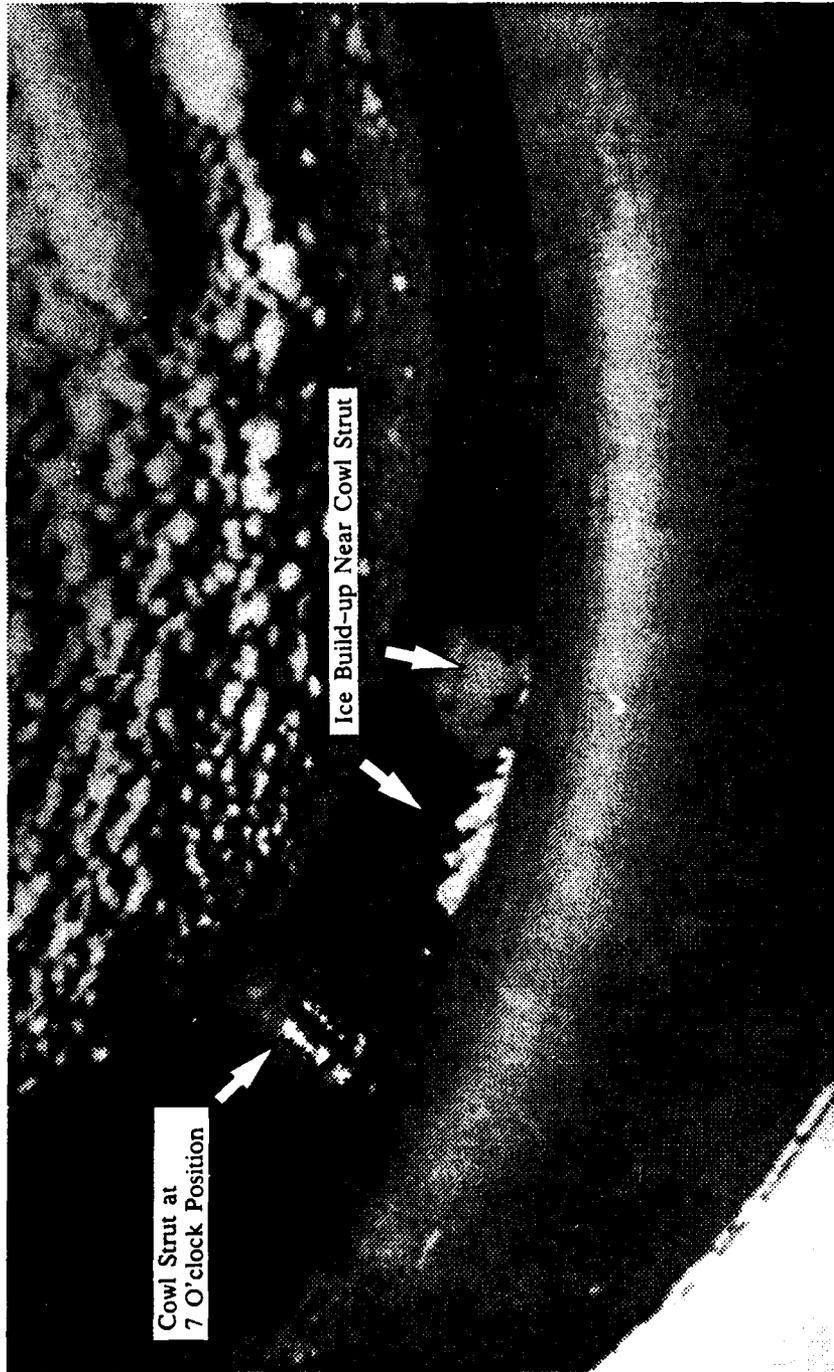
Cowl Strut at  
7 O'clock Position

Ice Build-up Near Cowl Strut

Figure E-4. Right Engine Cowl  
Conditions: Avg LWC = 0.63 gm/m<sup>3</sup>  
Avg OAT = -19.0 DEG C

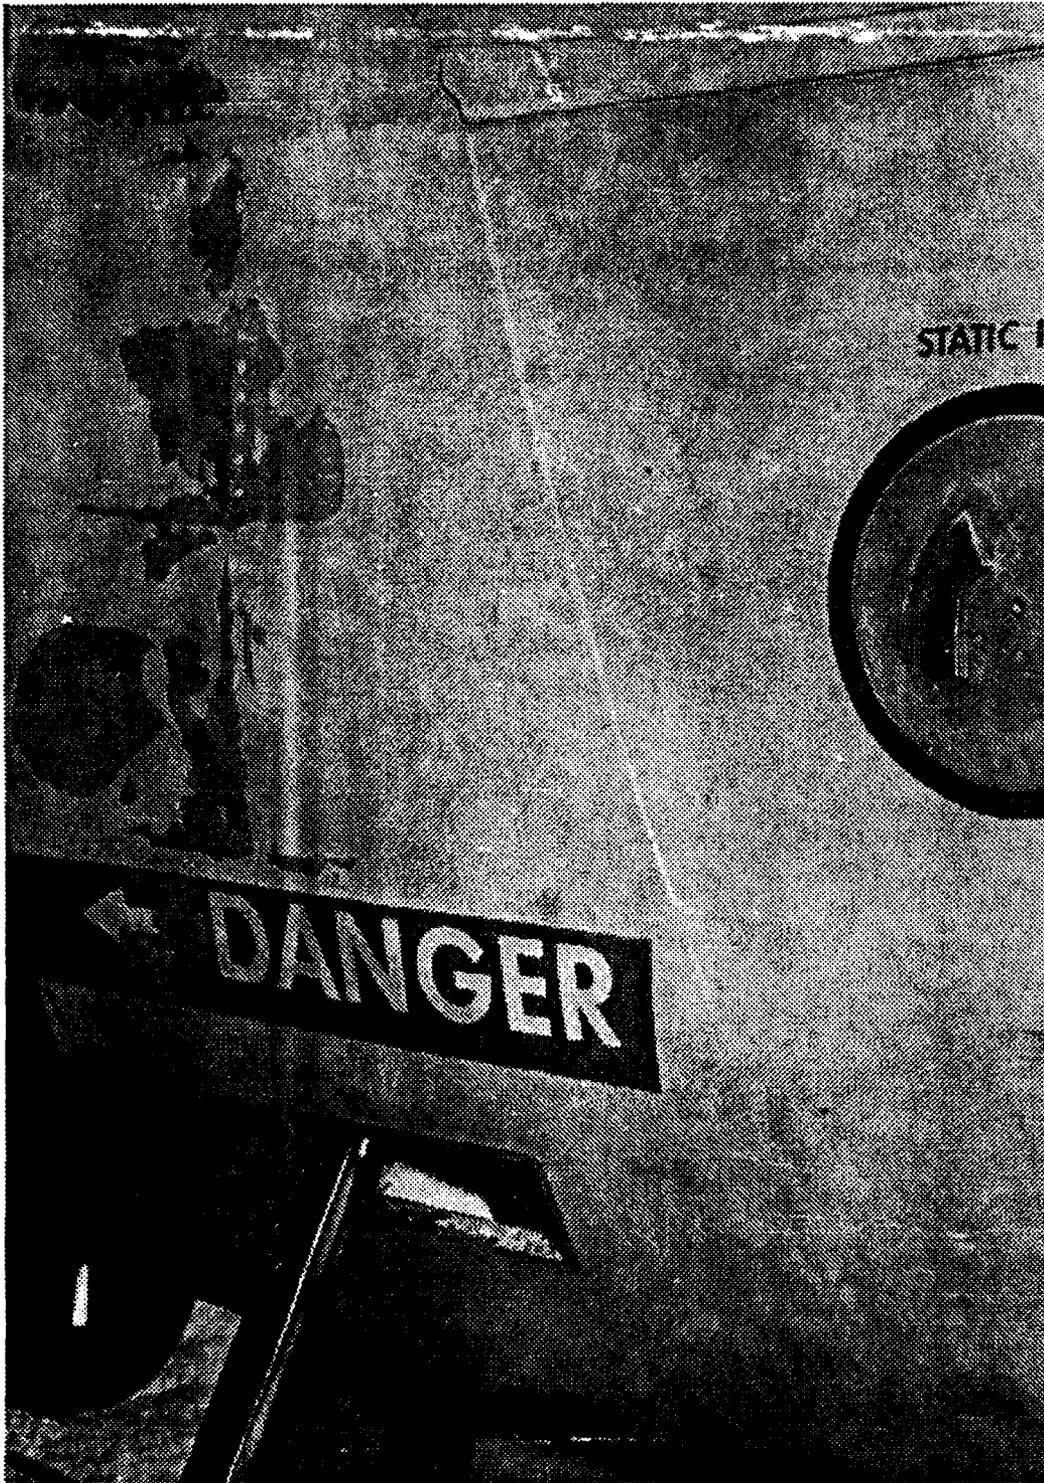
Figure E-6. Fuselage Damage from Ice Shedding

20. Propeller ice sheds occurred in all of the icing conditions tested. Ice departing the blades frequently hit the fuselage empennage or fuel drop tanks. Figure E-6 depicts fuselage damage resulting from propeller ice sheds. Dents as large as 3/8 inch deep and 4 inches in diameter were observed on one drop tank (fig. E-7). Airframe and stores damage caused by ice shedding from the propellers is a shortcoming as discussed in paragraph 11.

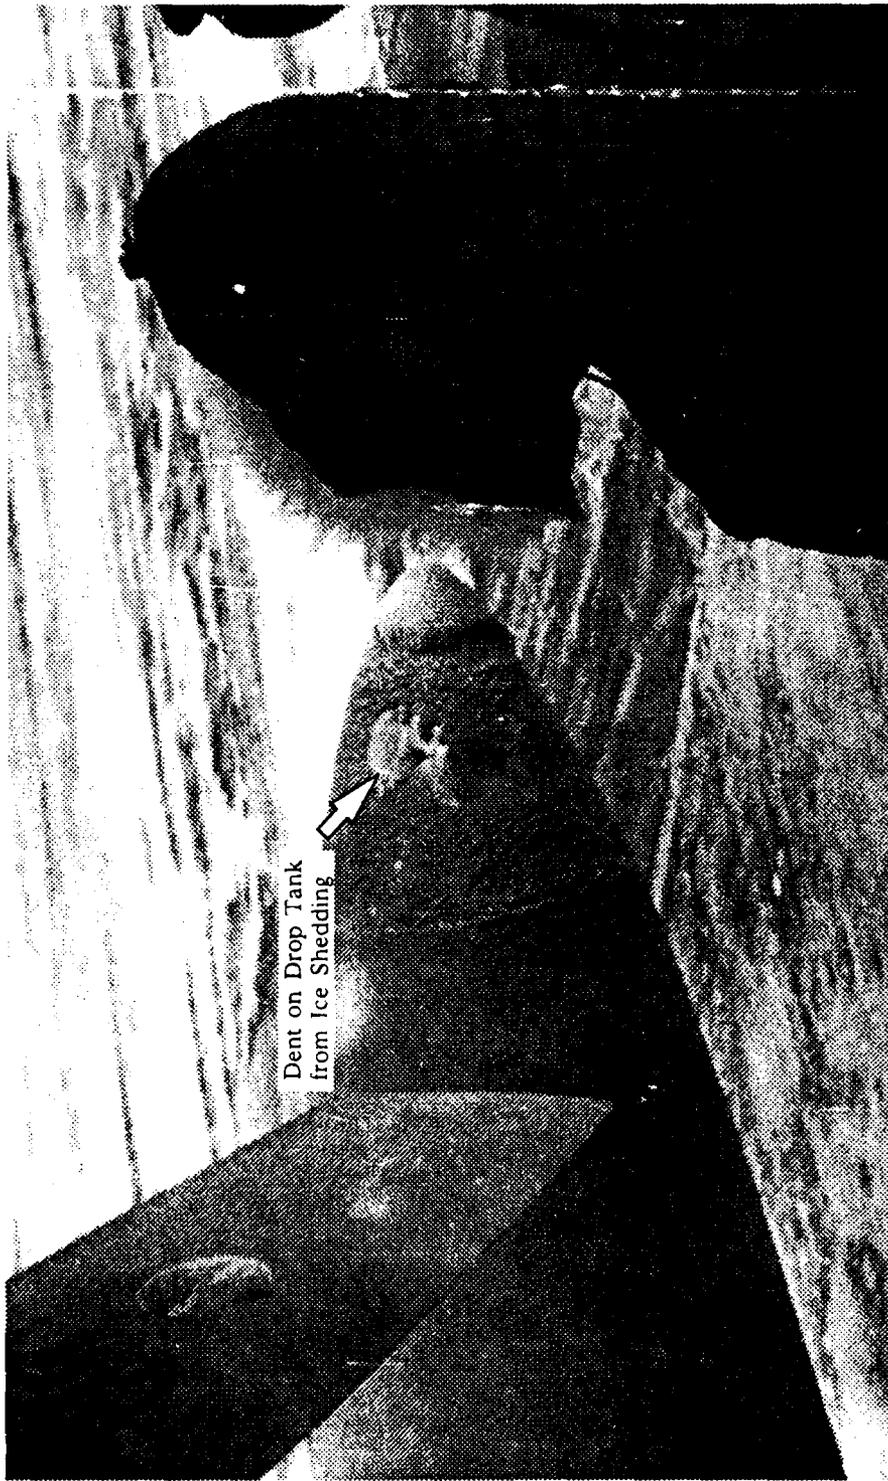
Figure E-7. Left Drop Tank

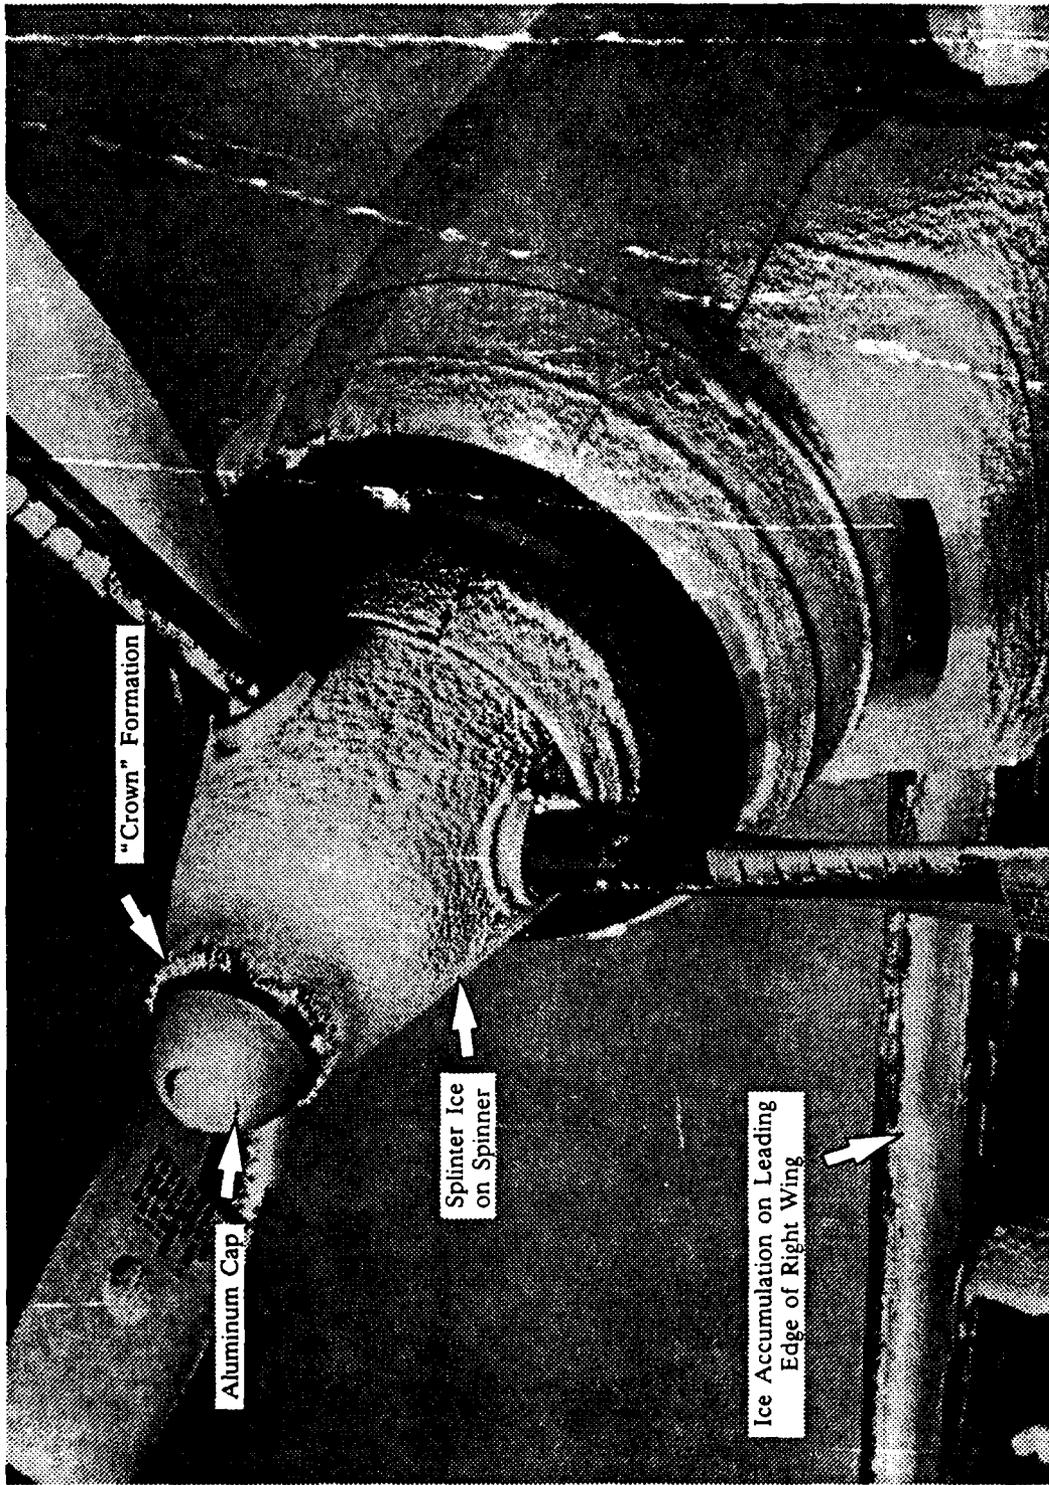
12. The propeller spinner nose was anti-iced at the aluminum cap only (fig. E-8). During artificial and natural tests, the spinner accreted ice in a donut or crown shape which was observed during one shed to go down through the propeller and away from the engine inlet area. Spine type splinter ice formations started growing on the spinner portion just aft of the "crown" and accumulated to a depth of 1/2 to 1 inch with the higher (0.5) LWC's and lower (-15 degrees C) temperatures (fig. E-8). Grumman analysis showed that any accretions on the spinner aft of the aluminum cap would be thrown out of the engine inlet area by centrifugal force and, therefore, was not considered to be an ingestion hazard to the engine. No ice from the propeller nose and spinner was observed being ingested by the engine.

Figure E-8. Right Engine  
Conditions: Avg LWC = 63 gm/m<sup>3</sup>  
Avg OAT = -19.0 DEG C

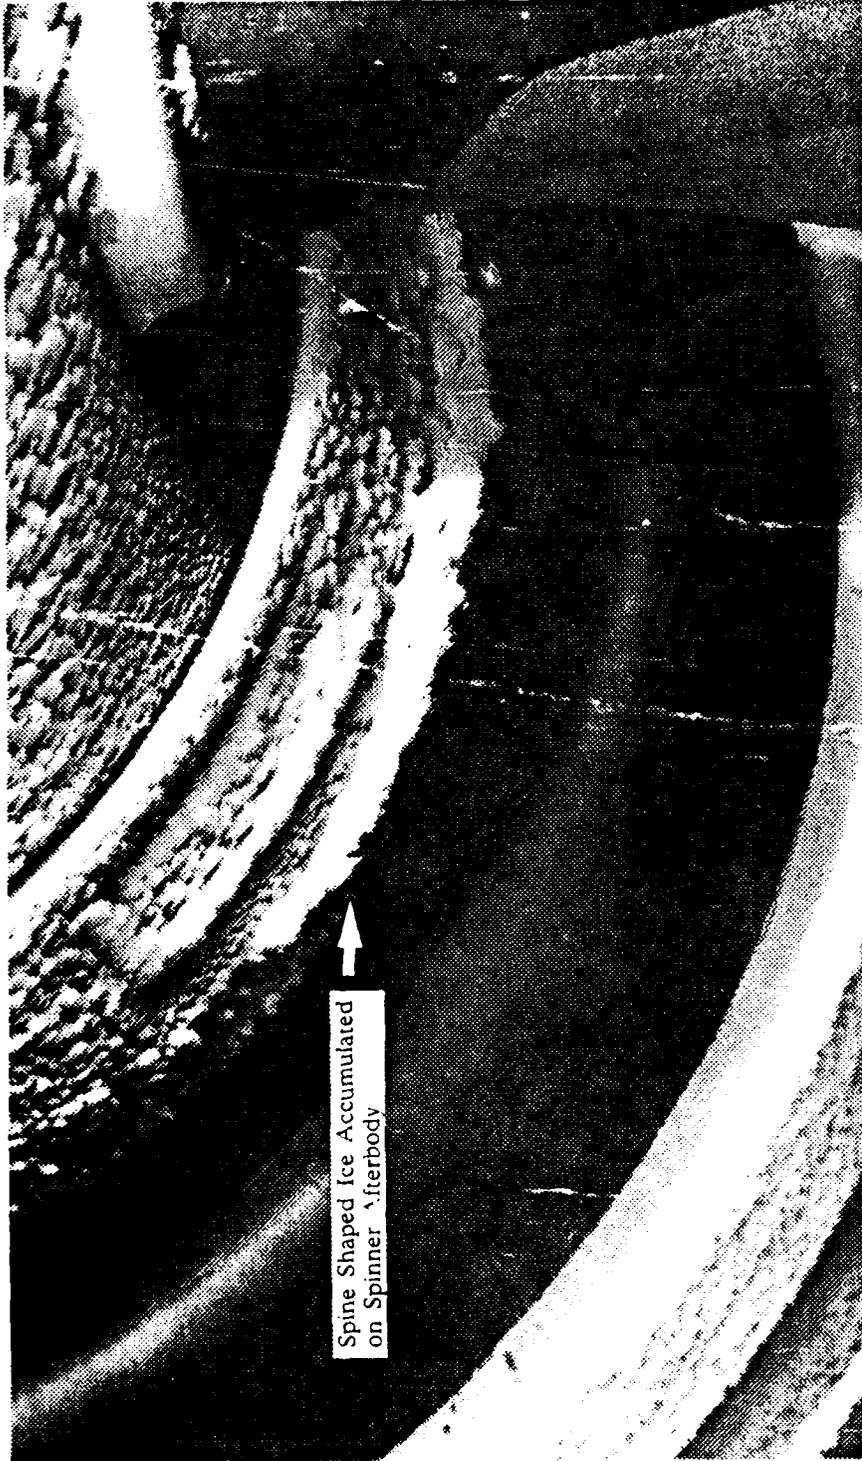
13. Spine shaped ice accreted on the spinner afterbody on the bottom portion from the 4 to 8 o'clock positions from the leading edge of the afterbody to approximately 6 inches aft (fig. E-9). During a natural icing encounter, ice accreted at the leading edge of the afterbody and grew forward to the point where it was impacted by the rotating propeller blade shank. When a section of the accretion was impacted by the propeller blade shank, it broke off and was ingested into the inlet and, therefore, is an ingestion hazard to the engine. The ice accretion and shedding characteristics of the propeller spinner afterbody in light and moderate icing conditions are a deficiency.

Figure E-9. Spinner Afterbody of Right Engine  
Conditions: Avg LWC = 0.63 gm/m<sup>3</sup>  
Avg OAT = -19.0 DEG C

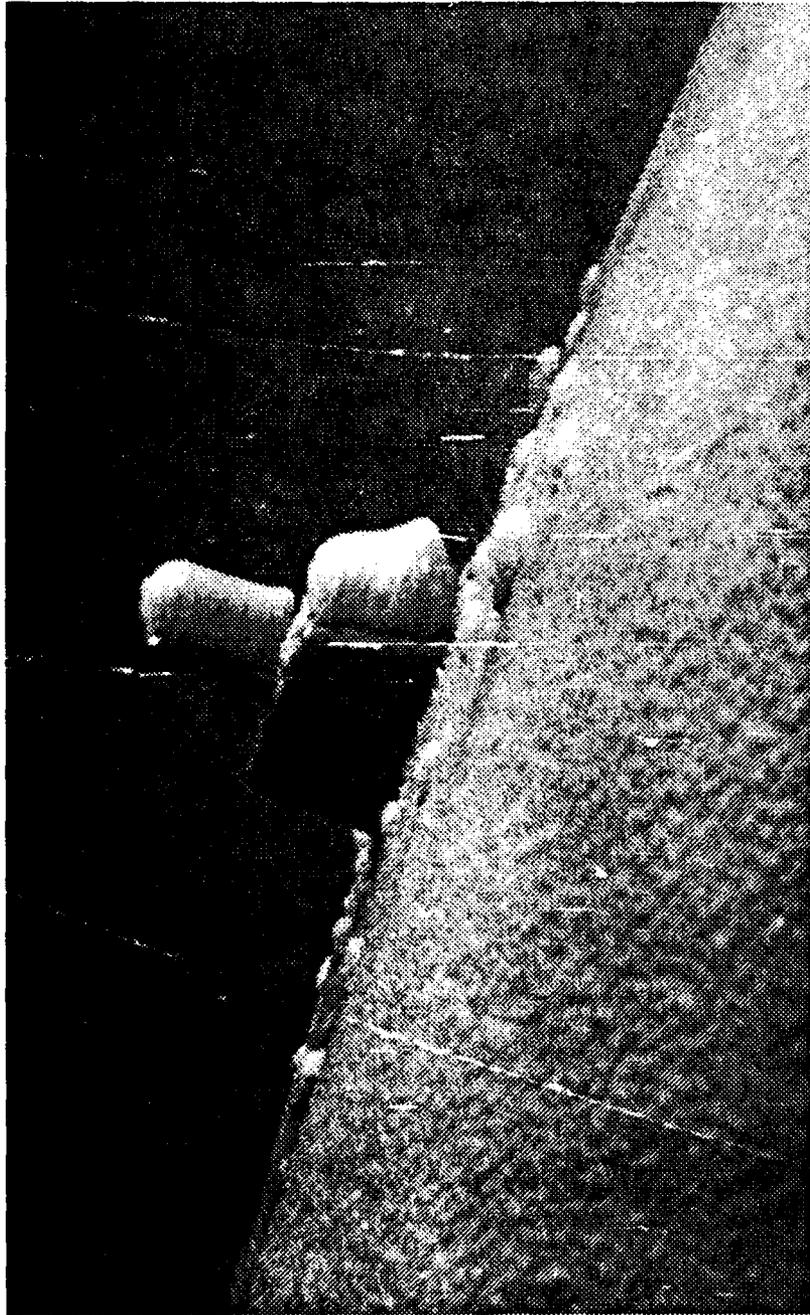
Figure E-10. Ice Accumulation on the Ice Detector Probe

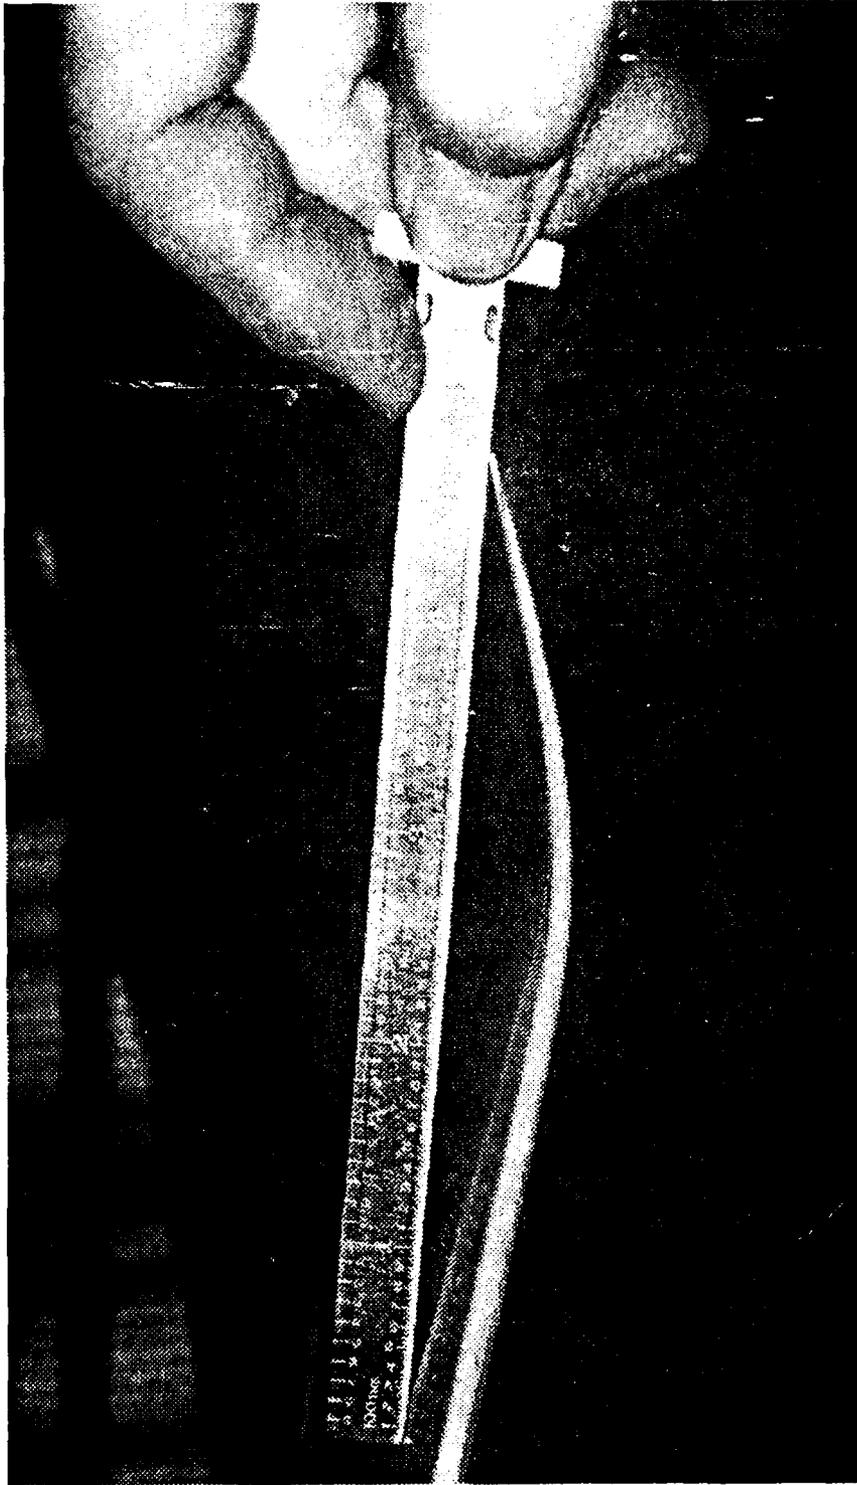
21. During a flight in natural icing conditions, a large chunk of ice, approximately 2 inches by 5 inches was observed to shed from the right windshield wiper arm and go through the right propeller, causing impact damage to one of the blades. The propeller blade damage is shown in figures E-12 and E-13. Ice accumulation on the left windshield wiper is shown in figure E-14.

Figure E-12. Propeller Damage

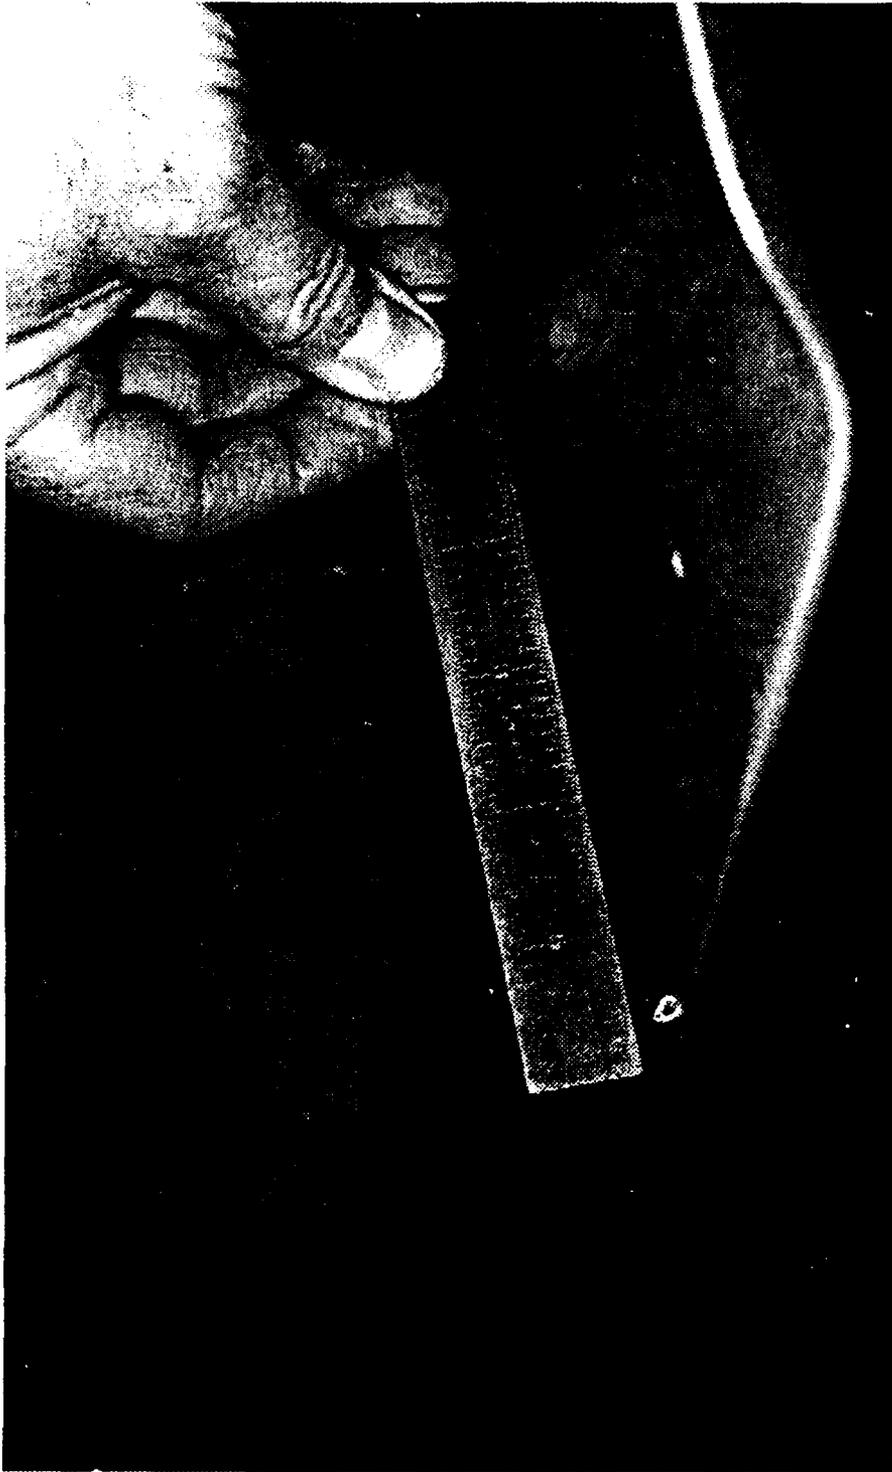
Figure E-13. Propeller Damage

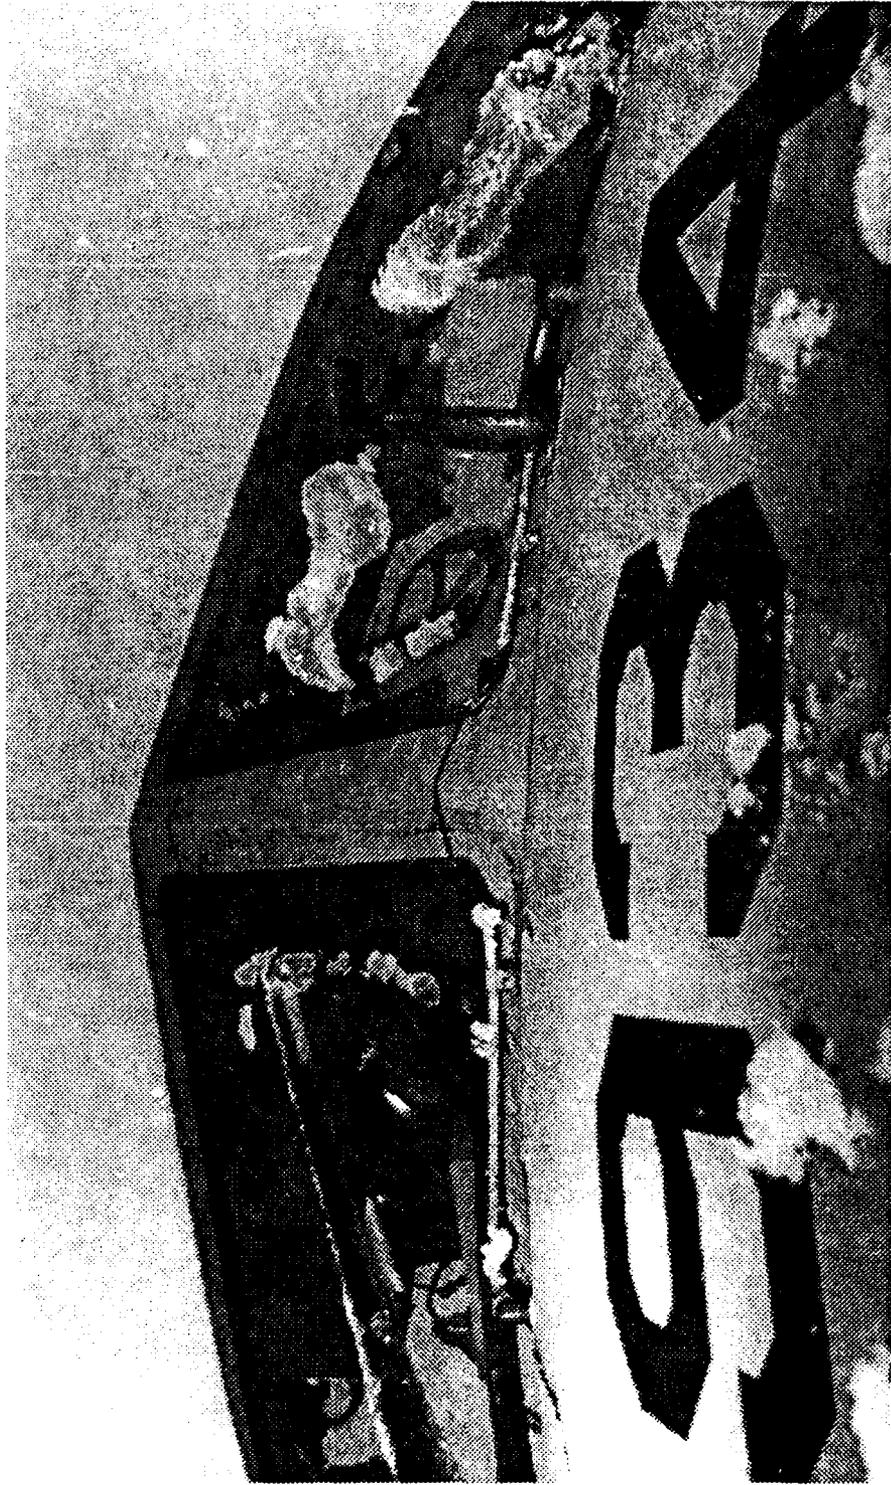
Figure E-14. Ice Accumulation of the Left Windshield Wiper

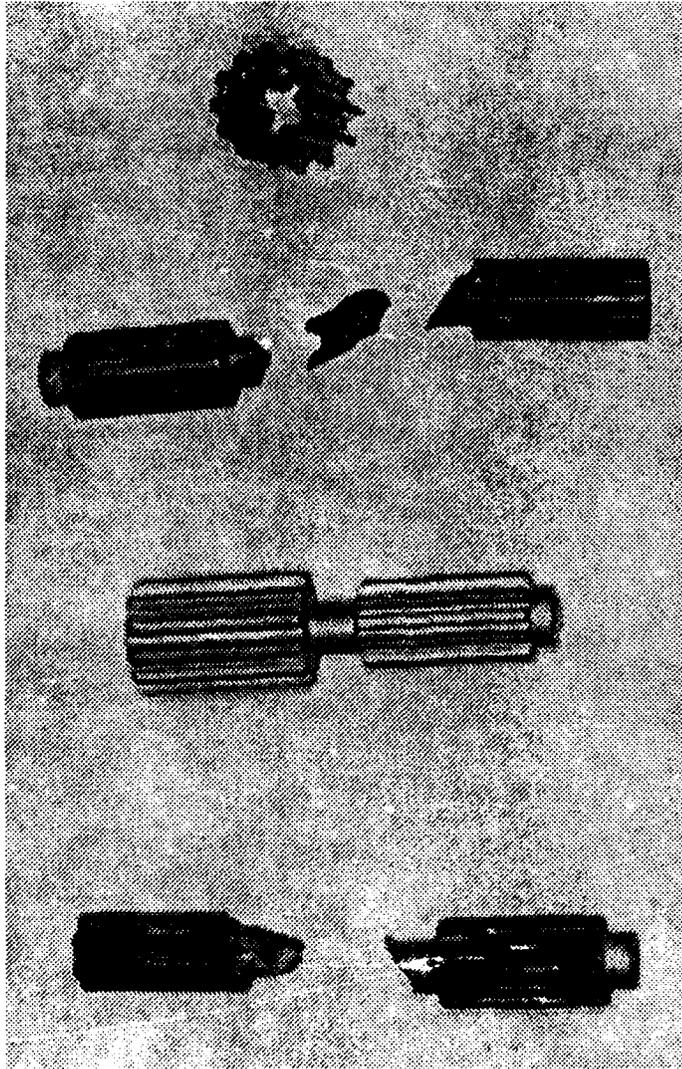
29. During the artificial and natural icing flight tests, a total of five AC generator drive shafts were sheared. This is the short shaft that connects the generator drive to the hydraulic pump drive shaft. Test Incidence Reports were submitted and a copy of each is included in appendix F. Figure E-15 shows the damaged shafts. GAC engineering believes the shafts to be too brittle to withstand the cycling loads imposed by the improved anti-ice system. The excessive number of AC generator drive shaft failures is a deficiency.

Figure E-15. Comparison of Damaged and Undamaged AC Generator Drive Shafts

57. Action: Replaced shaft.
