**Disorientation Accidents and Incidents  
In U.S. Army Helicopters**

**1 January 1980 - 30 April 1987**

**P. Vyrnwy-Jones**

**United States Army Aeromedical Research Laboratory  
Fort Rucker, Alabama 36362-5292**

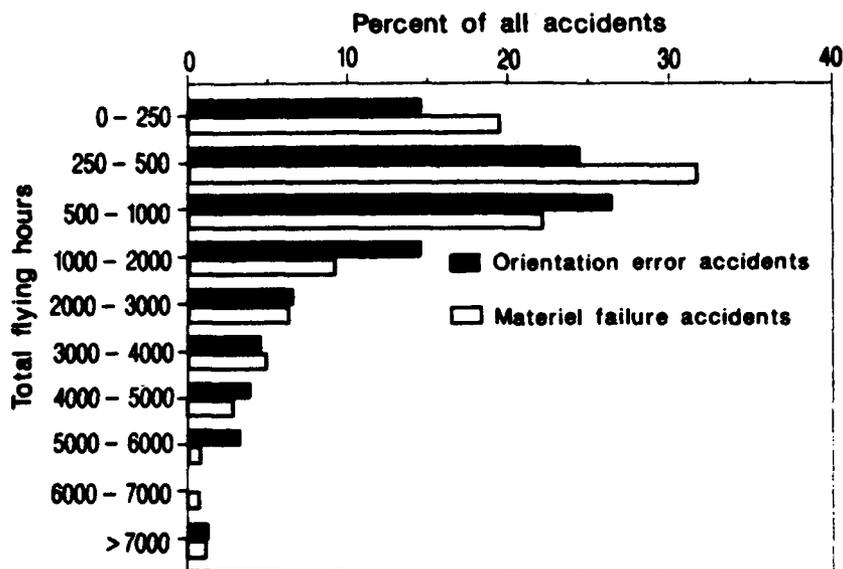
Total pilot flying hours and pilot instrument weather hours also are shown in Figures 1 and 2. These total hours are compared with the same data derived from pilots who were involved in helicopter accidents caused by mechanical failure which occurred during the same period of time. Data concerning flying experience for all U.S. Army aviators currently are not centrally collated. It is assumed those pilots involved in materiel failure accidents represent a reasonably accurate sample of the actual pilot flying and instrument flying experience in the entire U.S. Army aviator population. As can be seen by study of the graphs, the experience level in both groups is very similar, implying that total flying and instrument experience are not necessarily directly correlated with one's chances of being involved in an OE accident.

Figure 1. Percentage of all orientation error and materiel failure accidents expressed as a function of total flying experience.

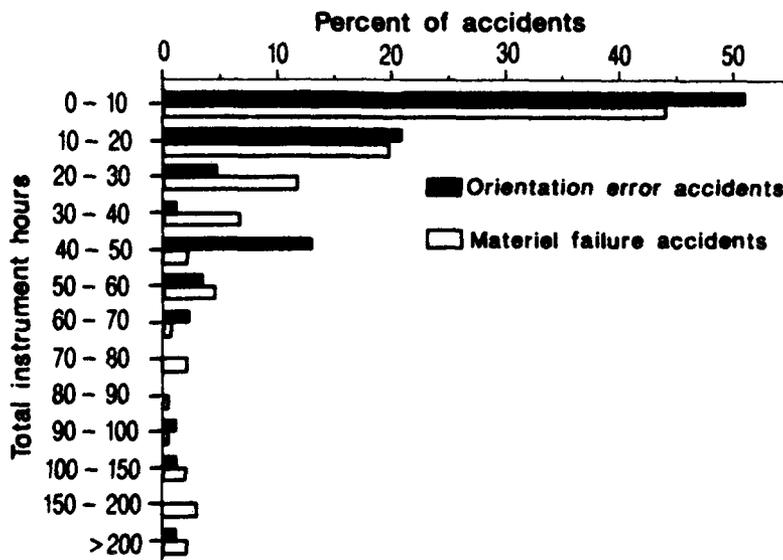
Figure 2. Percentage of all orientation error and materiel failure accidents expressed as a function of total instrument weather flying experience.
