**REPAIR, EVALUATION, MAINTENANCE, AND
REHABILITATION RESEARCH PROGRAM**

TECHNICAL REPORT REMR-CO-3

**CASE HISTORIES OF CORPS BREAKWATER
AND JETTY STRUCTURES**

PACIFIC OCEAN DIVISION

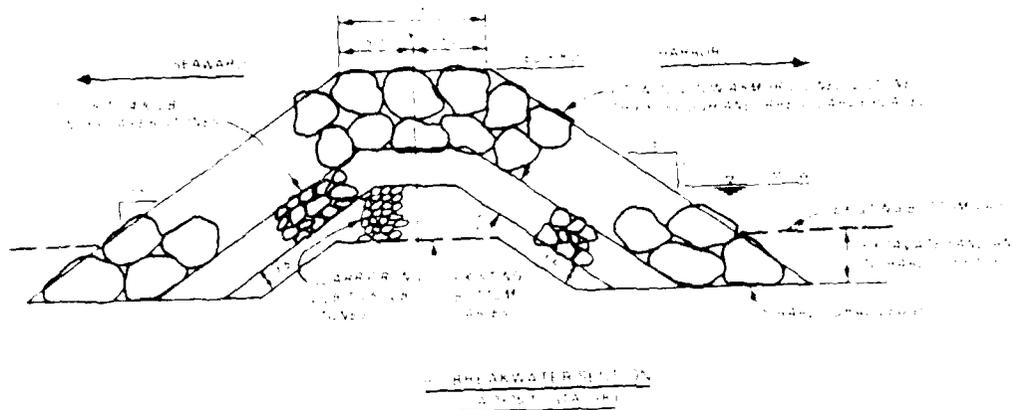
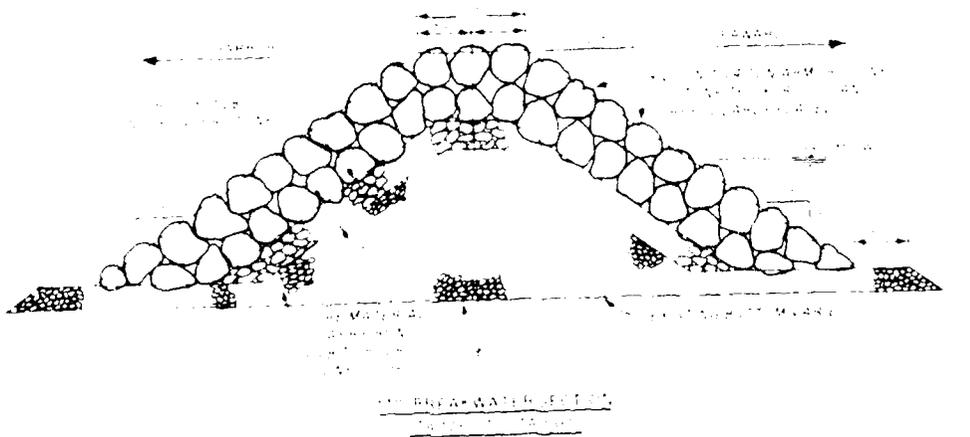
Figure 2. Typical breakwater cross sections, Haleiwa Harbor, Oahu, Hawaii

<u>Date(s)</u>	<u>Construction and Rehabilitation History</u>
1975	The 80-ft-long west and 110-ft-long east breakwaters were added to the existing project at a cost of approximately \$150,000 (Figure 1). The armor stone on the east and west breakwaters (Figure 2) was designed for 6- and 4-ft nonbreaking waves, respectively.
1978	The head of the west breakwater was rebuilt. Failure of the original head was thought to be due to the original structure toes not being placed on a firm foundation, thereby resulting in undermining of the toe and slippage of the armor stone layer. The head was rebuilt with the same size armor stone; but the sand was excavated, and the toe was placed on a firm coral bottom.
1984	Inspection of the stub breakwaters in July revealed that both structures were in good condition.

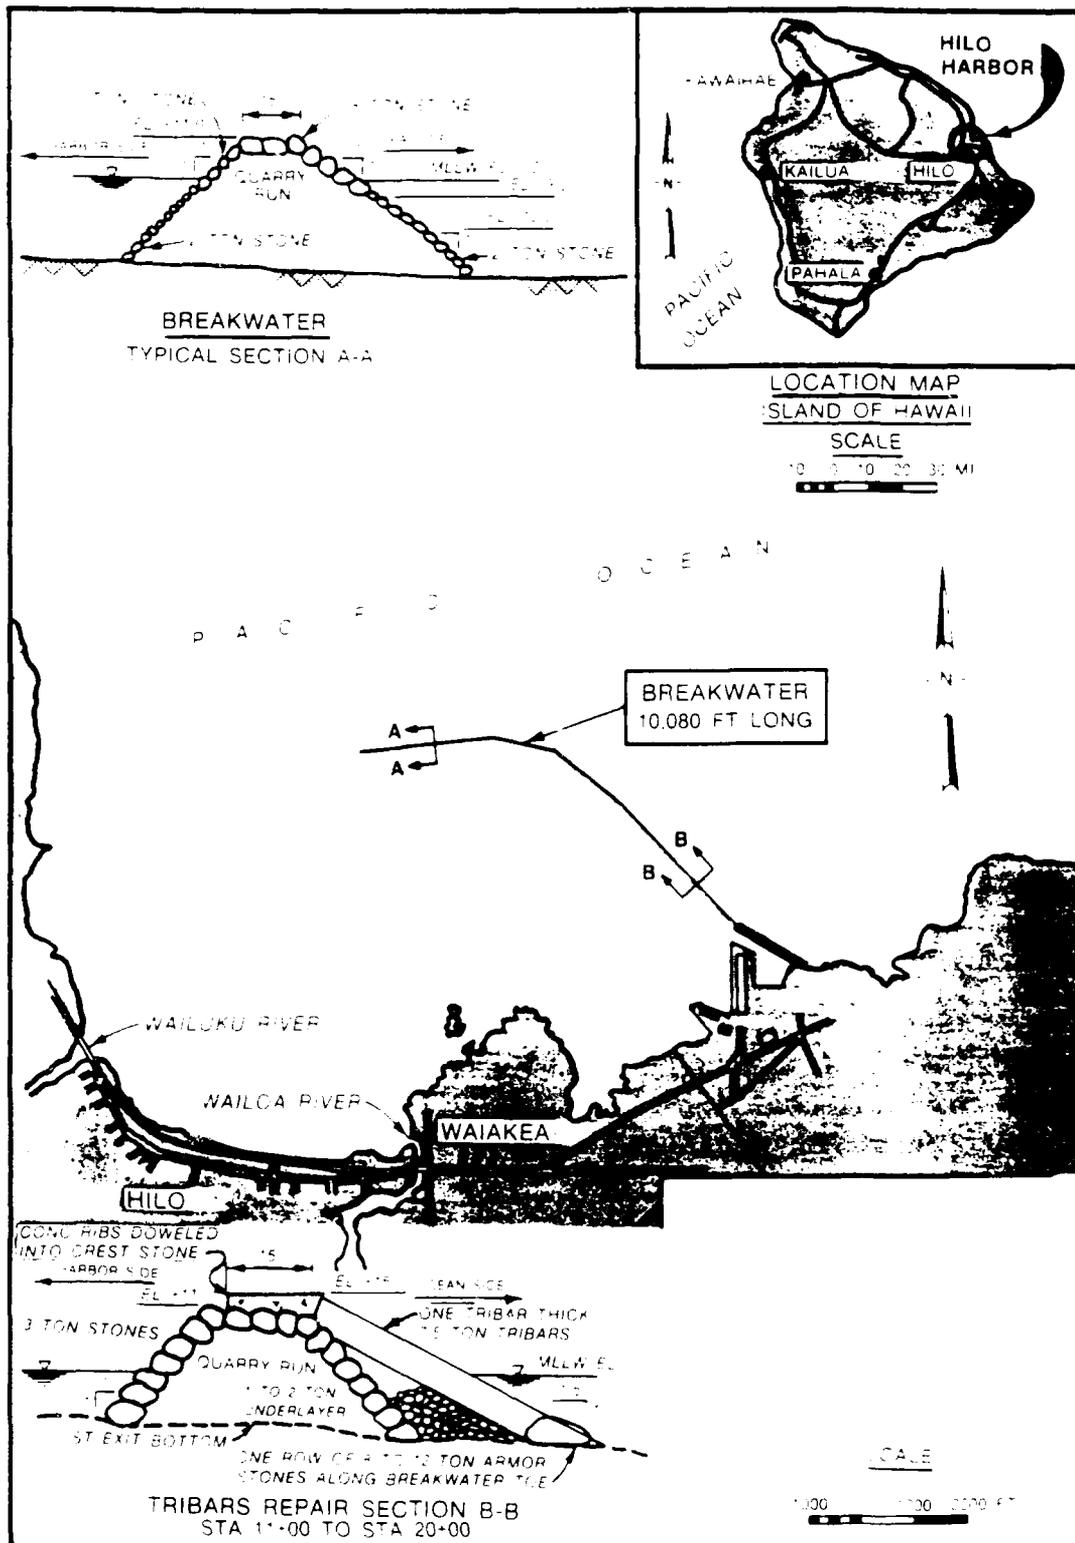
Figure 3. Hilo Harbor, Hawaii, Hawaii

<u>Date(s)</u>	<u>Construction and Rehabilitation History</u>
1930	The Corps completed the 10,080-ft-long rubble-mound breakwater (Section A-A, Figure 3).
1931- 1945	Only minor repairs were required to restore the original construction at an average annual cost of \$10,000 based on 1967 money.
1946	The tsunami of 1 April severely damaged 6,000 ft of the breakwater. Primary armor stone and core material were displaced both seaward and toward the harbor down to an average elevation of -3.0 ft mllw. A 1,100-ft-long breach occurred adjacent to the piers.
1946- 1948	Tsunami damage was repaired using original design criteria at a total cost of \$1,500,000.
1949- 1952	Storm waves of December 1951 caused damage to 13 areas (Figure 4). By October 1952 the structure had been repaired to the original cross section at a cost of \$76,000.
1954- 1957	Storm waves of March 1954 caused damage to several areas (Figure 4). By August 1957 the structure had been repaired to its original cross section at a cost of \$80,000. The structure was exposed to the tsunami of 9 March 1957 but sustained no damage.

1960	The tsunami of 1960 caused breakwater damage (Figure 4), but it was not as severe as that sustained by the 1946 tsunami. Less severe damage was attributed to the direction of wave attack. The 1960 approach was less direct than that of 1946; therefore, wave energy reaching the structure was less than what had occurred in 1946. Between 1946 and 1960 average annual maintenance costs were \$25,000. It was thought that the 1946-1948 repair work did not key the replacement armor into the existing structure, thus resulting in weaker cross sections in these repair areas.
1965	Storm waves of February 1965 caused additional damage at sta 15+00, 36+30, 73+40, 85+00, and 90+00.
1967	Between the 1960 and the 1967 tsunami, no repair work was done due to the possibility of total rebuilding of the breakwater as one leg of a proposed tsunami barrier for Hilo Harbor. The average annual cost of structure maintenance had been \$43,900 for the first 37 years of the project.

Date(s)	Construction and Rehabilitation History
1968	Repair work was completed in August. A total of 11 areas was repaired. Due to the severity of wave overtopping and the recurrence of damage in many areas, the armor stone weight used for repair of the crown was increased from a minimum of 8 tons to a minimum of 10 tons. The remainder of the repair work followed the original cross section design. The total cost of repair was approximately \$124,500.
1971- 1973	An inspection on 7 April 1971 revealed deterioration of the structure at various points along the entire length, but it was thought that immediate repair of 1,700 ft at the shoreward end of the structure was needed to protect the berthing area. Emergency repair work was completed in 1973 at a cost of \$184,000. The original cross section design was used for repair.
1975	Major repair of the breakwater was completed. Both new and reset 8- and 10-ton minimum weight armor stones were used to repair various areas along the entire length of the structure. The structure slopes and crown elevation were unchanged from the original design cross section. The total cost of the work was approximately \$591,000.

<u>Date(s)</u>	<u>Construction and Rehabilitation History</u>
1981	<p>The breakwater was repaired between sta 11+00 and sta 20+00. One layer of uniformly placed 7.5-ton tribars extended from sea-side toe to crown on a 1V:1.5H slope. The tribar toe was buttressed with a single row of 8- to 12-ton stone, and concrete ribs were constructed on the crown (Section B-B, Figure 1). The design was based on a 15.5-ft water depth, a breaking wave height of 13.5 ft, and a K_D of 7.5. Excess tribars were stockpiled in a single layer on the seaside of the breakwater shoreward of the repair site.</p>
1984	<p>During a 2 August inspection by US Army Engineer Waterways Experiment Station (WES) personnel, it was noted that the tribars seemed to be on a steeper than 1V:1.5H slope in some areas. No broken armor units were seen during the inspection. Inspection only went to sta 40+00, but just beyond the tribar repair area damage to upper sea-side slope and crown armor stones was noted in a couple of areas. The tribar repair is in good condition. The old armor stone structure is in need of some repair and will continue to need repair as long as the repair work continues to be done with the original size armor stone. Although the maximum wave heights that the structure has seen are unknown, it is exposed to large wave conditions on a regular basis.</p>

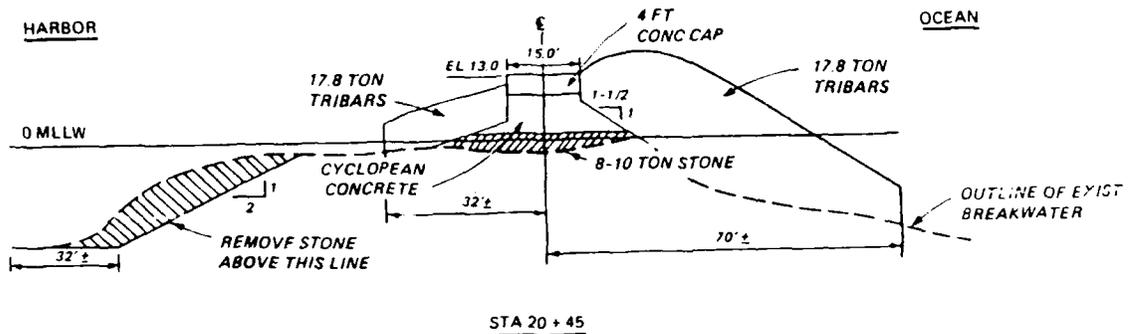
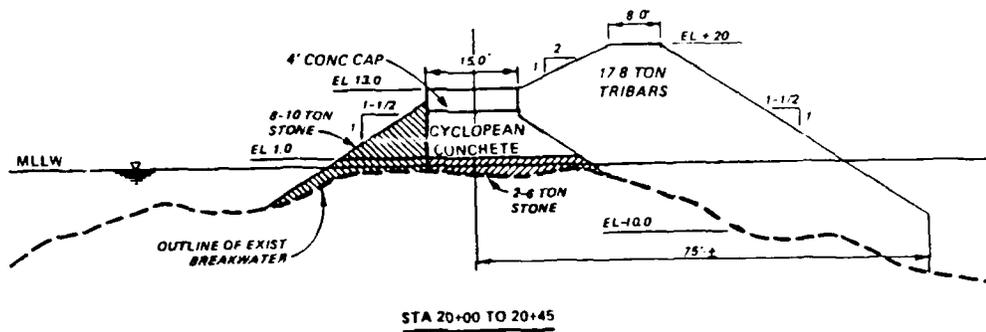
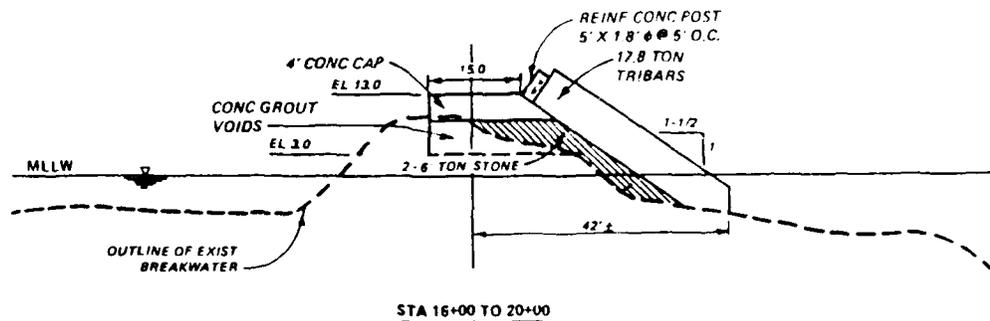
Figure 16. Typical cross sections for 1959 repair of Nawiliwili breakwater

<u>Date(s)</u>	<u>Construction and Rehabilitation History</u>
1926	The original Corps-constructed (Figure 15) 2,150-ft-long rubble-mound breakwater was completed (construction started in 1922). It consisted of one-layer 8-ton keyed and fitted armor stone over core stone (500 lb and less) with 1-V:1-H slopes and a 15-ft-wide crown at +11.0 ft mllw. Except for severe wave action, it was considered to be a satisfactory empirical design cross section.
1927- 1953	Minor repair work was done at various times during this period. In 1931 114 stones were reset, and 3,153 tons of stone and concrete blocks were placed (no details available) at a cost of \$46,040. In 1930, 1932-37, 1945, 1951, and 1952, 1,998 tons of stone were used in repair work at a total cost of \$76,285. Details of the repair work were not found.
1954- 1957	The breakwater was severely damaged as the result of a storm in 1954 (hindcasted depth-limited breaking wave height of 24 ft at structure) which destroyed the head, washed 100 ft of core stone shoreward, and settled capstone to an elevation of a few feet below mllw with little lateral movement. Storm waves displaced armor stone and exposed and removed core material between sta 17+50 and sta 20+45 in 1956. Observed wave heights of 16 ft at the breakwater in September 1957 caused additional armor stones and core displacement between sta 16+00 and 20+45 and displacement of a few armor stone and core exposure between sta 14+00 and sta 16+00. Hydrographic and topographic surveys of January 1958 revealed that Hurricane Nina (depth-limited breaking waves at structure on 1 and 2 December 1957) displaced a few armor stones and exposed core material on the sea-side slope between sta 14+00 and sta 15+00. It also caused settling and raveling of all armor stone on the crown and sea-side slope between sta 15+00 and sta 20+20, resulting in an exposed core and large voids between armor stones and all armor stone and core above mllw (sta 19+25 to sta 19+50 and sta 20+20 to sta 20+45) which was displaced shoreward.

1958- 1959	The head was rebuilt 100 ft landward of the original head (new head at sta 20+45), and 500 ft of the adjacent trunk were repaired (Figure 16) at a cost of approximately \$1,000,000 (model tested by Jackson, Hudson, and Housley 1960). Additionally, 17.8-ton tri-bars were randomly placed in two layers on the sea-side slope of the head and uniformly placed in one layer on the sea-side slope

Date(s)	Construction and Rehabilitation History
1958- 1959 (cont.)	of the trunk; 351 of the 598 tribars placed were reinforced; and concrete cap with reinforced concrete posts was added to the crown in the repaired area. Hurricane Dot (1 August 1959) produced estimated wave heights approaching the 24-ft design wave height at the structure which caused some minor damage. One reinforced concrete post was broken off, one tribar was displaced over the crown, two tribars were broken, and some downslope slippage of tribars (maximum of 9 in.) was noted.
1959- 1963	Detailed surveys of 148 tribars during this 4-year period showed settlements of up to 3 in., except for two tribars that had settled approximately 2 ft each.
1967	After the storm of 8-13 April 1967 (maximum wave height of 15 ft at the structure), an inspection on 9 May 1967 revealed a total of seven broken tribars--one displaced and one missing--and four severed concrete posts. (cumulative damage since original construction). The structure was still functioning very well.

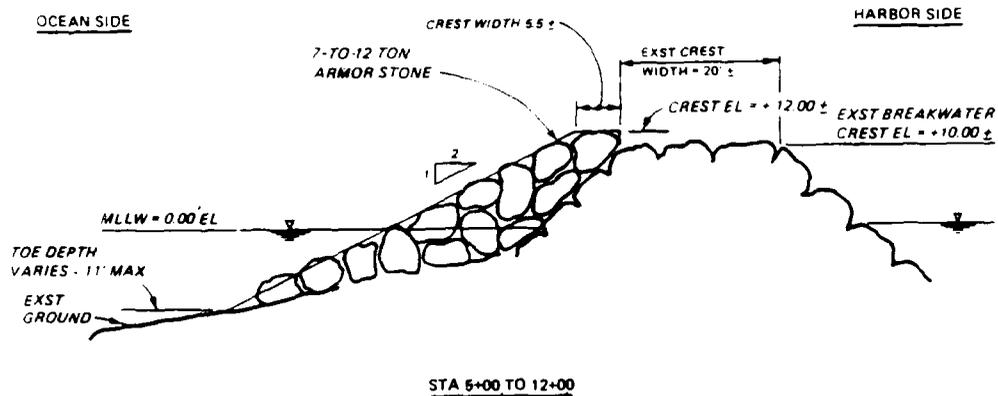
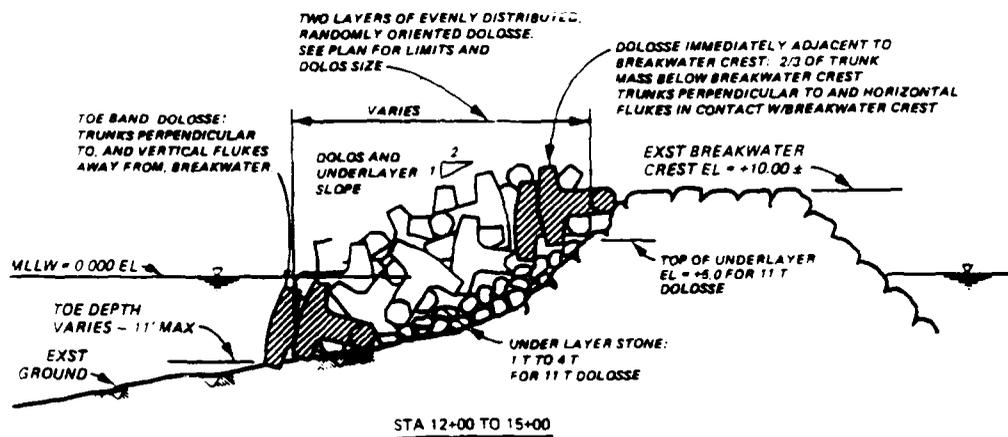
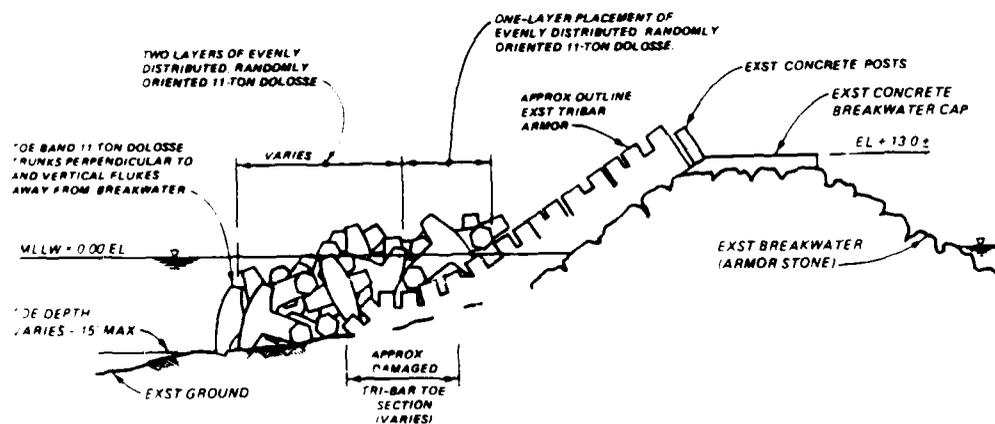
Figure 17. Typical cross sections for 1977 repair of Nawiliwili breakwater

1968- 1976	After the storm of 16 June 1976, a field inspection and subsequent underwater inspection revealed 98 tribars broken in the one-layer tribar area, 43 above water and 55 below water. Damage was thought to be due possibly to slippage of the tribar toe. Model tests of the tribar rehabilitation had recommended the use of large buttressing stone, and there is no evidence of their existence on the tribar toe.
1977	The existing one-layer tribars and a 300-ft section of the sea-side slope shoreward of this area were repaired (model tested by Davidson 1978). Two layers of 11-ton unreinforced dolosse (485 units) were placed from the toe to approximately +5.0 ft mllw over the one-layer tribar area. Two layers of the same size unit (449 units) were placed from the toe to the crown on the sea-side slope of the trunk for a distance 300 ft shoreward of the tribar area. The design condition for the dolosse overlaying the tribar area was a 12-sec, 19.4-ft breaking wave in an 18.5-ft water depth. On the other hand, the design condition for the dolosse overlaying the old existing armor stone was a 16-sec, 8.9-ft breaking wave in a 10-ft water depth. Portions of the sea-side slope shoreward of this area (approximately 300 ft) were repaired with one layer of 7- to 12-ton stone. This armor stone repair was not model tested. The total cost of repairs was approximately \$2,000,000. Typical cross sections of the repair areas are shown in Figure 17.
