TECHNICAL REPORT CERC-88-16

# SIDE-SCAN SONAR APPLICATIONS FOR EVALUATING COASTAL STRUCTURES

James E. Clausner, Joan Pope

November 1988  
Final Report

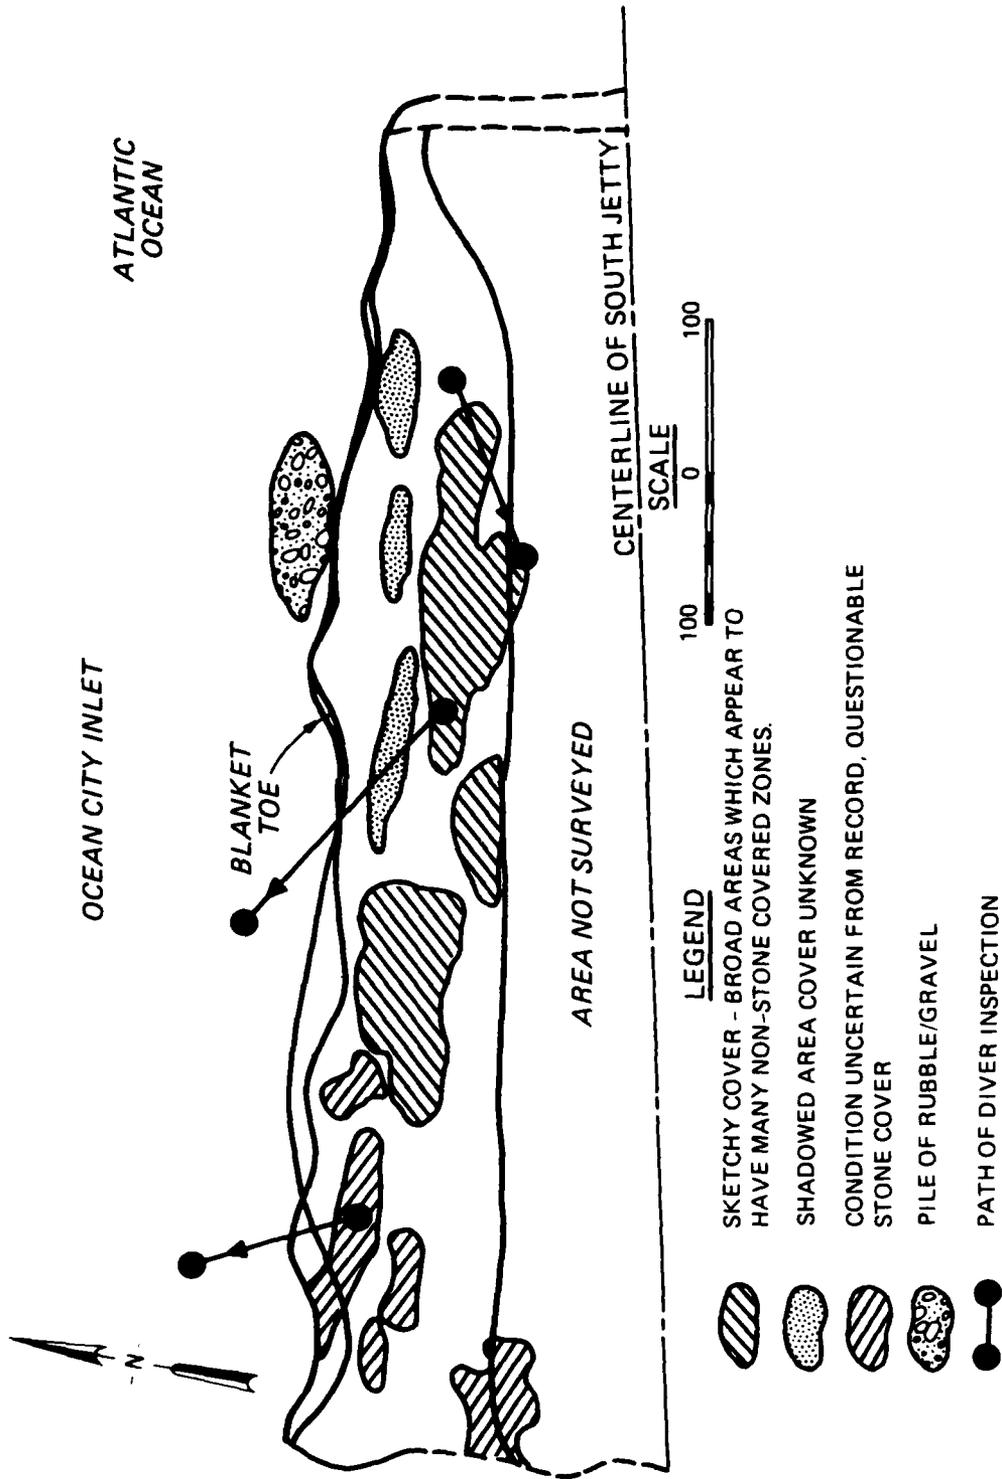
Figure 17. Map of stone blanket coverage produced from composite of several individual side-scan sonar records

then composited to create a map showing cover over the specified stone blanket area (Figure 17). Divers verified the results shown on the side-scan sonar images by traversing along the three tracklines shown in the figure. Some of the areas identified as sketchy cover were determined to be areas with adequate stone cover but where drifting sand had covered the stone.

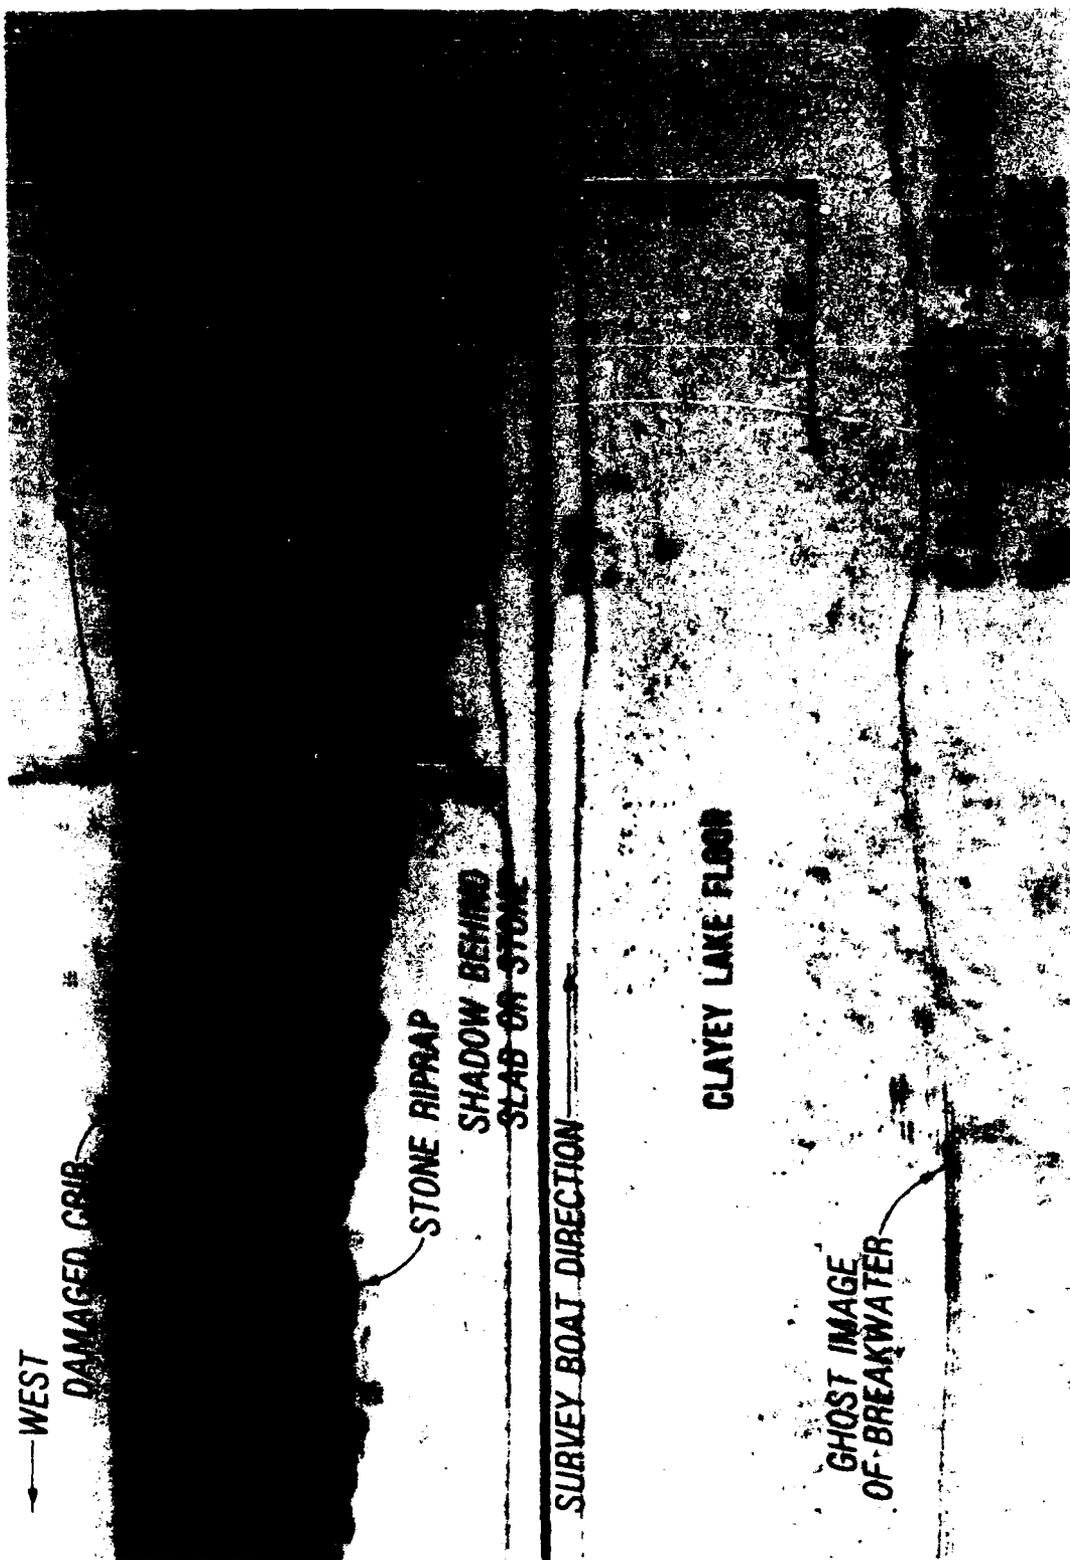
Figure 21. Timber cribs along the lake side of the breakwater at Calumet Harbor, Illinois; section A, 50-m range, 100 kHz

40. Images of the harbor side of section A reveal a section of a crib which appeared to have been displaced slightly inward. The lakeward face of section A had numerous irregular reflections occurring up to 10 ft behind the face of the breakwater (Figure 21). It is hypothesized that these reflections occur at gaps in the damaged face of the cribs where the acoustic signal has entered a void and has reflected from the fill material within the cribs similar to the records of the cribs in Cleveland Harbor shown in Figure 13.
