REPAIR, EVALUATION, MAINTENANCE, AND REHABILITATION RESEARCH PROGRAM

TECHNICAL REPORT REMR-CO-3

CASE HISTORIES OF CORPS BREAKWATER AND JETTY STRUCTURES

Report 6

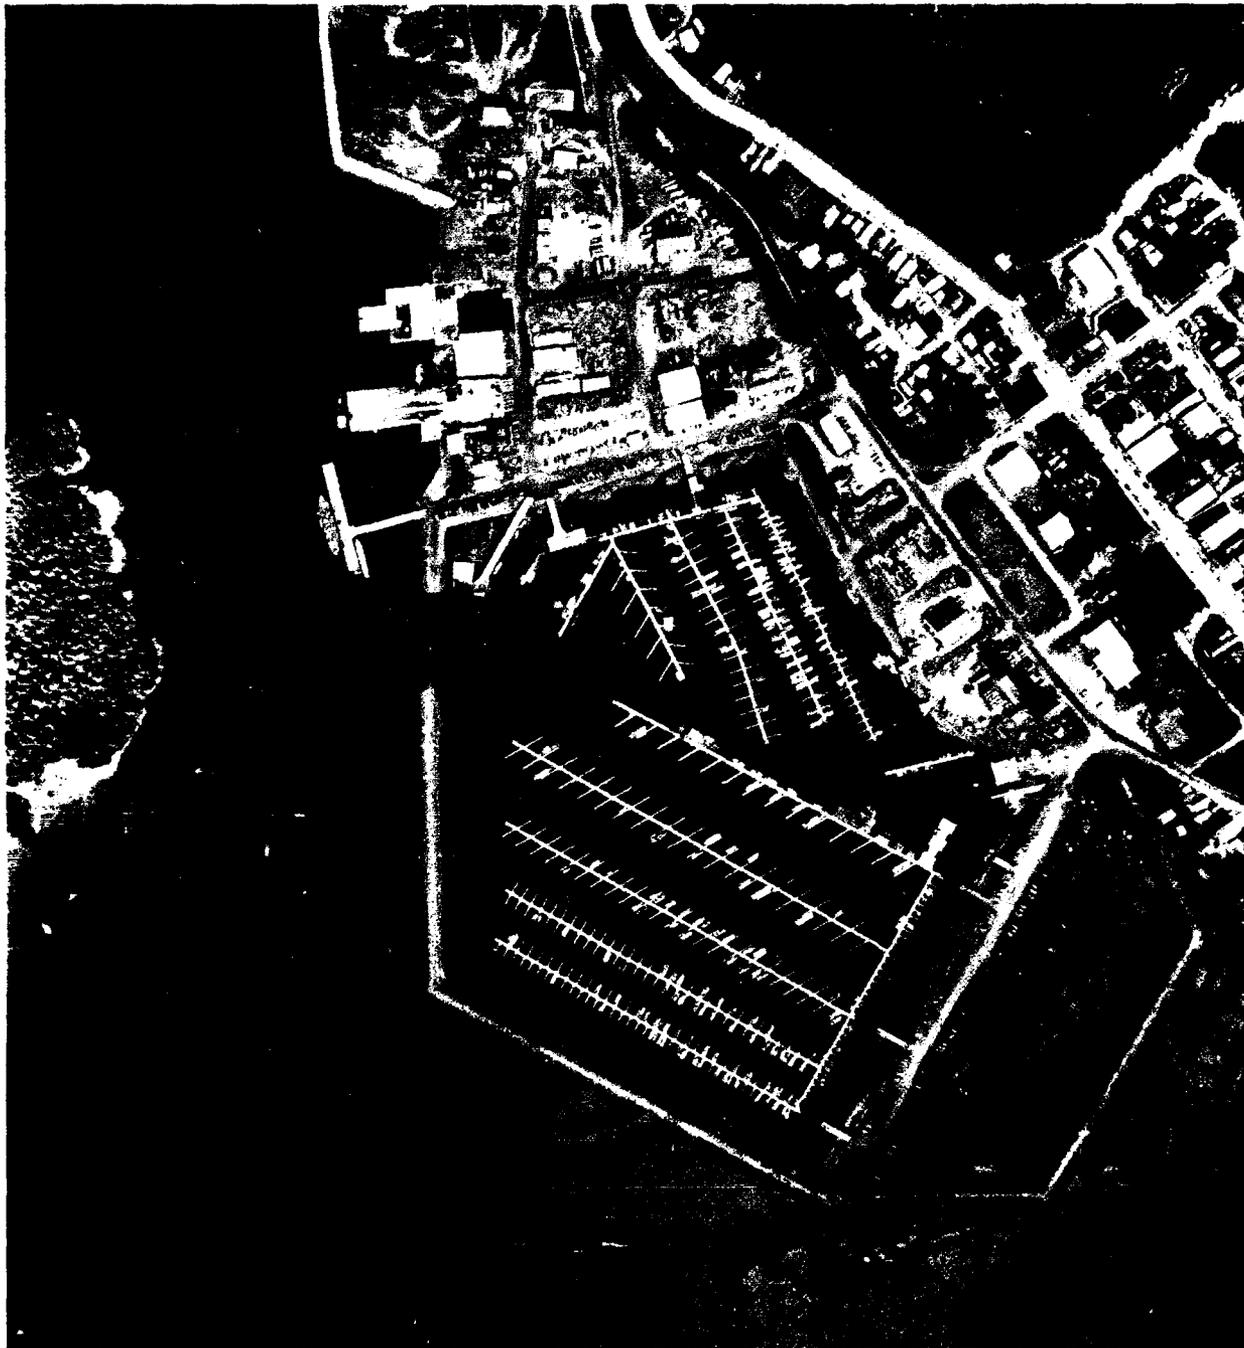
Figure 6. Aerial photograph of Cordova Harbor, Alaska, 1984

1985	The harbor is illustrated in Figure 5, and an aerial photograph of the harbor is presented in Figure 6. The breakwaters appear in good condition at this time.

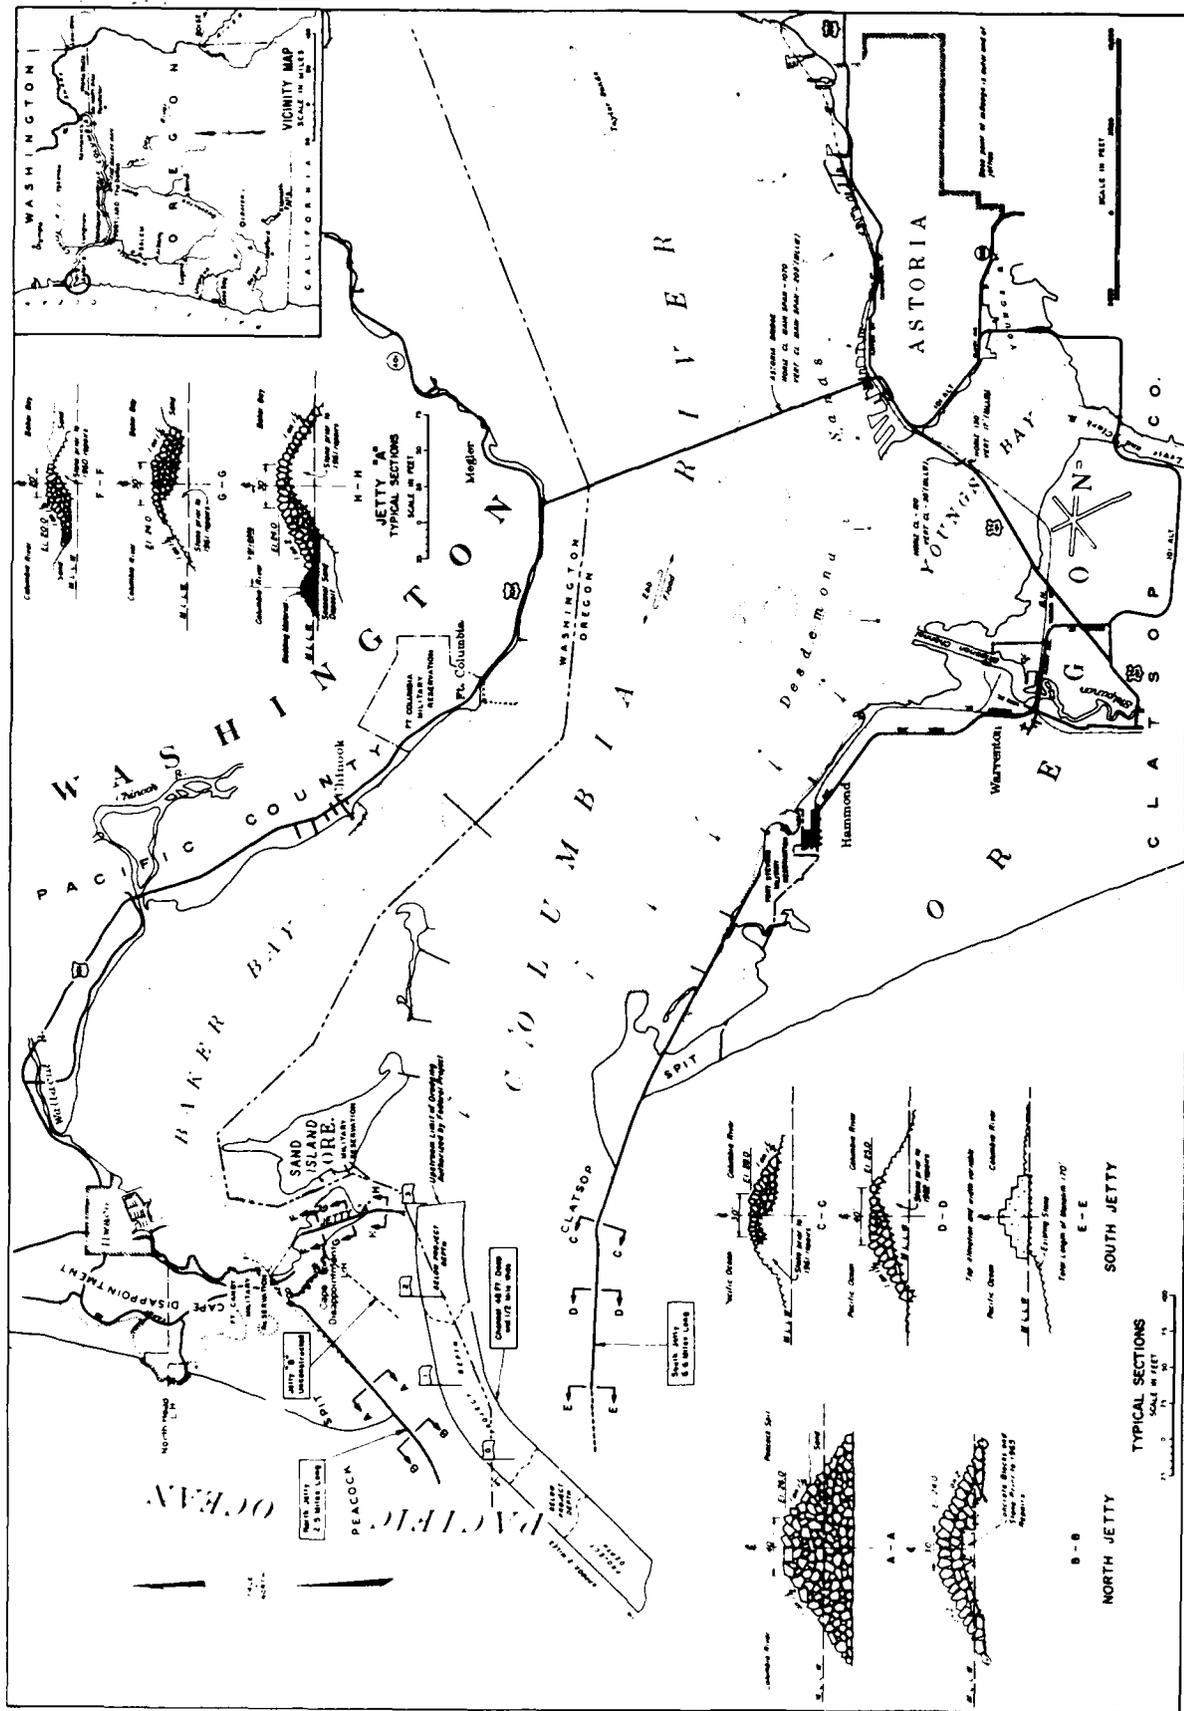
Figure 53. Site layout of Columbia River at Mouth, Oregon and Washington (revised 1979)

1964- 1965	The south jetty was repaired from "knuckle" to sta 158+00 with 308,101 tons of stone.
1965	The north jetty was rehabilitated with 136,935 tons of stone.
1982	The south jetty was repaired from sta 38+00 to sta 158+00 by filling of cavities in the structure.
1985	The harbor and cross sections of the jetties are illustrated in Figure 53. The north jetty and training jetty "A" have scour problems at the heads. The south jetty is in need of repair.

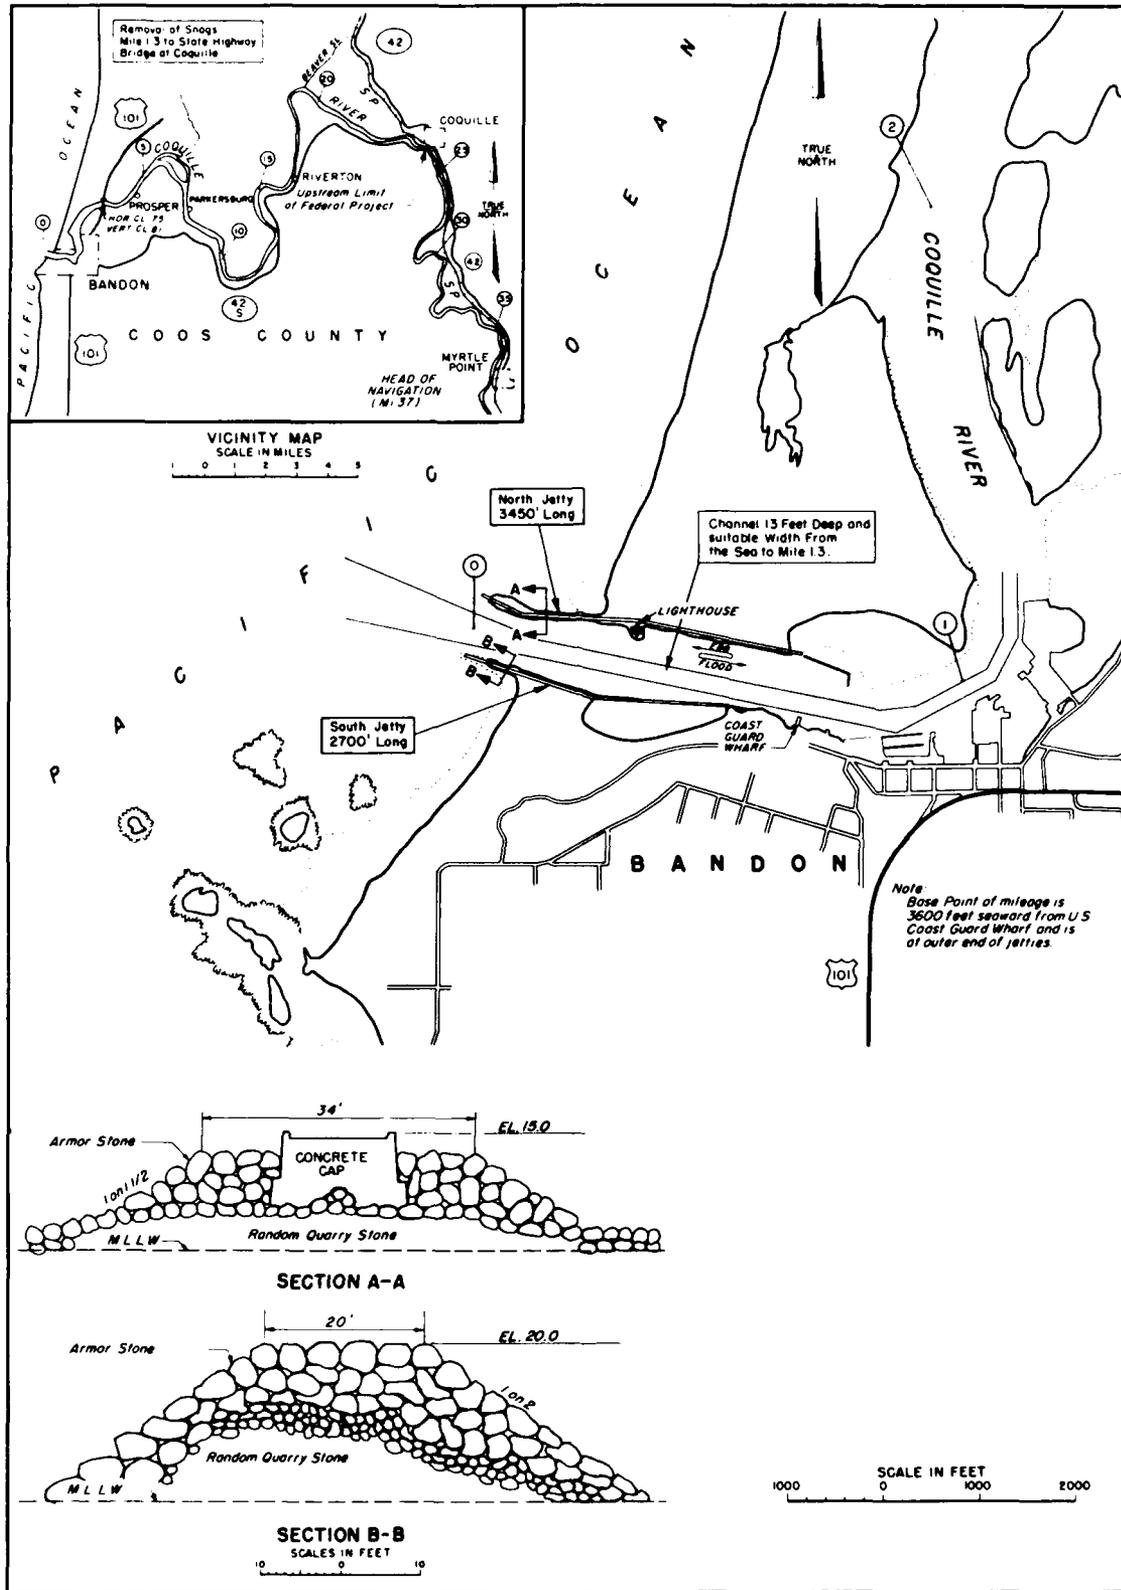
Figure 55. Site layout of Coquille River, Oregon (revised 1981)

1956	The north jetty was repaired, including placing concrete under the jetty cap in voids caused by erosion of the cap foundation stones and placing jetty stone along the north and south sides of the jetty cap. Stones were 50 percent class "A", weighing at least 4 tons and averaging 6 tons, and 50 percent class "B", weighing at least 1 ton and averaging 2 tons.
1982	The small-boat basin was constructed at Bandon, Oregon, including construction of a rubble-mound breakwater about 350 ft long with a crest elevation of +14 ft mllw and a crest width of 6 ft.
1985	The harbor and cross sections of the jetties are illustrated in Figure 55. The head of the north jetty is in need of repair, but it is still functional. The south jetty is in good condition.

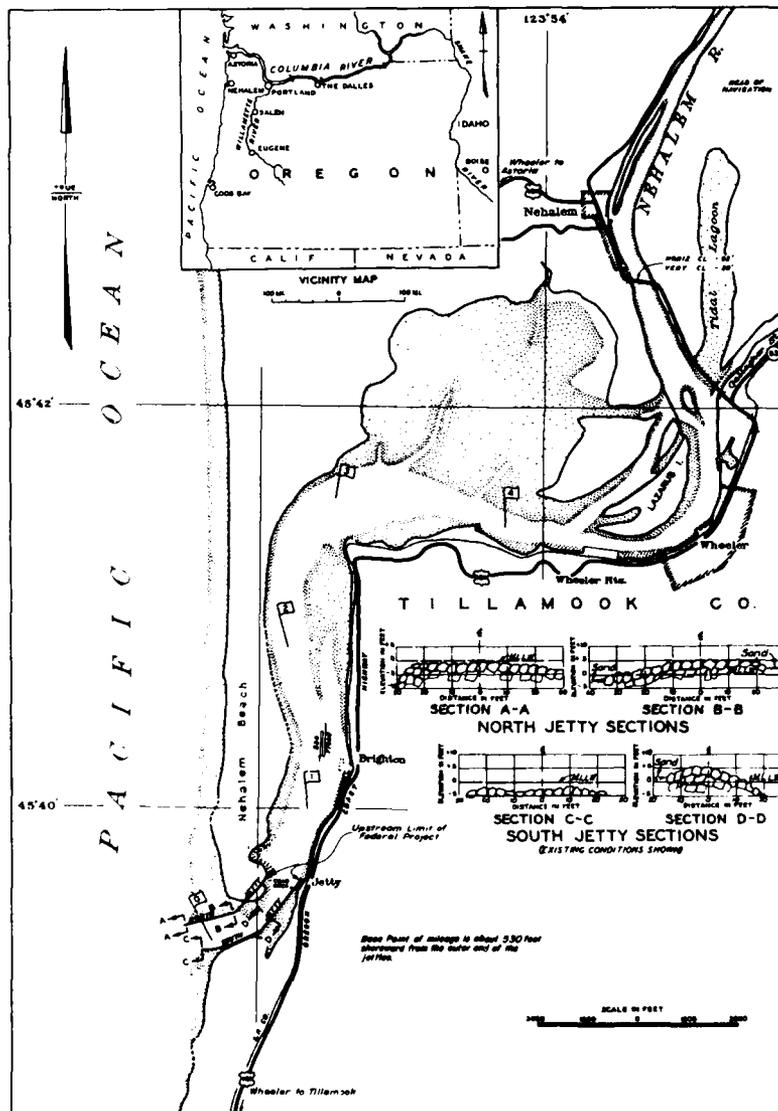
Figure 57. Site layout of Nehalem Bay, Oregon (revised 1979)

Date(s)	Construction and Rehabilitation History
1981 (Cont)	required an estimated 66,900 tons of class "A" stone, 104,000 tons of class "B", 40,300 tons of core stone, and 10,500 tons of bedding stone. Class "A" stone had a minimum weight of 7.0 tons and an average weight of 9.3 tons; class "B" stone had a minimum weight of 4.2 tons and an average weight of 5.6 tons. All weights were based on a unit weight of 170 pcf. Stone placement during construction was not as precise as desired due to inexperience of the contractor. However, the stones were sufficiently overweight that the jetties should be stable.
1985	The harbor and cross sections of the jetties are illustrated in Figure 57. The jetties are in good condition at this time.

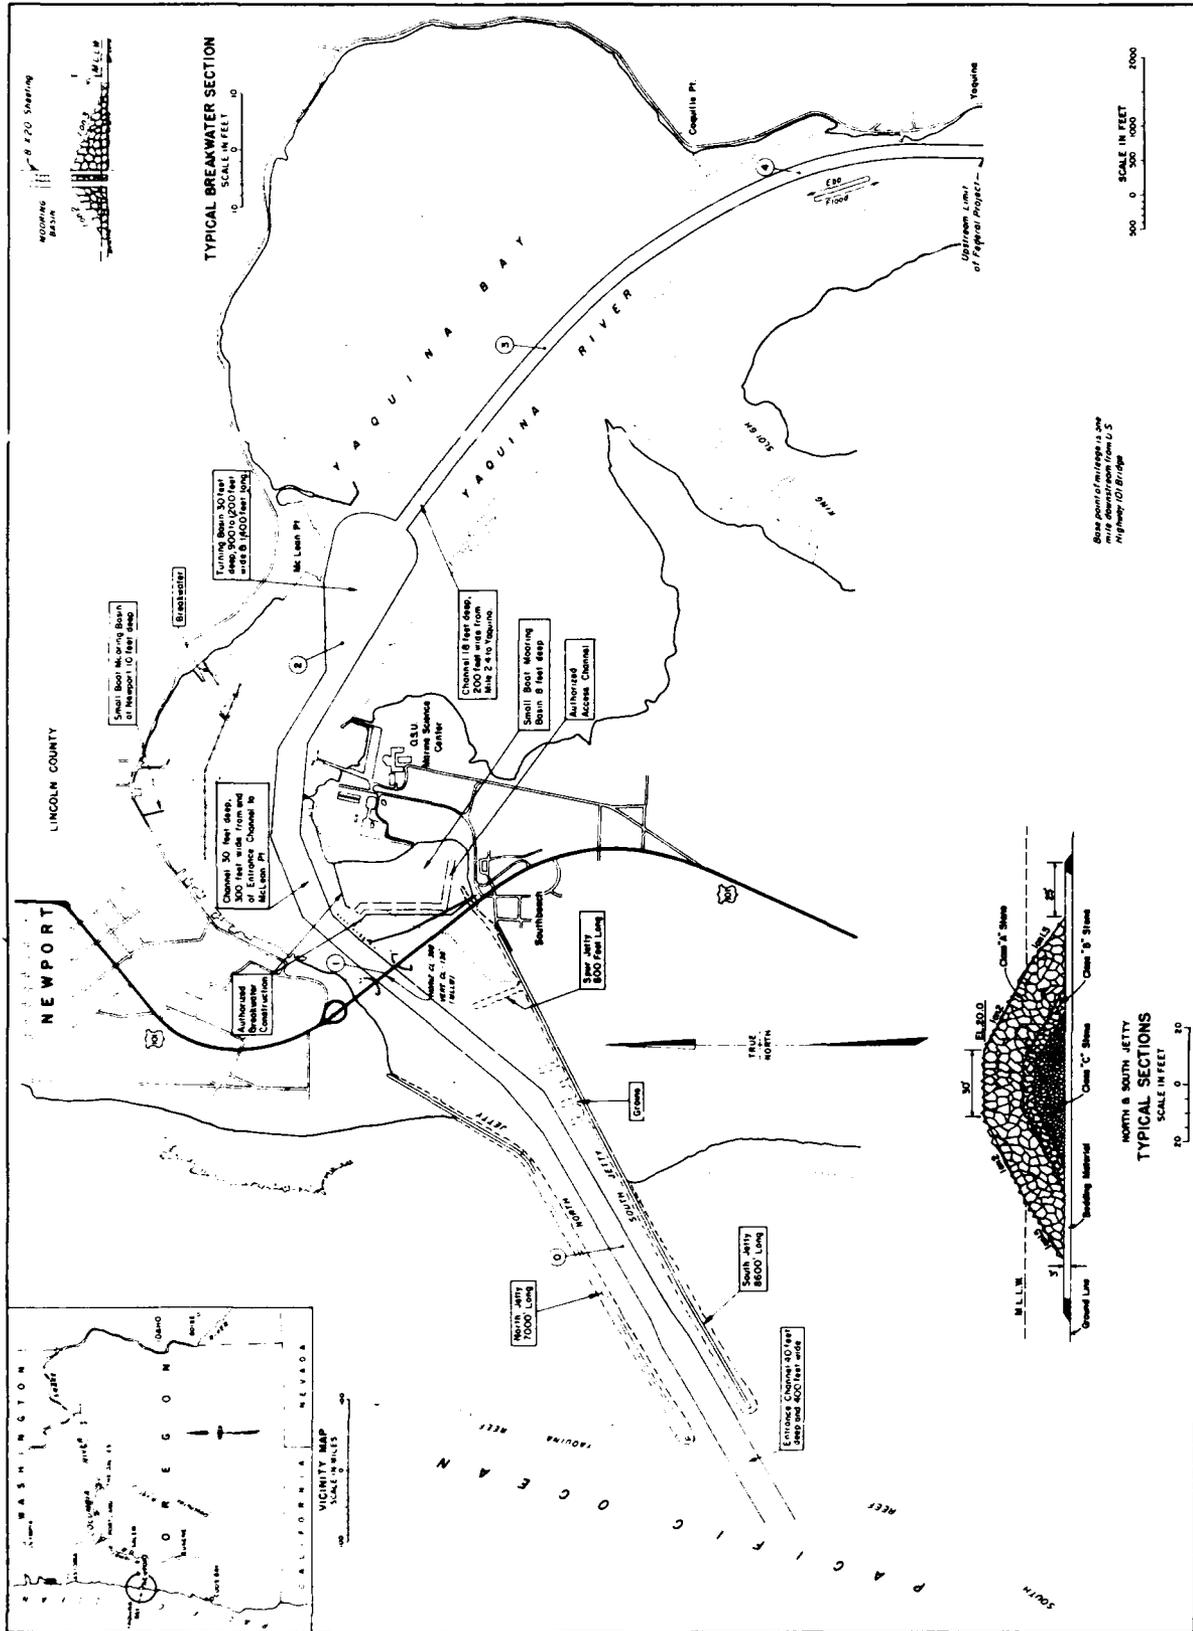
Figure 65. Site layout at Yaquina Bay and Harbor, Oregon (revised 1978)

1985	The harbor and cross section of the jetties are illustrated in Figure 65. The south jetty shows some damage but is serviceable, and no repairs are planned at this time. Studies are currently being conducted for major rehabilitation of the north jetty.
