Special Publication ARASM-SP-88003

ROOT CAUSE ANALYSIS, TANK FIRE PROBLEM,
M1A1 MAIN BATTLE TANK

MAJ John Dowalgo

February 1989

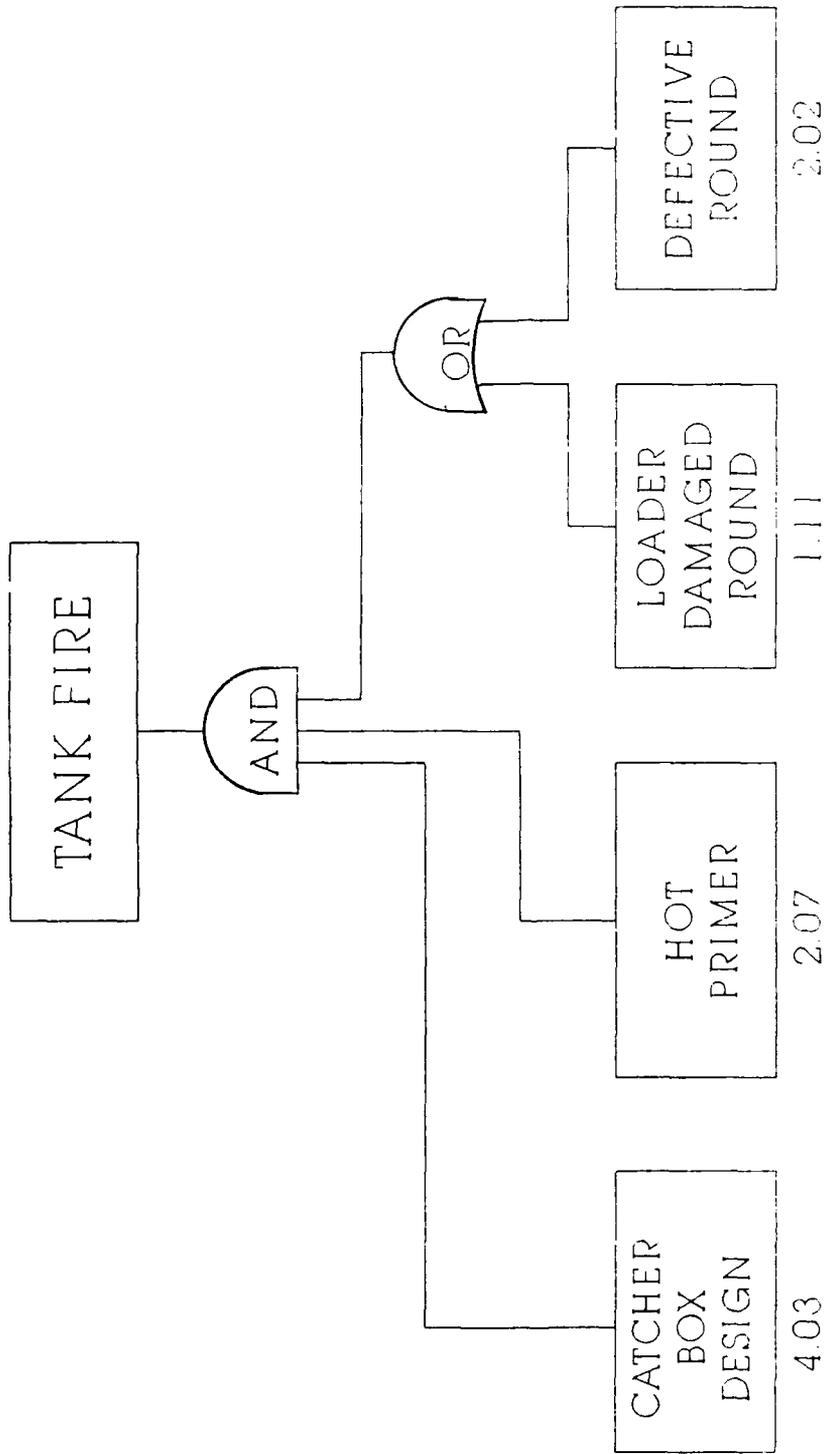
Figure 7. 4 July 1988 tank fire

a. The most likely cause of the 4 July 88 fire was propellant spilling from a damaged or defective M865 round during the loading process. The fire erupted when loose propellant contacted a hot case base primer in the case base catcher box.

The Root Cause Analysis Team has determined that the cause of the 4 July 88 fire was mostly design related, supplemented with human error. During a tank gunnery exercise, the loader either damaged a M865 TPCSDS-T round while loading or drew a defective/damaged round from the bustle. The round separated, allowing propellant to spill throughout the bustle and crew compartment. Some of the propellant fell into the cartridge case base catcher box, and contacted the hot case base primers. The propellant ignited, the loader panicked, dropped the round, and a larger fire started.

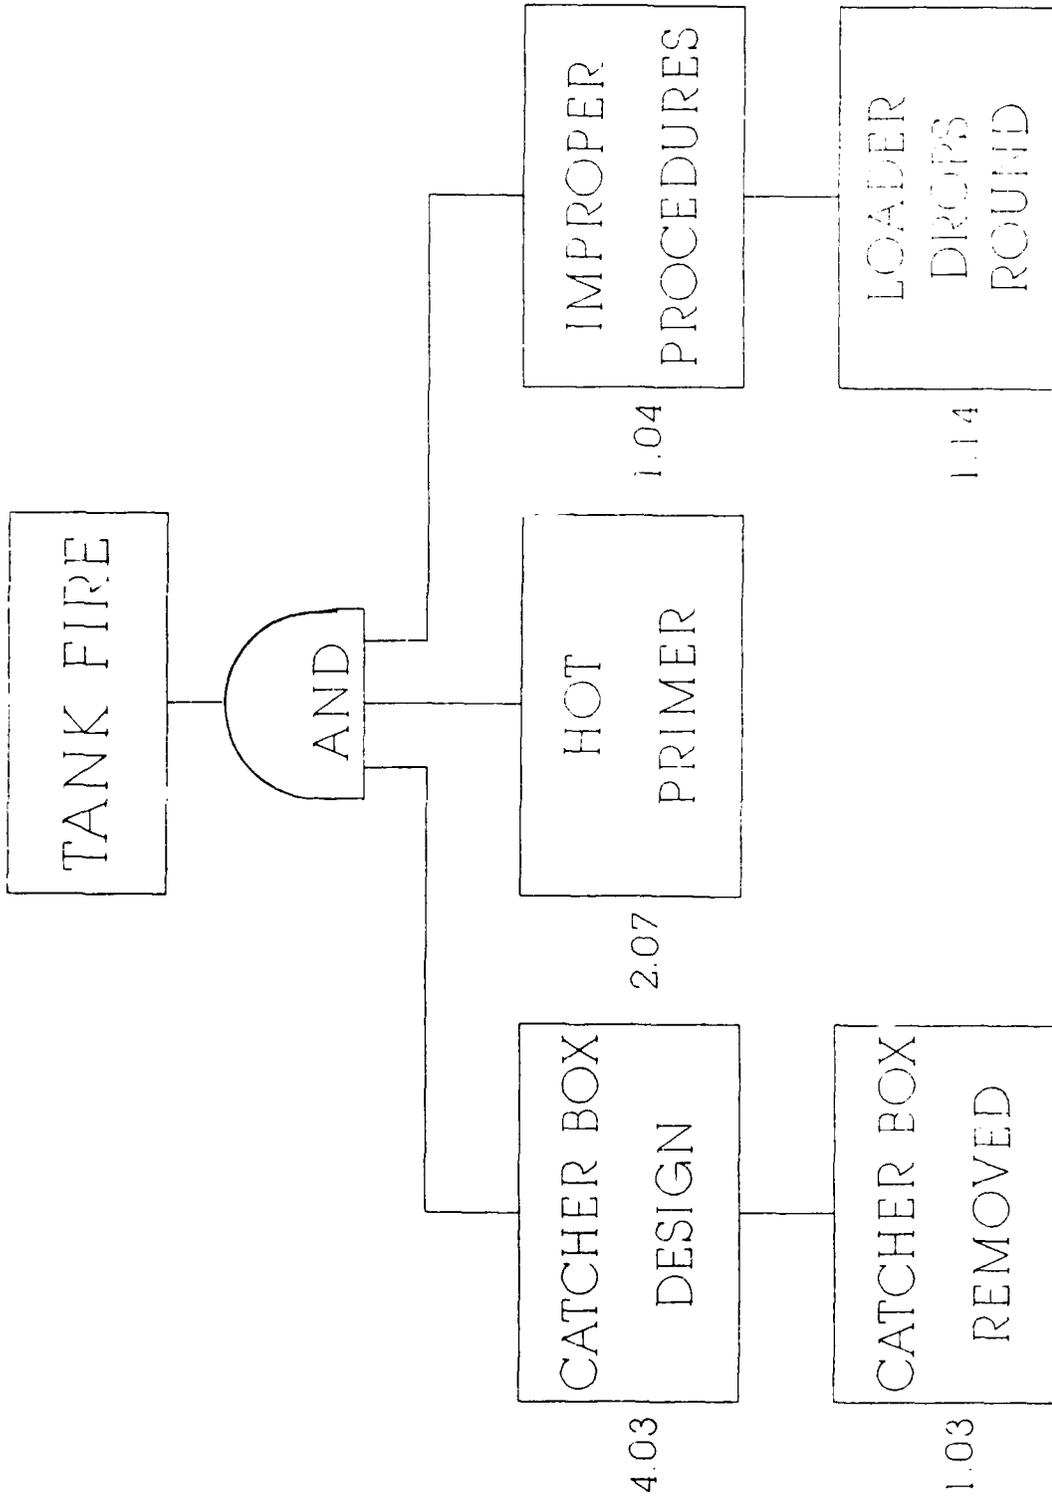
Figure 8. 14 August 1988 tank fire

The second fire was caused by a combination of crew actions and design shortcomings. The tank was engaged in a multiple target rapid fire gunnery exercise. The cartridge case base catcher box was not installed and all hot case bases were falling to the turret floor. Round #3 of the exercise was fired. The loader immediately chambered round #4 and drew round number #5 from the turret bustle. With round #5 in the loader's hands, he noticed that round #4 was not fully seated in the breech. While attempting to seat round #4, the loader lost control of round #5 and let it fall onto a hot case base primer from a previously fired round which initiated the fire.

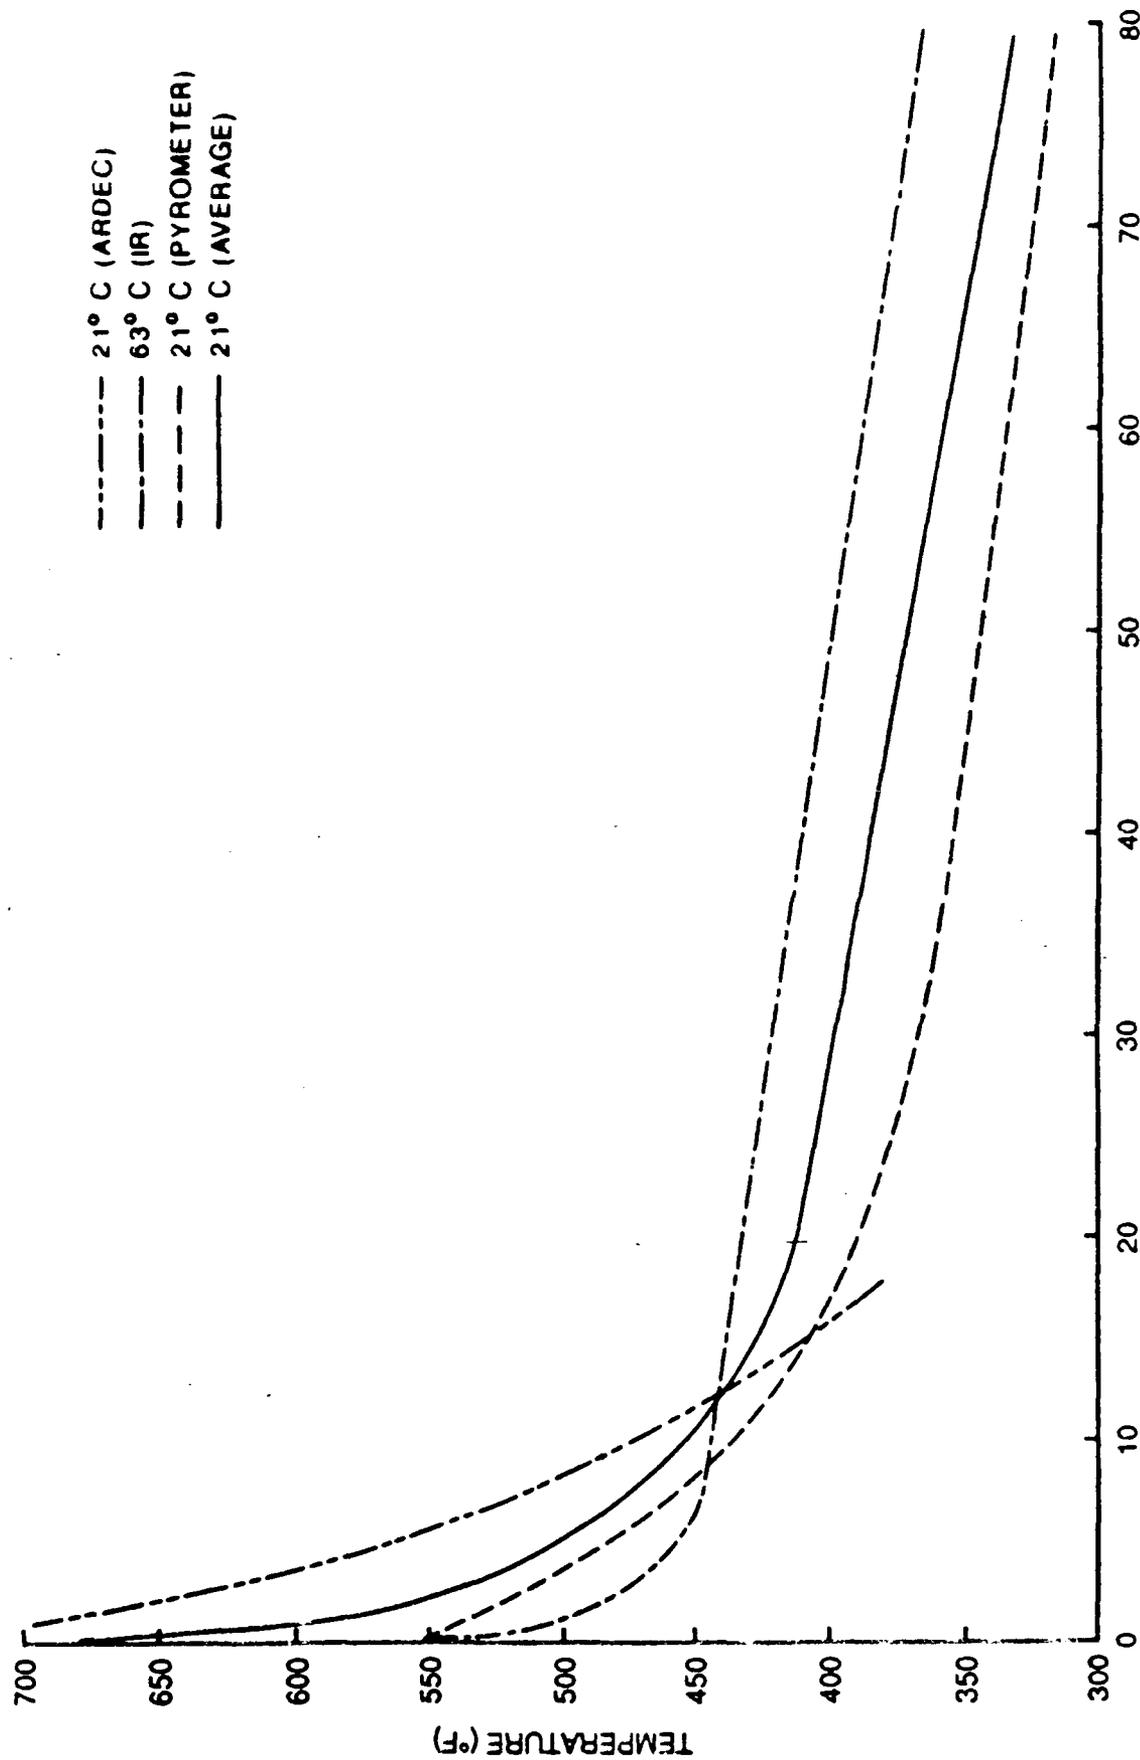
FIGURE E1

PRIMER COOLING CURVES AFTER GUN FIRING

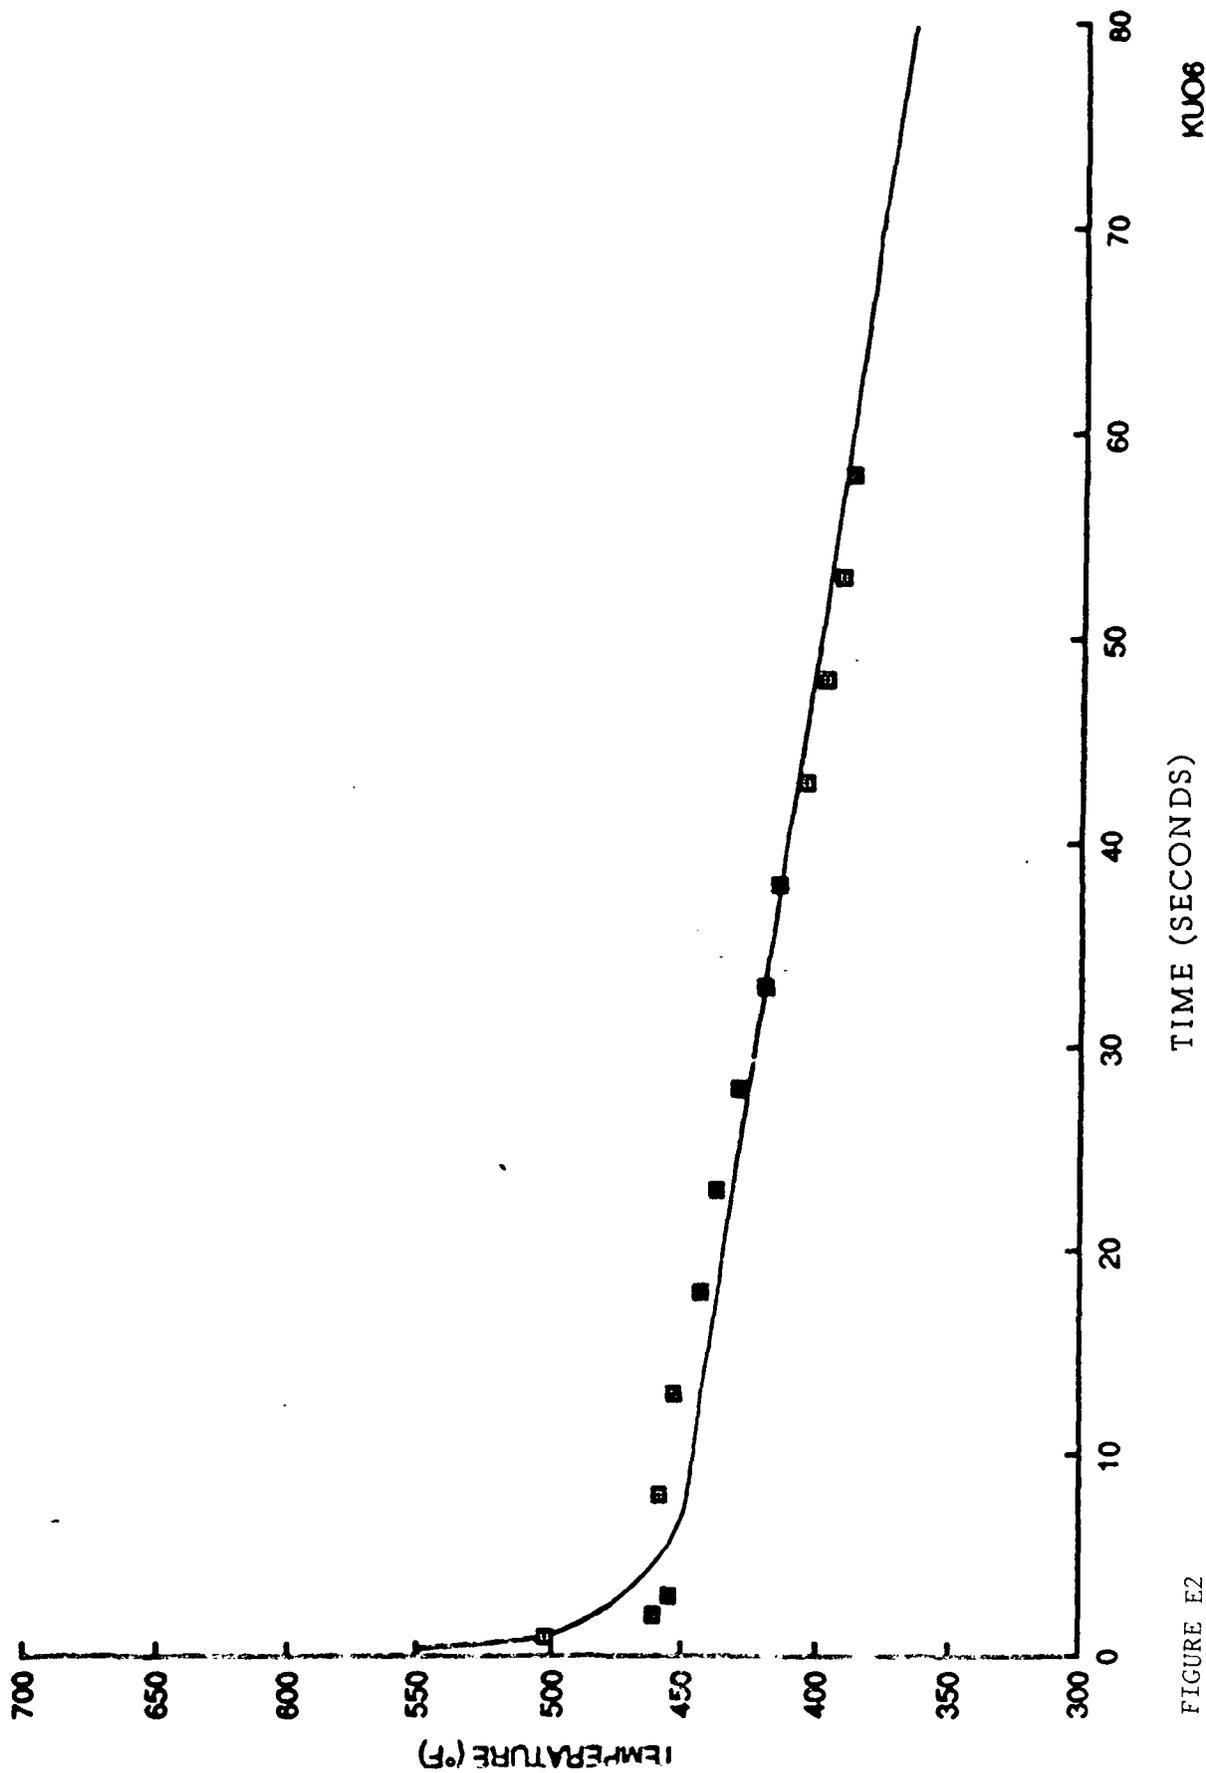
FIGURE E2

PRIMER COOLING RATE (MID SECTION) FIRING FROM 63°C CARTRIDGE
