TECHNICAL REPORT REMR-CO-3

CASE HISTORIES OF CORPS BREAKWATER
AND JETTY STRUCTURES

Report 5

NORTH ATLANTIC DIVISION

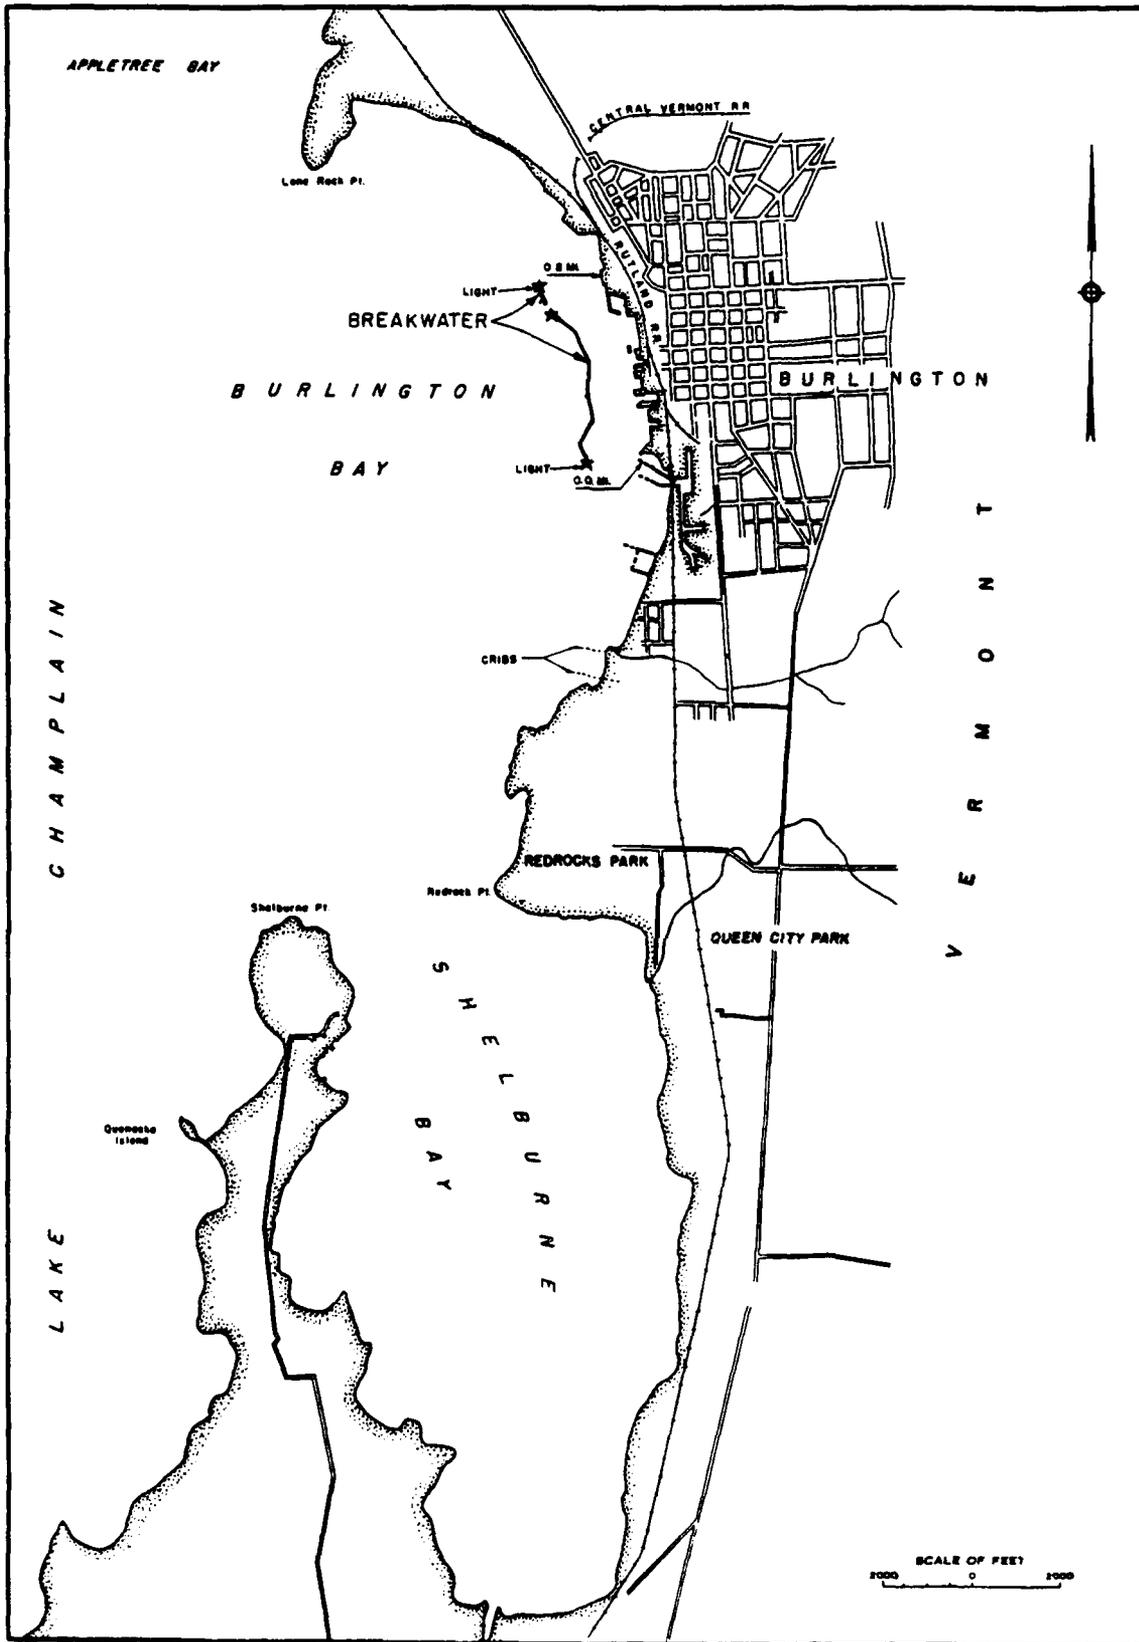
Figure 8. Burlington Harbor, Vermont

<u>Date(s)</u>	<u>Construction and Rehabilitation History</u>
1890	A 4,157-ft breakwater was completed after 54 years of construction (Figure 8). The breakwater consisted of two segments at lengths of 364 ft (north) and 3,793 ft (south) which were separated by 250 ft. Construction was of rubble mound resting on rock-filled timber cribs capped by either concrete (2,457 ft), or rock (1,700 ft). The cribs rested on a sand and gravel bed and were fastened with dowels and tenons. Crest elevation was +8.0 ft low lake level (lll), and crib width ranged from 24 to 34 ft.
1948	The breakwater was repaired. Stone was placed on the lakeside at weakened sections.
1960	A survey indicated the existing structure had settled 1.0 to 3.0 ft along the entire length. Deterioration of sections of the timber fasteners left unconnected sections and caused timber displacement and leaning of the structure lakeward. Deterioration was believed to be caused by wave action and ice conditions over long periods of time. Approximately 550 lin ft of the stone superstructure was undermined. Eighty feet of the structure was breached.

1962- 1965	The breakwater was rehabilitated using 16,573 tons of stone at a cost of \$381,000.
1986	No further repair or maintenance information has been found.

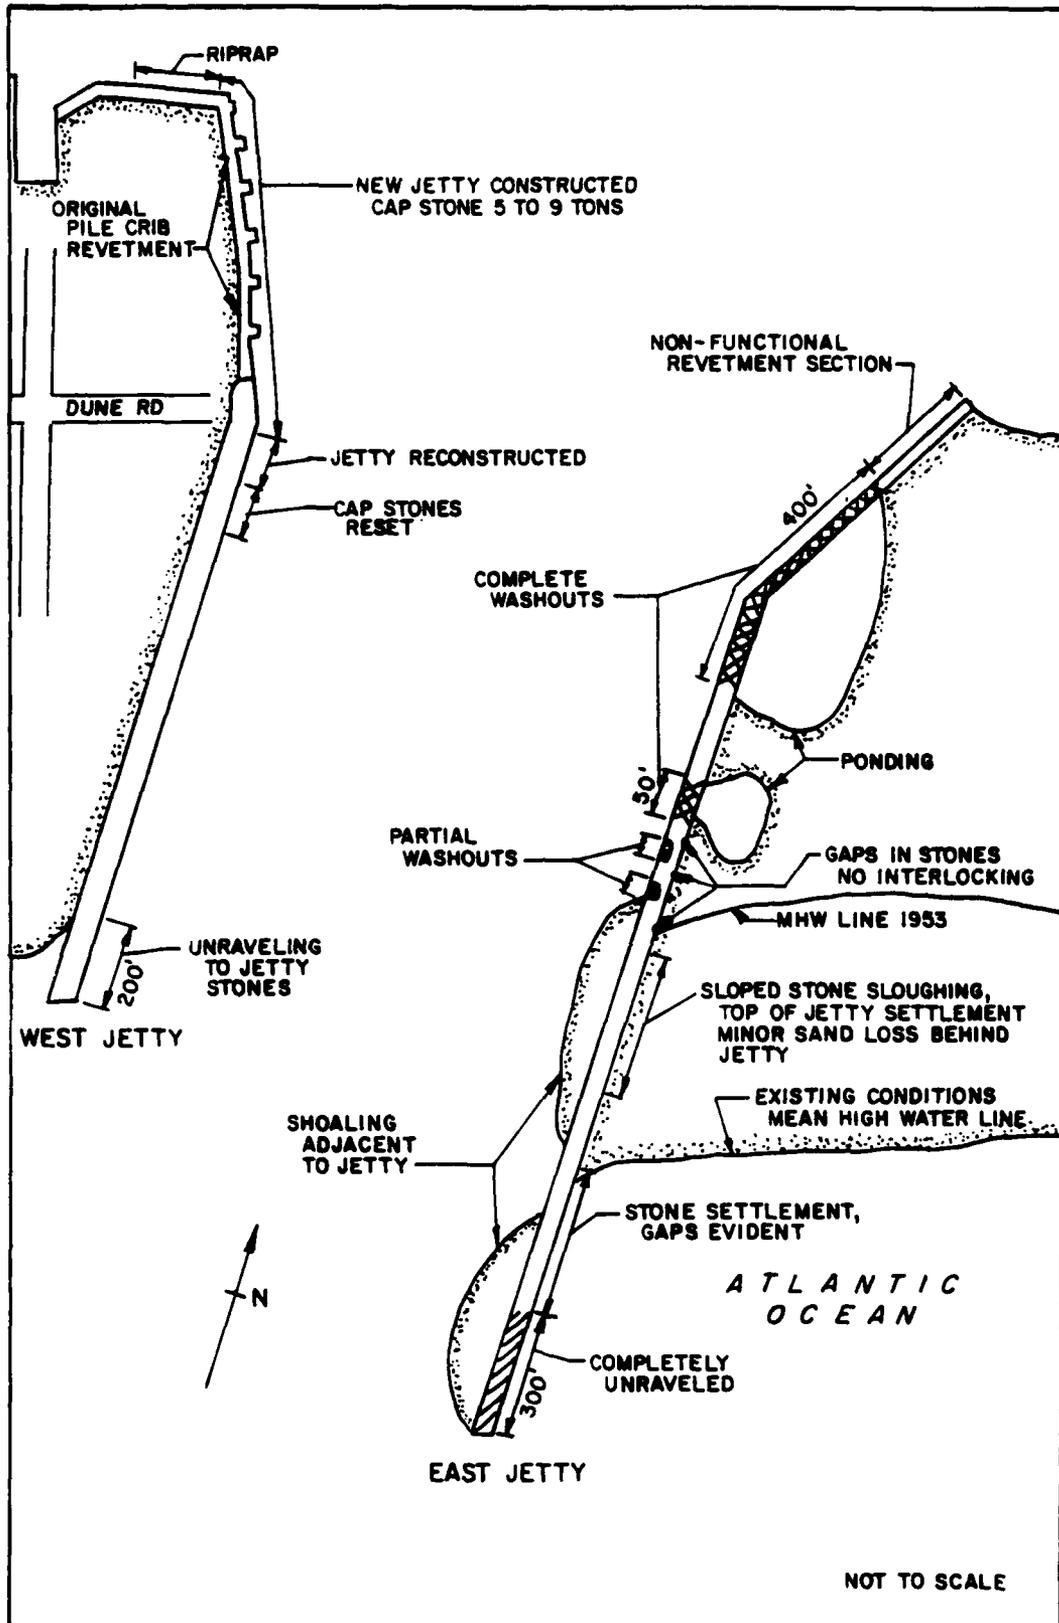
Figure 18. 1982 reconstruction of west jetty and 1985 existing conditions of east jetty, Shinnecock Inlet

1956	A survey revealed that the east jetty had suffered severe damage. Capstones and slope stones had slipped and were disarranged in numerous spots. Core stones were washed out in several places. Capstones and core stones were washed out in four locations totaling 150 ft. The outer 250 ft of the jetty was partly washed out. Beach and dunes adjacent to the jetty eroded, and waves rode over the dunes and flanked the jetty. The west jetty was in fair condition with minor slips and disarrangement in five spots. The inlet was in a shoal condition. Most of the damage was due to a hurricane in 1954.
1982	The west jetty was reconstructed by resetting cap stones to original design geometry over 170 ft. A 1,470-ft-long pile crib revetment on the north end of the west jetty was replaced by a rubble-mound jetty. (Figure 18).
1985	A survey revealed that the reconstructed portion of the west jetty was in good condition. The seaward 200 ft of the west jetty had unraveled and capstones were scattered. The west jetty head had not maintained design configuration. Stones on the inlet side of the east jetty had sloughed in some sections, but stones on the beach side had retained their original position. Two areas on the northern end were completely deteriorated. Erosion of sand caused undermining of the east jetty with continual loss of sand undermining it further.

Date(s)	Construction and Rehabilitation History
1985 (Cont.)	There were areas of partial washouts of stone, settlement, and non-interlocking capstones. The seaward 300 ft was completely unraveled, with all stones scattered (Figure 18). It was determined that the jetties had served their function of inlet stabilization and they were not leaking significant amounts of sand.
1986	Plans call for rehabilitation of the jetties. The east jetty will need new capstones and core stones where there are complete washouts, approximately 450 ft. Original stones will be removed and reset where settlement and sloughing has occurred, approximately 700 ft. The 300-ft east jetty head section will be completely rebuilt with new and original stone. A blanket will be placed for scour protection. A 5.0-ft-thick blanket using 1,000-lb stone will be laid on the existing bottom to prevent additional scouring of the west jetty toe. New capstone and core stone are needed to supplement the displaced stones of the west jetty head. The section will be rebuilt using existing stone but will consist of two layers of armor stone.

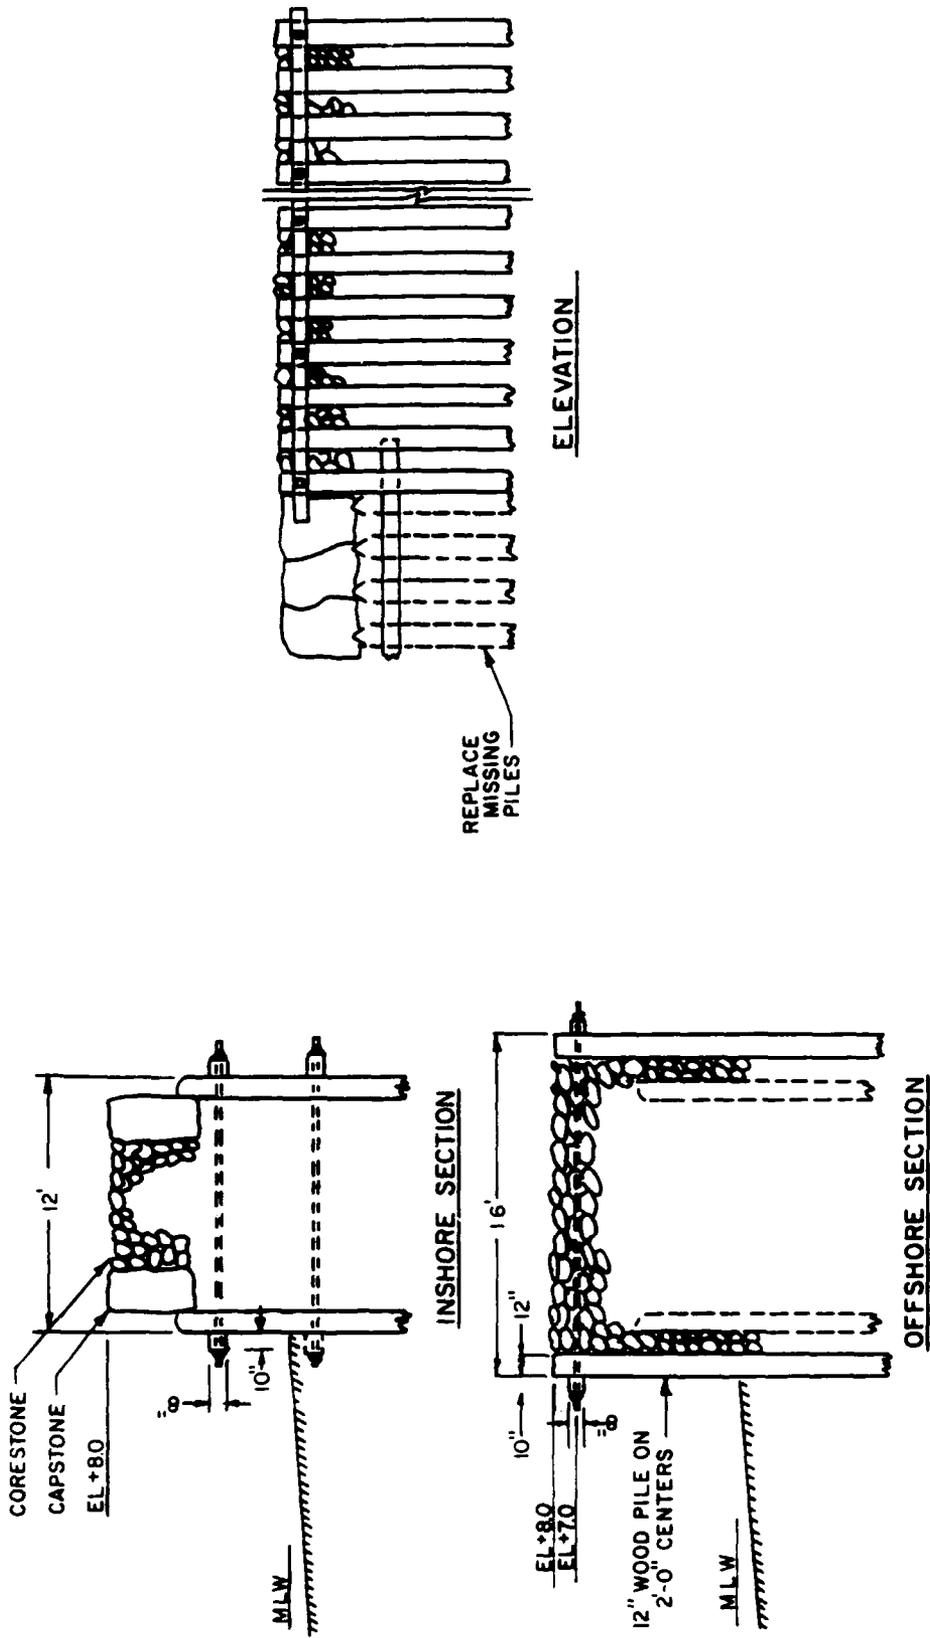
Figure 29. Rehabilitation of Mantua Creek jetties, 1963

<u>Date(s)</u>	<u>Construction and Rehabilitation History</u>
1907	Two jetties were constructed to provide channel protection. Lengths were 754 ft and 580 ft east and west, respectively. The jetties were constructed of stone-filled timber cribs, with mat brush placed to support the stone (Figure 28). Top width and elevation were 12.0 ft and +8.0 ft mlw, respectively, for each jetty.
1912- 1913	The east jetty was extended to 1,577 ft, and the west jetty was extended to 1,456 ft (Figure 28).
1918	Repairs were made by the addition of stone.
1962	An investigation of the jetties revealed the jetties had settled an average of 2.0 ft. Approximately 100 ft of the offshore end of the east jetty had deteriorated, with most of the pilings gone, and stone had fallen out to below the waterline. Most of the walings had deteriorated and were missing. Piles were missing at intermediate locations along the jetties, but there was no significant loss of stone at those locations. Piles that remained were in good condition.

1963	The jetties were rehabilitated at a cost of \$136,895. A new row of piles was placed over approximately 100 ft at the offshore ends. Piles were placed 7.5 ft on either side of the center line of the jetties. Corestone was dumped between the piles to an elevation of +8.0 ft mlw (Figure 29). Missing piles were replaced, and new wales were provided along the remainder of the jetties. One row of capstone was placed on the inner sides of both cribs on top of the existing stone to +8.0 ft mlw. Core stone was filled between the capstones in the center of the jetties to +8.0 ft mlw (Figure 29). Crown width was 16.0 ft at the offshore ends and 12.0 ft on the remainder of the jetty. Design wave height was 4.2 ft.
1964	Repairs were made to the seaward end of the east jetty at a cost of \$4,864. The Corps was reimbursed later for this work.
1986	No further repair or maintenance information has been found.

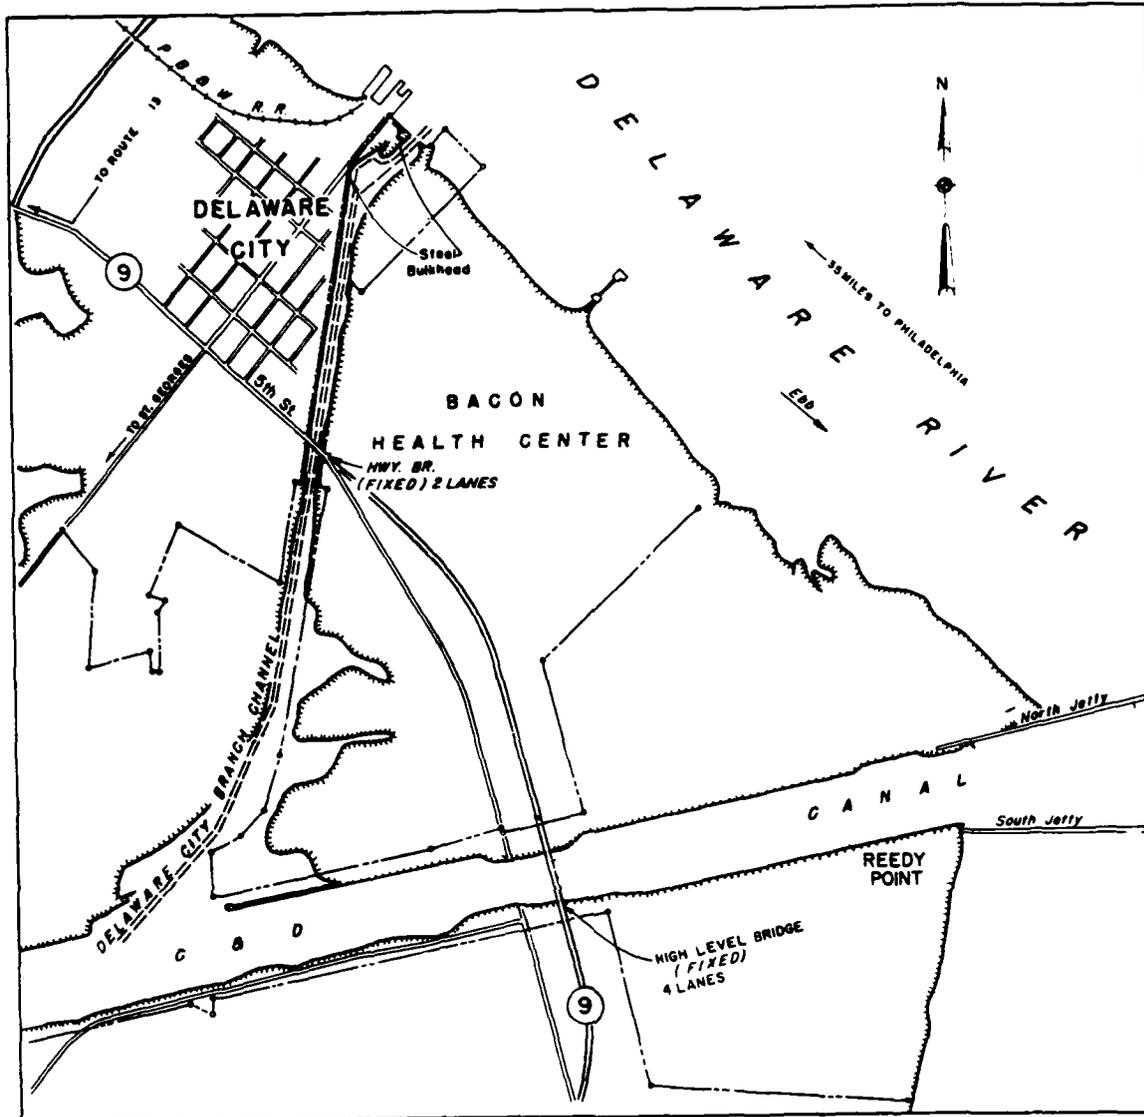
Figure 32. Delaware River and Chesapeake Bay Canal, Delaware

<u>Date(s)</u>	<u>Construction and Rehabilitation History</u>
1903	Construction of two rubble-mound jetties, north and south of the canal, was completed to provide channel protection. The length of each jetty was 725 ft, crest elevations were +8.0 ft mlw, crown widths were 6.0 ft, and side slopes were 1:1 (Figure 32).
1938	Each jetty was extended to 2,095 ft (Figure 32).
1960's	The south jetty was removed and replaced by a new jetty to increase the entrance size to accommodate larger vessels and to improve navigation safety. The new jetty had a crest elevation of +8.0 ft mlw and a 14.0-ft crown width (Figure 32). The design wave was 6.3 ft, 4.8 sec.
1985	The north jetty has subsided, lost stone, and the toe has scoured.

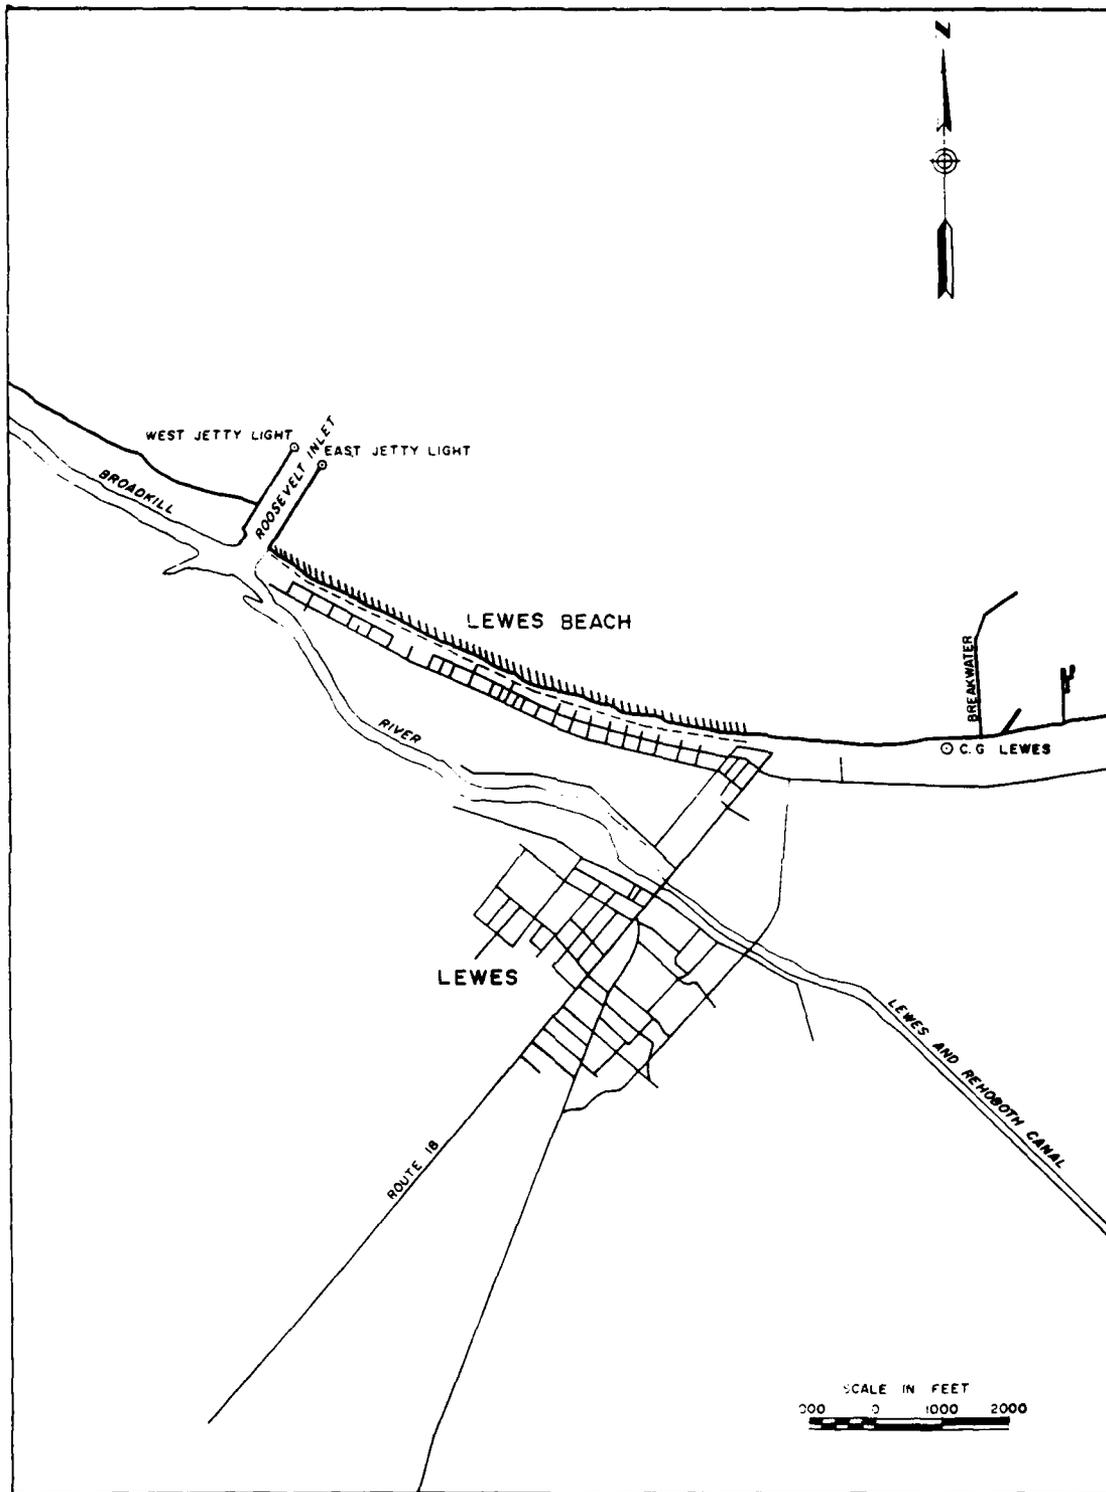
Figure 36. Roosevelt Inlet, Delaware

<u>Date(s)</u>	<u>Construction and Rehabilitation History</u>
1908	A 1,263-ft-long stone-filled timber crib jetty was constructed on the west side of the inlet.
1911- 1914 1917, 1920, 1923	Stone replacement repairs were made each of these years. Cause of damage was due to inadequate jetty design; waves easily damaged the timber cribs. The cribs were also permeable to sand.
1937	The timber crib jetty was replaced by two steel sheet-pile jetties, constructed 500 ft apart, on the east and west sides of the inlet. Both jetties were 1,700 ft long (Figure 36). Crest elevations were +8.0 ft mlw, except the shoreward ends which were +10.0 ft mlw.
1939	The jetties had deteriorated due to corrosion.
1944	The jetties were flanked and rubble was placed along the east bank. The additional rubble extended the east jetty shoreward 400 ft. The possibility of the west jetty becoming completely flanked was determined to be remote; therefore, no rubble was placed on the west bank. Seaward ends of both jetties were repaired due to deterioration by corrosion.

1985	The jetties are in poor condition and are ineffective. They are considered a navigation hazard and are to be removed.
