HISTORIC STANDING STRUCTURE  
INVESTIGATION OF THE SOURIS RIVER  
BASIN PROJECT RURAL IMPROVEMENTS

HISTORICAL RESEARCH ASSOCIATES

FINAL REPORT

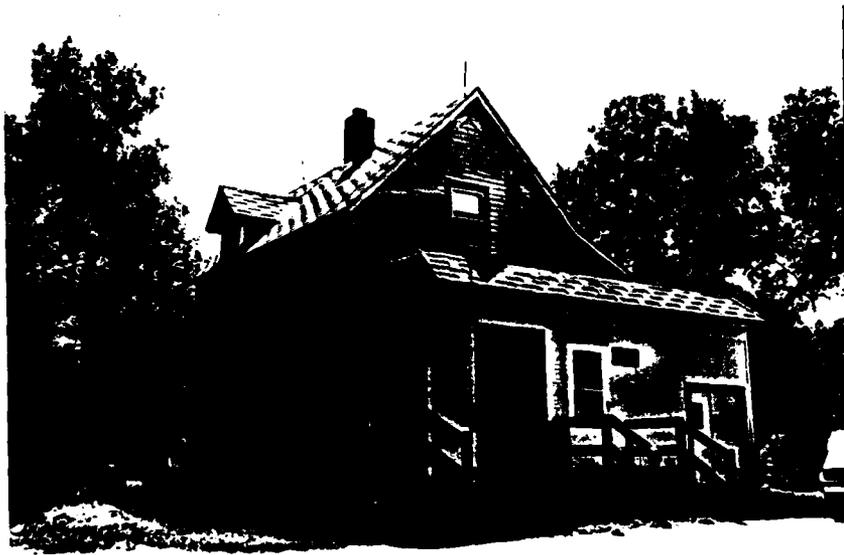
Figure 5. Looking southeast at Feature 6 of 32MH31 (HRA 81).

Feature 6 is a two story, gable-roofed, wood frame residence built, according to the present owners, in 1906 or 1907 (Figure 5). The building has a shed-roofed, frame addition on the west elevation and a flat-roofed, frame, enclosed porch addition on the north elevation. There is a small, gable-roofed dormer on the second floor of the east elevation of the main feature and a recently added redwood deck on the first floor of the east elevation. The feature rests on a cut sandstone foundation. The siding material is 1x4 clapboard on the original structure and the shed-roofed addition, and is wood paneling on the north-facing, flat-roofed addition. There is one one-over-one (1/1) double-hung window with an aluminum storm on the second floor of the north elevation, and two two-lite Anderson windows and two single-entry doors on the porch addition on the north elevation. There is a three-lite fixed-pane window on the west elevation of the porch addition, a one-lite Anderson window and a 2/2 double-hung window on the west elevation of the original structure, and

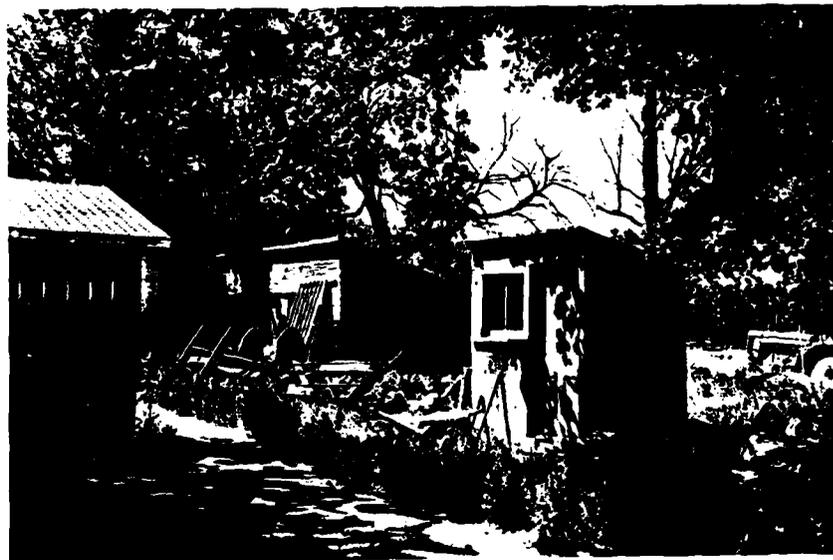
Figure 6. Looking northwest at Feature 8 (far right) and Feature 9 (rear center) of 32MH31 (HRA 81). A portion of Feature 10 is visible in the left of the photo.

Feature 8 is a one story, frame, shed-roofed, storage building (Figure 6). The siding and roofing material consists of plywood panels. The building does not have a foundation. There is a single-entry door and one two-lite fixed-pane window on the south elevation. The building is in good condition and, although the owners did not know when it was built, it was probably constructed in the late 1930s. The feature is not architecturally significant.

Feature 9 is a one story, shed-roofed, frame, chicken coop that rests on the ground (see Figure 6). The roofing material is wood shingles and the siding is 1x4 tongue and groove. There are a single-entry door, three window openings without glass, and one two-lite fixed-pane window on the south elevation of the feature. The chicken coop is in fair condition and probably was built in the 1930s. The feature is not architecturally significant.

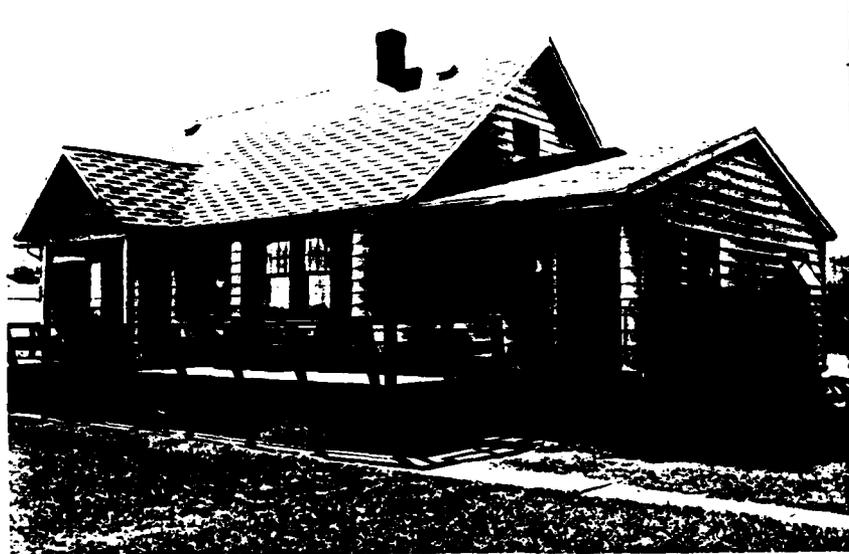
Figure 16. Looking southeast at Feature 10 of 32MH33 (HRA 195-199).

Feature 10 is a one and one-half story, wood frame, gable-roofed dwelling (Figure 16). There is a gable-roofed addition on the north elevation. The main house stands on a concrete foundation, while the addition has a concrete block foundation. The roof is composed of asphalt shingles and the house is sided with aluminum siding. On the north elevation of the house are two single-entry doors, three 6/1 double-hung windows, one 1/1 double-hung window on the main portion, and a single-entry door on the west addition. A deck runs the length of the north elevation. On the west elevation are two one-lite Anderson windows. The south elevation has three 6/1 double-hung windows and one 1/1 double-hung window on the main portion, and a one-lite Anderson window on the addition. The east elevation has two 1/1 double-hung windows. The house was built since 1945 and is

in good condition. The feature is less than fifty years old and does not maintain historic association.

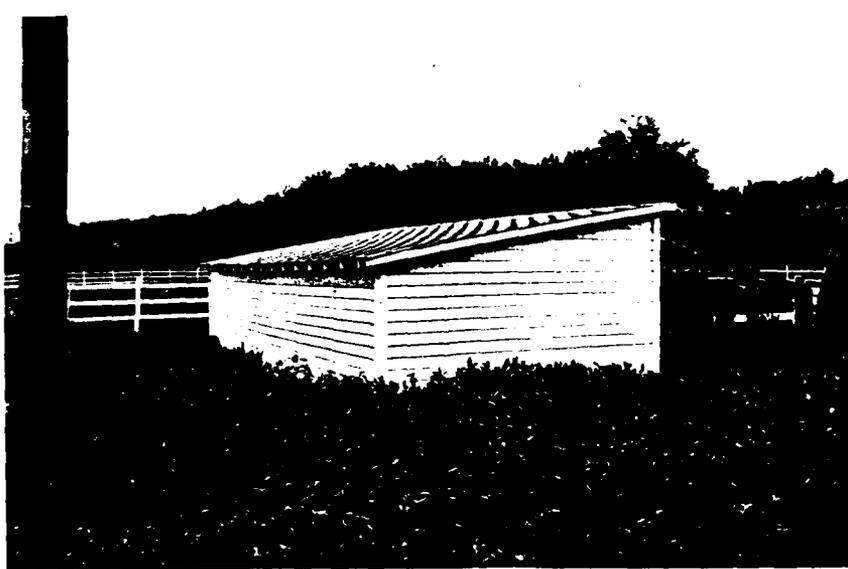
Figure 29. Looking southeast at Feature 8 of 32MH36 (HRA 320).

Feature 8 is a one story, wood frame, shed-roofed, chicken house (Figure 29). The structure has an asphalt shingle roof, 1x4 tongue and groove siding, and no visible foundation. There are single-entry doors on the east and south, and six window openings covered with chicken wire along the south elevation. The chicken house probably dates from around 1930-1945 and is in good condition. The feature is not architecturally significant.

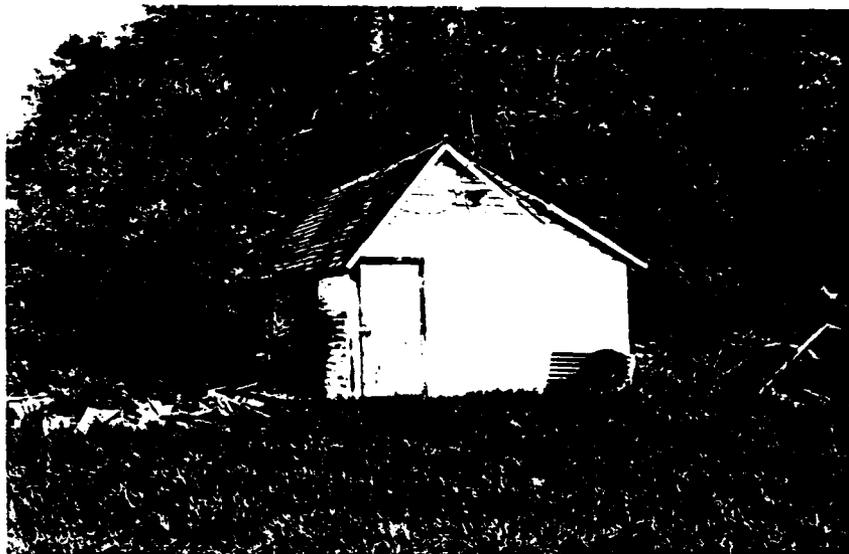
Figure 38. Looking west at Feature 8 of 32MH43 (HRA 430).

Feature 8 is a one story, wood frame, storage building with a saltbox roof (Figure 38). It is roofed with wood shingles and sided with 1x4 clapboard. The building rests on a concrete foundation. There is a single-entry door on the east elevation and four six-lite fixed-pane windows on the south elevation. The storage building probably was built after 1945. It is now used partially for coal storage and is in good condition. The feature

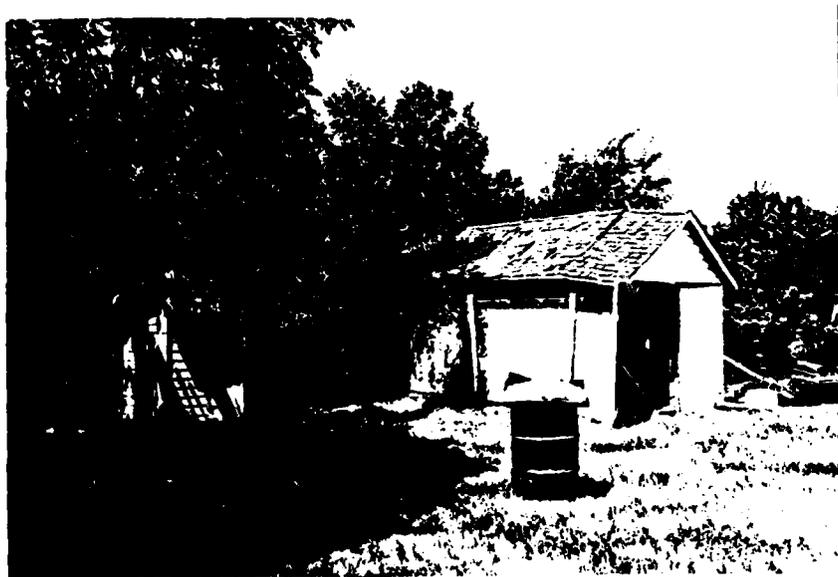
Figure 42. Looking northwest at Feature 2 (left) and Feature 3 (right) of 32MH34 (HRA 451).

Feature 3 is a one story garage with a gable roof (see Figure 42). It was built in 1935. Probably once used as a buggy shed, the western three-quarters of the feature is the original portion, and the eastern one-quarter is an addition, which is separating from the original. The roofing material is wood shingles and the exterior siding is comprised of tongue and groove. The foundation is concrete. There is a single vehicle entry with two hinged doors on the east elevation. The feature

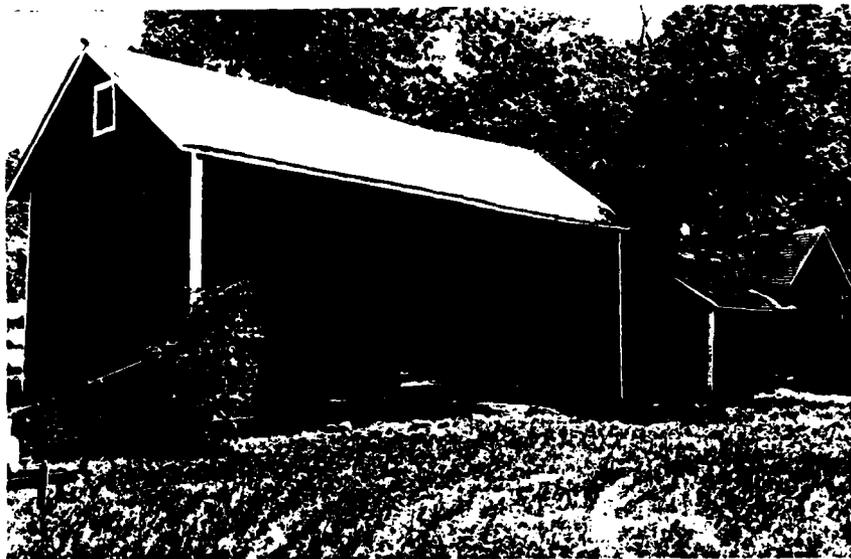
Figure 44. Looking east at Feature 7 (left) and Feature 8 (right) of 32MH34 (HRA 451).

Feature 8 is a one story storage building with a gable roof (see Figure 44). The feature appears to be two buildings joined together. The roofing material is wood shingles. The exterior siding is comprised of tongue and groove. The feature rests on a rock foundation. On the west elevation is a boarded up window opening and two single-entry doors. The feature is in fair

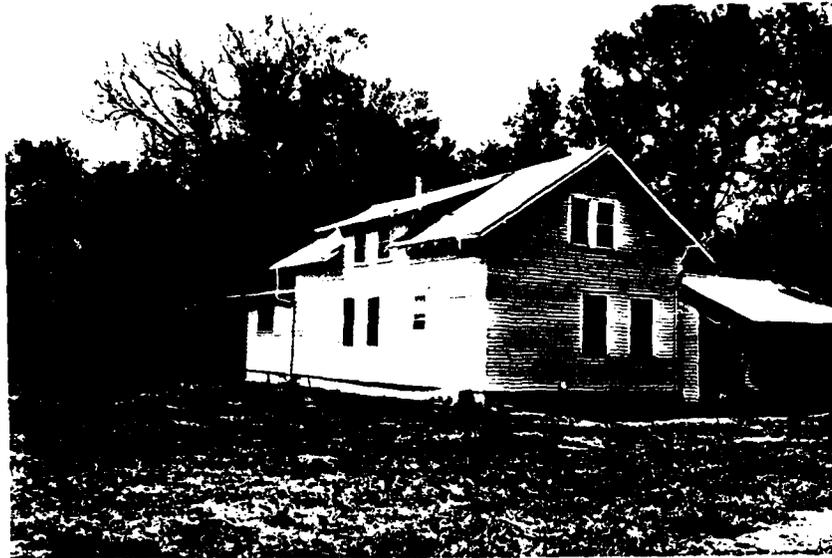
Figure 54. Looking southwest at Feature 11 of 32MH35 (HRA 454).

Feature 11 is a two story, frame, house with a gable roof (Figure 54). The house has asphalt shingle roofing, 1x4 clapboard siding, and rests on a concrete foundation. There are two story gable-roofed additions on both the north and south elevations, a one story gable-roofed addition on the south elevation, and a one story gable-roofed garage adjoining the northwest elevation. The east elevation has five 6/6 double-hung windows with wood frame screens and a one-lite fixed-pane window on the one story addition. The north elevation has four 6/6 double-hung windows on the house and two four-lite fixed-pane windows on the garage. There are three 6/6 double-hung windows, one six-lite fixed-pane window, and two single-entry doors on the west elevation. The south elevation has two four-lite fixed-pane windows in the garage, two 6/6 double-hung windows on the second floor, and a picture window on the ground floor with a one-lite Anderson window on either side. The feature was moved onto the site in 1946. The two story additions and the garage were built

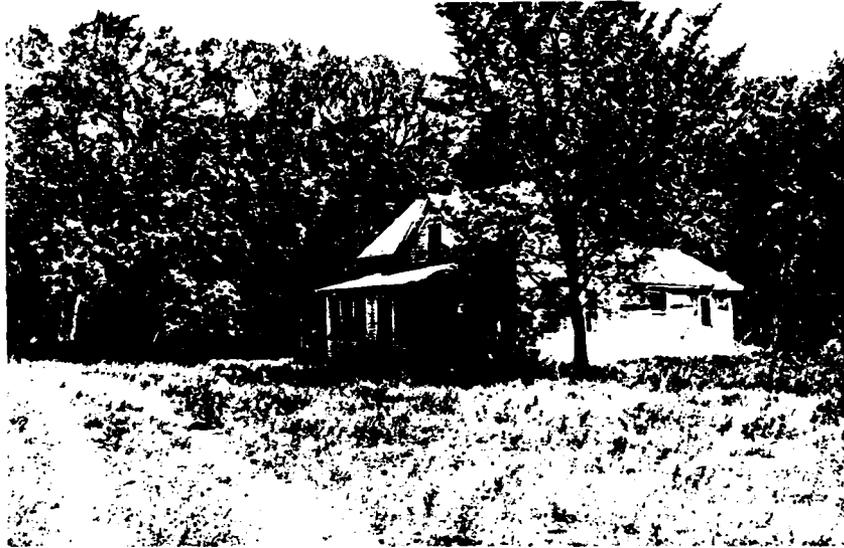
Figure 58. Looking north at Feature 11 of 32MH40 (HRA 475).

Feature 11 is a two story, wood frame, gable-roofed dwelling on a concrete foundation (Figure 58). There is an original, rectangular portion with a north/south orientation, and additions are located on the east and west elevations. The south elevation of the original portion has a 1/1 double-hung window in the second floor gable and two 1/1 double-hung windows on the ground floor. The north elevation has a 1/1 double-hung window in the second floor gable, one off-centered 1/1 double-hung window on the ground floor, and an exterior brick chimney opposite it. On the west elevation is a one 1/1 double-hung gabled window in the upper floor. There is a one story, shed-roofed addition on the west elevation, with a single-entry door and three 1/1 double-

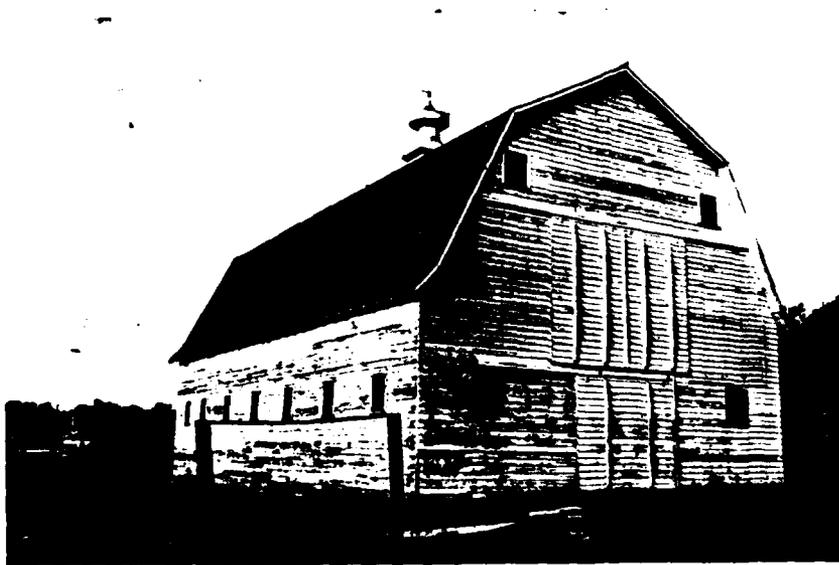
Figure 62. Looking southwest at Feature 7 of 32MH39 (HRA 485).

Feature 7 is a three story, frame, barn with a gambrel roof (Figure 62). The roofing material is wood shingles. There is a metal vent at the center of the roof. The exterior siding is 1x4 clapboard. The foundation is concrete. On the north elevation are two four-lite fixed-pane windows. On the first floor of the

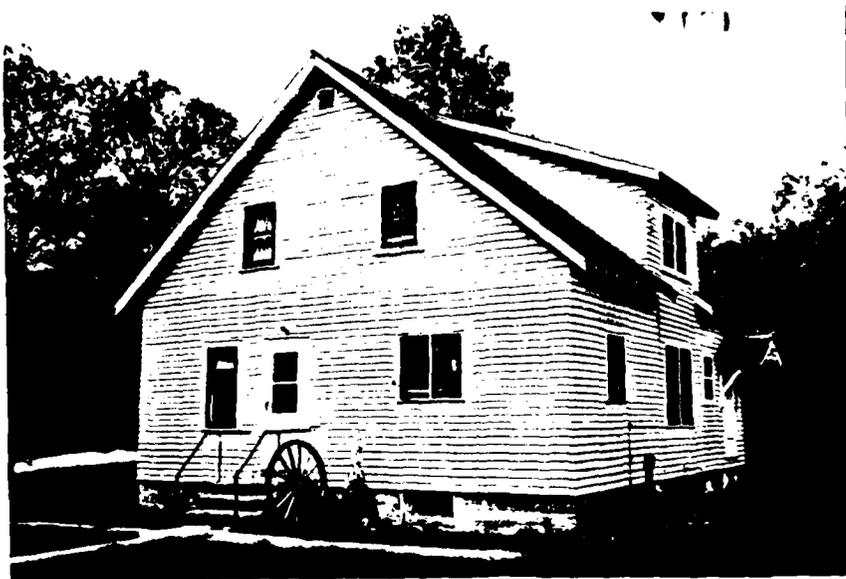
Figure 71. Looking northwest at Feature 7 of 32MH41 (HRA 580).

Feature 7 is a two story, wood frame, residence with a gable roof (Figure 71). It was built in 1949. The roofing material is wood shingles. There are two dormers -- one on the west elevation and one on the east elevation. A chimney is located in the center of the roof. The exterior siding is 1x4 clapboard. The foundation is concrete. The feature includes a three-step, concrete porch on the south elevation, and a basement. Also located on the south elevation of the feature are two 3/1 double-hung windows on the upper level and a twelve-lite fixed-pane window, a 1/1 double-hung window, and a single-entry door on the lower level. There are two 1/1 double-hung windows and one 3/1

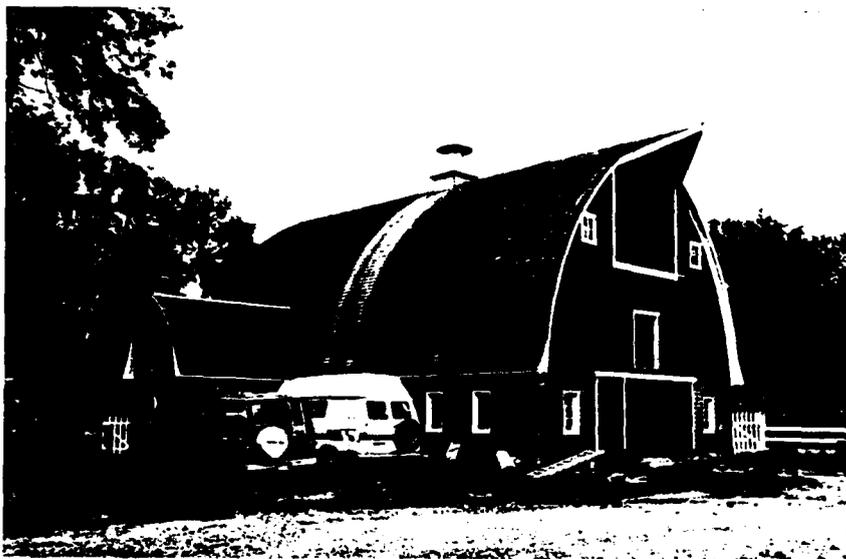
Figure 80. Looking northeast at Feature 5 of 32WD55 (HRA 1130).

Feature 5 is a two and one-half story, gothic-roofed, frame barn on a concrete pad (Figure 80). The north elevation has three four-lite fixed windows in the upper floor, one hay loading door on the second floor, and a wide vehicle access opening with sliding wooden doors. The west elevation has one single-lite fixed window and one six-lite fixed window on the northwest end. There is a six-lite window with a 3/4 wooden door above it on the addition to the west elevation. There are a door and a six-lite window on the south elevation of the addition. There are five six-lite fixed-pane windows on the ground floor of the west elevation of the main structure. The south elevation has a large opening with a hinged door in the hay mow. There are two four-lite fixed-pane windows on either side of this door. There is one hay loading door on the second floor. There are two six-lite fixed-pane windows on the first level. There is also a wide vehicle access opening with sliding wooden doors. The east elevation has seven six-lite fixed-pane windows and one single-entry door. The walls of the barn are constructed of ceramic tile bricks on the first floor with horizontal tongue and groove milled lumber on the second and third floor of the north and
