TECHNICAL REPORT REMR-CS-21

IN SITU REPAIR OF DETERIORATED CONCRETE  
IN HYDRAULIC STRUCTURES:  
A FIELD STUDY

April 1989  
Final Report

Prepared for DEPARTMENT OF THE ARMY  
US Army Corps of Engineers  
Washington, DC 20314-1000

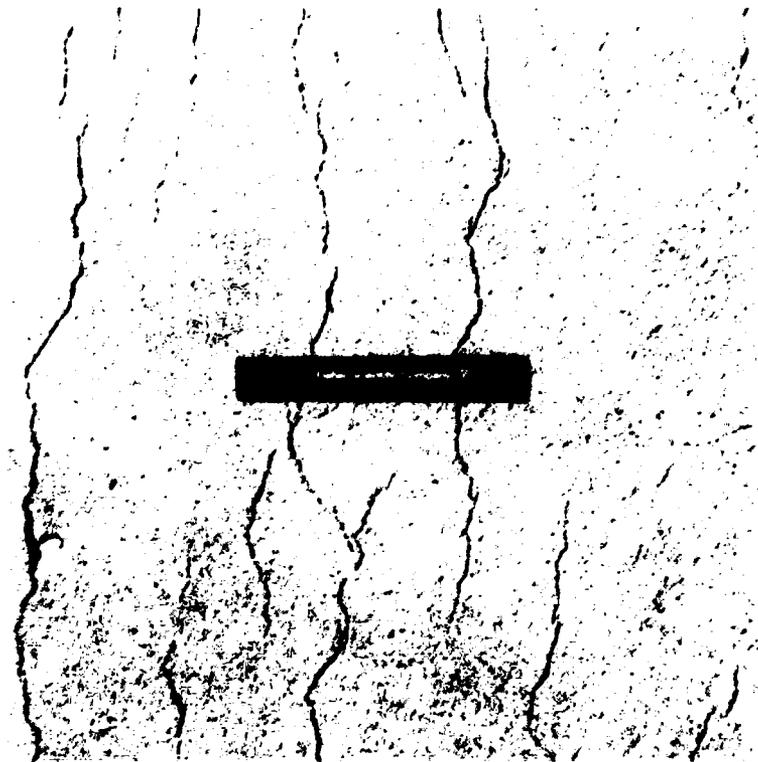
Figure 2. Typical crack pattern in the shielding blocks

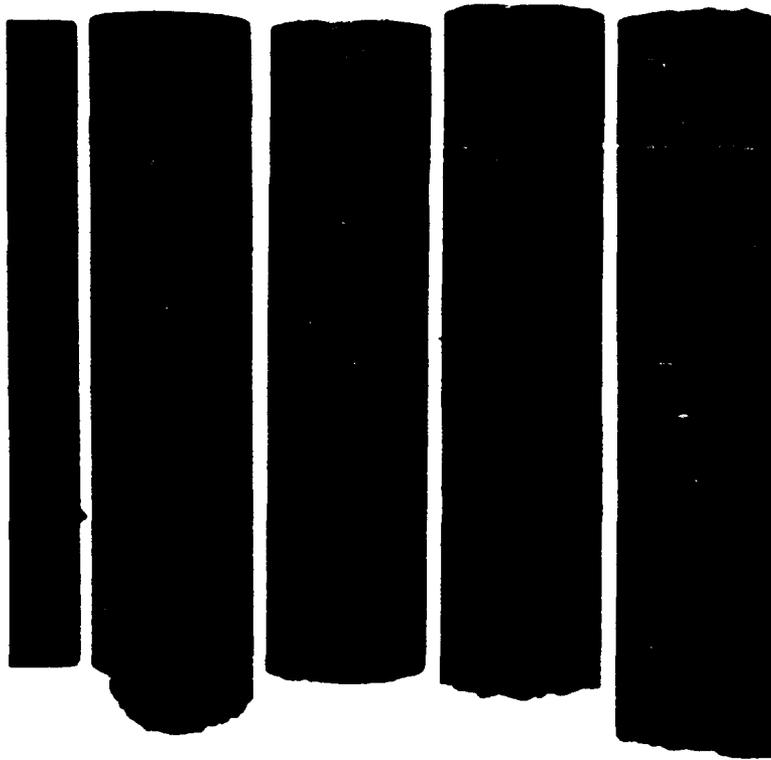
32. Visual examination of the 3-in.-diam cores removed from the wall after repair showed that the crack extended a minimum of 12 in. into the wall (Figure 7). Crack thickness varied up to 0.04 in. The cracks appeared to contain 80- and 100-percent epoxy.

33. Results of splitting tensile strength tests varied between 591 and 805 psi and averaged 693 psi, compared to an average of 659 psi for the uncracked controls.

Figure 7. Cores removed from concrete retaining wall after repair

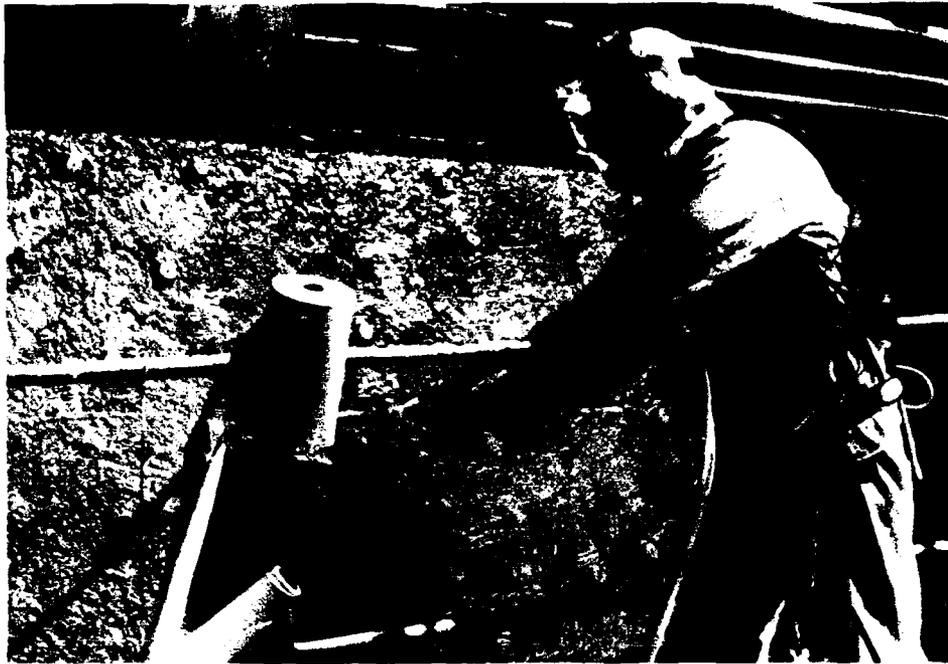
Figure 22. Injection of downstream face of pier stem

58. The eastern corner of the downstream face contained an extensive network of interconnected cracks. A majority of these cracks were filled by injecting epoxy into the centermost injection port over a 45-min period.

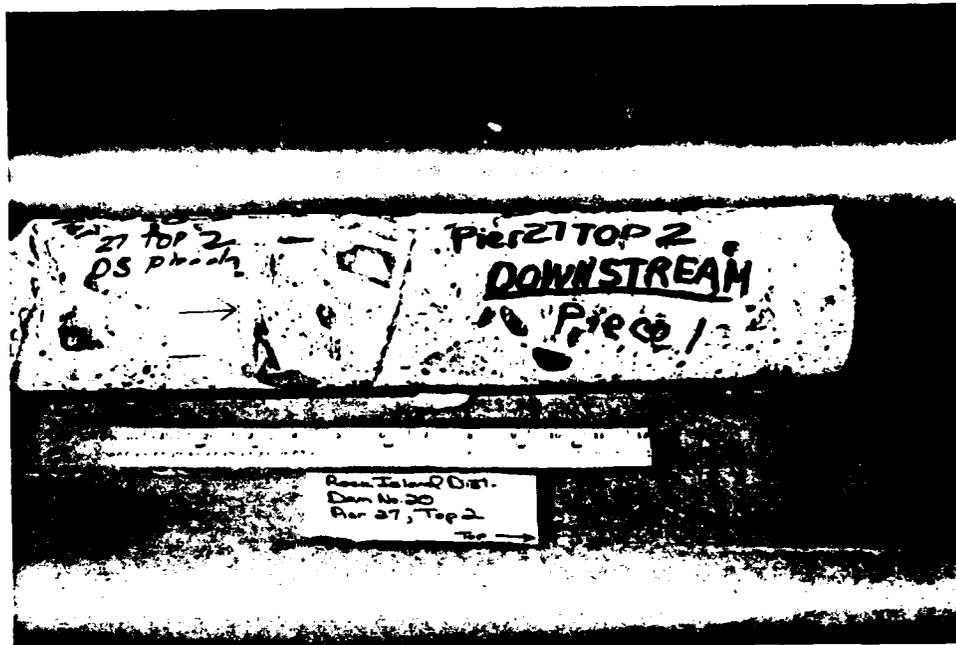
Figure No. 1

Side view of 4 in. dia. epoxy impregnated concrete core. Arrow denotes highly fractured deleterious chert coarse aggregate particle transected by well developed open fracture.

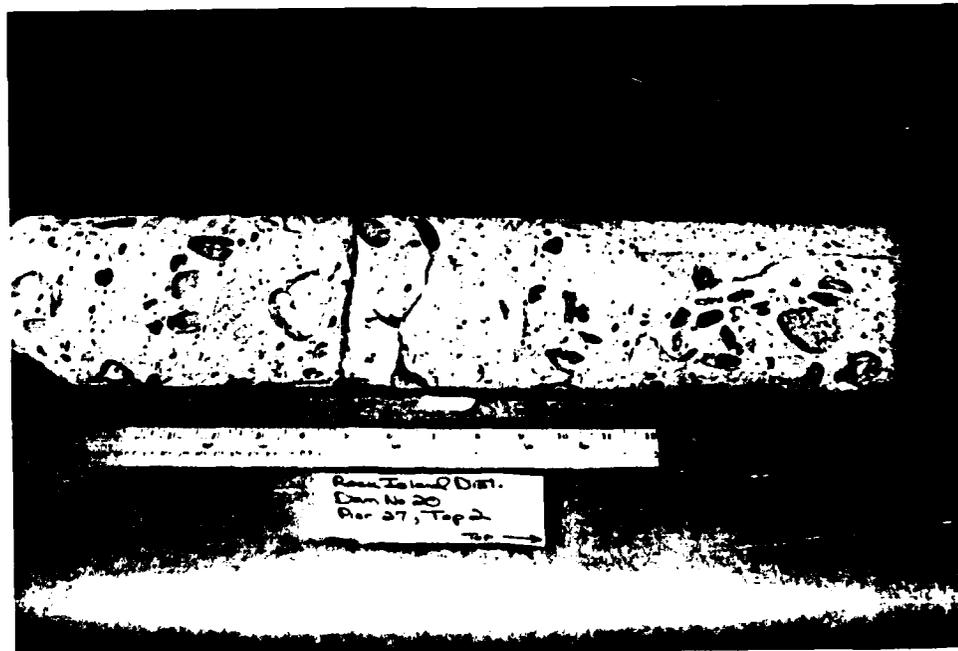
Figure No. 2

Same concrete core as in Figure 1, viewing opposite side. Note the two open fractures midway in the core at 0.88 ft. and 1.0 ft. below top of concrete.

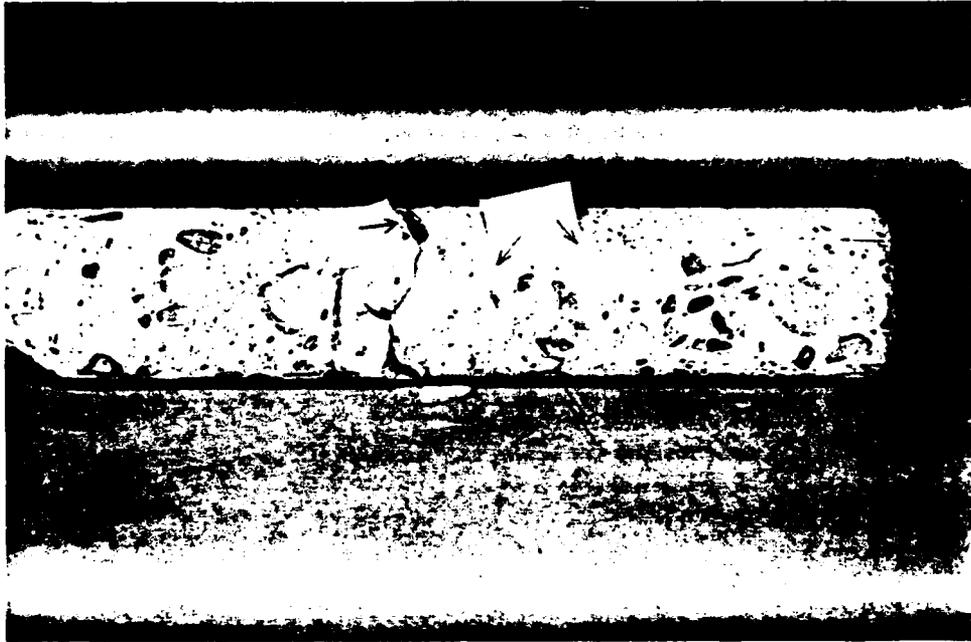
Figure No. 3

Same view as in Figure 2, arrows denote highly fractured freeze - thaw susceptible clay ironstone and chert coarse aggregate particles.

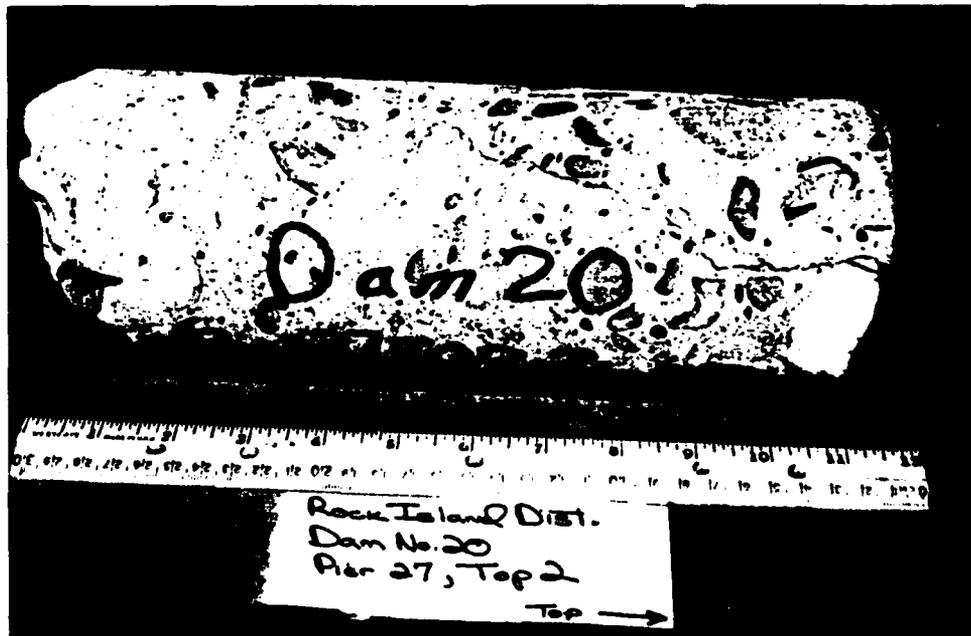
Figure No. 4

Same view as in Figure No. 1, close-up view of upper portion of epoxy injected concrete. Note prominent epoxy injected fracture oriented subparallel to the core axis.

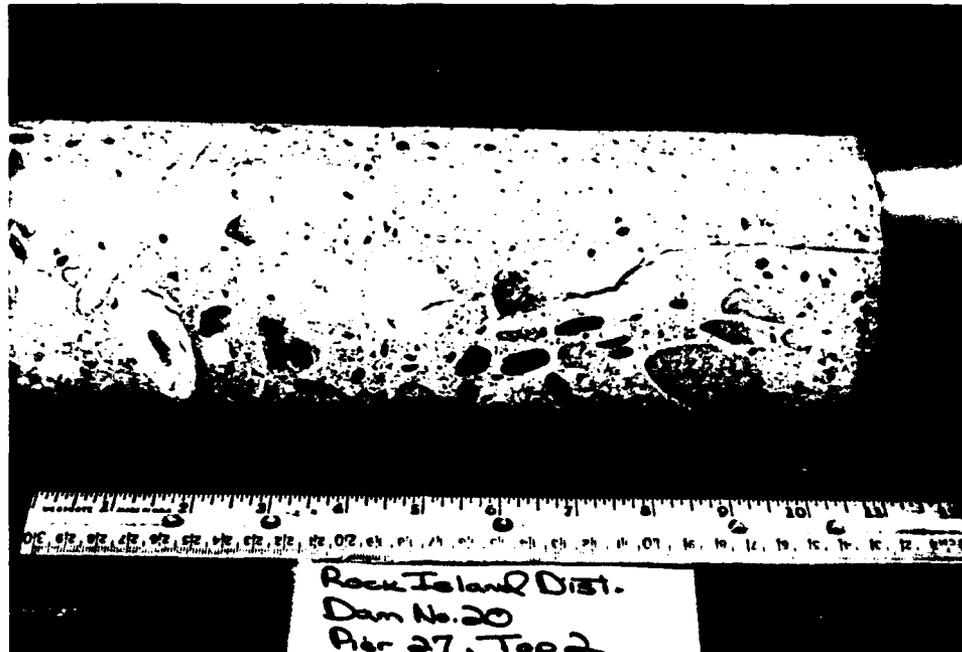
Figure No. 5

Magnified view of upper portion of concrete core shown in Figure 3. Note the light gray white chert coarse aggregate that have been highly fractured by freeze - thaw action.

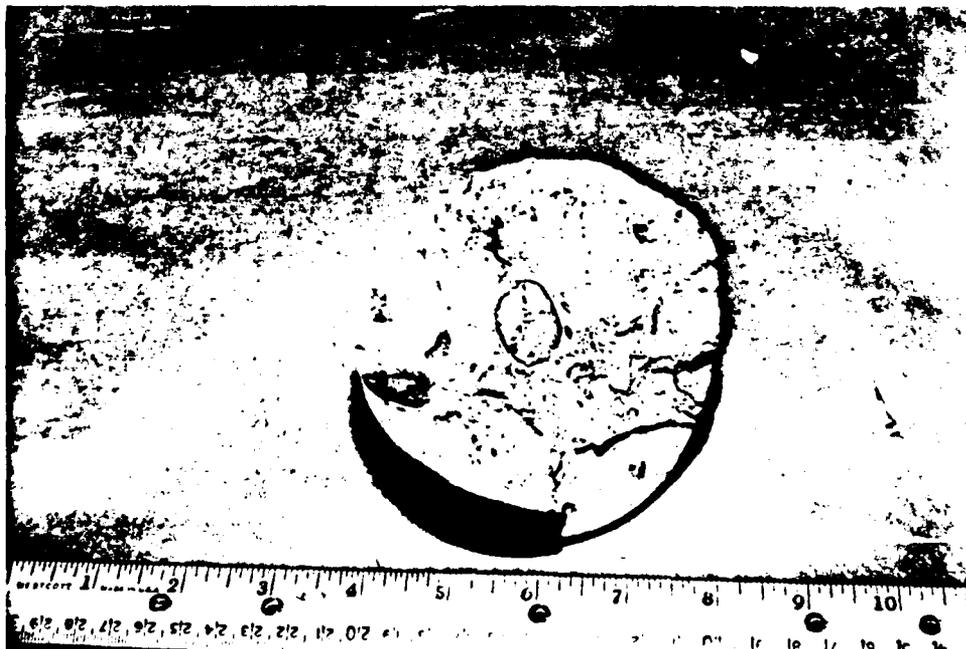
Figure No. 8

View of lower fracture surface located 0.88 ft. below top of core. Note alkali - silica reaction rims in deleterious coarse aggregate particles and white silica gel precipitate coating fracture surfaces.

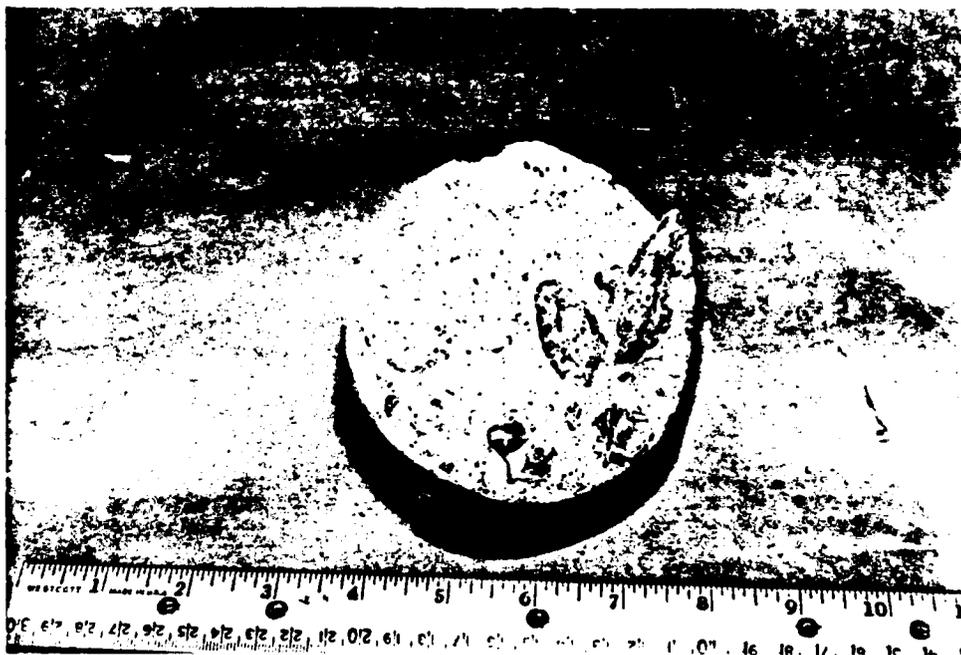
Figure No. 9

View of upper fracture surface located 1.0 ft. below top of concrete. Note white silica - gel soaking concrete paste surrounding alkali - silica reactive coarse aggregate.
