DEM-TR-89-01

NONCONVENTIONAL ROOF SYSTEMS FOR IN-HOUSE INSTALLATION AT AIR FORCE BASES

W.B. ROSE
D.M. BAILEY

JULY 1989
FINAL REPORT

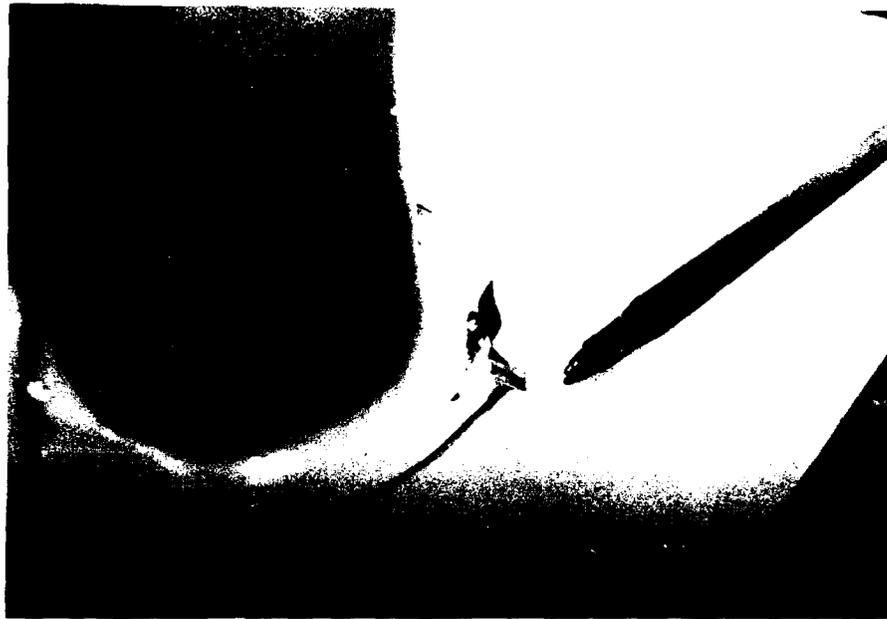
Figure 9. Poor weld due to local overheating of flange at the bottom of the pipe stem.

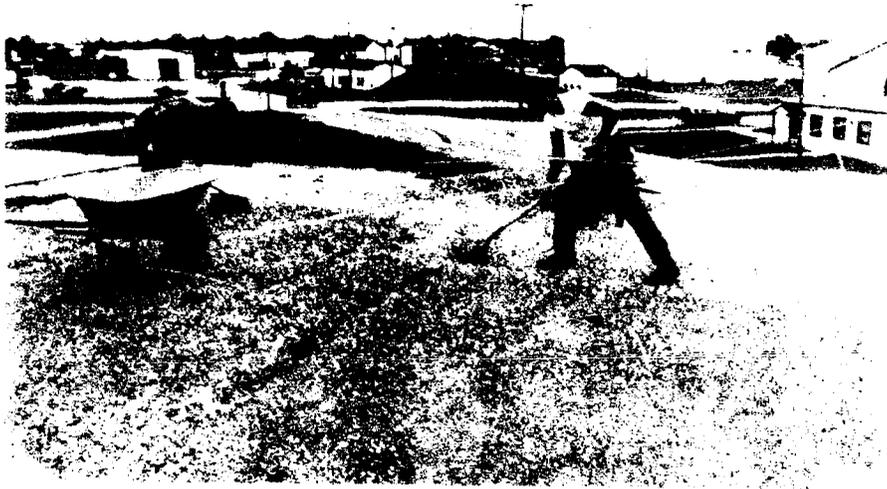
The existing roof was a gravel-topped BUR over high density fiberglass board insulation. The gravel was swept from the roof (Figure 11). A mechanical cutter was leased so the roof could be cut into sections and removed (Figure 12). The cutter was unreliable and was not used after the second breakdown. Further cutting was done by hand. Disposal of roofing materials was a problem. The quantity of gravel and other debris was much more than estimated. The dumpster was filled faster than it was emptied. The tearoff took much more time than expected.

Figure 11. Gravel being removed by shoveling and brooming.

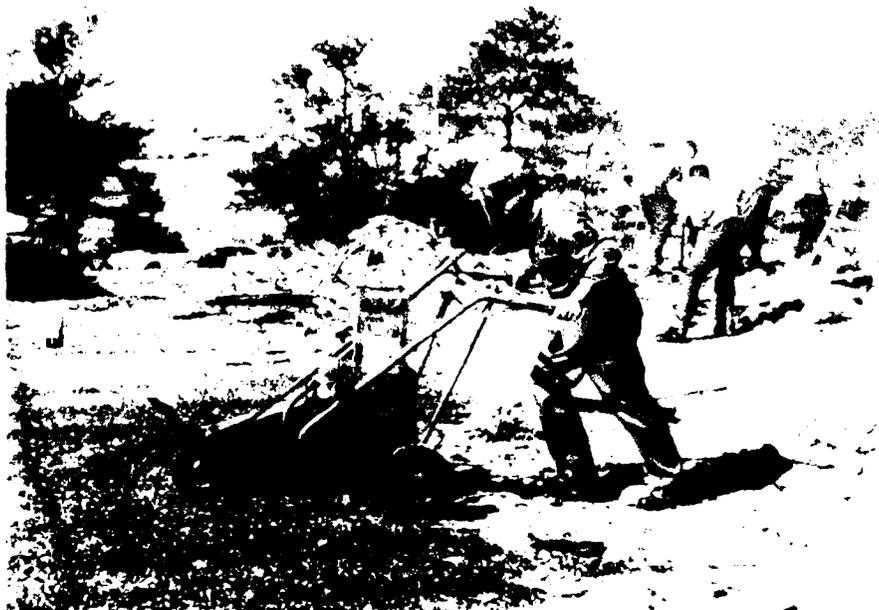
Figure 12. Mechanical cutter being used to separate sections of old BUR.

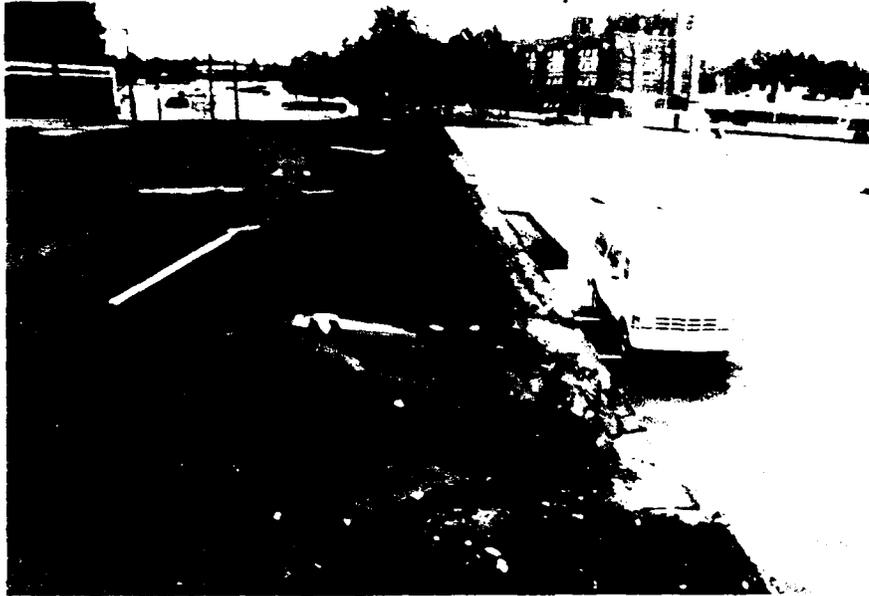
effort required to replace rotted edge nailers (Figure 57), and wet insulation on about 20 percent of the roof surface (Figure 58) was unexpected and disrupted the schedule. As in the other installations, the time necessary for proper preparation seemed very long.

Figure 57. Rotted wood edge nailers are removed and replaced.

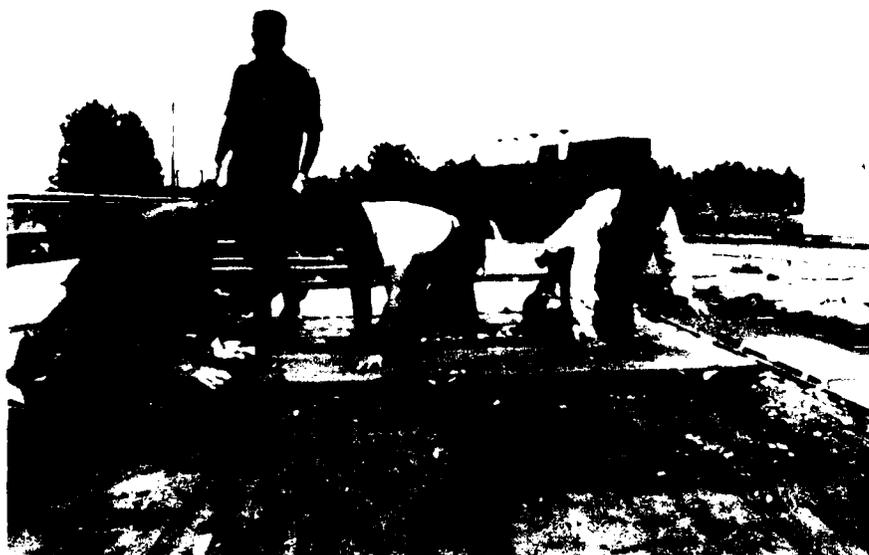
Figure 58. Wet insulation is removed and replaced.
