REPAIR, EVALUATION, MAINTENANCE, AND REHABILITATION RESEARCH PROGRAM

TECHNICAL REPORT REMR-CS-22

MONOLITH JOINT REPAIRS: CASE HISTORIES

Structures Laboratory

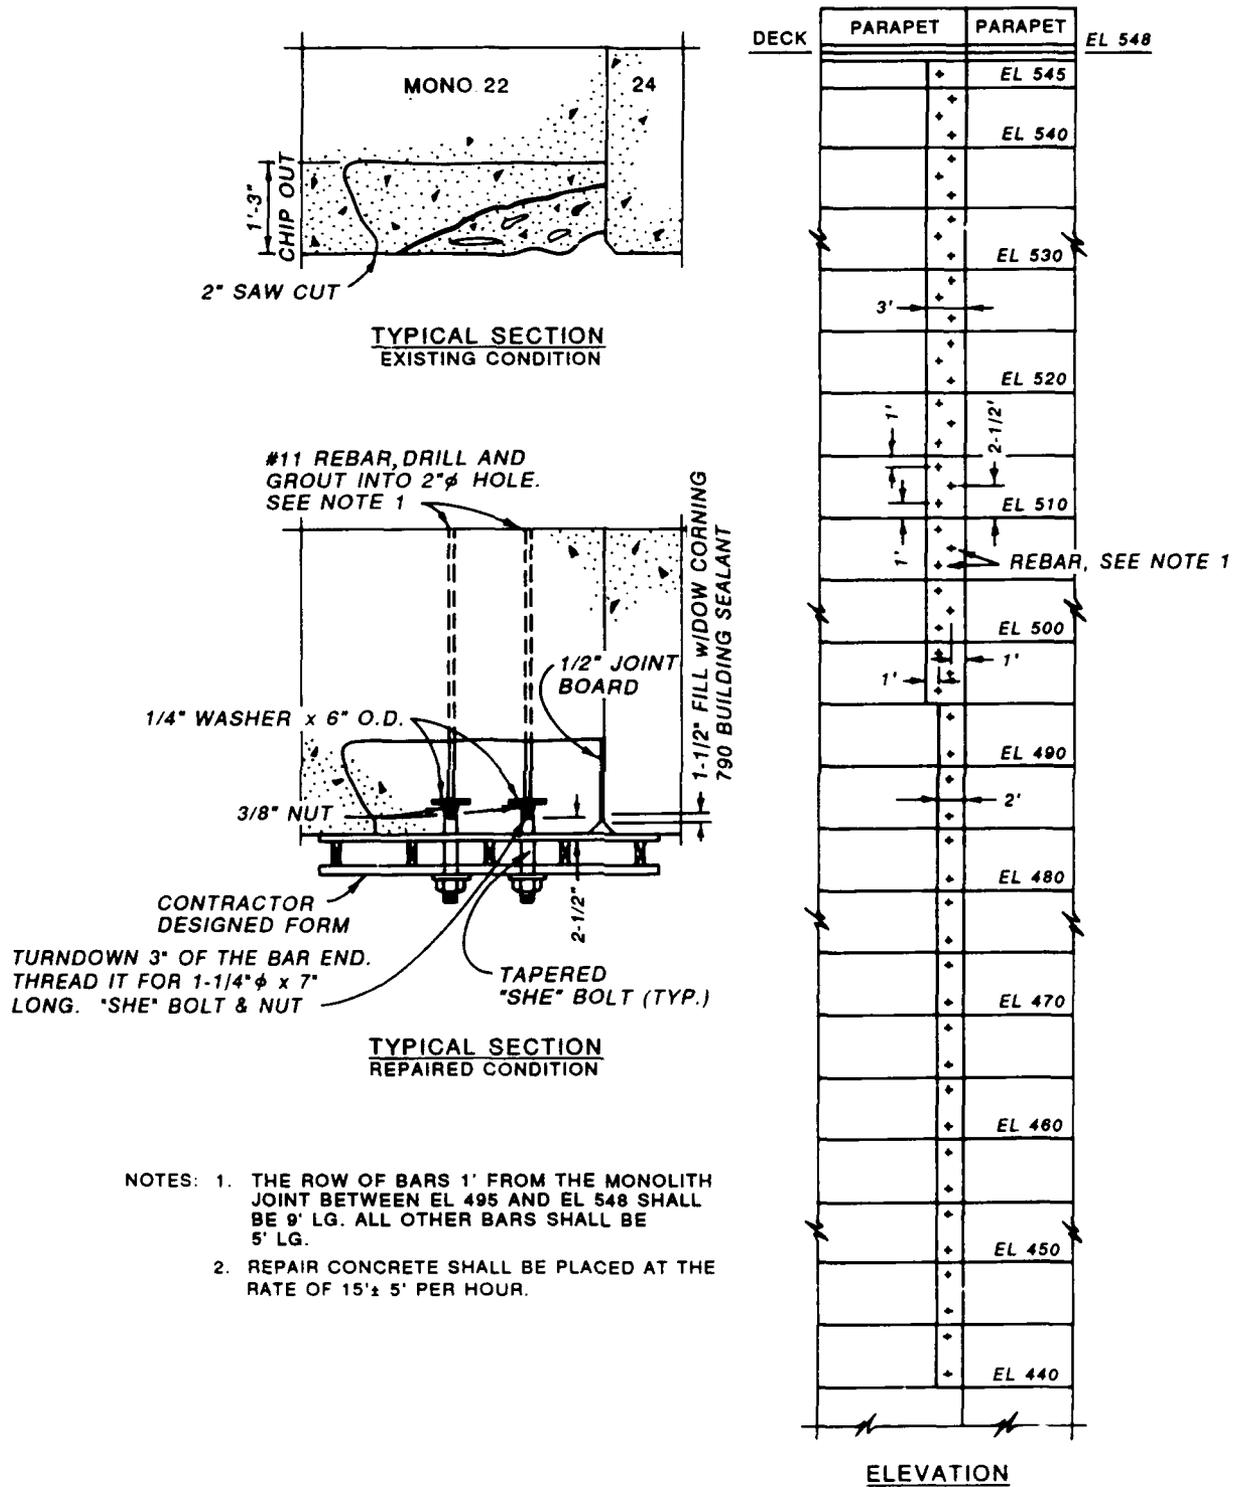
Figure 4. Monolith joint repair details, Lower Monumental Lock and Dam

The procedure consists of removing all loose concrete, saw cutting around the perimeter of damaged area that is not at least 15 inches deep, grouting horizontal anchors into the monolith (these anchors will serve as anchors for the pour-back repair concrete and for form supports), establishing a free joint between the repair concrete and adjacent monolith by installing a compressible joint board and filling the repair area with fibrous concrete from the bottom to the top in one continuous placement. Form pressures will stress the anchors which then hold the repair in place after it sets. A prestressed surface patch is thereby created. By using fibrous concrete, rebar is not required and the material will be more resistant than conventional concrete to impact, shear, and other forces.

Figure 4 illustrates the technique described (USAED, Walla Walla, 1977b). Strain gages used during the placement of the fibrous concrete indicated that high rates of placement caused little increase in form pressure, regardless of lift height. Also, the original design had called for the monoliths to join tightly without a joint board. Wherever this type of joining occurred, spalling invariably resulted. Conversely, wherever joint boards were installed, spalling was not a problem.

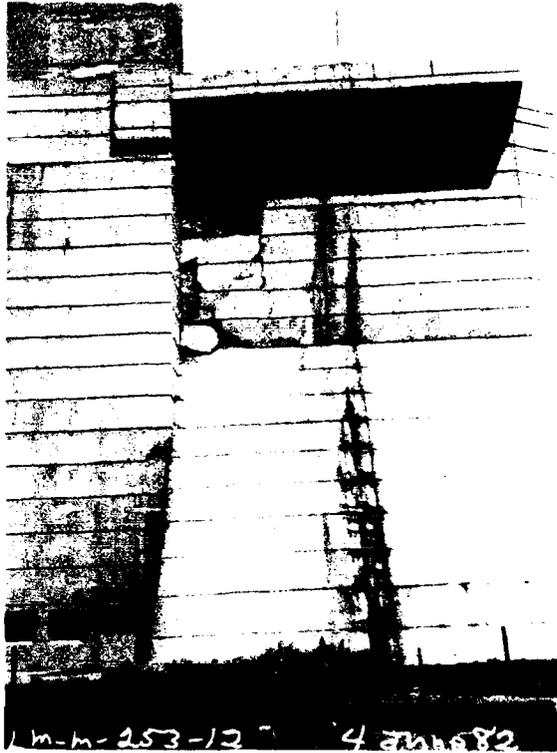
Figure 5. Monolith joint deterioration, 4 June 1982, Lower Monumental Lock and Dam

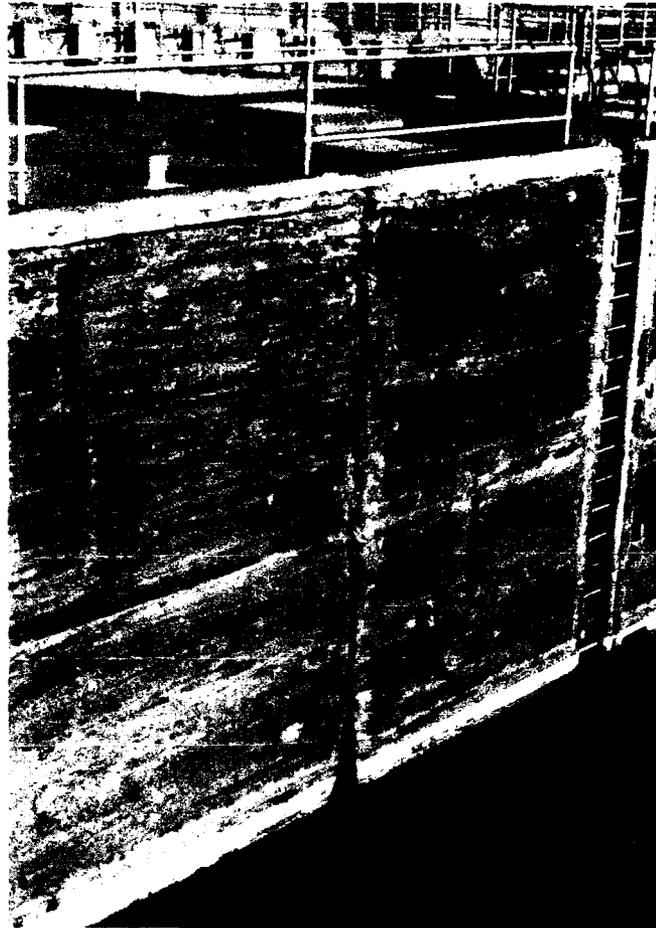
Figure 41. Typical monolith joint deterioration, Lock and Dam No. 2

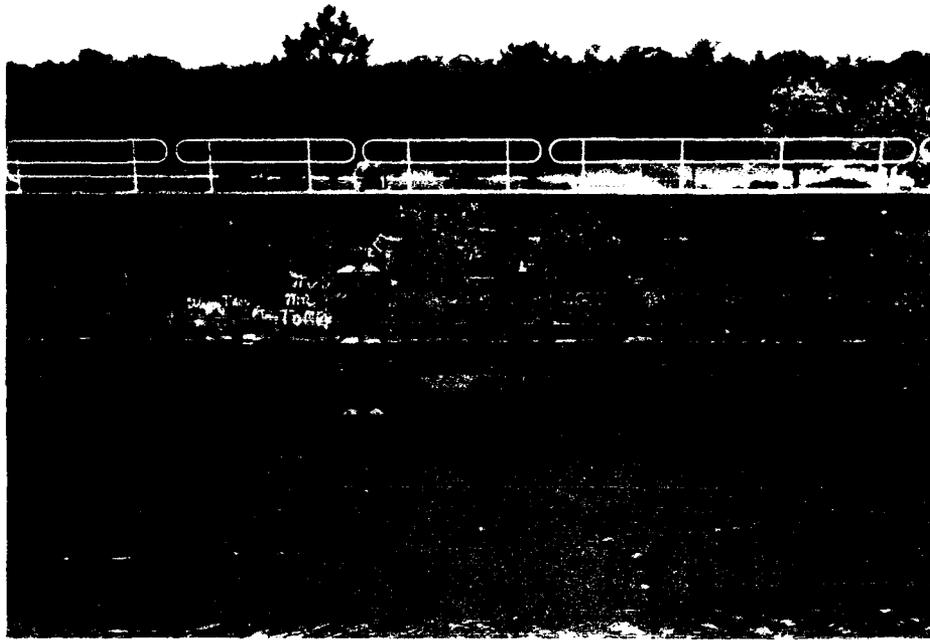
Figure 52. Typical examples of joint deterioration, Algiers Lock
