# AIRFIELD PAVEMENT EVALUATION

## PISCO AND LA JOYA AIR BASES, PERU

AIRFIELD PAVEMENT EVALUATION  
OF  
PERUVIAN AIR BASES

BY  
HQ AFESC PAVEMENT EVALUATION TEAM

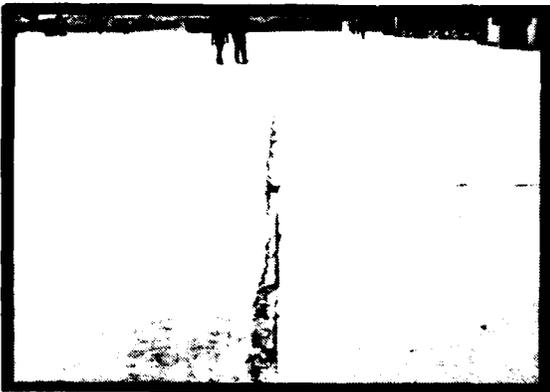
PHOTO 15: Spalled transverse joints which may be caused from incompressibles prohibiting slab movement resulting in joint spalls.

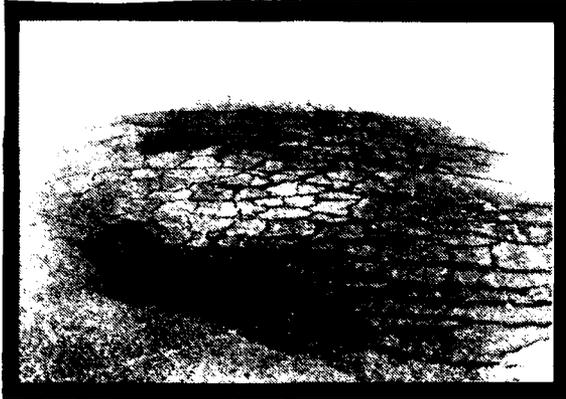
The other significant taxiway distresses are limited to the AC at the intersection of the Parallel Taxiway and the main parking apron (the south end of Feature T04A). Only 2 inches of AC protects the base course in this area. Isolated depressions and alligator cracking are evidence of pavement failure. Recommend the general area (approximately 800 square feet) be structurally repaired by enhancing the supporting soils and replacing the AC surface course.

PHOTOS 1-4: Pavement overloading is indicated by alligator cracks, block cracks, and depressions. These are common at the intersection of the Parallel Taxiway and the apron. Recommend this area be replaced.

d. The south area of Feature T4A is structurally distressed. Recommend this area, approximately 800 square feet, be rebuilt.

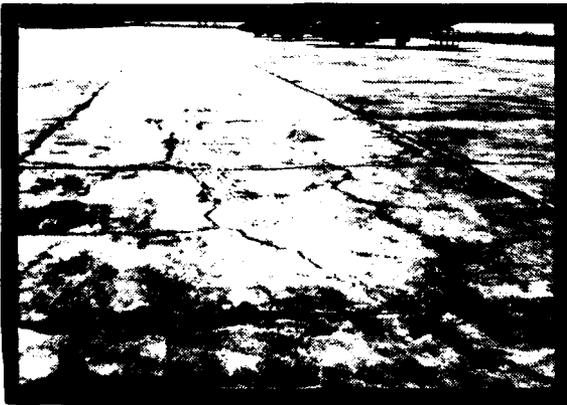
PHOTO 7: Typical shattered slabs concentrated on the apron taxi route. These slabs should be replaced.

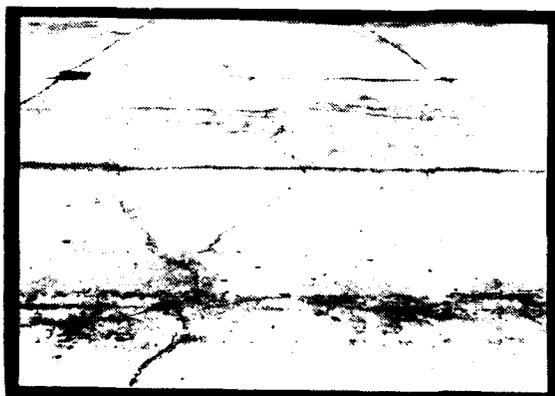
The PCC taxiway sections are generally in GOOD condition with the exception of two, which are in VERY POOR and FAILED condition. One is a small section of PCC near the intersection of Taxiway 2 and the Parallel Taxiway (Feature T10A). In this section, nearly all the PCC slabs have shattered due to overloading the pavement. The PCC thickness is between seven and eight inches and supporting soils are relatively weak. Recommend this area be replaced. The second area is the PCC (part of Feature A03B) connecting the main apron to the adjacent AC taxiway. It is in VERY POOR condition. Again, shattered slabs, spalled joints, and intersecting cracks are typical throughout. Recommend this area be replaced.

PHOTO 5: Failed PCC feature as indicated by extensive shattered slabs. Recommend the area be replaced.

c. Most PCC slabs on Feature T10A are shattered. Recommend this feature be replaced.

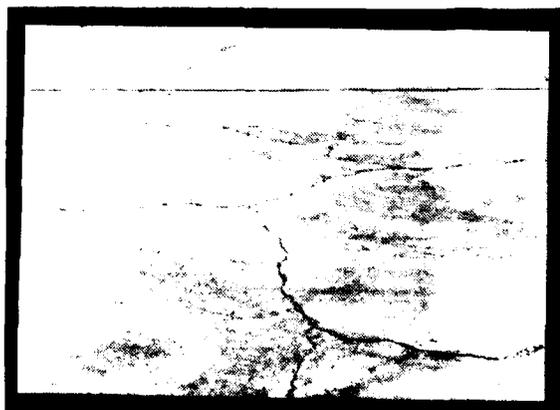
PHOTO 9: Typical shattered PCC slabs on apron.

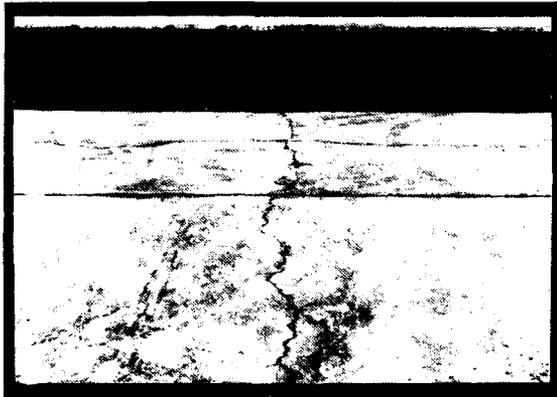
PHOTO 13: Cracks formed where joints should have been cut to control the cracking. Recommend the cracks be cleaned and sealed.

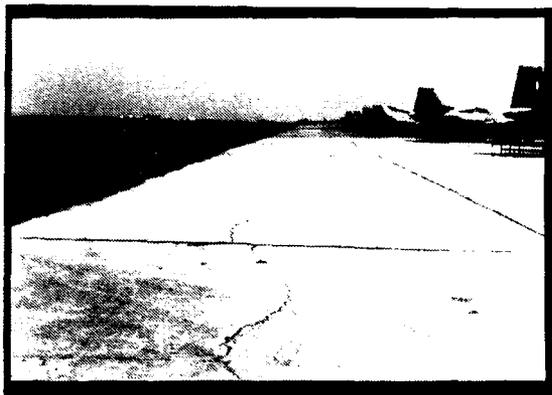
PHOTO 12: Typical longitudinal cracks extending the entire length of the apron. Recommend the cracks be cleaned and sealed.

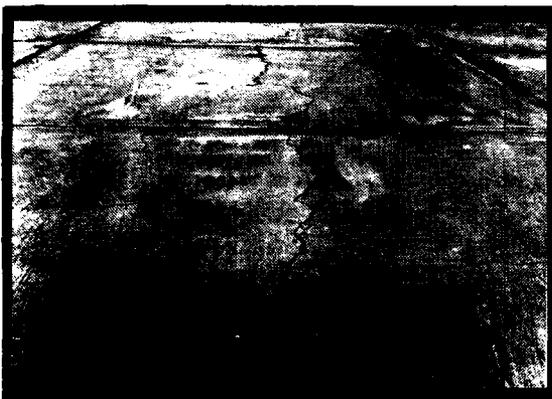
PHOTO 15: Shattered slabs typical across entire taxiway.
