Aircraft Structures Technical Memorandum 515

**FLUTTER INVESTIGATIONS ON A TRANSAVIA PL12/T-400 AIRCRAFT (U)**

A. Goldman, C.D. Rider and P. Piperias

An isolated flutter incident was reported in 1986 involving violent oscillations of the rudder and tail boom. This report details the subsequent activity to find a solution to the problem, and the tests conducted to verify the effectiveness of the solution.

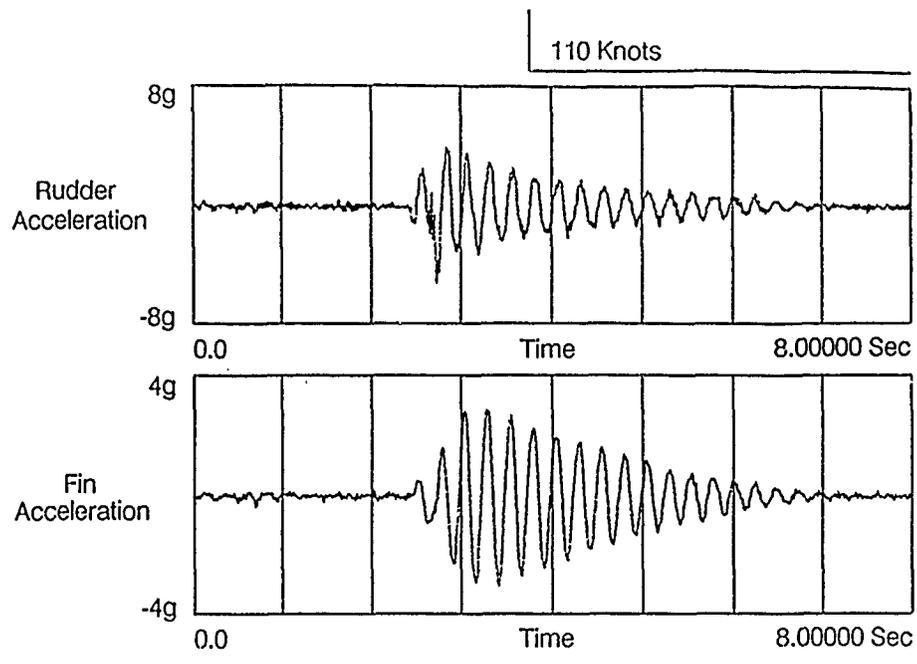
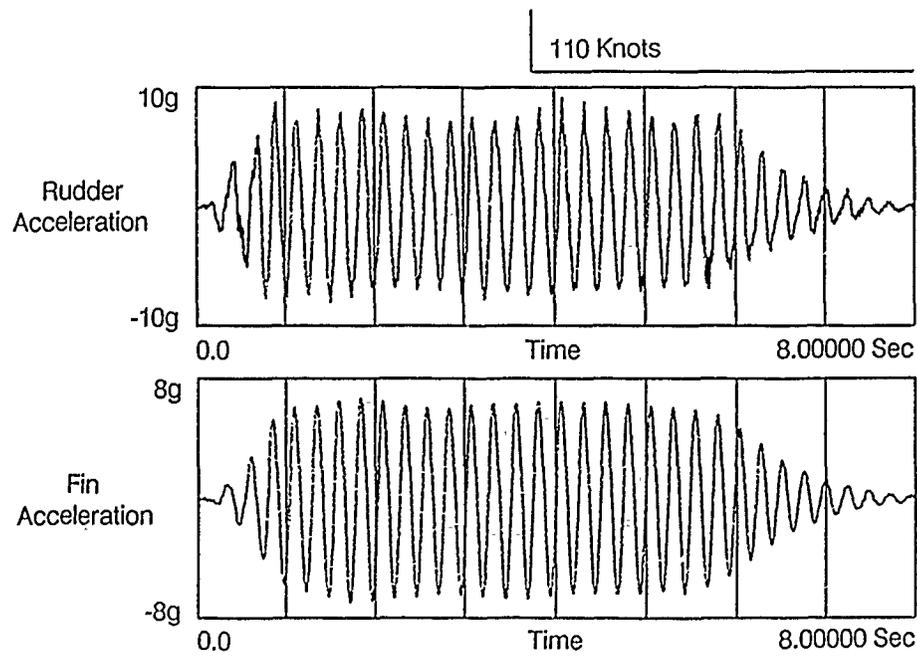
FIG 3. FLIGHT AT 110 KNOTS WITH INADEQUATE MASS BALANCE

Figure 3 shows the recorded data at 110 knots from the accelerometers on the fin and rudder. The amplitude indicated is acceleration measured in units of "g", "g" being the acceleration due to gravity and approximately equal to 9.8 metres/sec<sup>2</sup>. The displacement is readily derived knowing that the frequency is approximately 4 Hz. The relationship between acceleration and displacement is:-

The upper two traces show that the rudder oscillations applied, corresponding to 120 millimetres peak-to-peak amplitude measured at the trailing edge, were inadequate to overcome the frictional damping. When the applied amplitude exceeded 250 millimetres, the oscillations became self-sustaining as shown by the two lower traces.

In Figure 3 it will be seen that it required a considerable input on the rudder to initiate a self-sustaining flutter. The amplitudes indicated on Fig. 3, and all other similar figures are in acceleration units.

Using the relationship shown in para. 3 it will be seen that it was necessary to oscillate the rudder through more than 250 mm peak-to-peak amplitude measured at the trailing edge. In the upper two traces of Figure 3 it will be seen that an amplitude of approximately 120 mm was inadequate excitation.

The flight tests were suspended pending further investigations of the adequacy of the mass balance system.

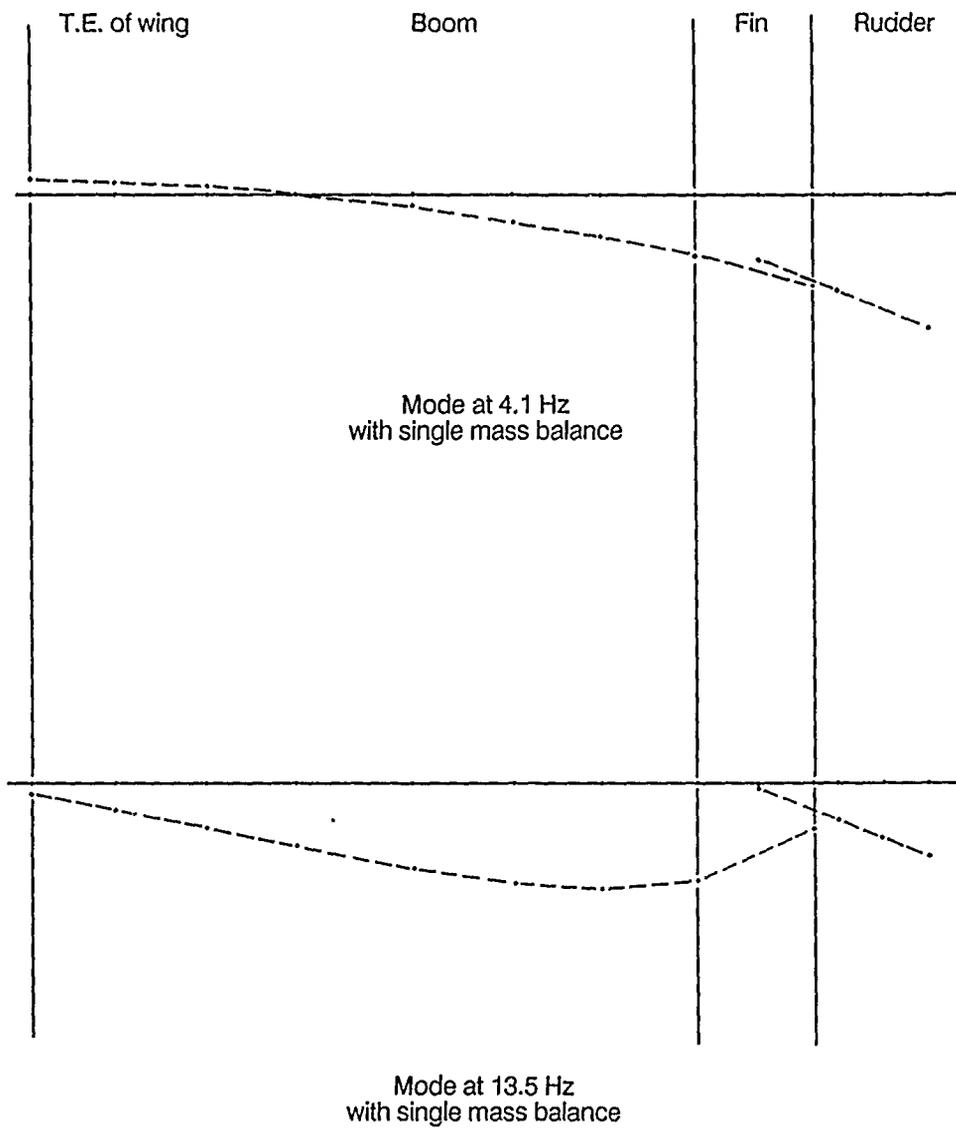
FIG 4. LATERAL MODES OF VIBRATION

In order to evaluate the effectiveness of the mass balance weights attached to the rudders, a ground vibration test was undertaken. This demonstrated that the zero static balance was insufficient to prevent the rudder from moving in the wrong direction when subjected to large amplitude vibrations in the lateral direction at the boom bending frequency.

Figure 4 shows the two mode shapes of concern.

An additional mass of approximately 500 gms was attached to the existing mass to correct this deficiency. The change in lateral bending frequency in the fundamental mode was not detectable. The frequency of the second lateral bending mode also remained constant at 13.5 Hz. However, the resonant frequency of the mass balance arm itself was measured at 14 Hz vertically and 16.6 Hz horizontally. This was considered to be too low as there was some concern about the effectiveness of the mass balance in controlling the mode at 13.5 Hz, and a resonant frequency of 16.6 Hz in the mass balance arm could possibly cause problems. The requirement is that the frequency be at least 1.5 times the highest frequency that it may couple with (Ref. 2).

A redesign of the mass balance system was suggested using two concentrated masses on stiffer arms placed on opposite sides of the rudder. On fitting the redesigned mass balanced rudder, the modal analysis indicated that the nodal line of the 13.5 Hz mode was still aft of the rudder hinge and the rudder would operate to attenuate the mode.

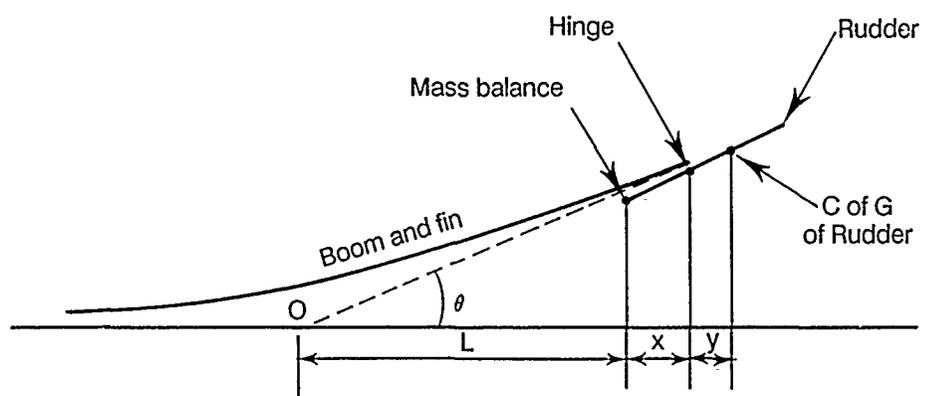
FIG 6. BENDING MODE AT 4 Hz

For dynamic balance of the inertia forces it is necessary to consider the acceleration experienced by the mass balance and the control surface, (Ref. 3). Referring to Figure 6, which represents the first bending mode of the tail boom, it will be seen that, for dynamic balance, the inertia force on the massbalance weight will need to equal the inertia force on the rudder.

The acceleration experienced by each component is approximately proportional to the distance of the centre of gravity of each from the centre of rotation of the mode under consideration.

If  $L$  is large, at least 10 times, compared with  $x$  and  $y$  the static balance is satisfactory. In this case, the centre of rotation of the rudder hinge is such that  $L$  is approximately 4 times  $x$  or  $y$ . Hence the need to consider the mode shape when balancing control surfaces.

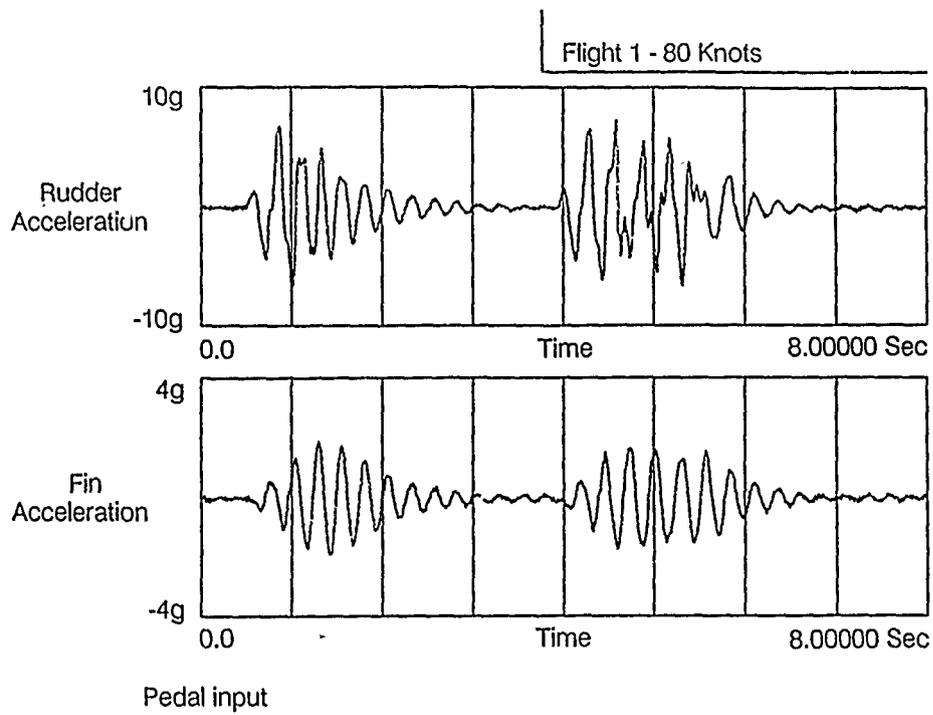
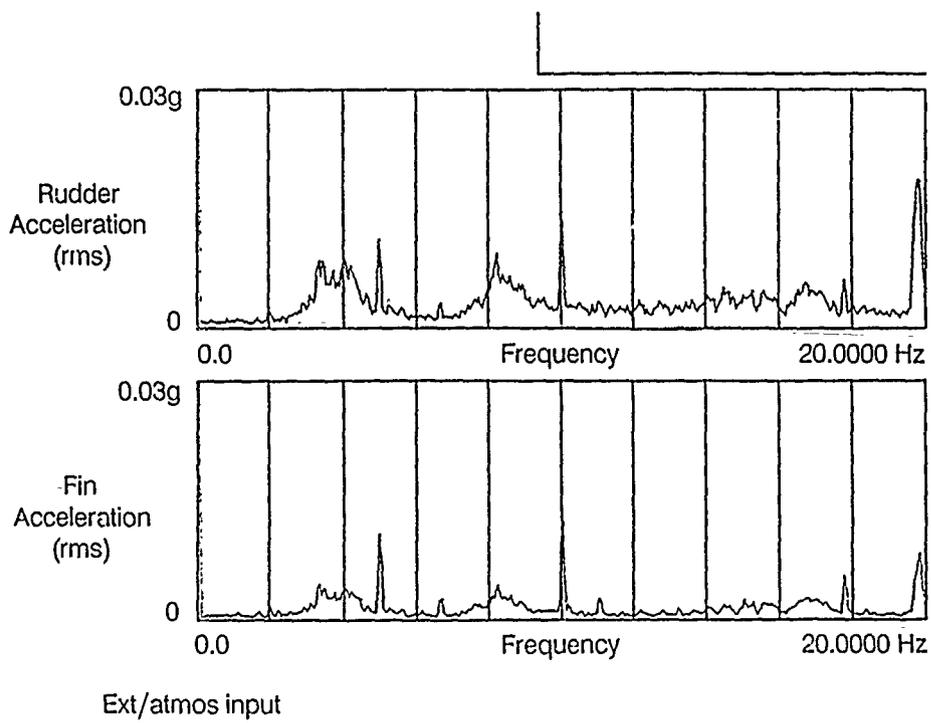
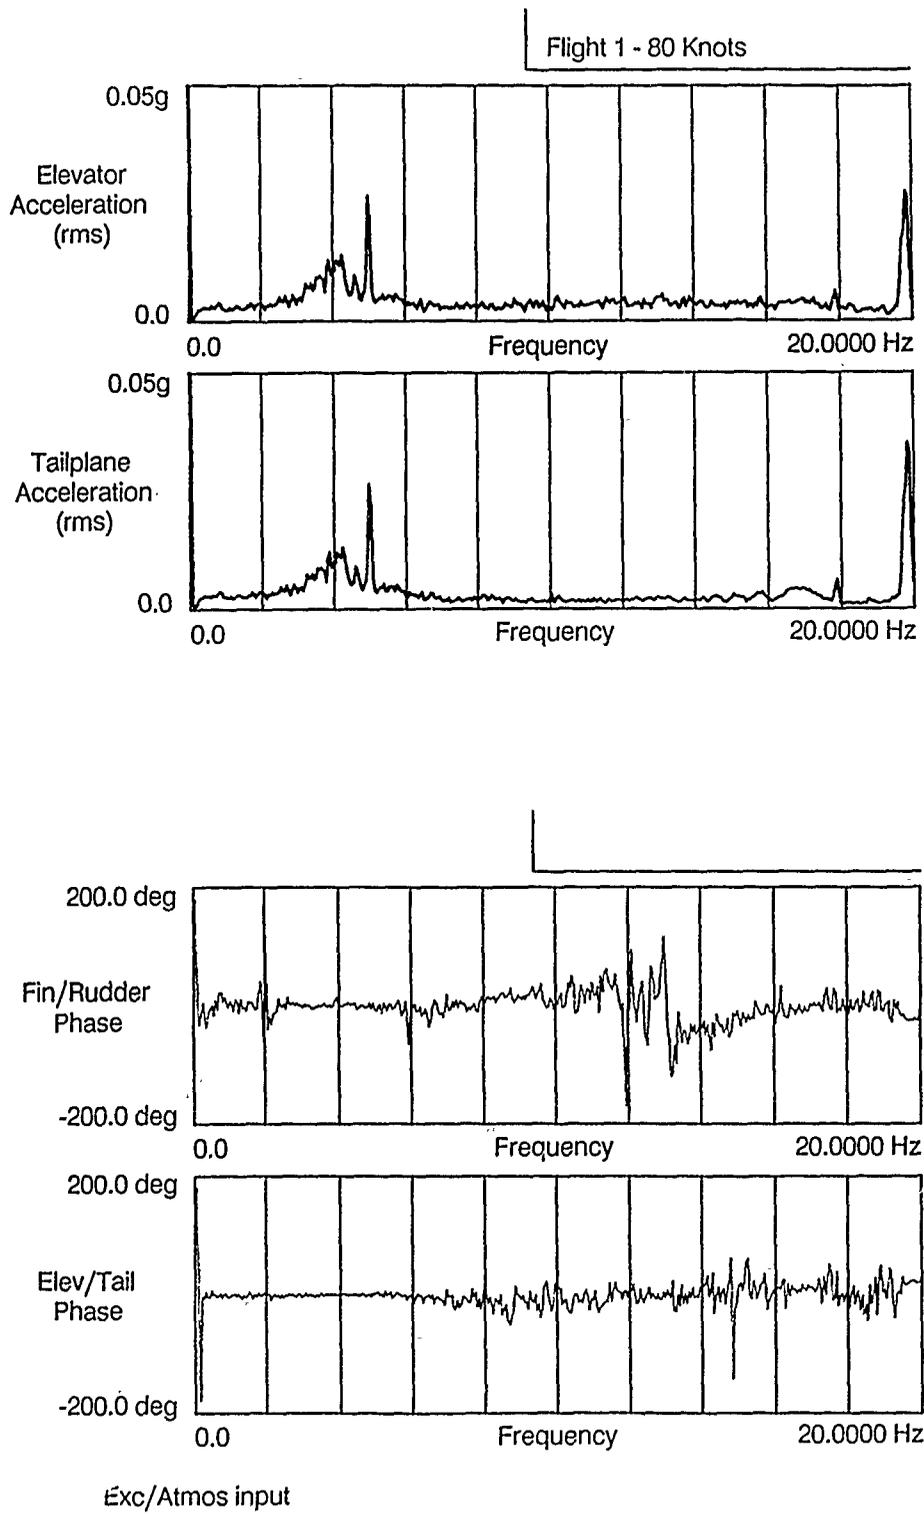
FIG 7a. FLIGHT 1 - 80 KNOTS

Following the fitting of adequate mass balance to the rudder, it will be seen from Figures 7 to 11 that it was not possible to excite this mode of flutter with rudder oscillations up to 800 mm in amplitude. These amplitudes, of course, are in absolute terms and include the fin motion.

The large response, measured at most locations and test points, at a frequency of approximately 5 Hz, is a mechanical vibration originating at the engine. The vibration is non-sinusoidal as it also gives rise to the harmonics at 10, 15 and 20 Hz.

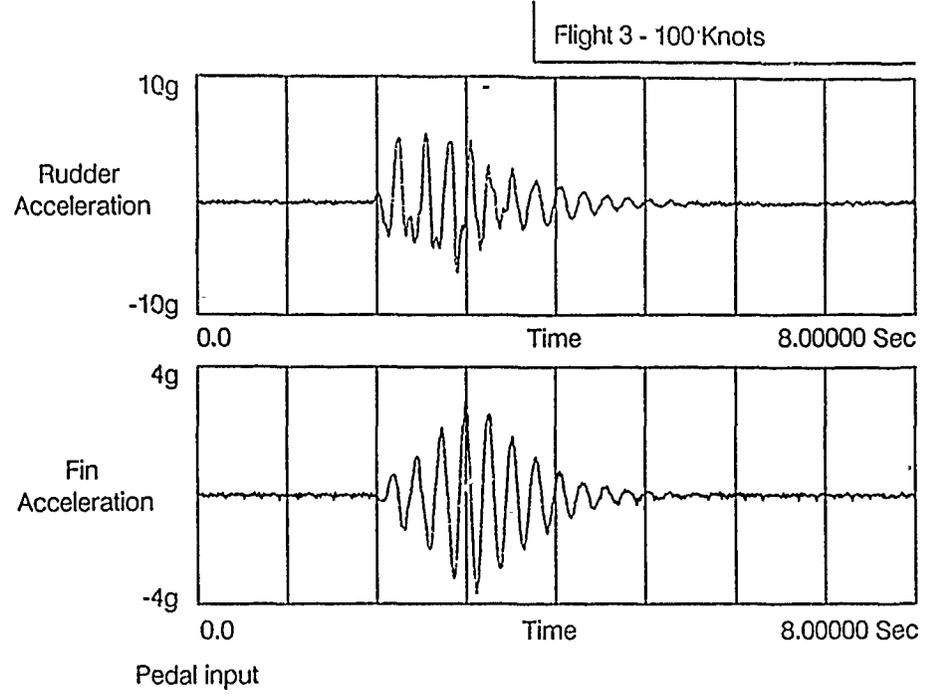
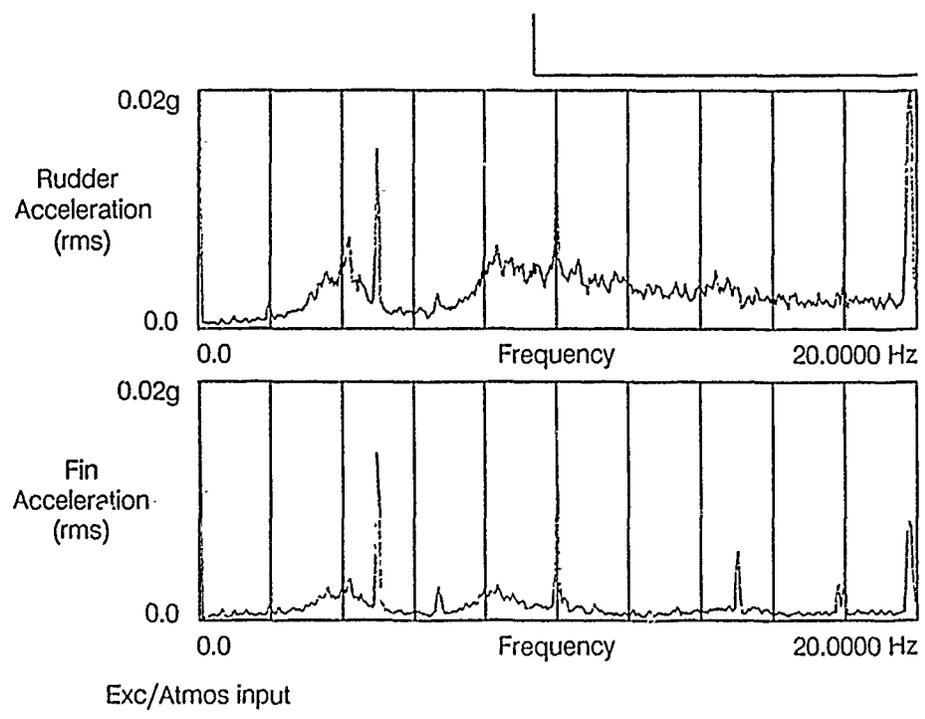
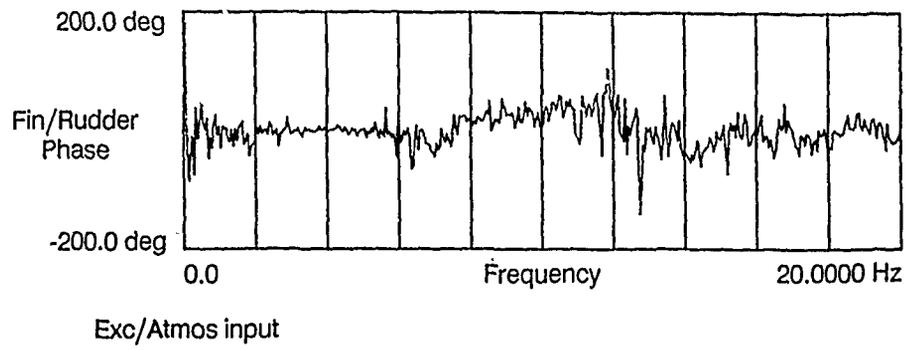
FIG 9a. FLIGHT 3 - 100 KNOTS

On flight 3 the tape recorder installed to record tailplane and elevator response failed to operate. The problem was corrected for all subsequent flights, and the indications from analysis of the data from flight 2 were such that it was not considered necessary to repeat that test point.

At no speed was there any indication of a mode of vibration becoming unstable or losing damping. The phase relationship between the fin and rudder shows some undesirable features around 13 Hz in flights 1 to 3 and again in flight 9. However, the associated vibration levels are so low that it is not considered to be a reliable indicator of a problem. That the exciter operated sufficiently to shake the structure was confirmed by the pilot's observation. The response to the exciter is only a fraction of that excited by the pilot's pedal operations at the lower speeds. However, it does indicate that the turbulence present in the atmosphere was equal to
