NASA Technical Memorandum 102681  
USAAVSCOM Technical Report 90-B-003

# Behavior of Composite/Metal Aircraft Structural Elements and Components Under Crash Type Loads--What Are They Telling Us?

Huey D. Carden, Richard L. Boitnott, and Edwin L. Fasanella

May 1990

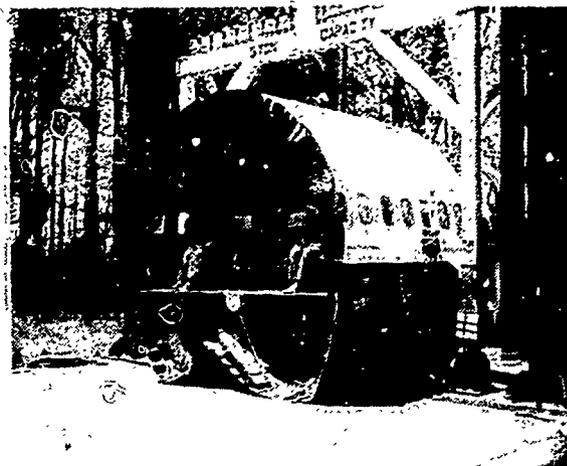
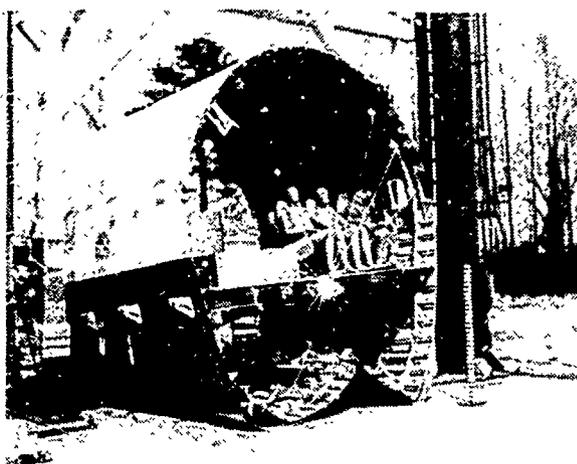
Figure 8. - Structural damage to metal aircraft structures resulting from impact tests.

**Dynamic tests.** - Structural damage of the transport aircraft structures resulting from the 20 ft/s drop tests is shown in figure 8(a) and (b). The damage to the transport sections was confined to the lower fuselage below the floor level. Under the vertical impact of 20 ft/s, all seven of the frames ruptured near the bottom impact point. Plastic hinges formed in each frame along both sides of the fuselage about 50 degrees up the circumference from the bottom contact point (See figure 8(c)). The crush of the lower fuselage was approximately 22-23 inches at the front end and 18-19 inches at the rear for the section taken from forward of the wing location (figure 8(a)) whereas for the aft section (figure 8(b)) the crushing was about 14 inches in front and 18 inches in the rear. Although the aircraft structures are metal and the failures discussed above involve plastic deformations with some tearing of the metal rather than brittle fractures, the general observed failure pattern and locations for the transport fuselage sections will be shown to be quite similar to the results of the composite frames and subfloors discussed later.

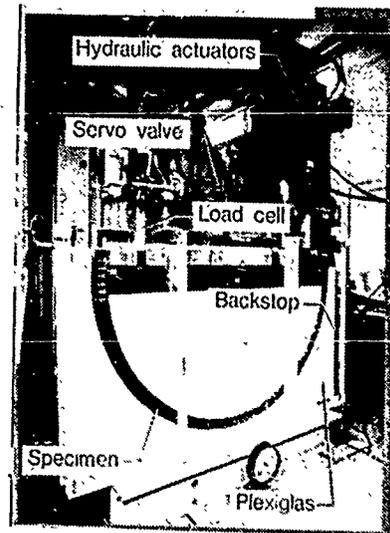
(a) Static test apparatus.

**Static tests.** - Results from the static test of a semi-circular frame with a Z cross-section<sup>27</sup> are presented in Figure 11. A photograph of the static test apparatus in figure 11(a) shows that the splice plate was at the load point. Consequently, the frame failed just outside the doubler splice plate area by a complete fracture across the Z-section. Load-deflection data and the location of failures of the frame are shown in figure 11(b). The load-deflection data show a saw-toothed behavior of loading and unloading. The load increased linearly until initial failure, then falls off to under 600 pounds force. Subsequent loading of the frame after initial failure was at a new, reduced stiffness. Second and third fractures occurred up the side again at about 54 and 58 degrees under continued loading as may be noted in the sketch at the right of figure 11(b). Photographic data in figure 10(c) shows that the initial failure was induced by a local buckling of the frame which occurred at about 18 degrees from the bottom loading point outside the splice plate area.

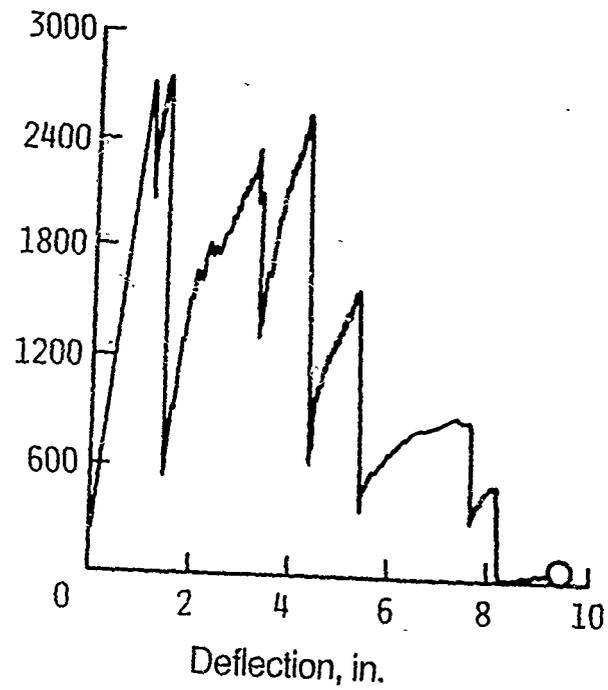
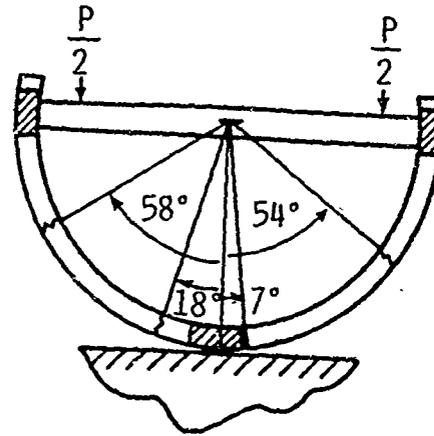
(b) Load-displacement and failure locations.

Furthermore, a comparison of the analytical cases (figure 12(a)) with the actual static load-deflection of the Z-section (figure 11(b)) indicates very similar load-deflection behavior patterns as discussed above. Although the Z-frame had no skin, if the ends jam together (as they did in several cases), the boundary is effectively between the skin stiffened case and a guided boundary. Thus, the predicted maximum moment location in the simple beam-frame model at about 50 degrees (See figure 12(b)) agrees well with the 54 and 58 degree failure locations in the experiment with the Z-section frame.

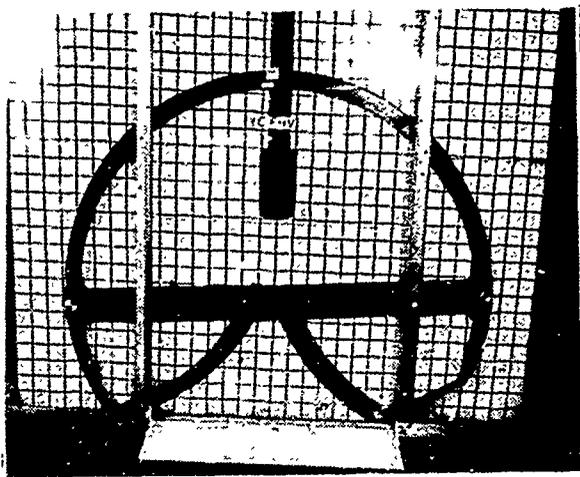
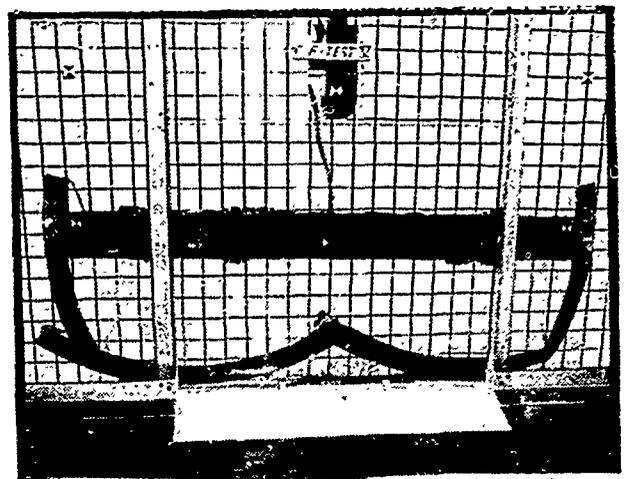
(a) Photographs of failed frames.

**Dynamic tests.**- Results from reference 29 on the dynamic studies of the response of composite frames are shown in Figure 13. Photographs of the failed Z-frames in the drop apparatus are shown in Figure 13(a). It should be noted, the splice plates joining the segments of the frame are 45 degrees up the circumference from the point of impact. As shown in figure 13(b), complete failures (fractures) of the Z-section frames occurred at the bottom and approximately 60 degrees from the bottom. It appears that the presence of the splice plates moved the top failure points up a few degrees (to about the 60 degree locations).

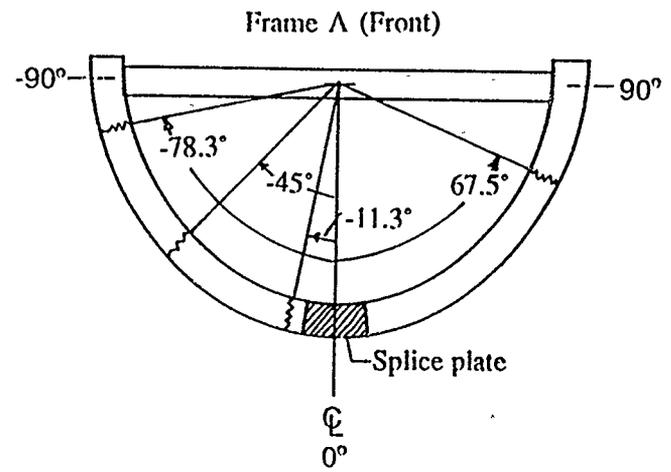
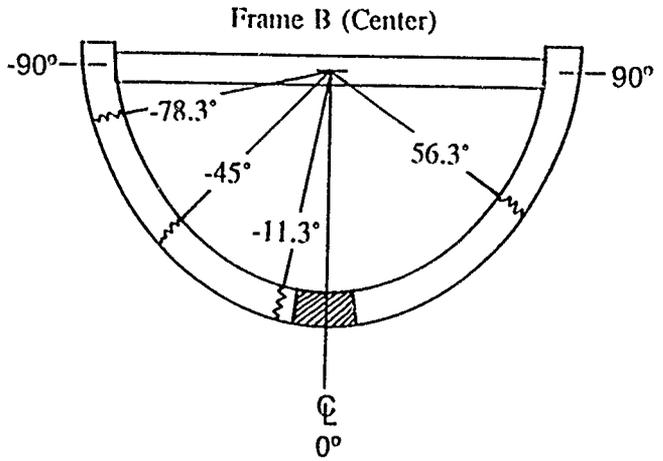
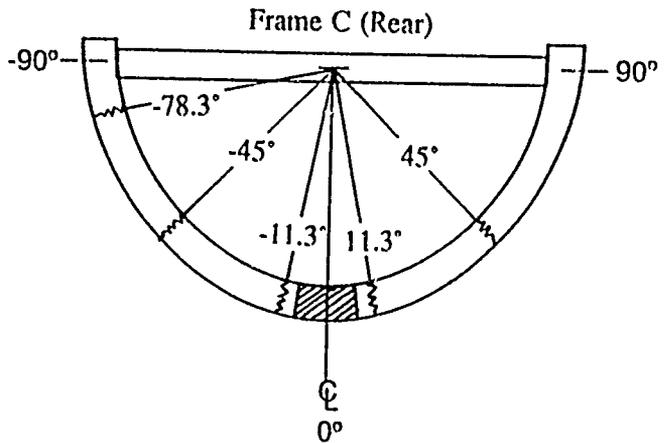
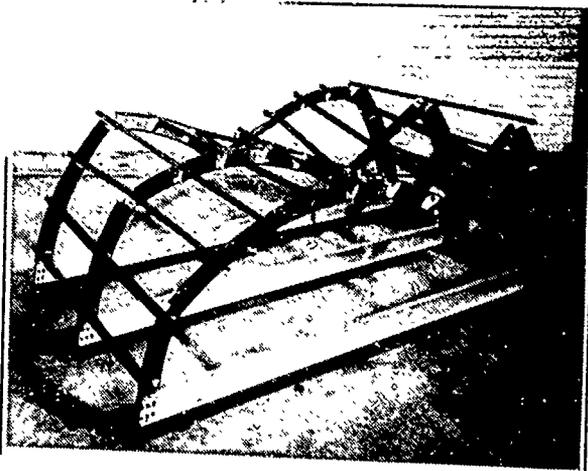
Figure 14. - Behavior of composite skeleton subfloor under static loading tests.

**Static tests.**- Experimental results<sup>30</sup> of the skeleton subfloor specimen following a static test are shown in Figure 14. As noted in figure 14(a) and (b), failures on the three Z-section frames occurred at 13 discrete locations. Unlike the single Z-frame, the failures in this specimen occurred at notches (which served as stress risers) in the frame through which the stringer passed. However, as shown in figure 14(b) the failures were still near the point of load application (approximately 11 degrees) and at other circumferential locations of approximately 45 to 67 degrees. In the absence of skin material, twisting and bending out-of-plane occurred with the frames. The stringers had only a minimal effect on the subfloor response and that was to maintain the lateral spacing of the three Z-frames.

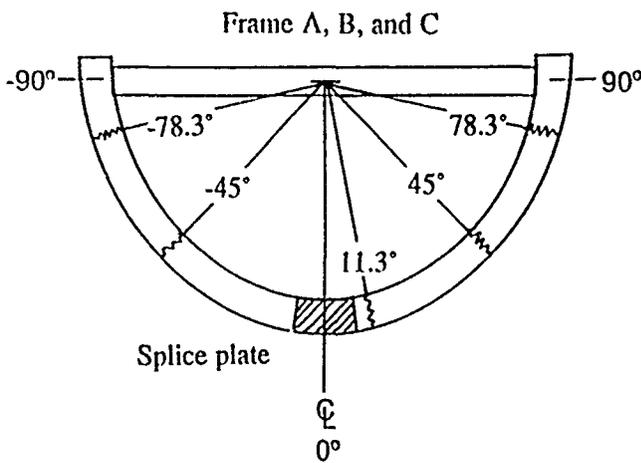
Figure 15. - Behavior of composite skeleton subfloor under dynamic loading tests.

**Dynamic tests.**- A photograph of a skeleton subfloor after an impact test onto a concrete surface at 20 feet per second is shown in Figure 15. In the dynamic test of the skeleton subfloor, fractures were produced at notches in the frames (Figure 15(a)). The locations, shown in figure 15(b), were also near the point of impact (about 11 degrees because of the splice plate) and at three other locations up the circumference of the frames (55 degrees and 78 degrees) totalling 15 fractures for all three frames. The impact energy exceeded the energy absorbed by the local fractures and the floor bottomed out during the impact. The normalized circumferential strain distribution measured on the flange of the front frame during the dynamic test just before first failure is shown in Figure 15(c). A comparison of the measured distribution to the predicted moment distribution of Figure 12(b) and (c) shows essentially identical shape between the single frame and skeleton frame distributions. Maximum values at 0 degrees and at approximately 50 to 55 degrees for the experiment agree well with the analytically predicted locations on the frame.

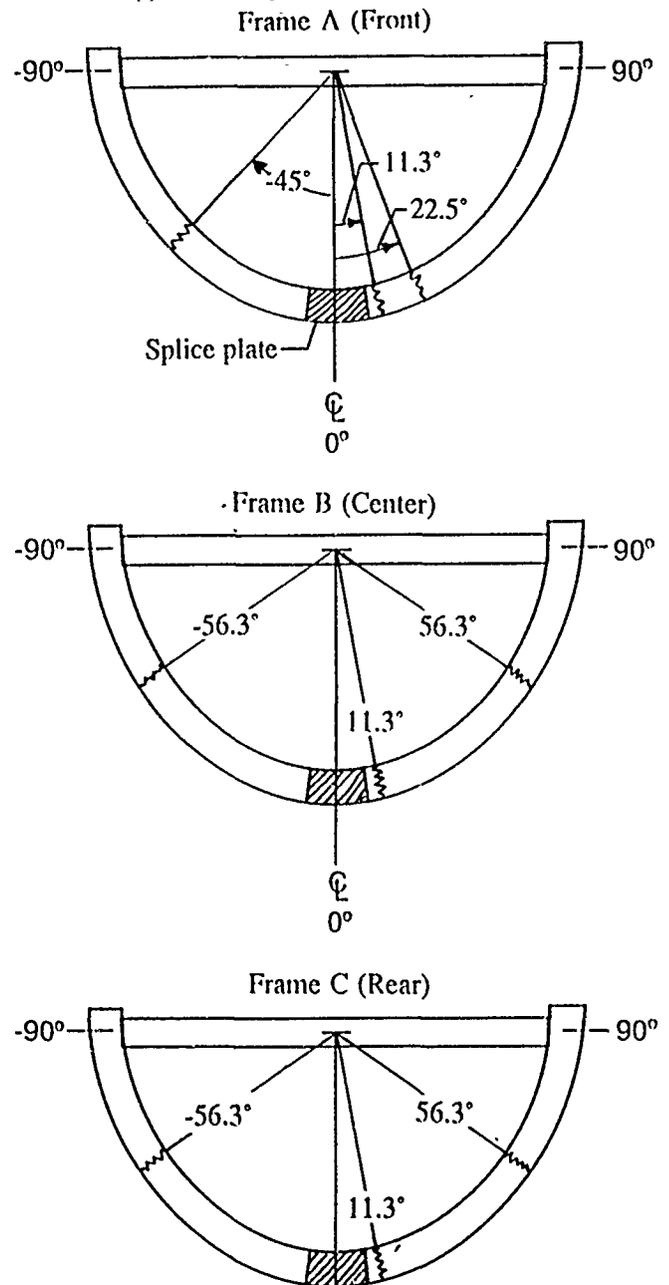
Figure 16. - Behavior of composite skinned subfloor under dynamic loading tests.

Impact results for the subfloor with skin after an impact of 20 feet per second are shown in Figure 16. A photograph of the subfloor specimen after the test is shown in Figure 16(a). Points of failure of the frames in this specimen are indicated in figure 16(b). Again the points of failure are at or near the impact point (within 12 degrees) and circumferentially at about 56 degrees up both sides of the frame on the middle and back frame and 45, 12 and 22.5 degrees on the front frame. It was observed that the subfloor impacted first on the front area which possibly explains the 12 and 22.5 degree fractures being different from the other locations. Again all three frames were involved in the failures. Some delamination of the frames from the skin was evident but the skin remained intact. Normalized strain distribution (just prior to first failure) measured on the skin at the location of the front frame during the dynamic test showed essentially identical shape as the single frame and skeleton frame distributions. As was the case for the skeleton subfloor maximums at 0 degrees and at approximately 50 to 55 degrees for the experiment agree well with the analytically predicted locations on the frame.
