TECHNICAL REPORT REMR-CO-14

# REPAIR OF LOCALIZED ARMOR STONE DAMAGE ON RUBBLE-MOUND STRUCTURES

## Coastal Model Investigation

September 1990  
Final Report

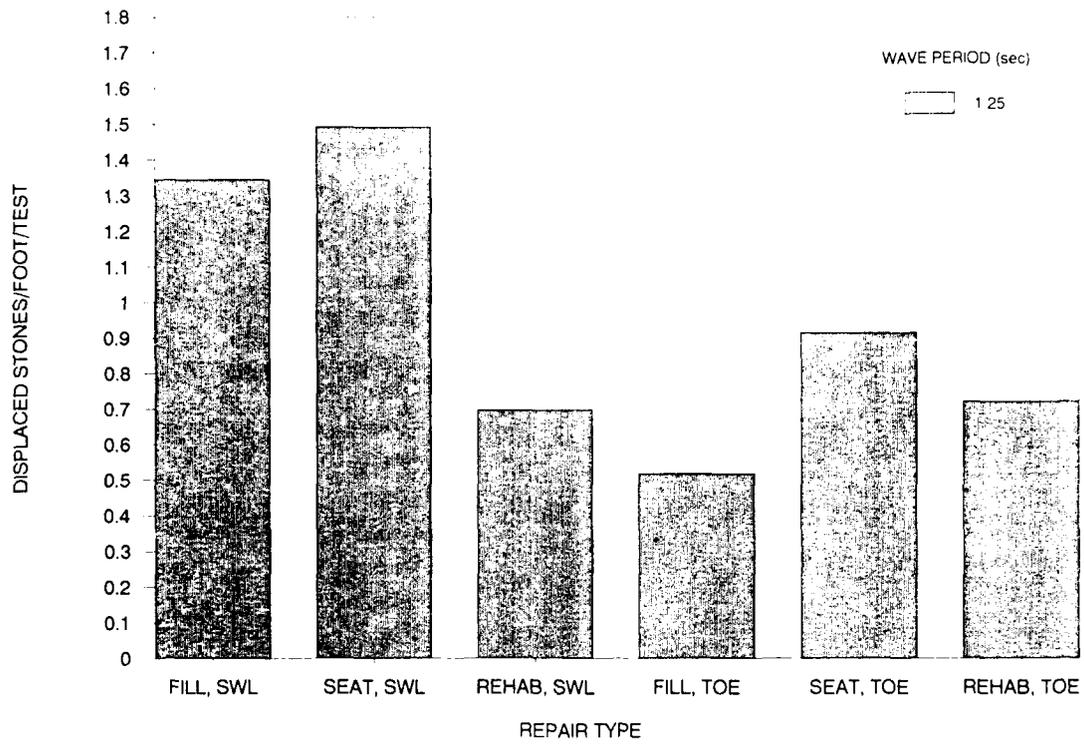
27. Results of the tests are given in Table 1, which shows the number of stones displaced after each repair in each test, and displayed graphically in Figures 8, 9, and 10. Because the tests were conducted on three different lengths of breakwater section, results were standardized for the figures by dividing stones displaced by length of breakwater section. The column heights in Figures 8, 9, and 10 indicate the average number of stones displaced per foot of breakwater trunk section per test for each of the repair options for Phases I, II, and III, respectively. Each column in the figures is also divided to show the relative portion of each total contributed by each of the wave periods tested. Note that these portions have been weighted by the

38. Results from the various phases of testing tended to contradict each other in several ways. In Phase I, both in the repairs above the swl and the repairs on the entire sea-side face, repairs performed better when voids were simply filled with new stone than when the stones were reoriented to improve the seating during the repairs. This is the opposite of the results shown in Phase II, whereas in Phase III the seated stones performed better on the repairs from structure toe to crown, but the simple fill performed better on the repairs from swl to crown. For a given repair type, repairing the structure on the entire sea-side face was more effective in Phase I than

Figure 8. Displaced stones after repairs for the repair tests in Phase I

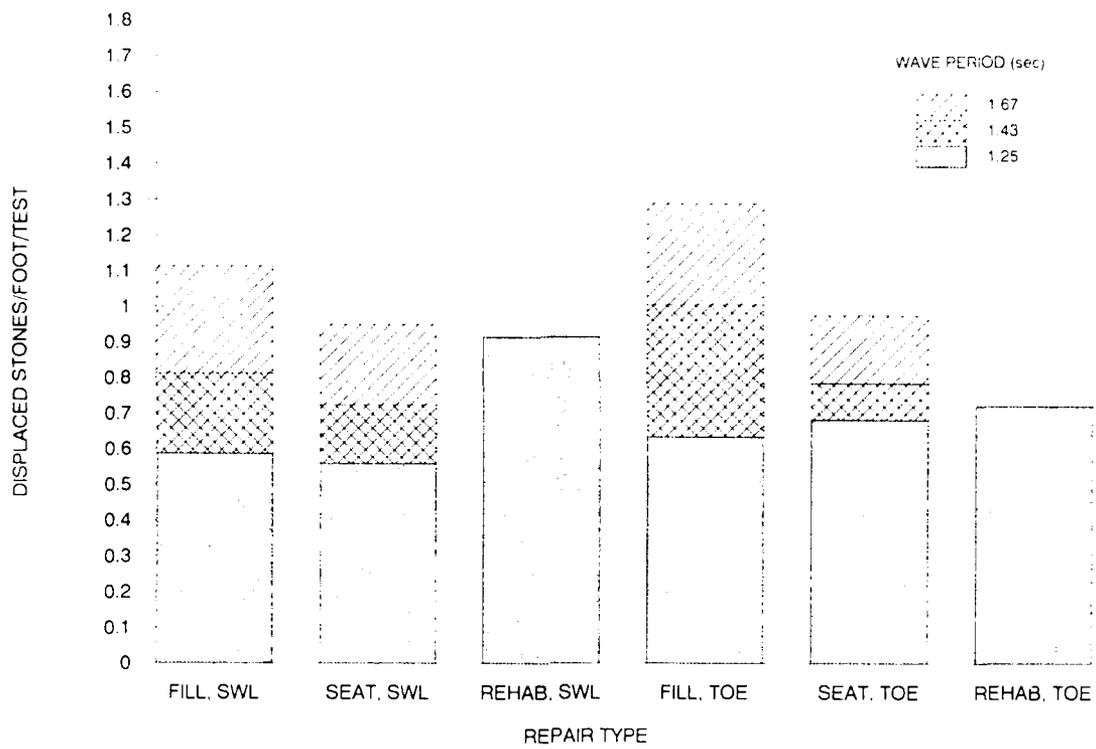
40. Figure 12 shows the combined results of all phases of the tests on the structure trunks. Although the trends varied during each of the tests, the figure shows that overall there was very little difference in the various repair methods above the swl. Repair of the entire sea-side face by just filling the voids showed the poorest performance overall, while local rehabilitation from the toe to the crown showed the best performance.

Figure 12. Averages of stones displaced after repairs in Phases I, II, and III (trunk)

these structures is due to the interlocking of armor stones. Shifting or reseating these stones during a repair can weaken the interlocking and decrease the stability of the structure. Great care must therefore be taken in the handling of stones on the structure. Similarly, new stone placed on the structure must be properly seated to maximize the interlocking of the new stone with the existing stone to ensure a stable repair.

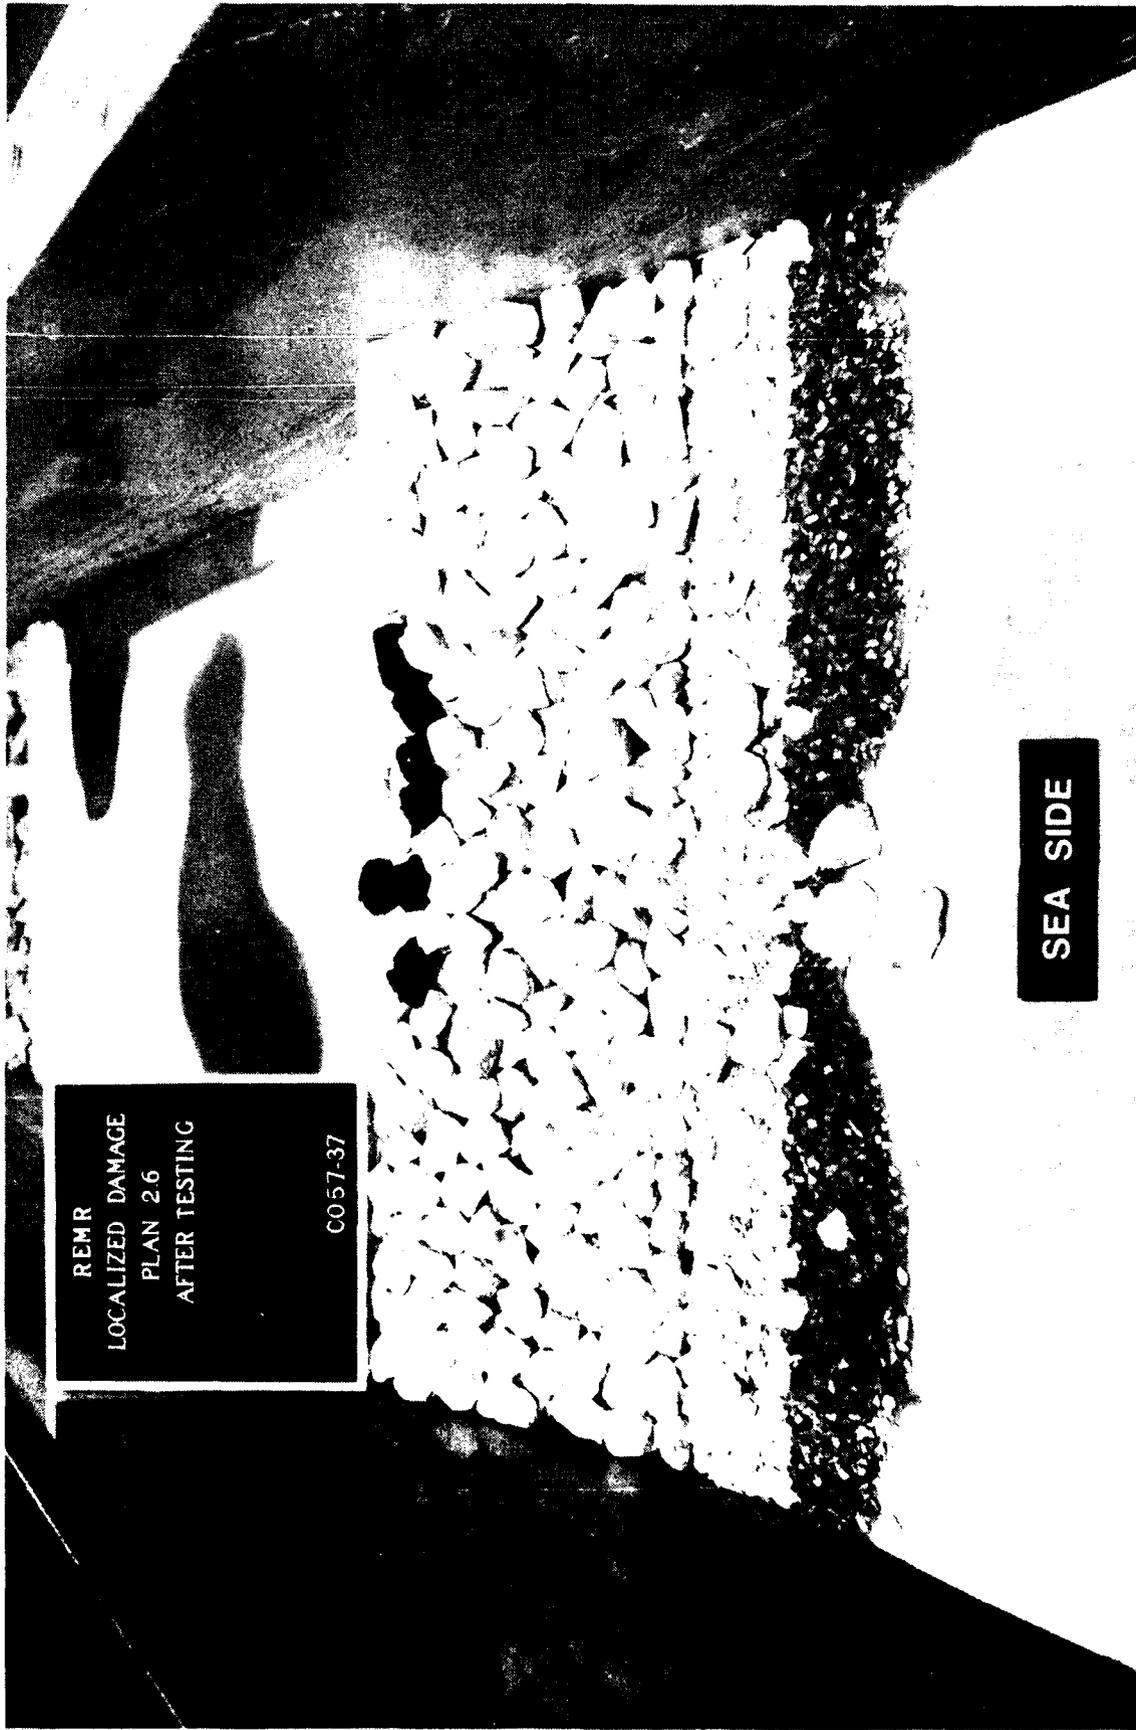
18. The Phase I test procedure was performed as follows. After the structure was completed in the facility, photographs of the structure were taken to record the initial condition of the structure. The flume then was filled to the selected water depth, and a set of waves of moderate height was run to settle the structure and simulate exposure of the structure to natural wave conditions prior to a design storm. Design waves then were generated for 30 min for each test. To minimize contamination of the incident waves by reflected waves, test time was accumulated on the structure in cycles of 30-sec generation time followed by a 5- to 7-min stilling time. The structure then was drained and the damage documented by photographs and written summaries. Damage to the structure was repaired using a selected repair method, and the structure was again documented with photographs. The structure then was exposed to the same test conditions that caused the damage to determine the repair option's response to wave attack. After testing a repair method, the flume was drained and the after-test conditions of the test sections were documented with photographs and written summaries. The test section armor layers and berm stone then were rebuilt, documented with photographs, and exposed to test conditions to produce damage for testing another repair method. The Phase I test procedure is shown in Figure 6; typical wave damage to the structures is shown in Photos 2 (5.00-ft flume) and 3 (6.75-ft flume).

35. All damage to the trunk of the structure occurred on the outer armor layer. A typical damage sequence on the trunk would start with stones being packed closer together below the swl, which loosened stones higher up the structure. Stones thus loosened or improperly keyed during initial construction would then be displaced, leaving a hole in the outer armor layer. This hole would either be filled by sloughing of stones from the outer armor layer farther up the structure, or the surrounding stones would interlock forming a tight ring around the hole (which might be several stone widths in diameter). Eventually, all holes were surrounded by an interlocked ring of stones, and the structure stabilized. This condition was usually reached during the first half of the test cycles.

Photo 2. Typical damage to structure in 5.00-ft flume during Phase I

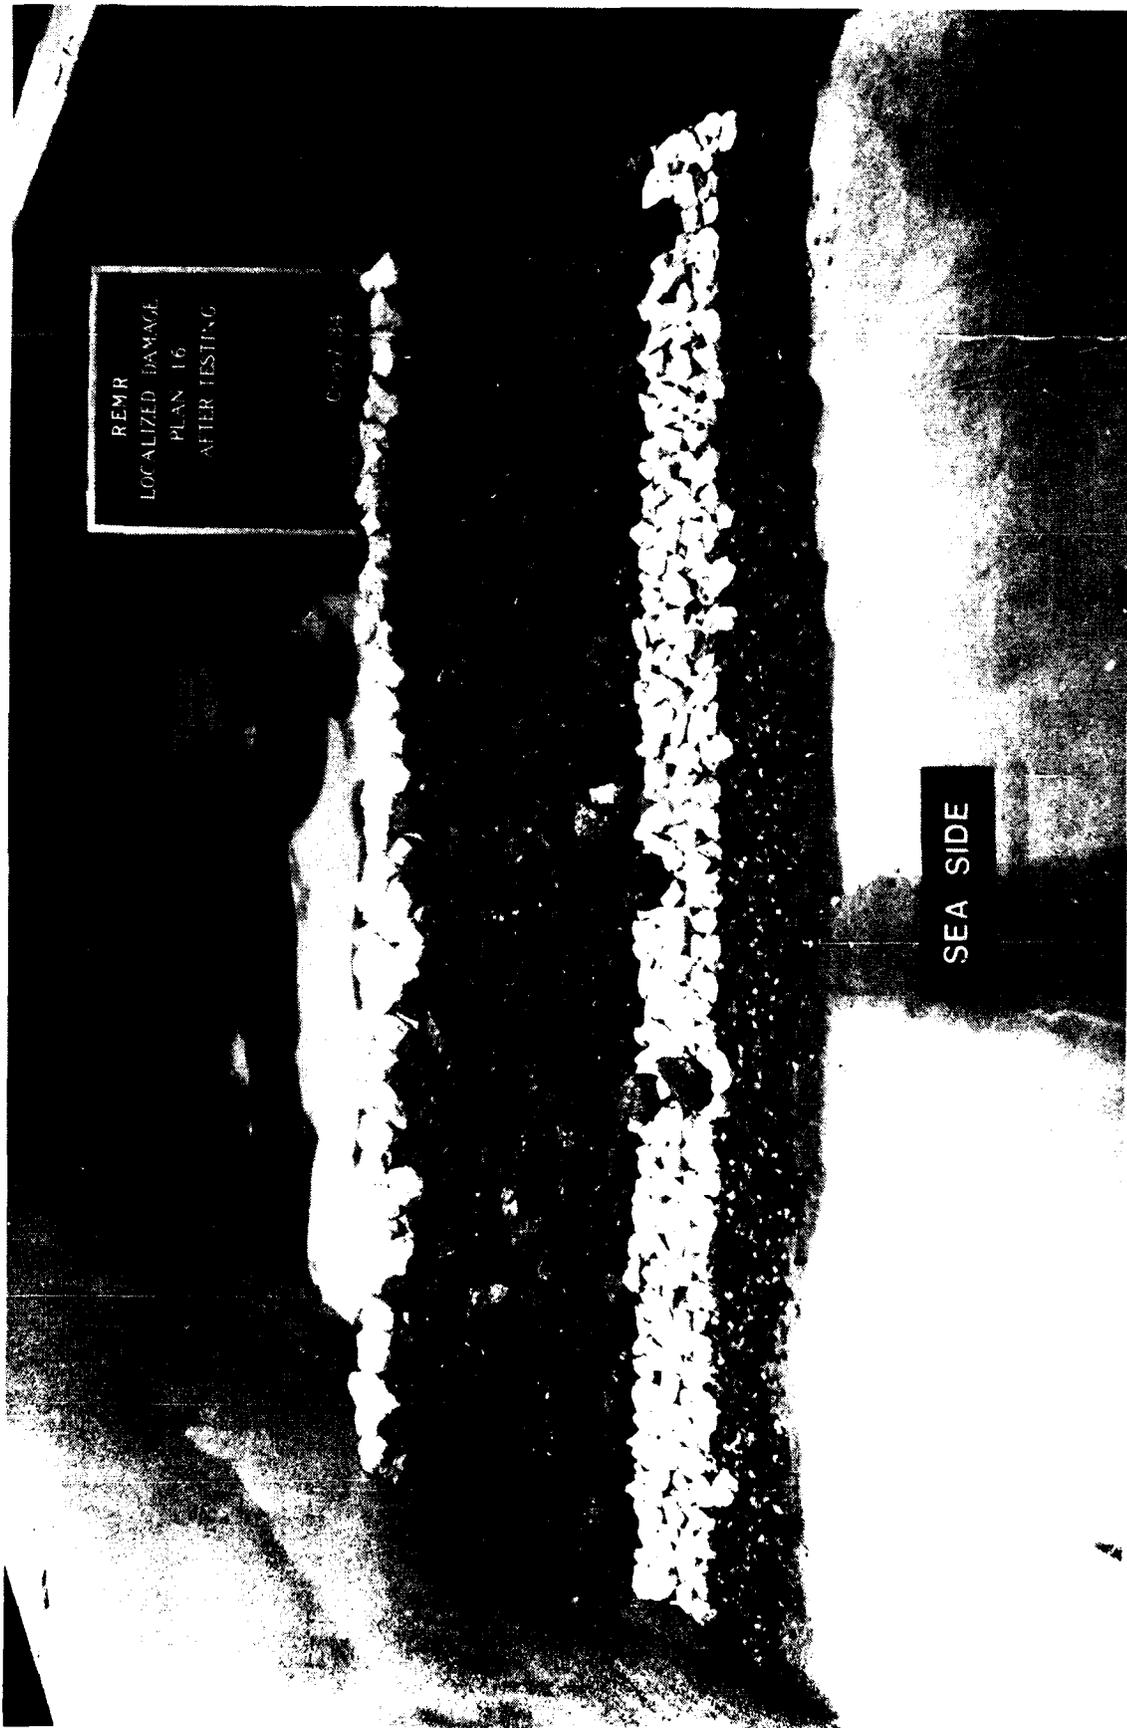
Photo 3. Typical damage to structure in 6.75-ft flume during Phase I

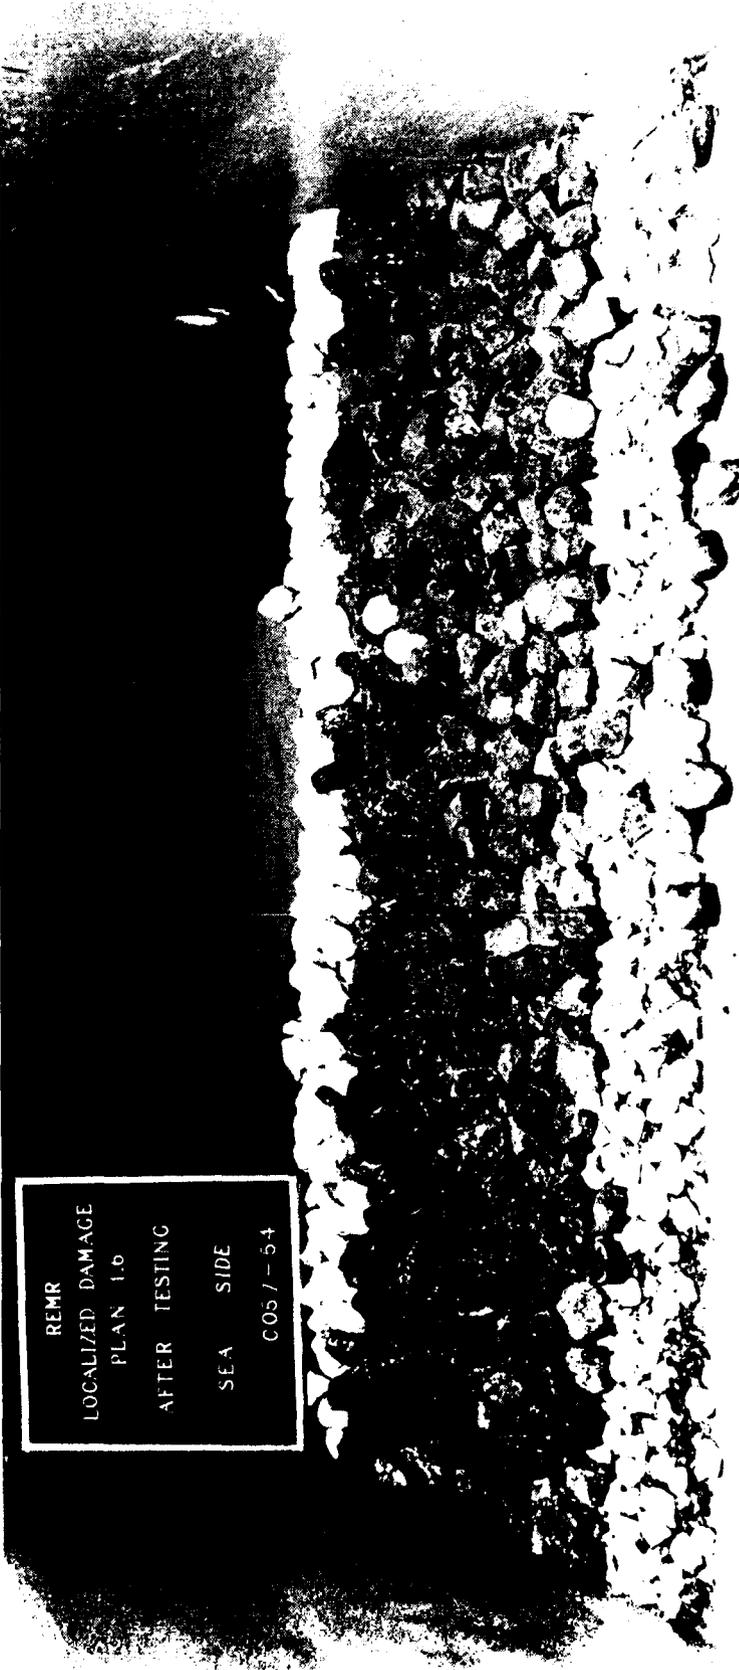
23. At this point, the armor layer was removed, and the structure was rebuilt. Photographs were taken to document the initial condition of the structure, and the procedure described in paragraph 20 was repeated except that repair options d and e replaced options a and b, respectively. Figure 7 illustrates the procedure used in Phase II; typical damage to the structure in Phase II is shown in Photo 4.

Photo 4. Typical damage to structure in 6.75-ft flume during Phase II
