MISCELLANEOUS PAPER GL-90-21

EFFECTS OF VARIABLE TIRE PRESSURE ON ROAD SURFACINGS

Robert W. Grau

September 1990

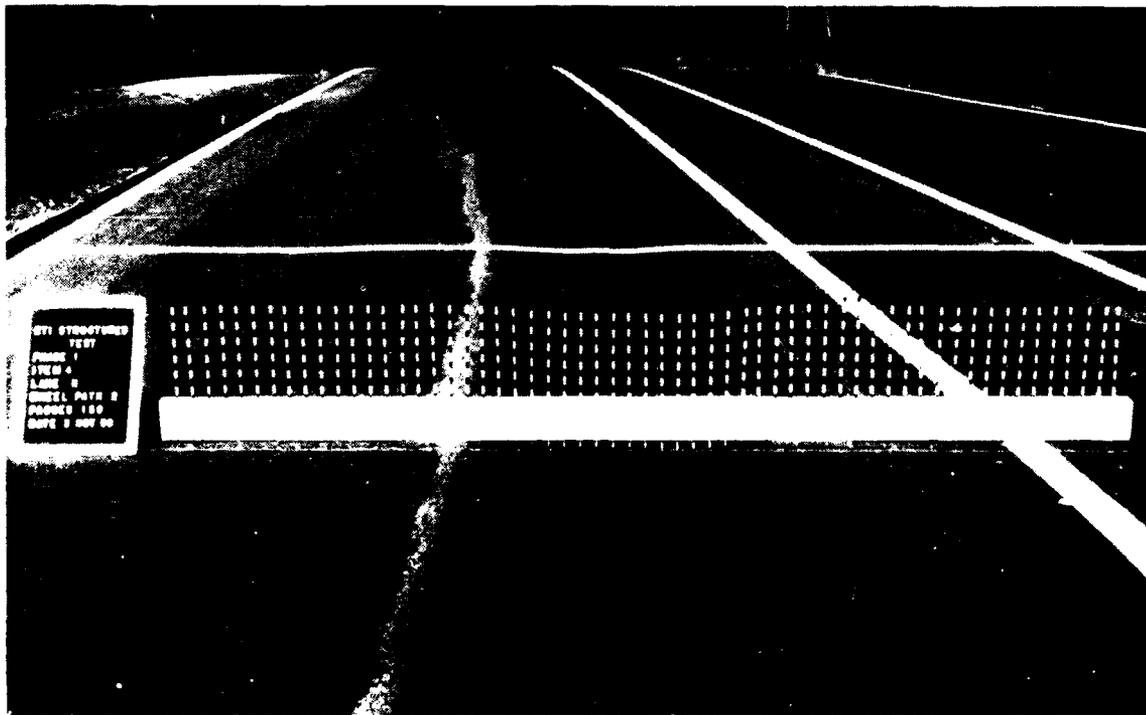
19. At the beginning of traffic, slight pumping of the surface was observed as the high-tire-pressure truck traversed the 2-in.-thick AC sections. Surface deformation and pumping was most evident in the outside wheelpaths of the horizontal curves. After about 71 passes, distinct rutting and hairline longitudinal cracking along the outside edges of wheelpath 2 were noticed in section 4. As traffic continued, the rutting and cracking in section 4 became more severe; one area was rated as failed after 158 passes. Figure 9 depicts a general view of this initial failure in the AC portion of the rest road. The maximum rutting in this area was 2.3 in. deep, and the cracking had progressed into alligator cracking. After an additional 165 passes, for a total of 323 passes, a second failure occurred in section 4, wheelpath 2. Figure 10 shows a general view of this second failure. It

Figure 9. High-tire-pressure lane, section 4, general view of initial failure, 158 passes

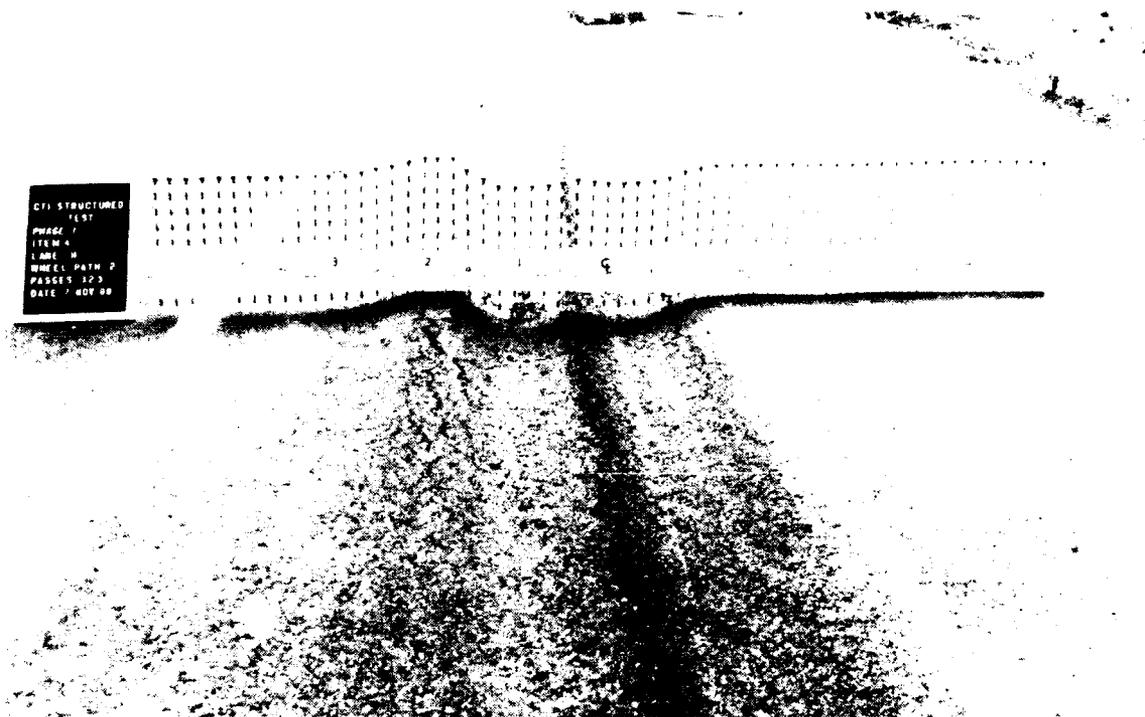
should be noted that again the majority of the rutting occurred in wheel-path 2, and very little distress had occurred in wheelpath 1. Wheelpath 1 in section 4 is located in the inside portion of the curve. This failure is attributed to overloading or failure of the subgrade. Figure 11, which is a view of a test pit excavated in the failed area, indicates severe rutting of the subgrade. At the time of this second failure in the high-tire-pressure lane (323 passes), very little distress was present in the low-tire-pressure lane. There was no cracking evident, and the maximum rut depth was only 0.5 in. The rate of pavement deterioration with traffic decreased after the second failure. The next failures occurred after 1,104 and 1,414 passes in wheelpath 1 of sections 6 and 5, respectively. When these sections were judged failed in the high-tire-pressure lane, only hairline cracking and minor rutting were detected in the low-tire-pressure lane. The average rut depth in the low-tire-pressure lane of section 6 after 1,104 passes was about 0.7 in. and in section 5 about 0.4 in. after 1,414 passes. Throughout the remainder of traffic in the high-tire-pressure lane (6,764 loaded passes), only two additional failures occurred, one in section 5, wheelpath 1 after 2,210 passes and another in section 10, wheelpath 1 at 2,210 passes also. The mode of failure in section 5 was the same as the previous failures, and the section 10 failure was attributed to severe shoving of the top lift of AC after 1,812 passes (see Figure 12) and then severe cracking and rutting of the surface as shown in Figure 13. The failure in section 10 occurred in an area where the traffic was entering a horizontal curve and at the beginning of warm weather traffic. Test traffic was applied to the AC section during two periods, from October 1988 to February 1989 and from June to November 1989. The shoving, shown in Figure 12, occurred after 245 passes had been applied in June 1989. Shoving (Figure 14) was detected in the low-tire-pressure lane of section 10 after 1,200 passes of warm weather traffic or a total of 4,200 passes.

Figure 10. High-tire-pressure lane, section 4, second failure, 323 passes

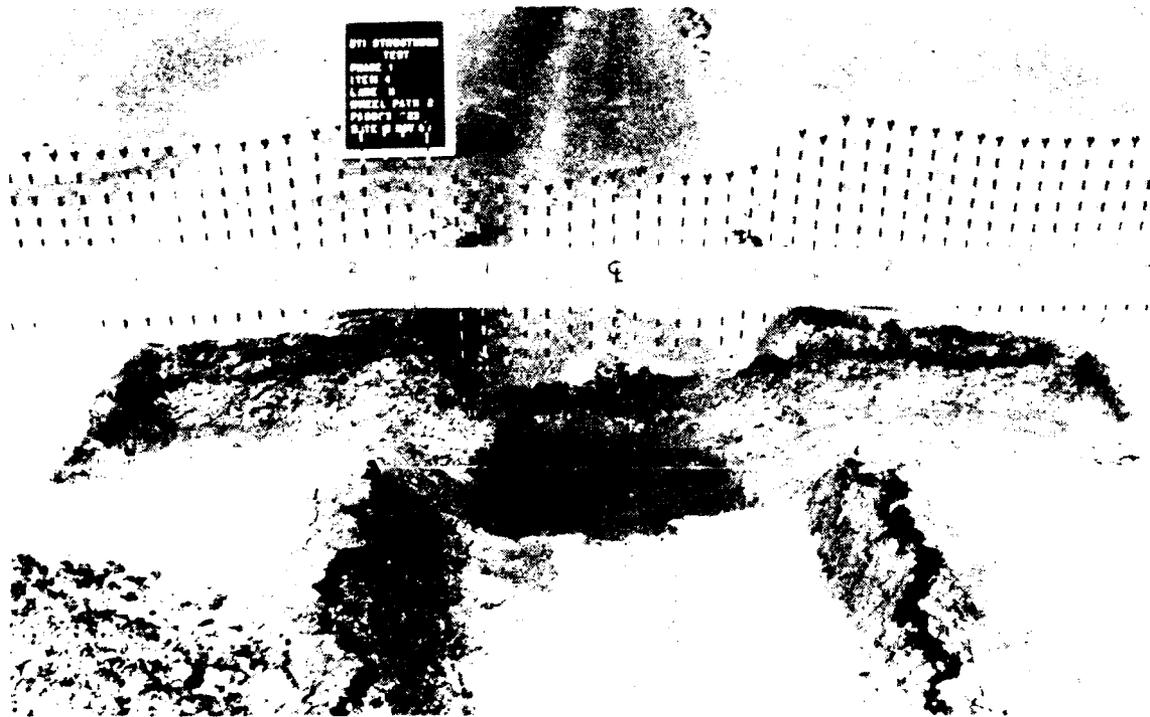
Figure 11. High-tire-pressure lane, section 4, test trench after 323 passes

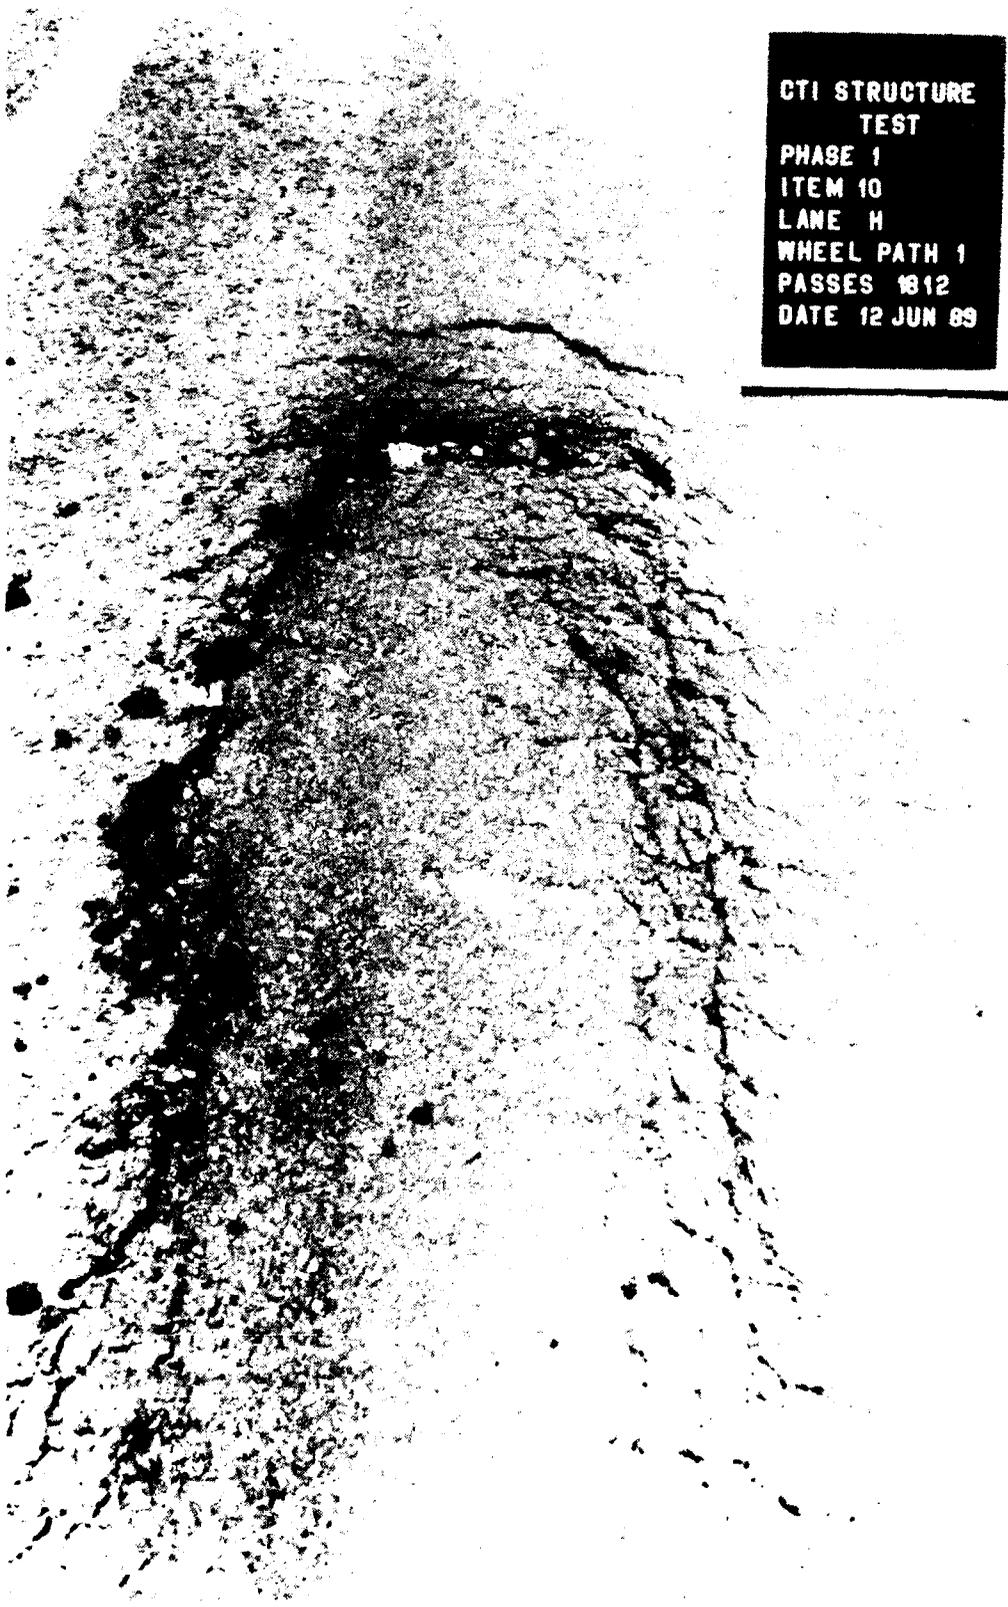
CTI STRUCTURE
TEST
PHASE 1
ITEM 10
LANE H
WHEEL PATH 1
PASSES 1812
DATE 12 JUN 69

Figure 12. High-tire-pressure lane, section 10,
shoving after 1,812 passes

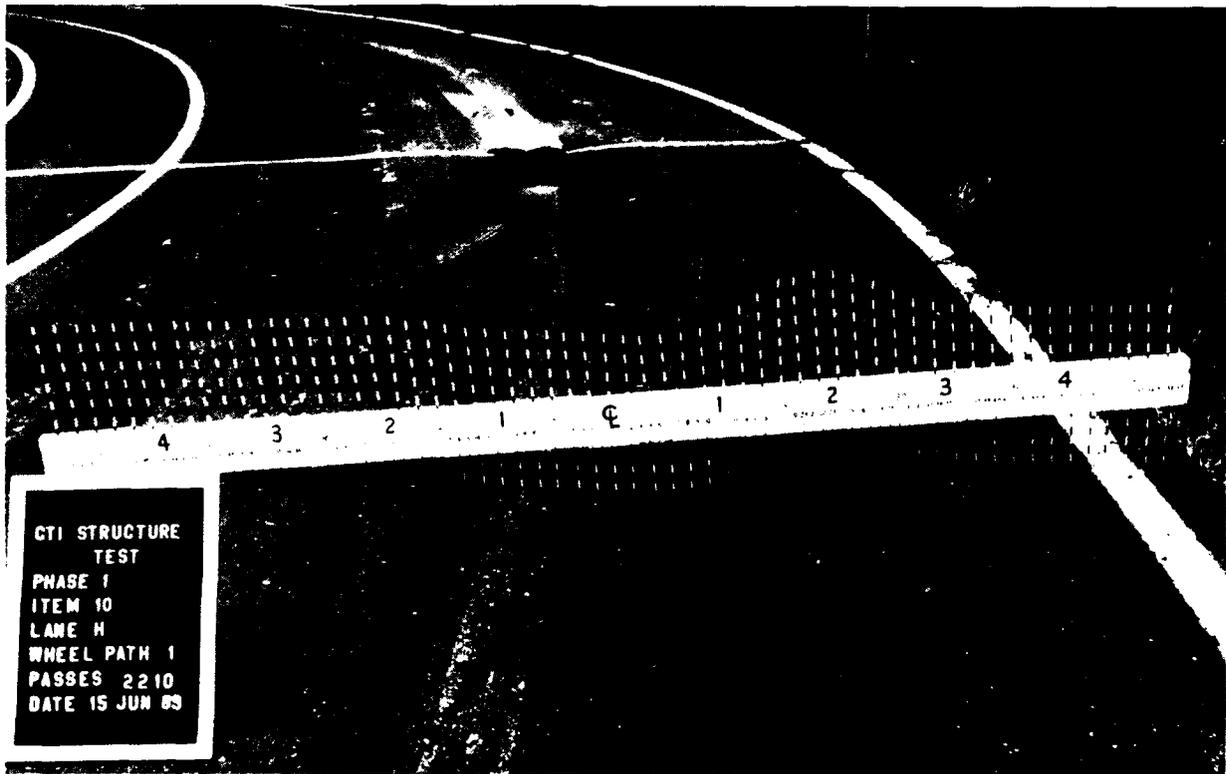
Figure 13. High-tire-pressure lane, section 10,
failure after 2,210 passes

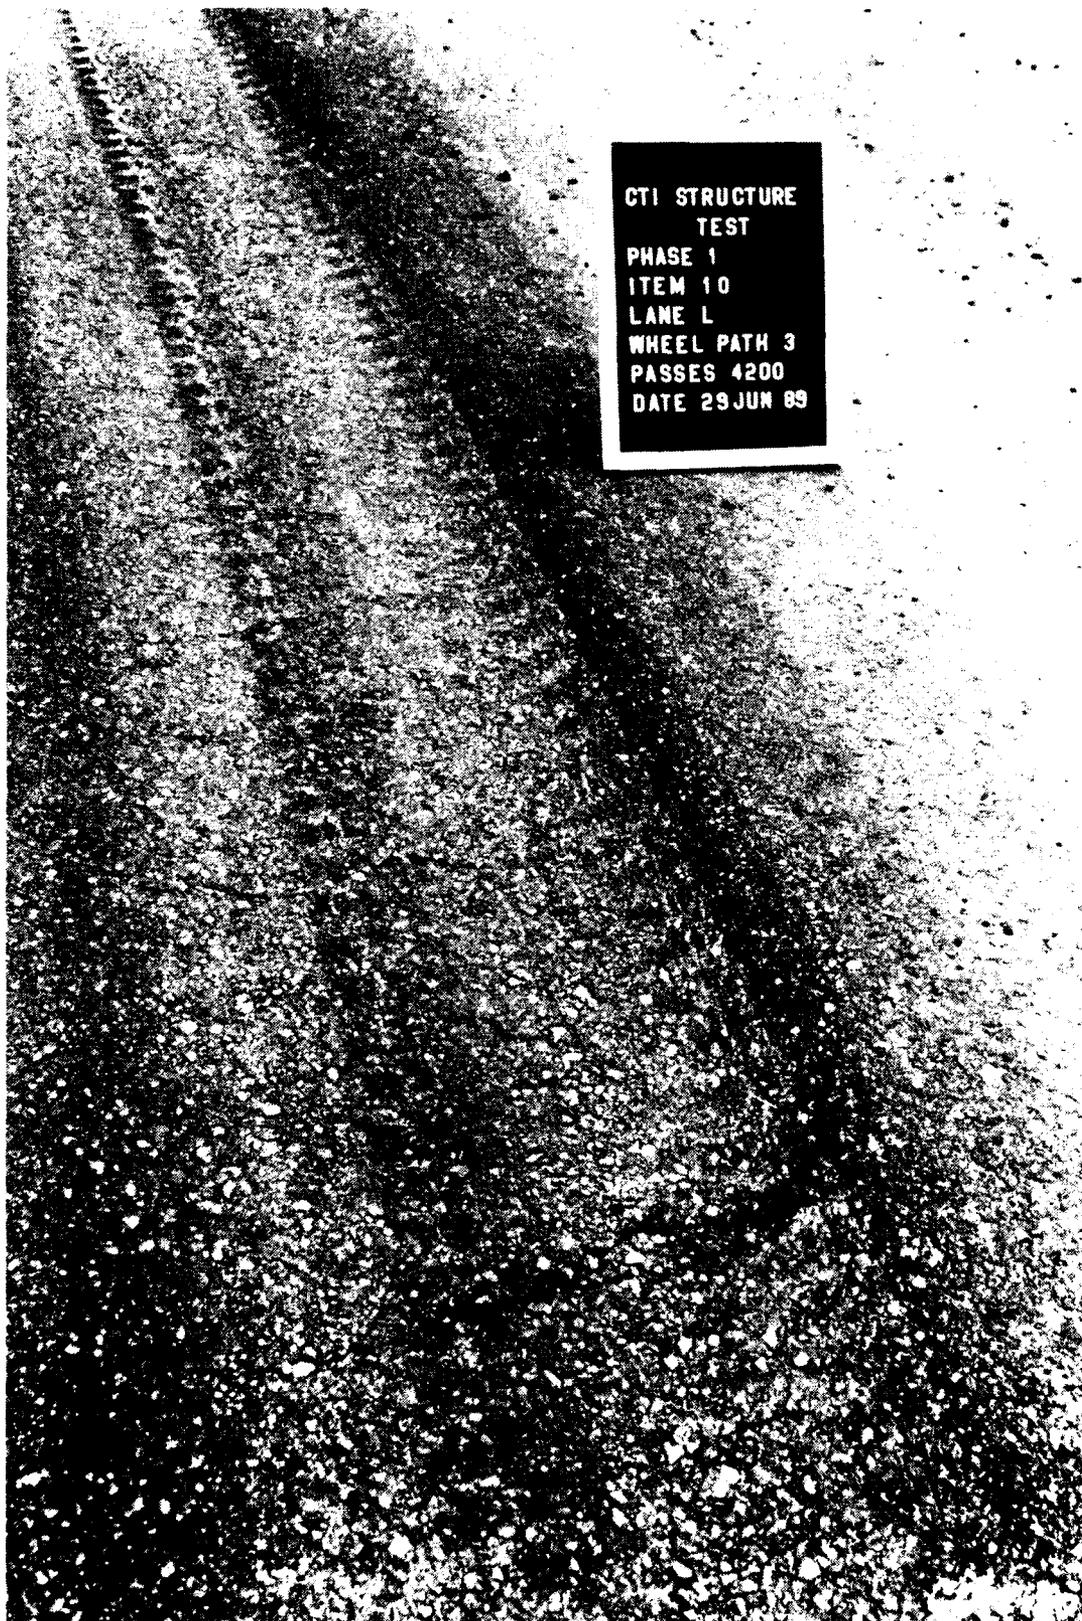
Figure 14. Low-tire-pressure lane, section 10, low severity shoving after 4,200 passes

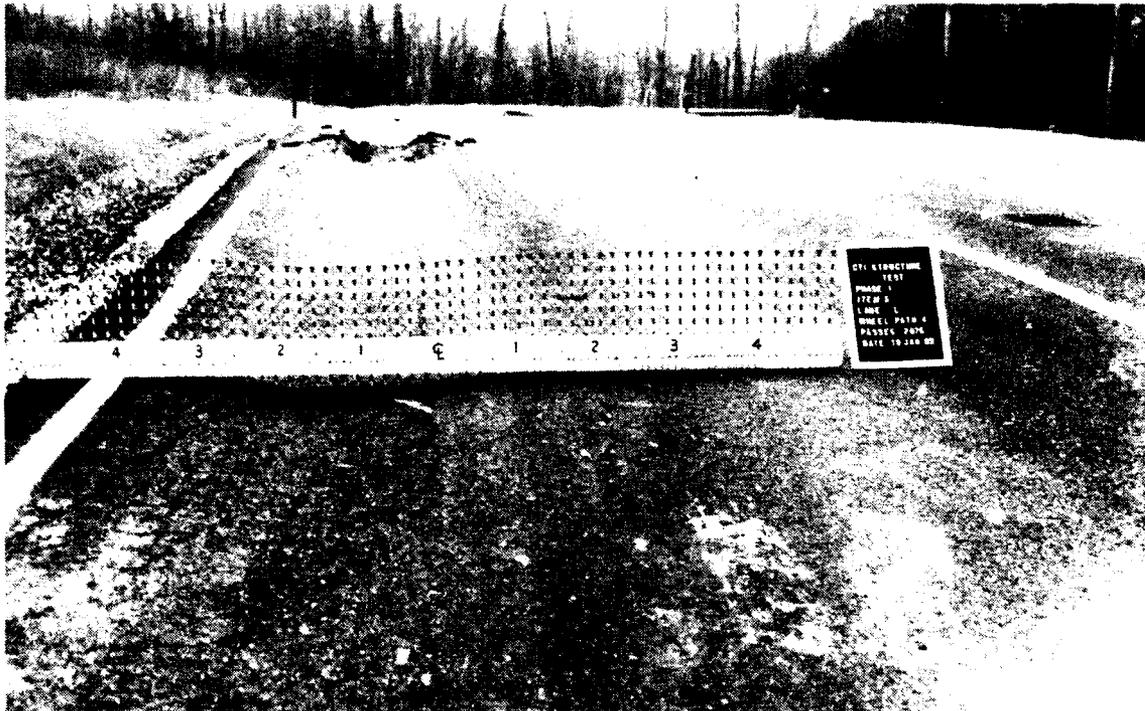
20. Four failures, two in section 4 and one each in sections 5 and 6, occurred in the low-tire pressure lane. The failures in sections 5 and 6 were judged as failed after 2,076 passes and those in section 4 after 3,324 and 3,845 passes. Severe cracking and rutting were the mode of each of these failures. A general view of the portion of section 5 was failed after 2,076 passes as shown in Figure 15.

Figure 15. Low-tire-pressure lane, section 5, failure after 2,076 passes

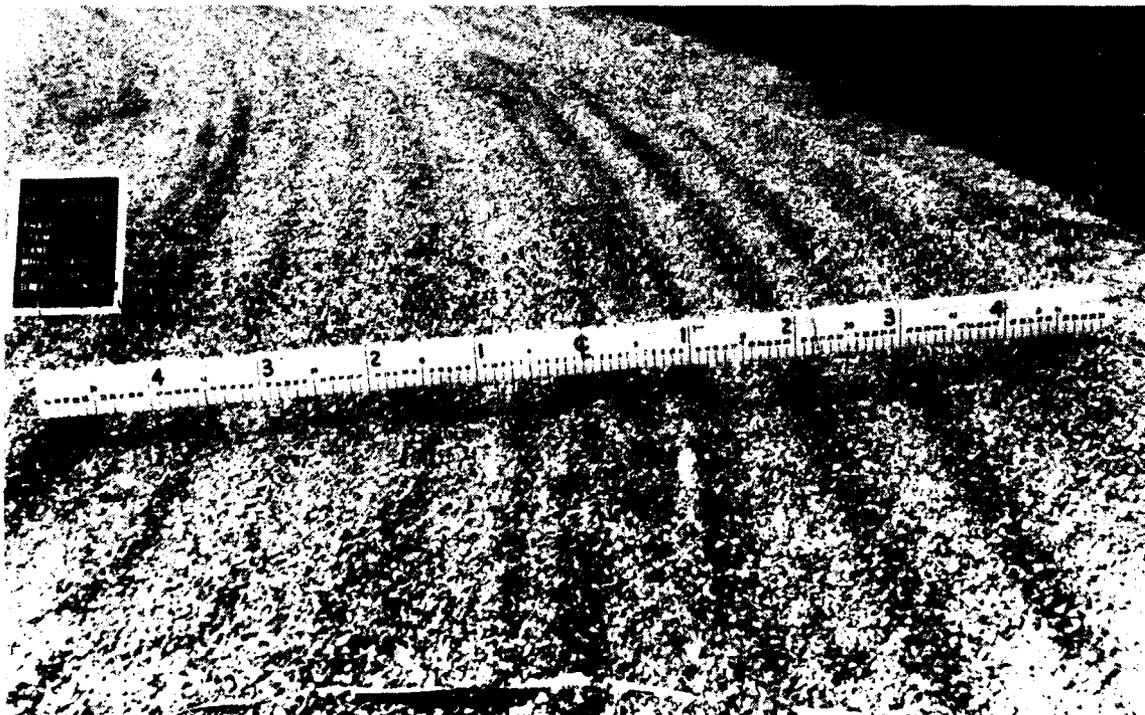
Figure 16. Low-tire-pressure lane, section 1, failure after 66 passes

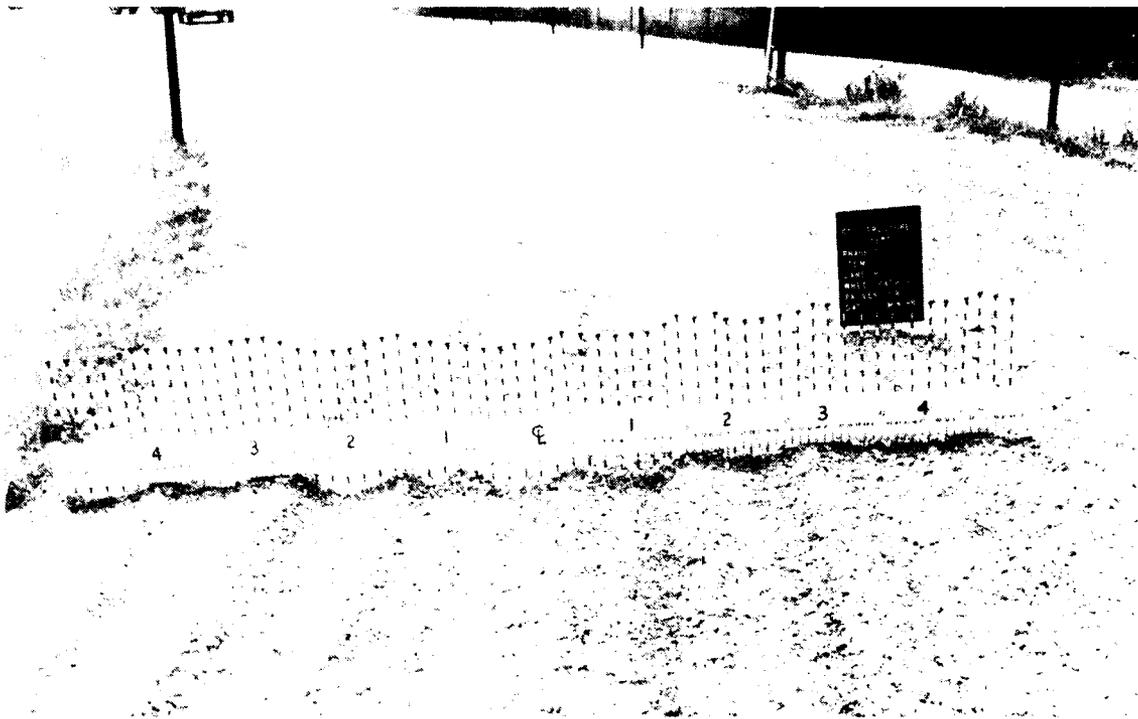
Figure 17. High-tire-pressure lane, section 1, failure after 58 passes

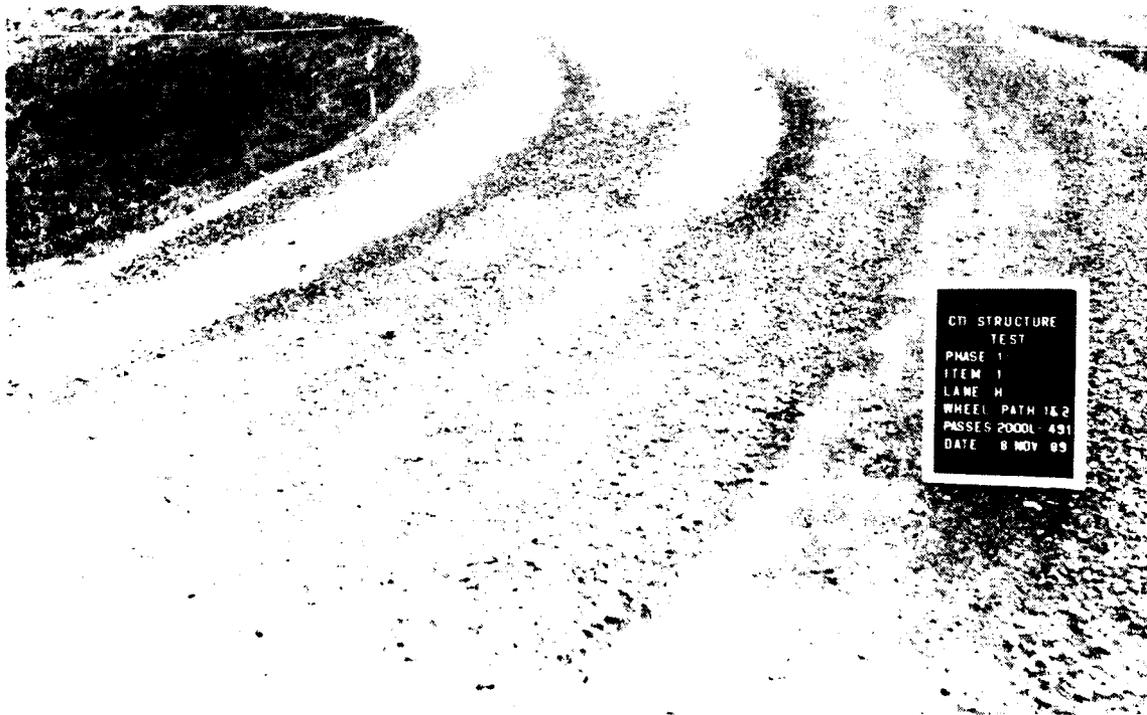
CD STRUCTURE
TEST
PHASE 1
ITEM 1
LANE H
WHEEL PATH 1&2
PASSES 2000L-431
DATE 8 NOV 05

Figure 20. High-tire-pressure lane, section 2, low severity rutting and corrugation

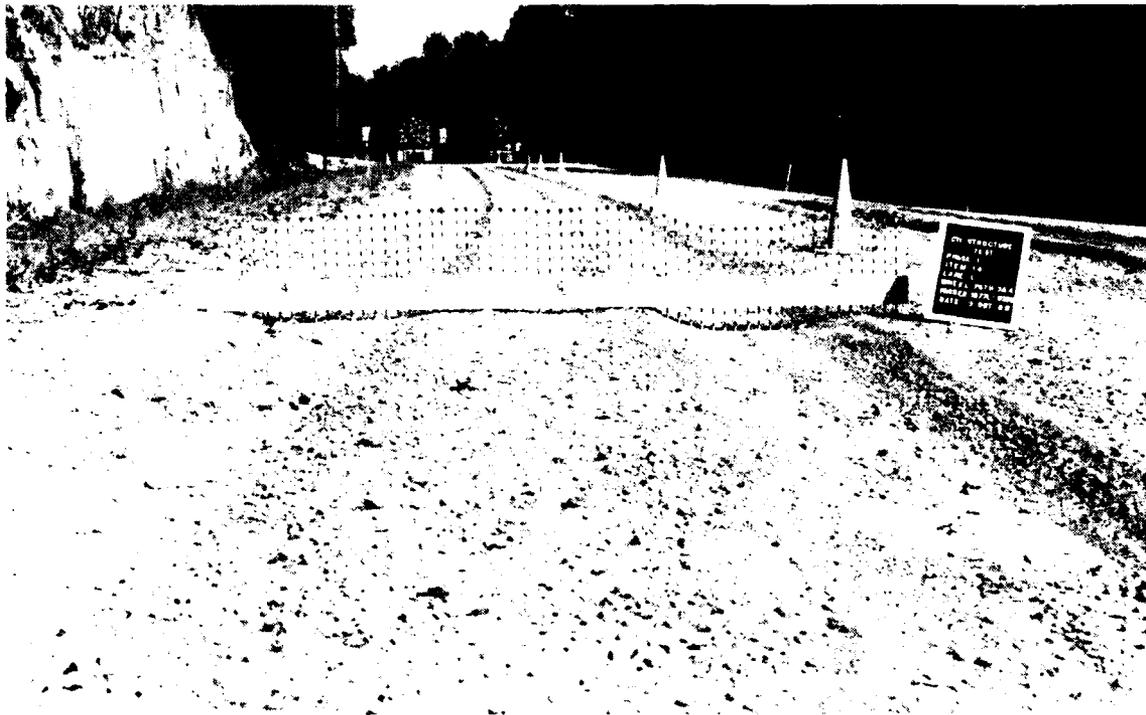
Figure 23. Low-tire-pressure lane, section 14, high-severity rutting after 90 passes in the rain

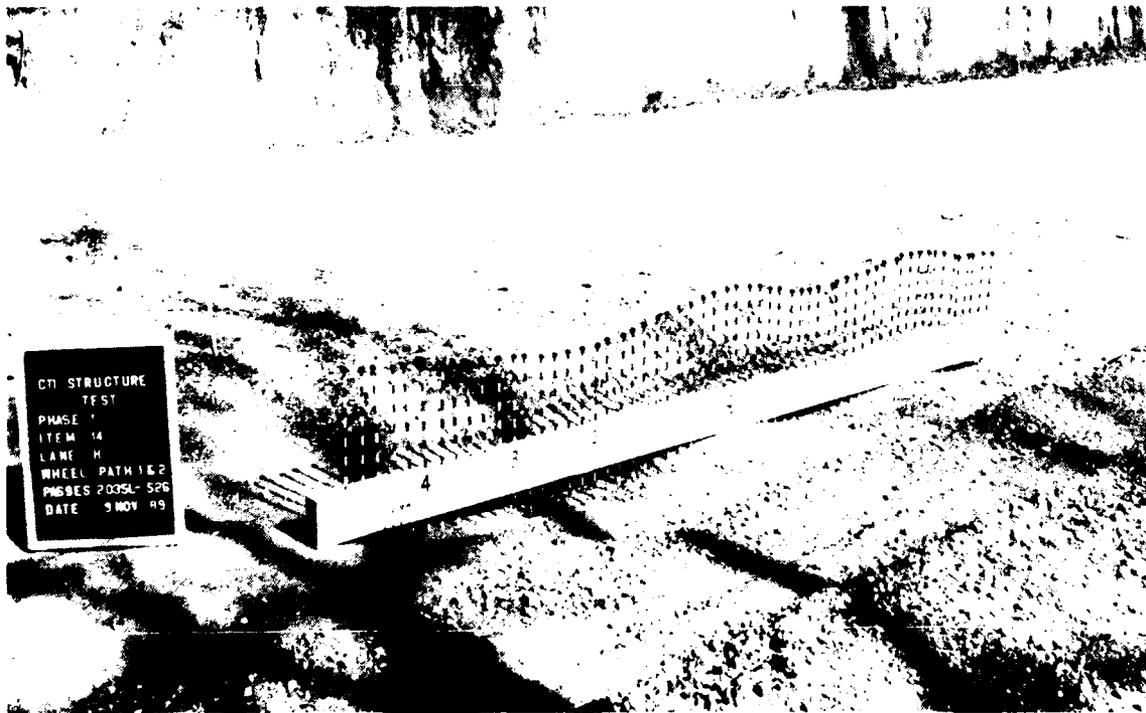
Figure 24. High-tire-pressure lane, section 14, high-severity washboarding

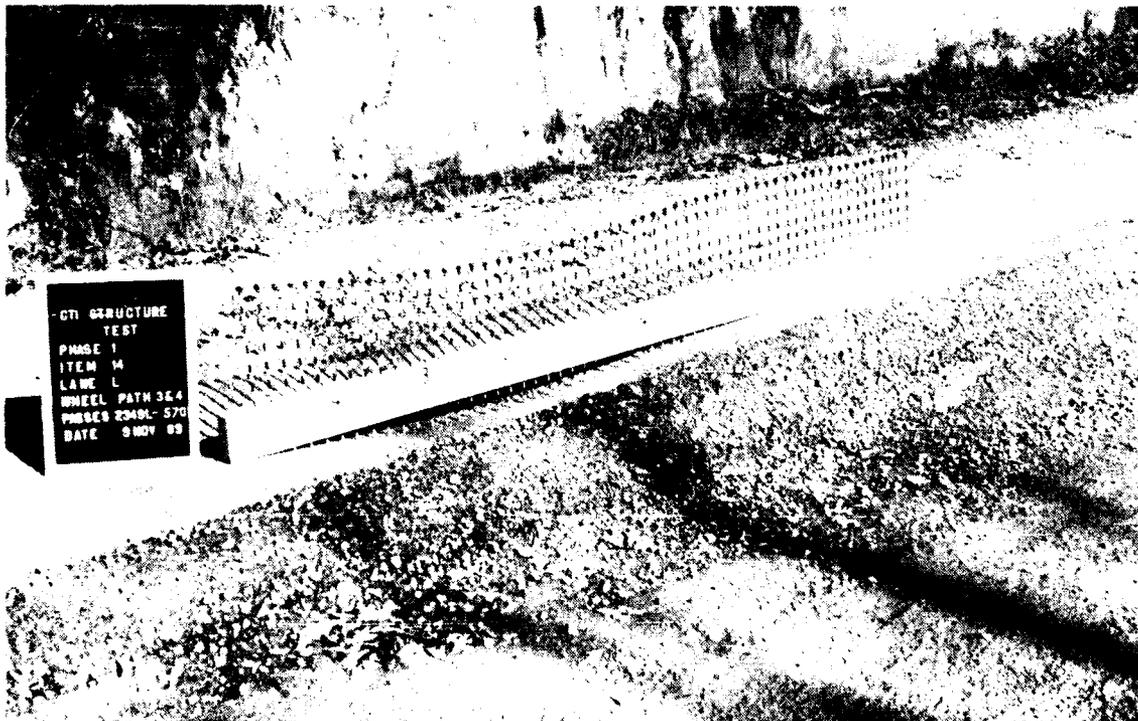
rainfall and weaken the pavement structure at a controlled rate. As water was applied, drop cone penetrometer measurements were taken in order to monitor the aggregate and subgrade strengths. As traffic was applied, failure was reached once it enter into the high-tire-pressure lane of section 14 and three times in section 15 due to rutting and severe washboarding. No failures were recorded in the low-tire-pressure lane. Figure 24 shows the high-severity washboarding in the high-tire-pressure lane of section 14 at failure. For comparison purposes, a view of the maximum distress in the low-tire-pressure lane of section 14 at the same time the high-tire-pressure lane was rated failed is shown in Figure 25.

Figure 25. Low-tire-pressure lane, section 14,
low-severity depression
