Report of Sampling and Analysis Results

Addison Army Housing Units
Addison, Illinois

September 1990

CETHA-BC-CR-90114

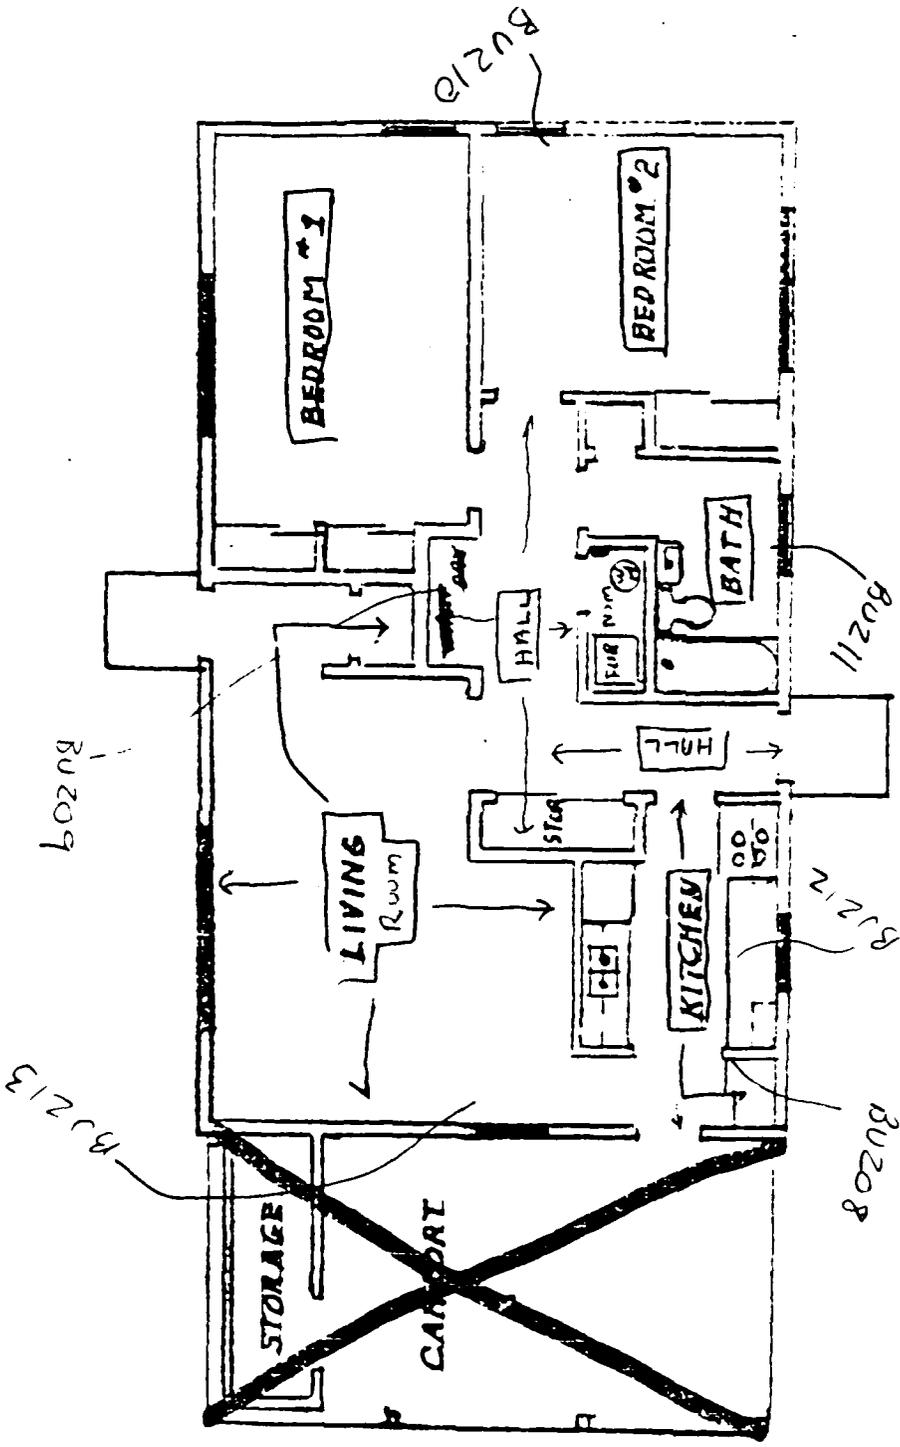
MC A 2 BEDROOM TYPE B HOME

NOTE NO.	NOTES/REMARKS/COMMENTS/DETAILS/OTHER MATERIALS, QUANTITY, ETC.
01	Gray 12" x 12" floor tile
02	Brown 12" x 12" floor tile. Also occurs in Bath, Bedroom 1, Bedroom 2, and Living Room.
03	Dust in floor ducts.

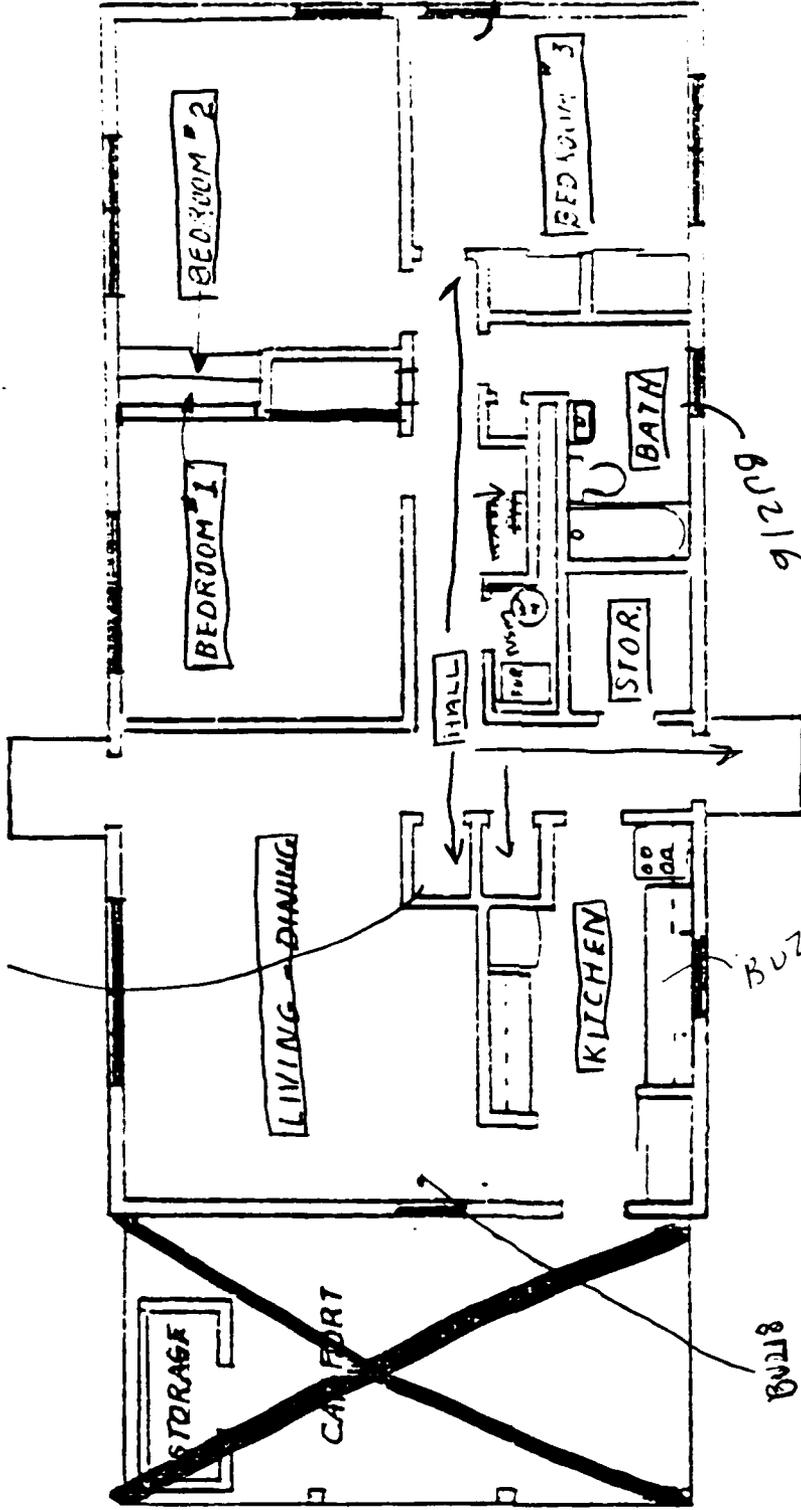
MCA 3 BEDROOM TYPE D HOME

Unit 5 is a three bedroom Capehart-style house with a concrete slab base. Outside walls are covered by cedar shake shingles; the roof is covered by tar shingles. The inside is covered by vinyl flooring while the walls and ceiling are painted over plaster board. No insulation could be found on any of the pipe runs. All were bare. One floor tile and four dust samples were taken. The areas for the closets were included with the area for the room in which the closet occurs. We could see down the pipe chase behind the Bath. All the pipes were bare.

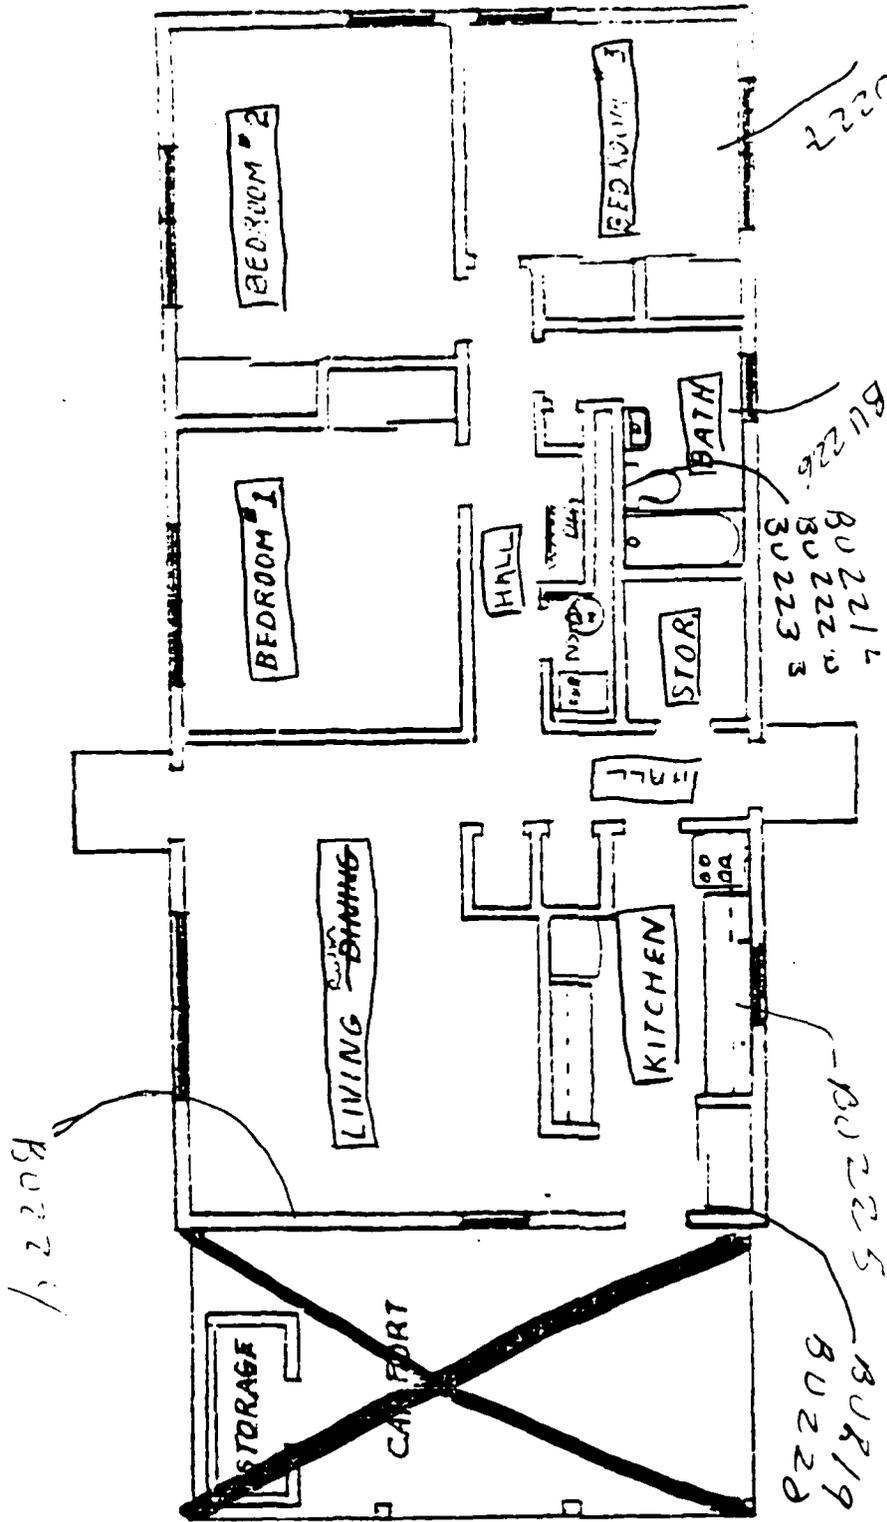
MCA 3 BEDROOM TYPE D HOME

Unit 1 is a three bedroom Capehart-style house with a concrete slab base. Outside walls are covered by cedar shake shingles; roof is covered by tar shingles. Inside is covered by vinyl flooring, while the walls and ceilings are painted plaster board. No insulation could be found on any of the pipe runs observed. All pipes were bare. The areas for each closet are included with the room in which the closet occurs.
