REPAIR, EVALUATION, MAINTENANCE, AND
REHABILITATION RESEARCH PROGRAM

TECHNICAL REPORT REMR-CO-15

FIELD EVALUATION OF PORT EVERGLADES,
FLORIDA, REHABILITATION OF SOUTH JETTY
BY VOID SEALING

Coastal Engineering Research Center

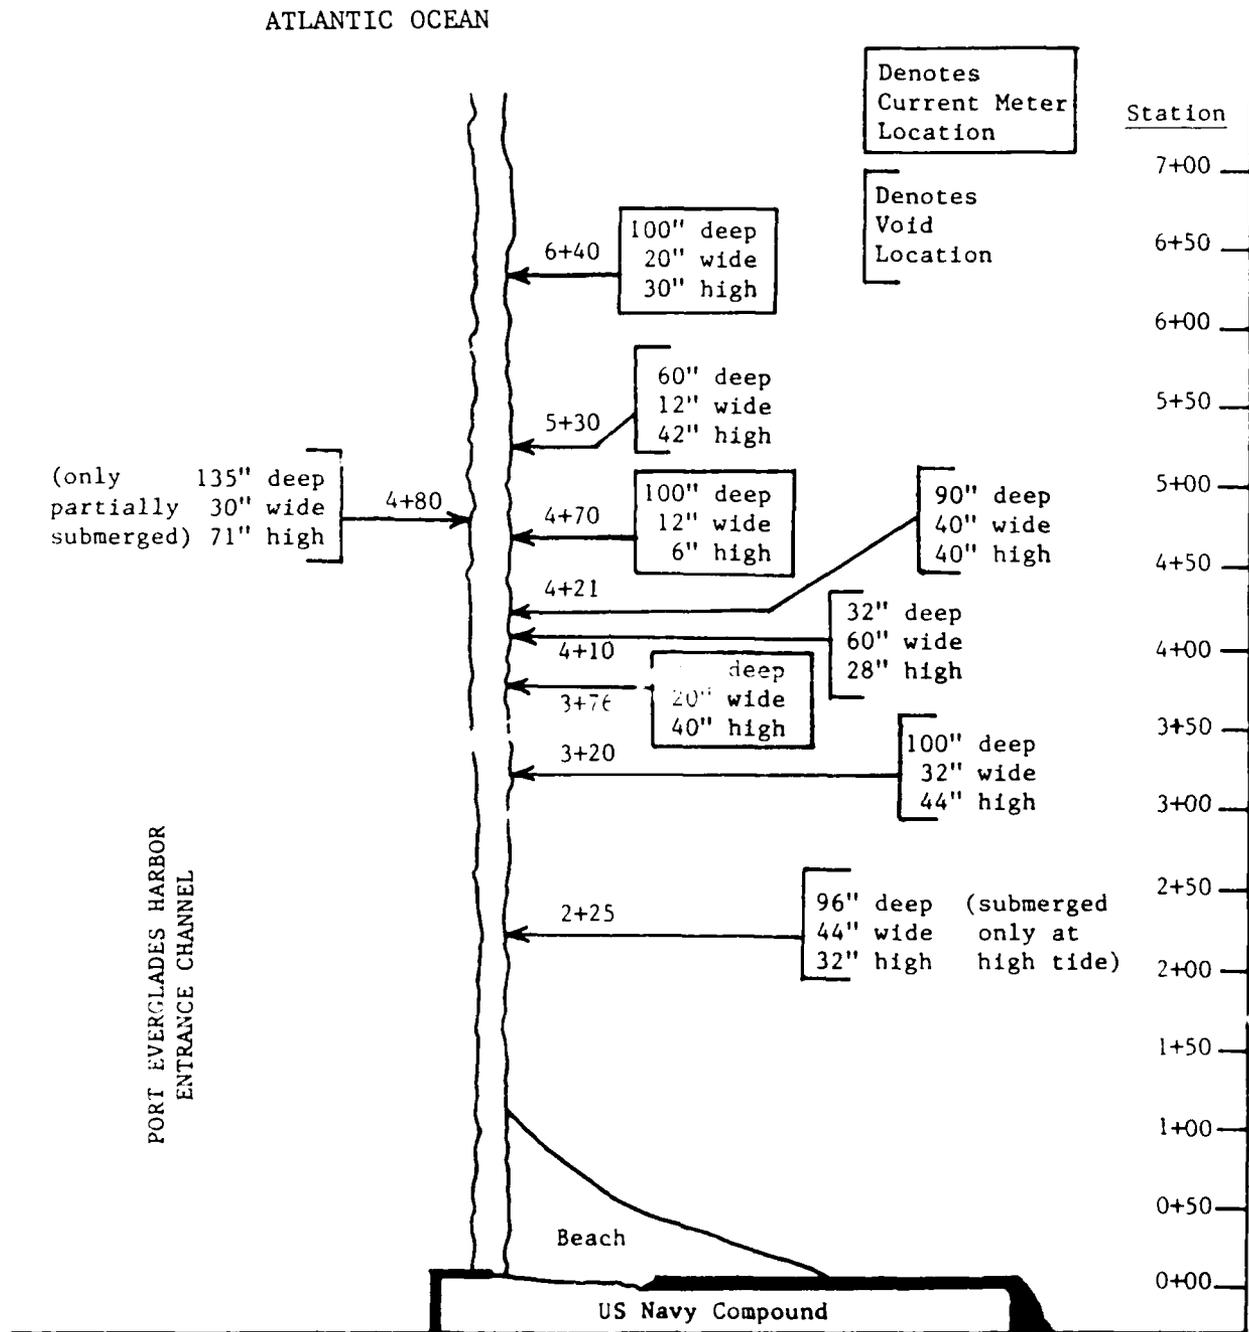
Figure 18. Locations and dimensions of larger structure voids along south jetty at entrance to Port Everglades, Florida

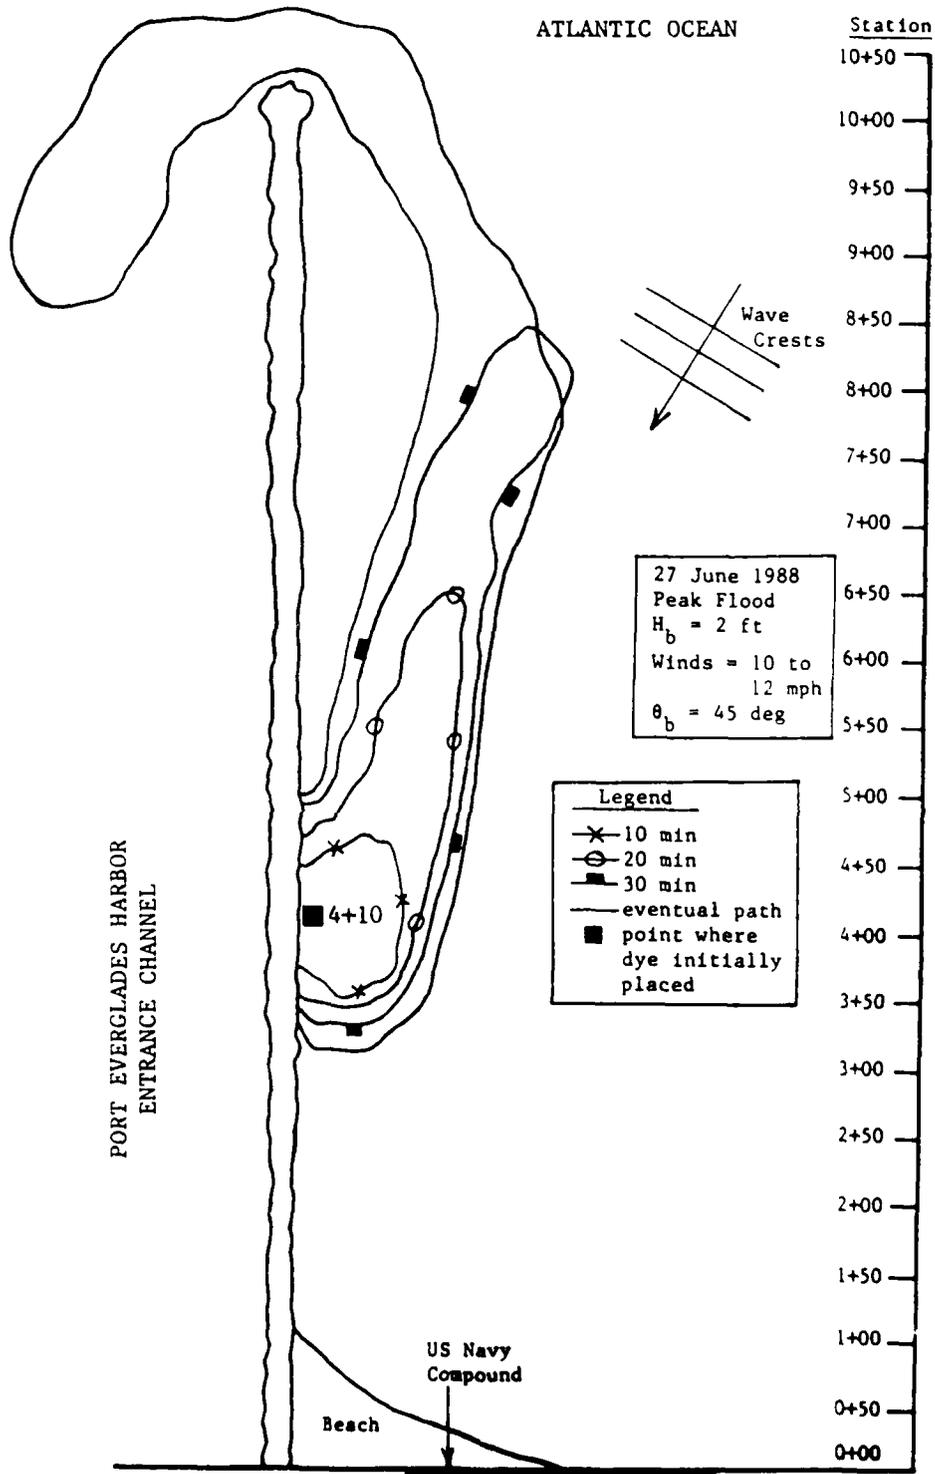
Figure 19. Visually observed dispersion of dye through south jetty at entrance to Port Everglades, Florida, peak flood flow, 27 June 1988

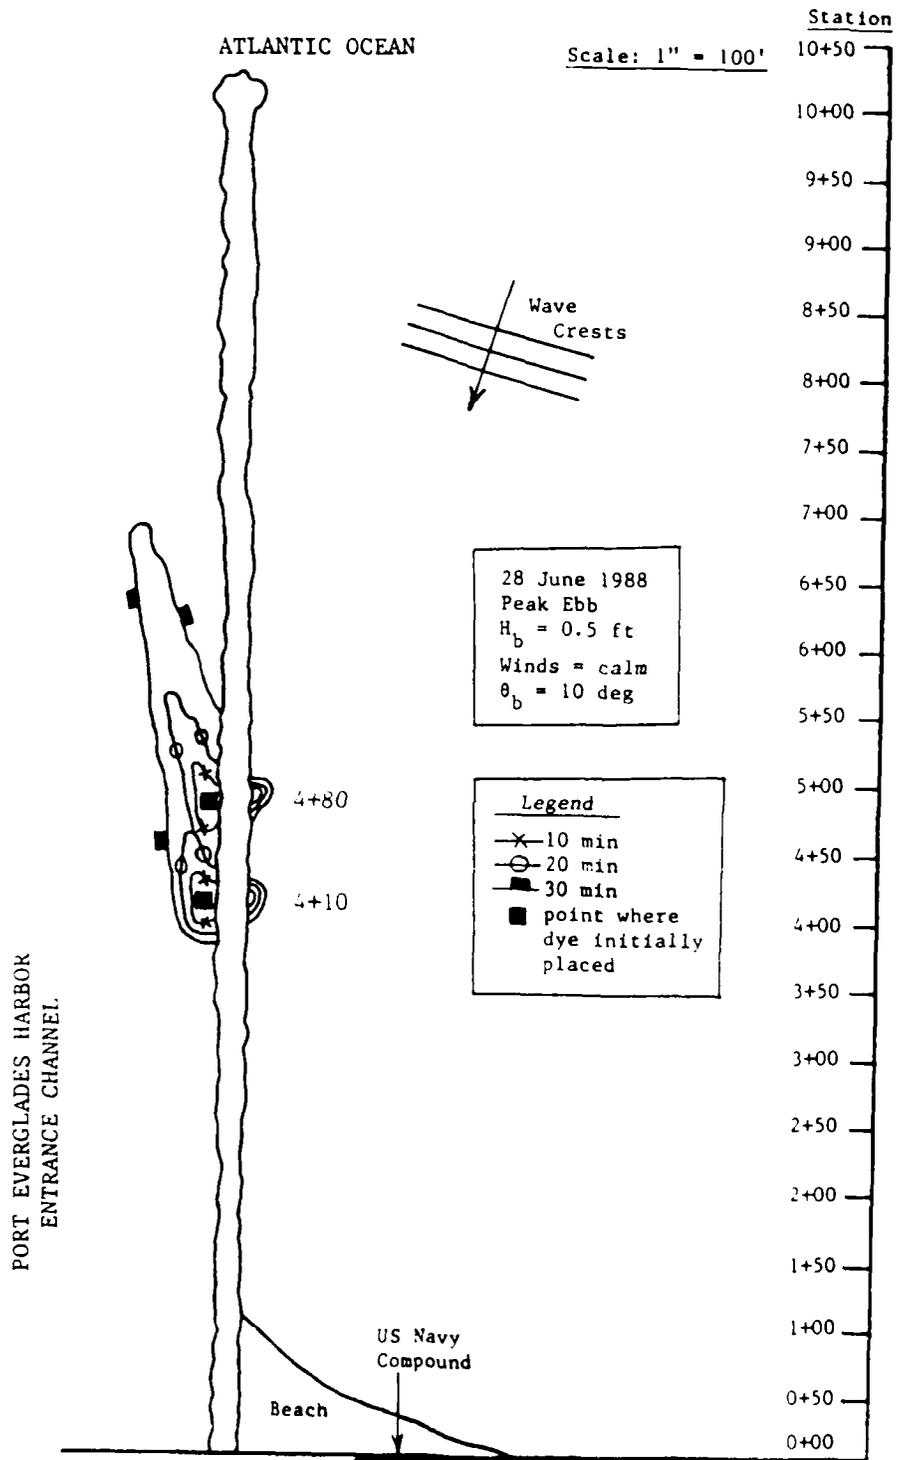
22. The dispersion of dye placed at two voids on the north side of the south jetty (Sta 4+10 and Sta 4+80) 10 min prior to peak ebb flow (1.1 ft/sec) on the morning of 28 June 1988 was documented with oblique aerial photography for an hour after peak ebb flow. The dispersion of dye through time is mapped in Figure 20. The dye passed through the structure to the south side at two locations within 10 min. Winds were calm, with a breaking wave height of about 0.5 ft at approximately 10 deg to the shoreline from the southeast.

Figure 20. Visually observed dispersion of dye through south jetty at entrance to Port Everglades, Florida, peak ebb flow, 28 June 1988

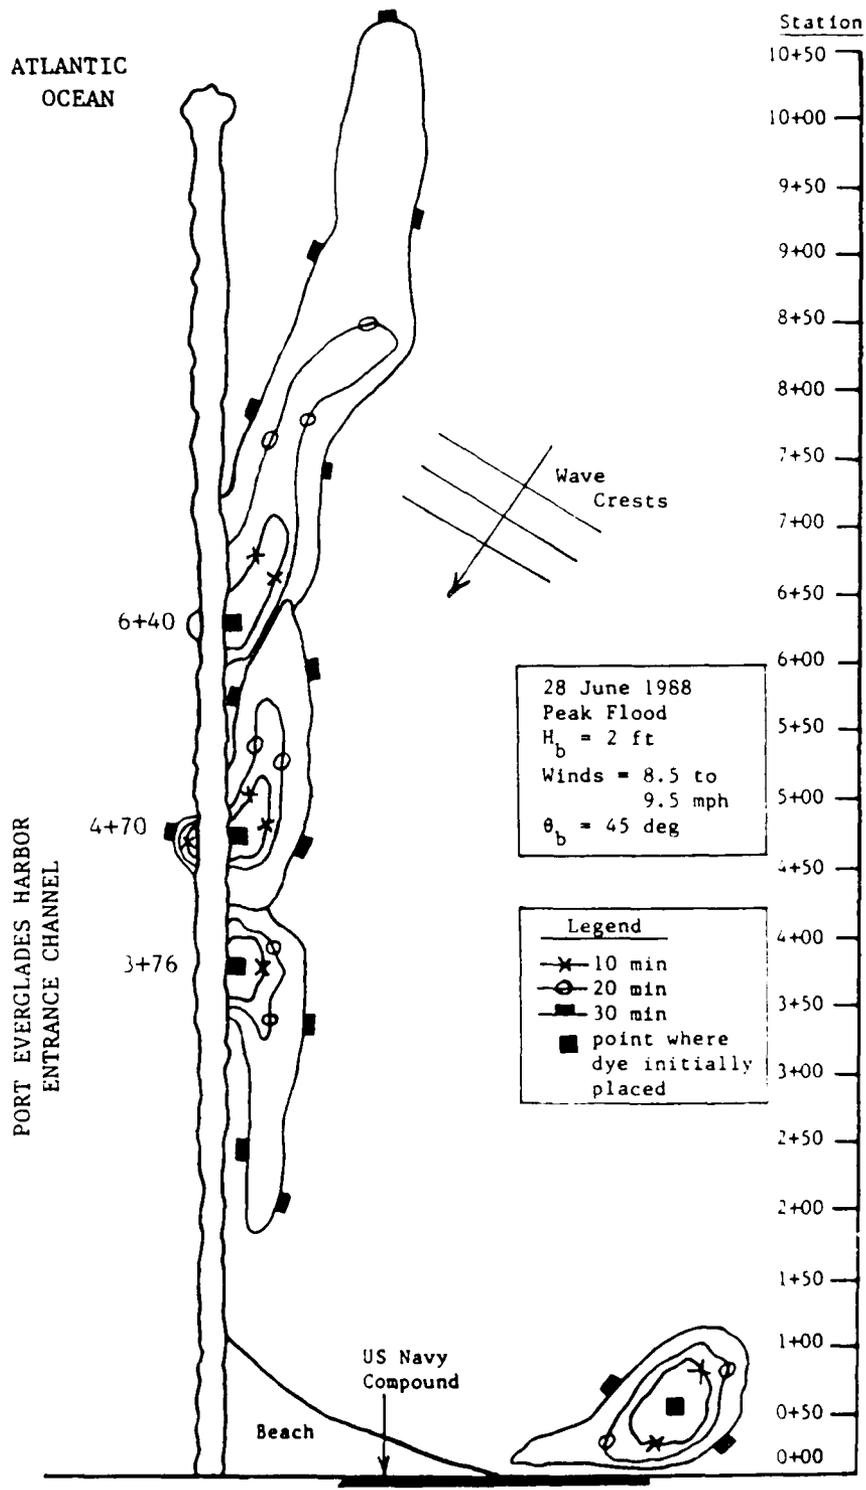
23. The third dye dispersal test was conducted on the afternoon of 28 June 1988 at peak flood velocity (1.1 ft/sec). Winds were approximately 8.5 to 9.5 mph, and 2-ft-high waves from the southeast were breaking at a 45-deg angle to the shoreline. The dispersal of dye was documented with oblique aerial photography for approximately an hour after dye release. Weighted sand sample bags partially filled with powdered dye were placed as close to the structure as possible in voids at Sta 3+76, Sta 4+70, and Sta 6+40 on the south side of the structure. A weighted dye packet was also thrown into the surf zone from the south end of the Navy Compound to indicate the direction and relative magnitude of any longshore current. The dispersion of dye from the structure voids was similar to that observed on the afternoon of 27 June 1988, with the same tendency for offshore movement of dye along the length of structure (Figure 21). Dye passed through the structure voids at

Figure 21. Visually observed dispersion of dye through south jetty at entrance to Port Everglades, Florida, peak flood flow, 28 June 1988

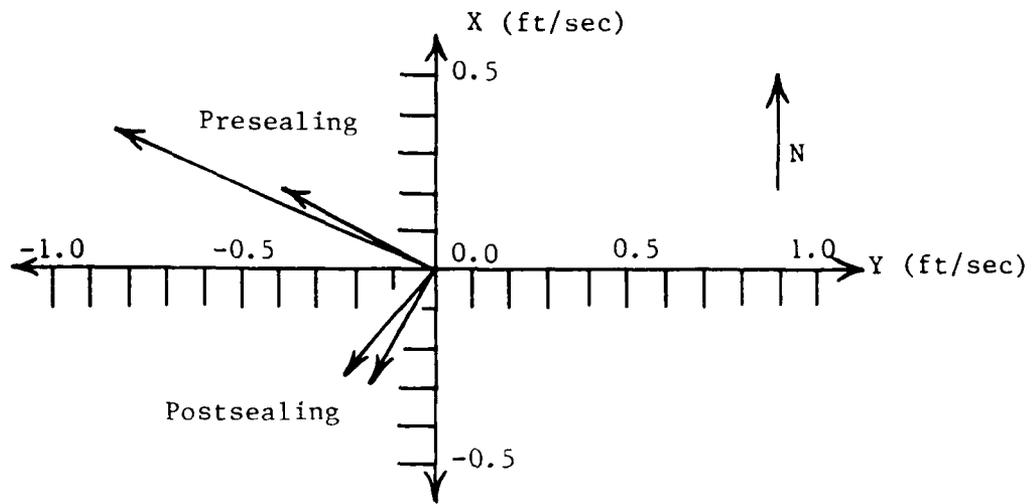
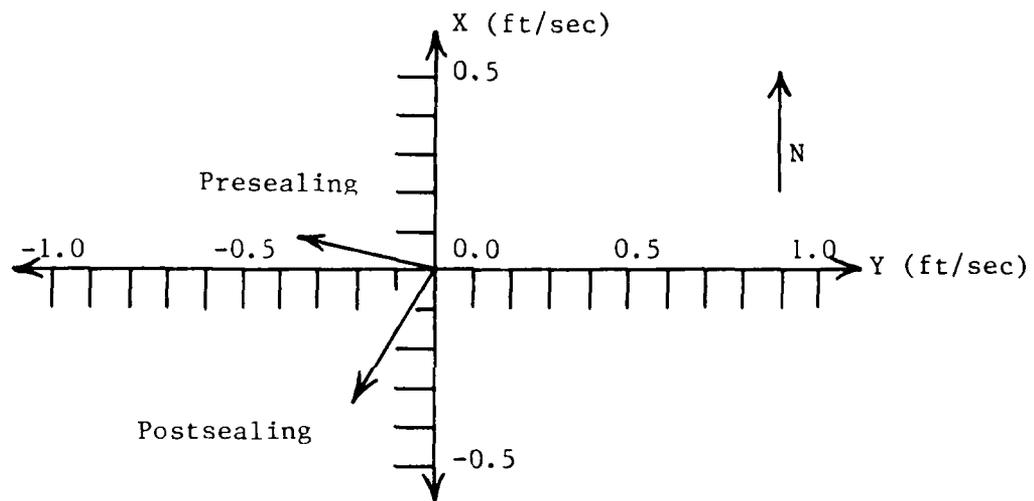
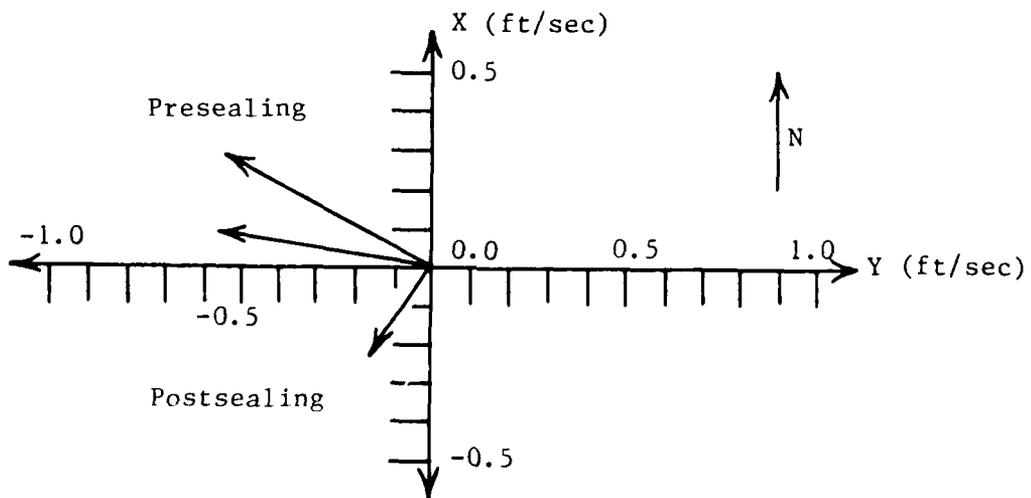
46. Averaging the x- and y-components of the flow for the three current meters deployed during a test results in average magnitude and direction vectors for the pre- and postconstruction experiments. These components are presented in Table 6, and the vectors are displayed in Figure 25 for the peak flood, high-water slack, and peak ebb tests. For the preconstruction tests, average currents move through the structure into the channel for all three flow test conditions. However, the vectors are directed away from the structure in the postconstruction tests, nearly perpendicular to the preconstruction vectors. This change in vector direction demonstrates a deflection in current flow and wave action, indicating a more reflective (hence, less transmissible) cross section.

Figure 25. Average currents measured in structure voids for pre- and postsealing conditions at south jetty, Port Everglades, Florida
