INVESTIGATION OF FATIGUE DAMAGE  
MECHANISMS IN A METAL MATRIX COMPOSITE  
UNDER ELEVATED TEMPERATURE

THESIS

Barry D. Portner  
Captain, USAF

December 1990

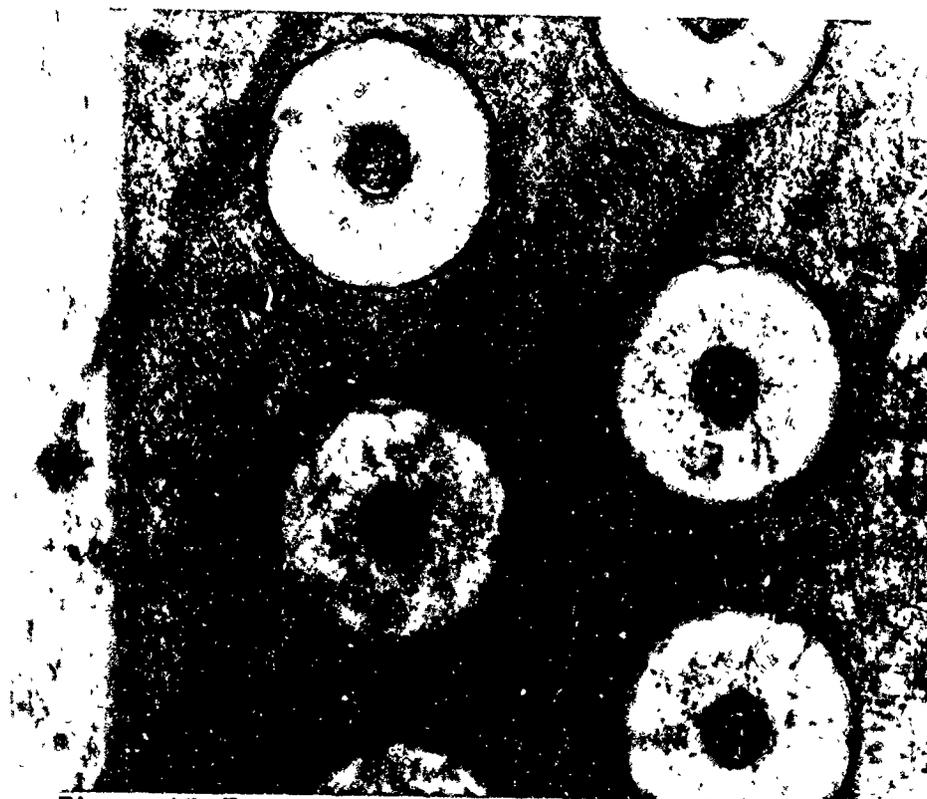
Figure 15. Transverse Cracking Between 90° Fibers and to 0° fibers. (375 MPa 0.0208 CPS, 42000 cycles )

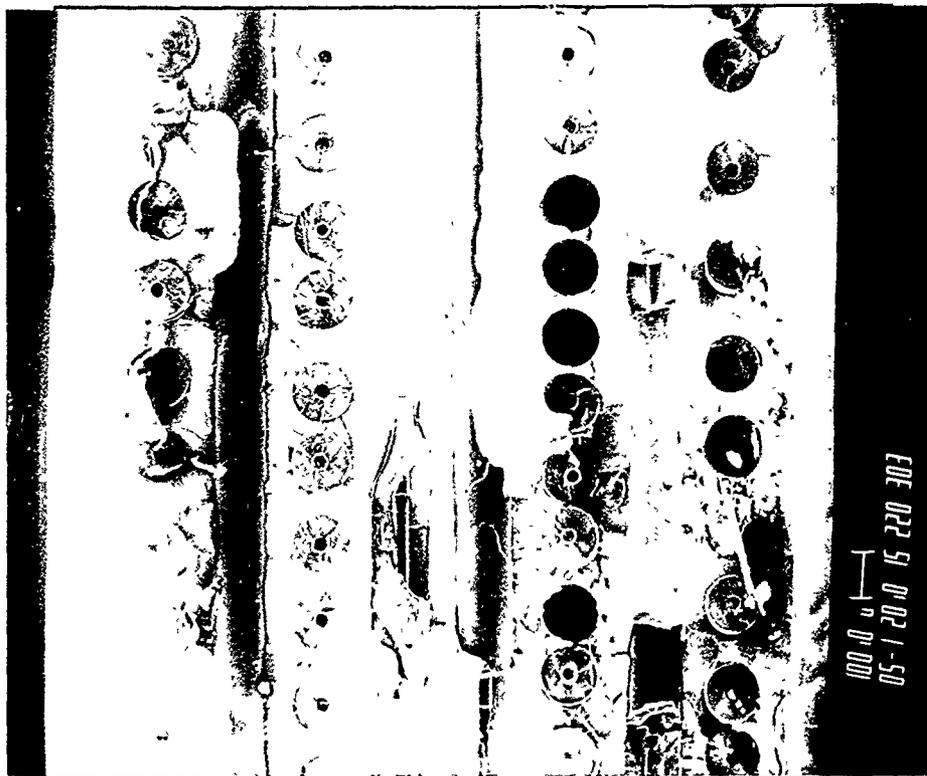
Figure 16. Fracture Surface of the 2.0 cps, 375 MPa Specimen

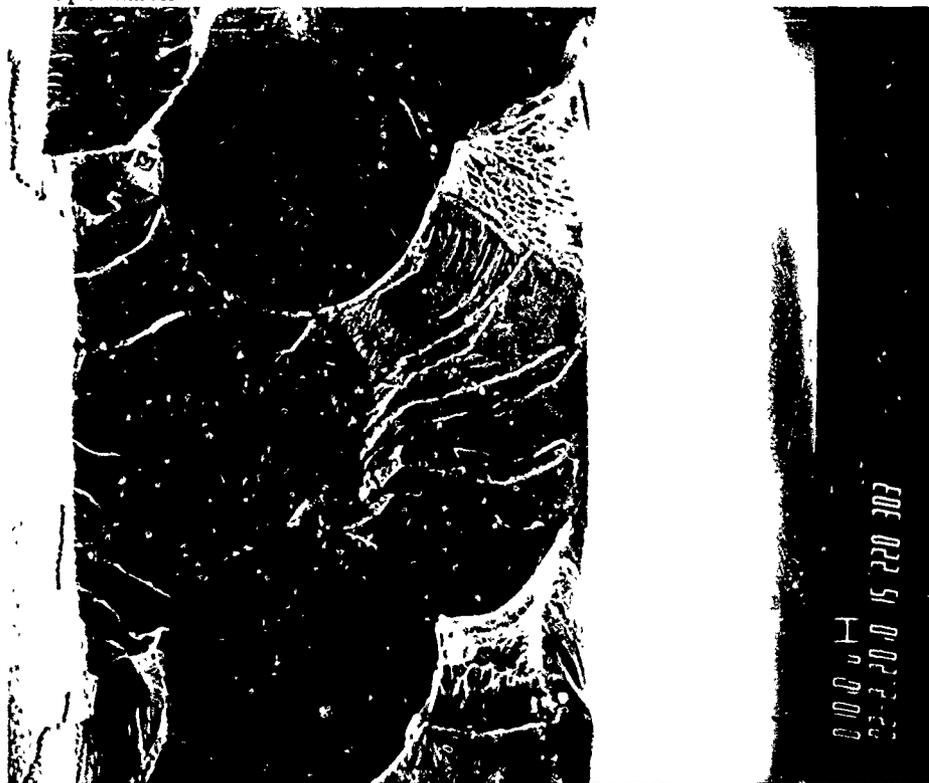
Figure 17. Matrix Crack Initiating at the 90° Fiber-Matrix Interface Then Propagating to the Surface. (Magnification of Figure 16, Center)

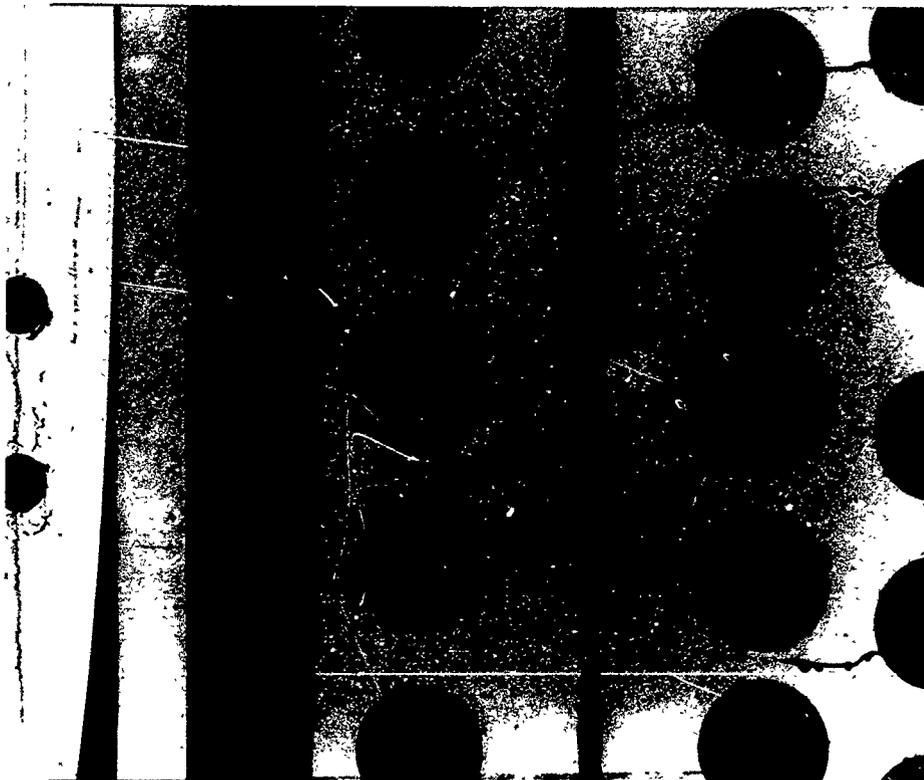
At the higher stress levels, 438 to 625 MPa, crack initiation commonly occurred at 2 locations depending upon the frequency of the test. The reaction zones were one of the locations of crack initiation. However, higher stresses increased the amount of fiber damage within the specimen. At the higher stresses, extreme stress concentration may exist between transverse matrix cracks and fractured fibers causing longitudinal cracking along the 0° fiber-matrix interface. In addition, higher stresses and longer exposure times to temperature are expected to cause degradation of the fiber-matrix interface region setting a path of least resistance between fractured fibers and transverse matrix cracks. This type of crack progression pattern can be seen at 2 locations along the 0° fiber on the left side of Figure 18. (Figure 18 also shows a number of 90° transverse matrix cracks coalescing.) Figure 19 is a photograph of a cross-section of the 0.0208 cps, 438 MPa specimen depicting transverse cracking initiated at the 90° fiber (bottom left), propagating to the 0° fiber, then propagating longitudinally along the 0° fiber to coalesce

Figure 18. Coalescing of 0° and 90° Fiber Interface Initiated Cracks. (500 MPa 0.0208 CPS)

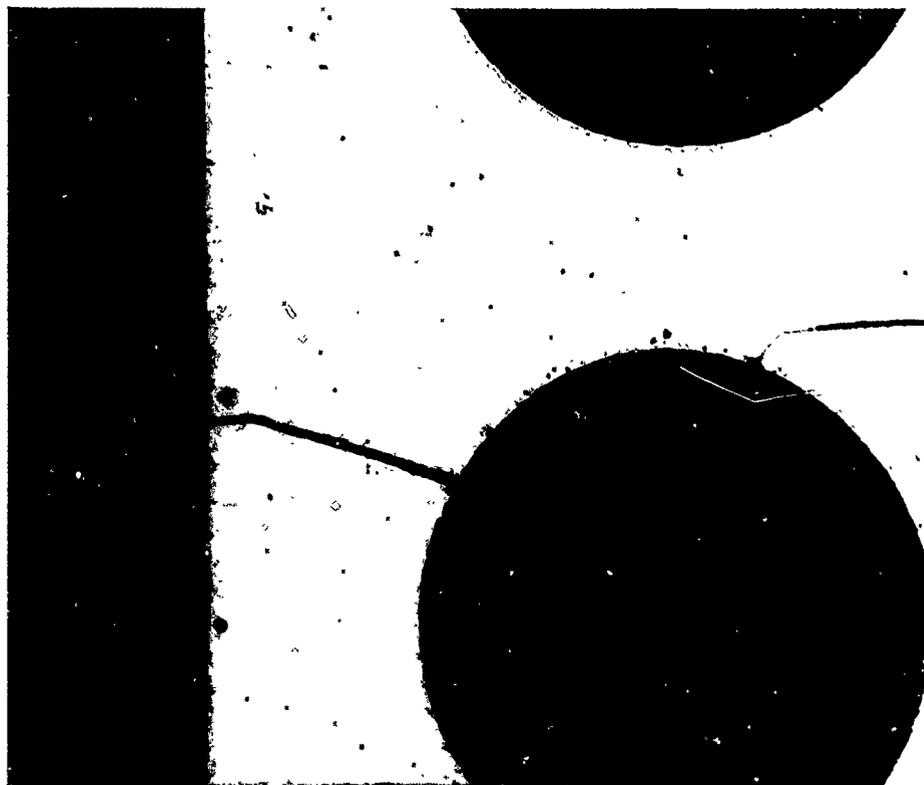
Figure 19. Transverse and Longitudinal Cracking Between 0° and 90° Fibers. (438 MPa 0.0208 CPS)

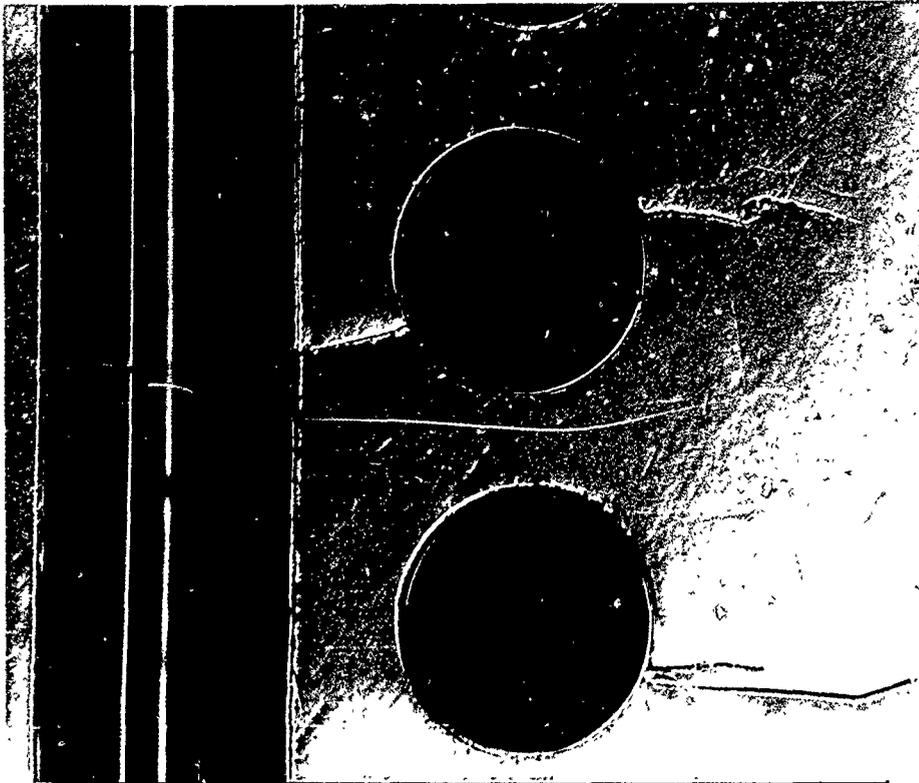
The discussion of crack progression patterns at different stress levels was, for the most part, pictorially represented by the low frequency specimens. However, the high frequency specimens generally witnessed the same type of crack progression patterns but with significantly fewer 0° fractured fibers at all stress levels. Though these crack progression patterns were similar between the high and low frequency tests, a distinction was made (Figure 24) between the number of occurrences of crack initiation types at specified stress levels. Note that for moderate to high stress levels, the high frequency specimens had a large number of matrix cracks initiating off the 90° fibers but

Figure 20. Coalescing of 0° and 90° Fiber Initiated Cracks. (542 MPa 0.0208 CPS)

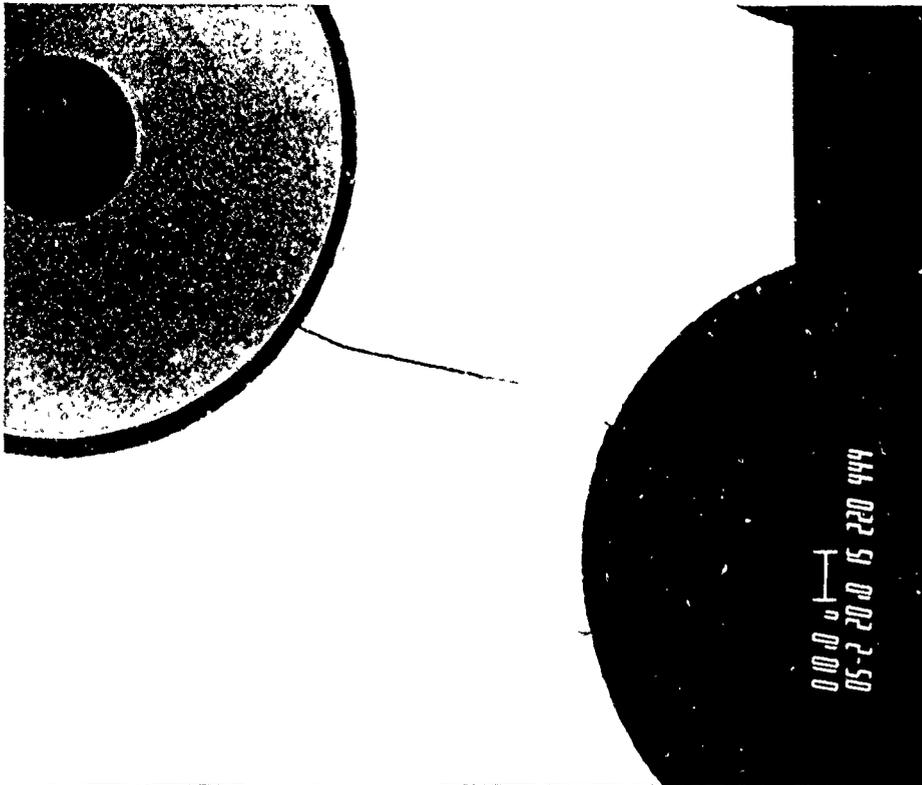
Figure 21. Inner Ply Cracks Coalescing and Debonding of 90° Fiber-matrix Interface. (438 MPa 0.0208 CPS)

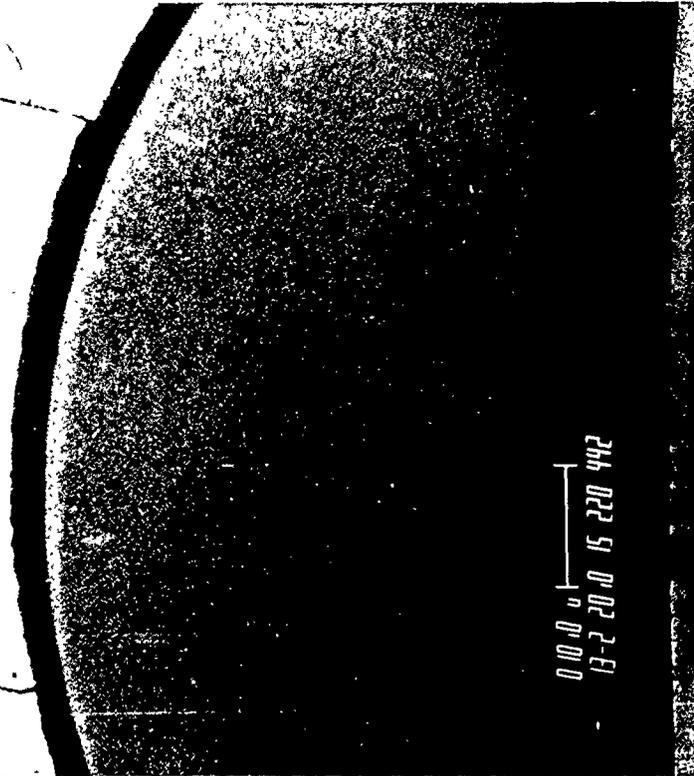
Figure 22. 90° Fiber-matrix Interface Separation.  
(438 MPa 0.0208 CPS)

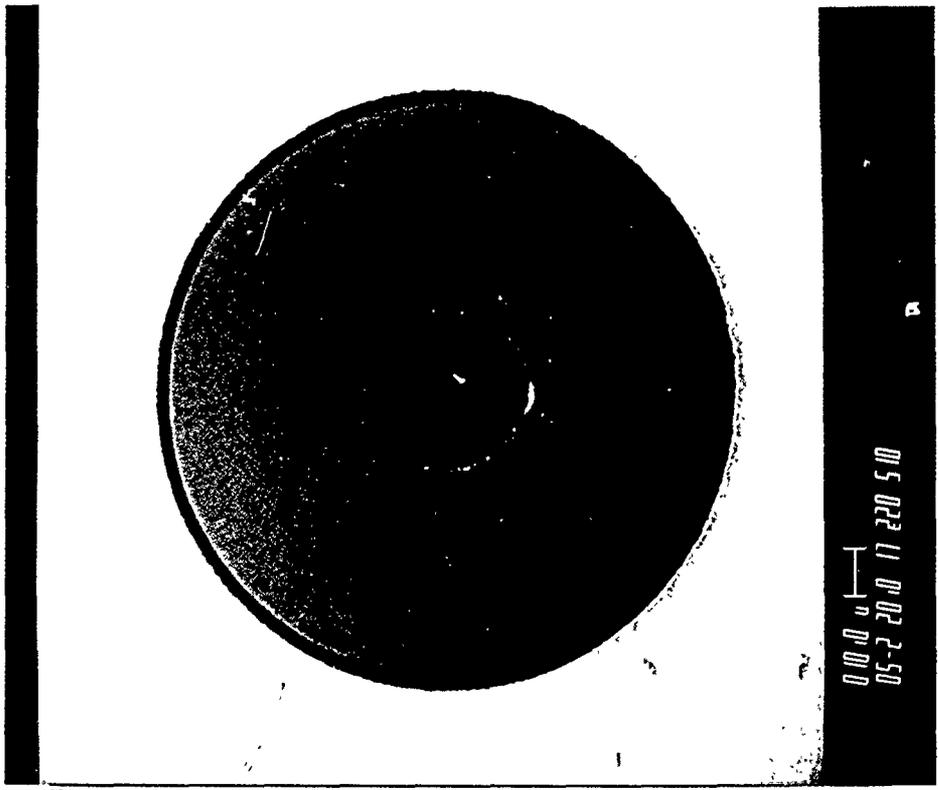
These types of fractures were revealed during microscopic examination of the sections. Eventually, these longitudinally fractured fibers initiate some matrix cracking. Figure 25 shows such a crack propagating through about 80% of the bulk SiC. Figures 26 and 27 also show crack propagation from the carbon core through the fiber-matrix

Figure 25. Crack Propagating From Inner Carbon Core of 0° Fiber. (500 MPa 2.0 CPS)

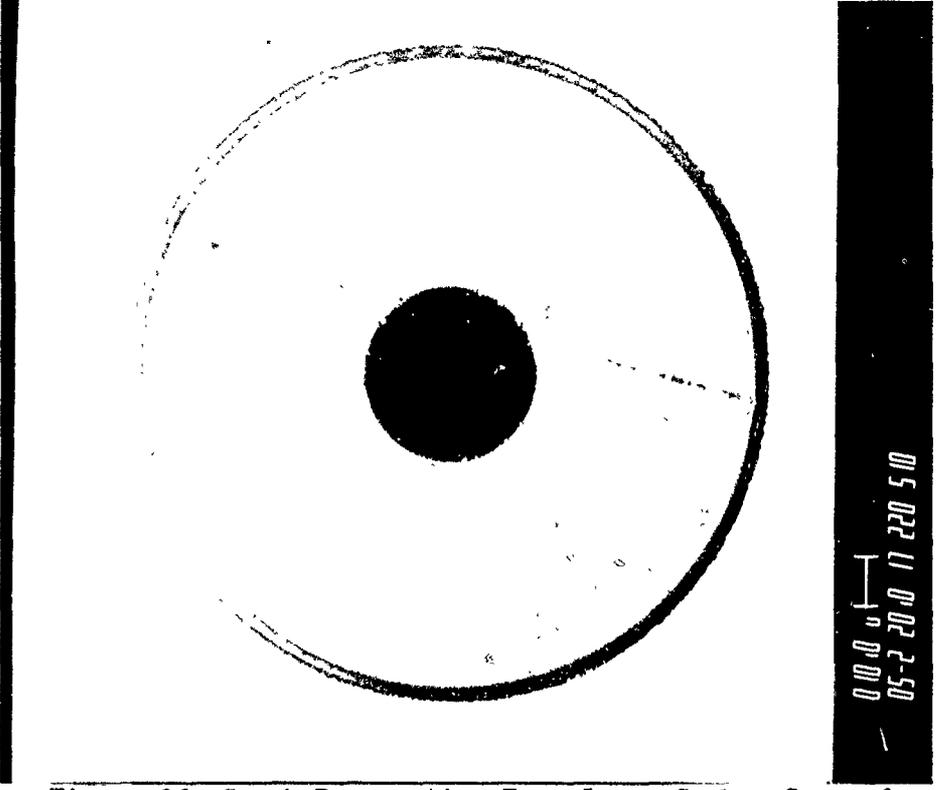
Figure 26. Crack Propagating From Inner Carbon Core of 90° Fiber to Titanium Matrix. (500 MPa 2.0 CPS)

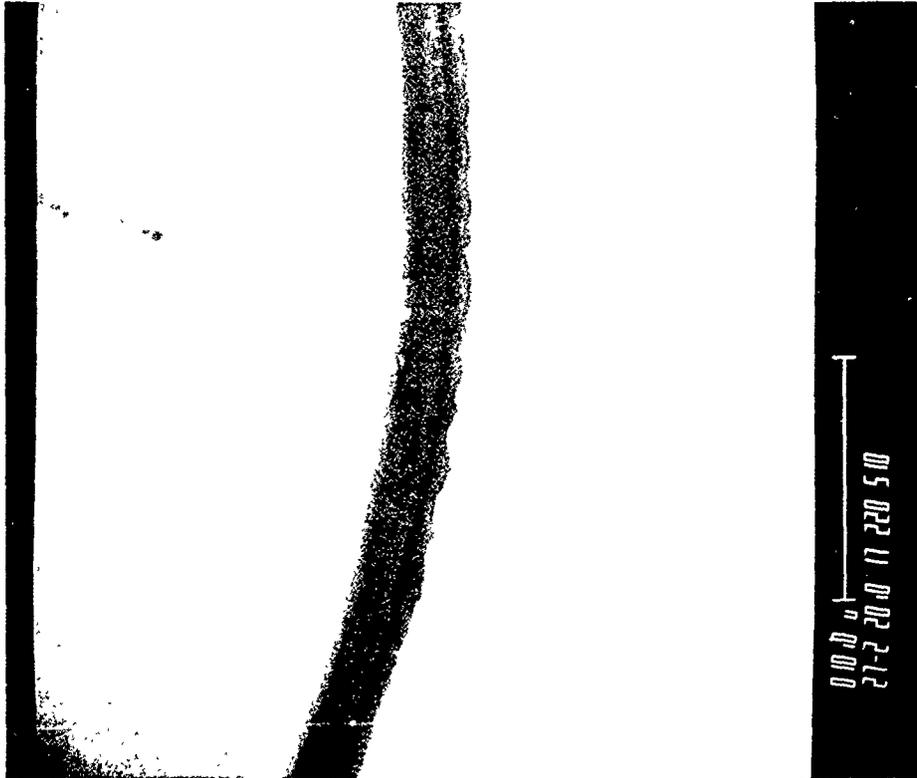
Figure 27. Magnification of Figure 26 (Right).  
(500 MPa 2.0 CPS)

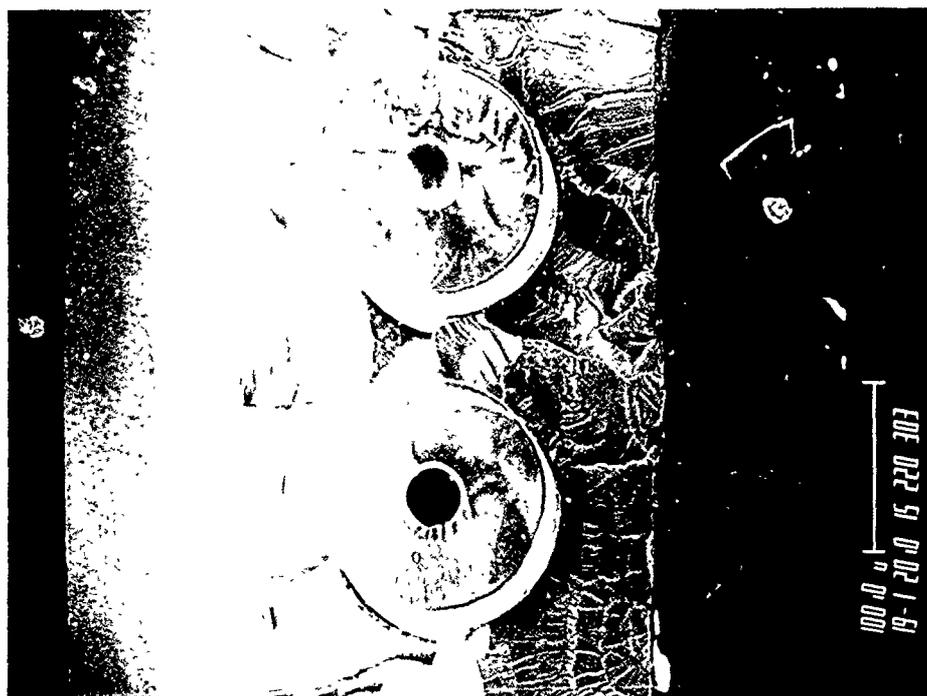
Figure 29. Magnification of Figure 28 (Center).  
(375 MPa 2.0 CPS)

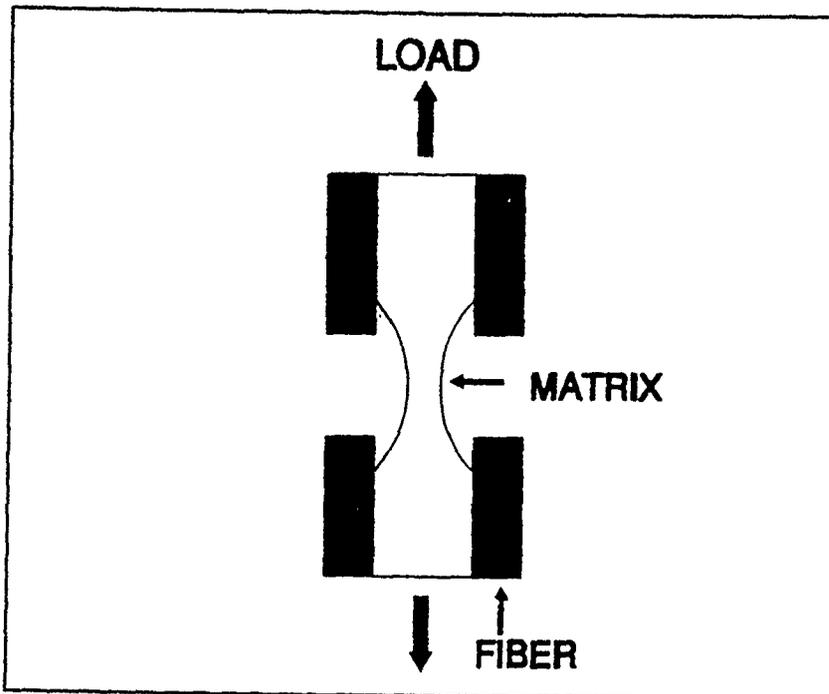
On the other hand, the low frequency group of fatigue test specimens witnessed a considerable number of fractured 0° fibers along with fiber-matrix interface initiated matrix cracks. For this group of tests, primary failure was due to ductile void coalescence preceded by fractured fibers. Figure 30 depicts the type of matrix deformation (necking) due to fractured fibers common with this group of specimens. Figure 31 is a SEM micrograph of a fractured surface showing this type of ductile void failure. This figure also indicates that substantial plastic straining has occurred over a "large" volume of material (the matrix surrounding the fiber). This ductile fracture region is characterized by dimples. Since plastic straining predominated, as opposed to the brittle cleavage type fracture that occurred with the

Figure 30. Matrix Necking (Plastic Deformation) Due to Fractured Fibers

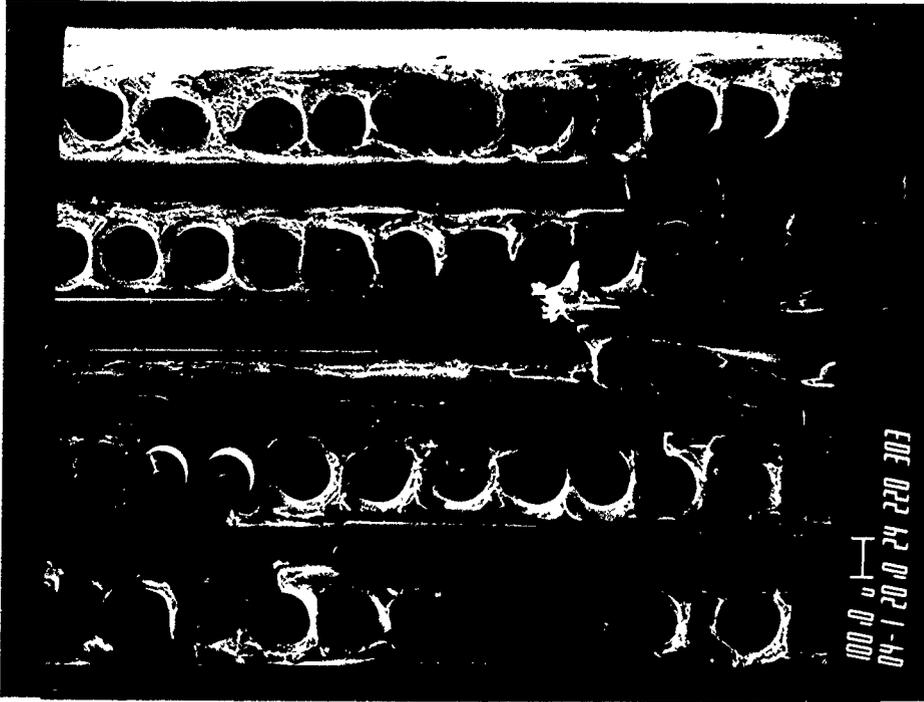
Figure 32. Fracture Surface of 427°C Tensile Tested Specimen

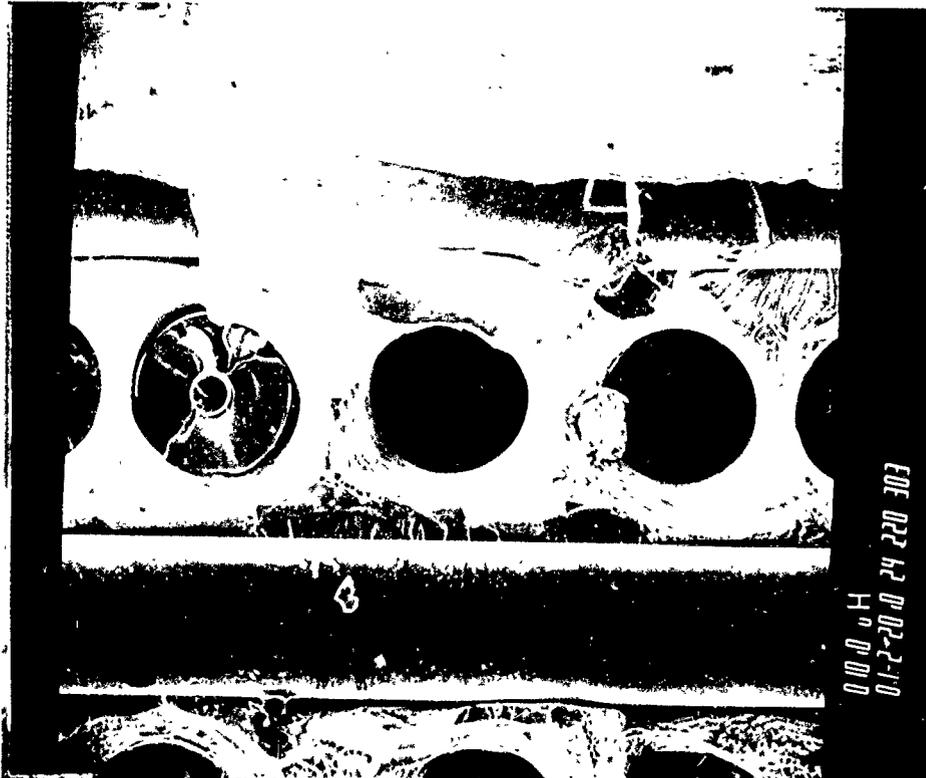
Figure 33. Magnification of Figure 32. Failure by Ductile Void Coalescence.

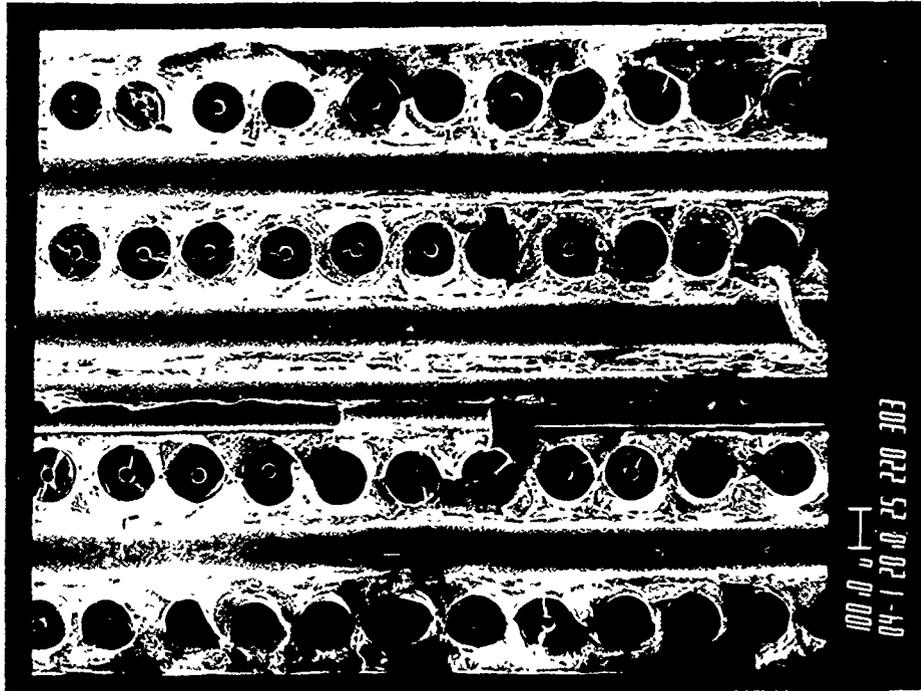
The specimen tensile tested at room temperature exhibited a slightly different type of fracture surface than the specimen tensile tested at 427°C. This matrix failure mode was primarily ductile void coalescence failure. Figures 34 and 35 are SEM micrographs of the fracture surface of this tensile tested (ambient temperature) specimen. Figure 35 is a magnification of Figure 34, bottom right. These micrographs show less debonding of the fiber-matrix interface: therefore, less fiber pullout as compared to the specimen tensile tested at 427°C. The micrographs also

Figure 34. Fracture Surface of Specimen Tensile Tested at Room Temperature

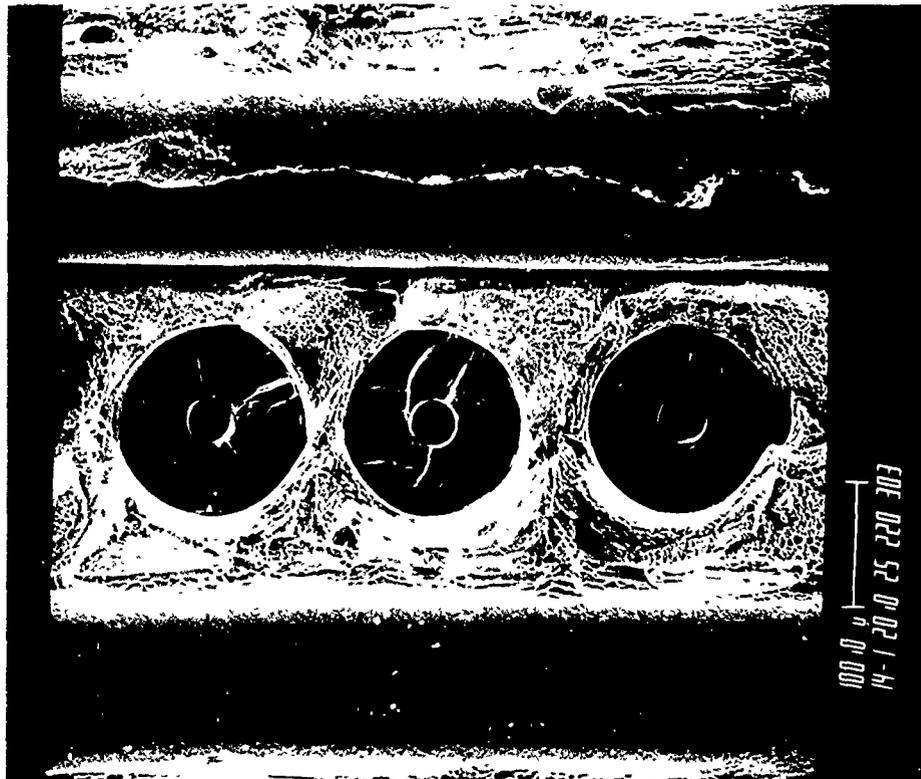
Figure 35. Magnification of Figure 34. Failure by Ductile Void Coalescence.

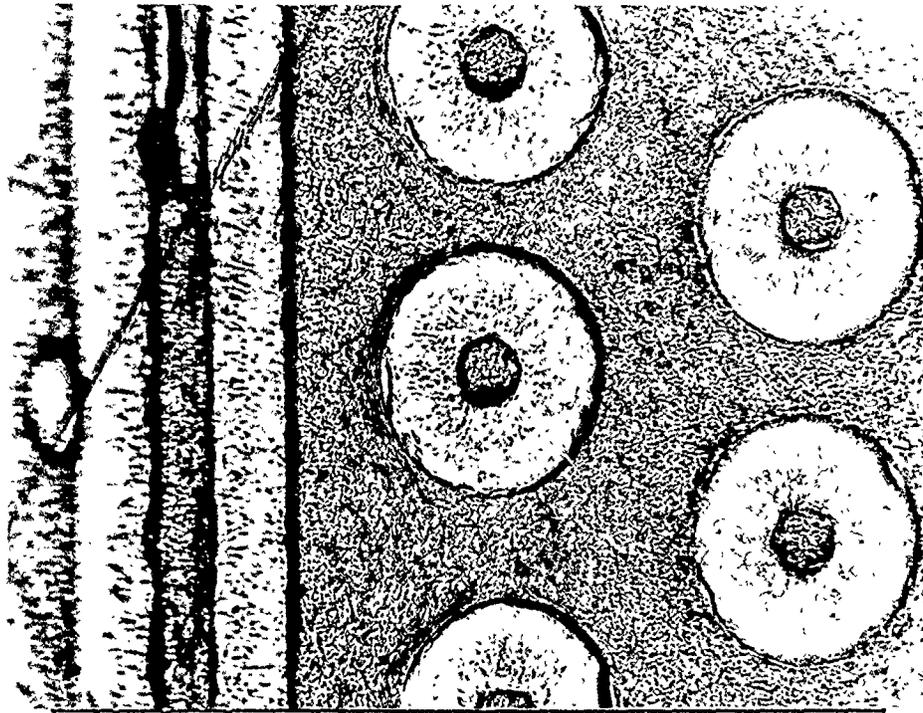
In several instances, transverse matrix crack progression was monitored during the fatigue testing at the precise location where the composite eventually failed. For example, on the 438 MPa high frequency specimen, transverse matrix cracking was observed via replica examination to initiate off the inner 90° fiber-matrix interface at 7500 cycles, Figure 36. Between 7500 and 10000 cycles (Figure 37), this crack propagated transversely across the 2 inner 90° plies to both of the 2 inner 0° plies and began

Figure 36. Matrix Crack Propagating to the Left of the Center 90° Fiber (438 MPa 2.0 CPS at 7500 Cycles)

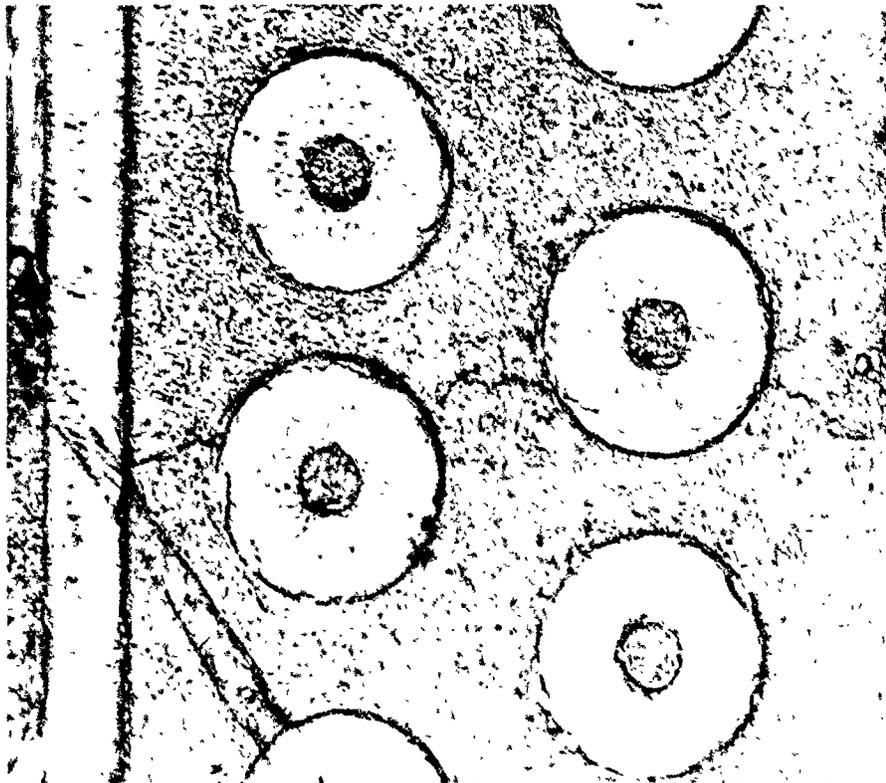
Figure 37. Crack Progressed Across the Inner 90° Fibers to Both Inner 0° Fibers (438 MPa 2.0 CPS at 10,000 Cycles)

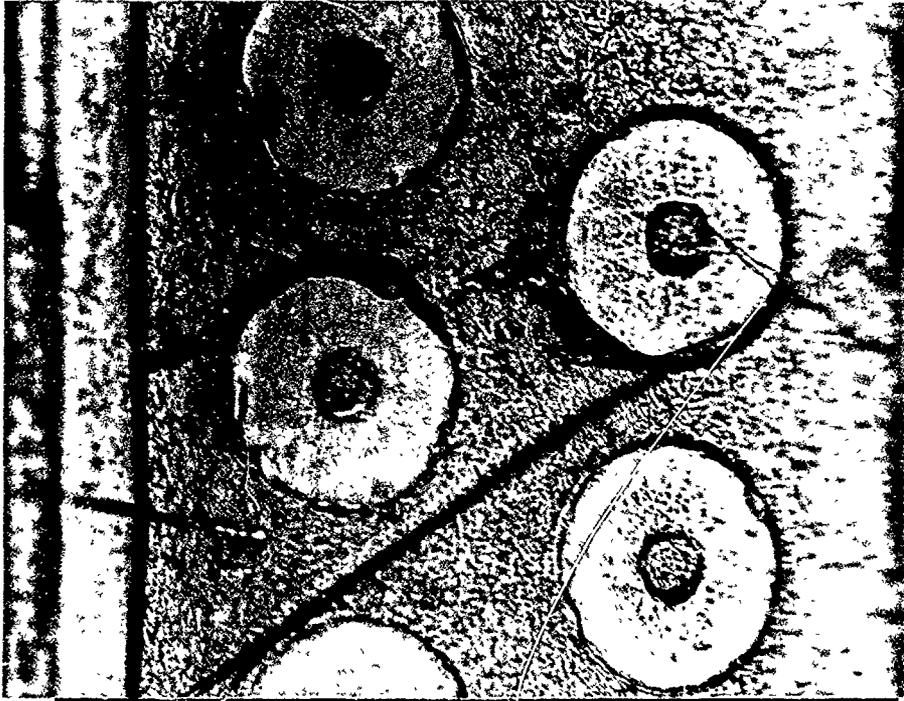
Figure 38. Damaged Fiber-Matrix Interface Zone. 90°  
Fibers Debonding with Matrix (438 MPa 2.0 CPS at 12,500  
Cycles)

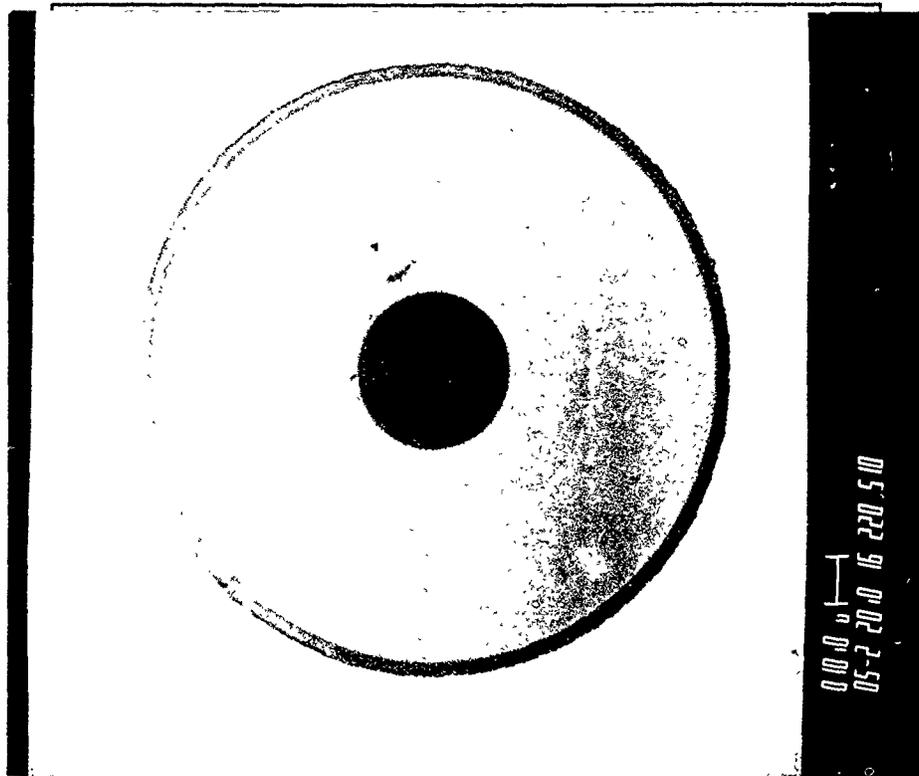
Figure 40. Micrograph of a 90° Fiber with Etched Surface Revealing Reaction Zone (500 MPa 2.0 CPS)

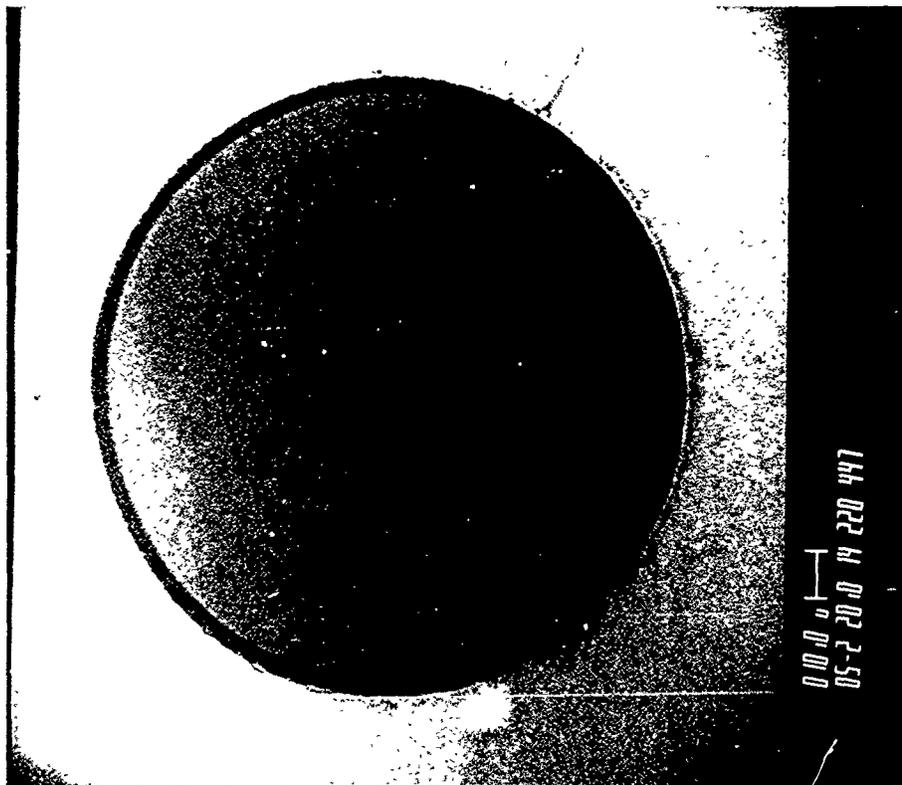
Figure 42. Micrograph of the 0° Fiber Reaction Zone of the Low Frequency 542 MPa Specimen Exposed to Temperature for 3 Hours

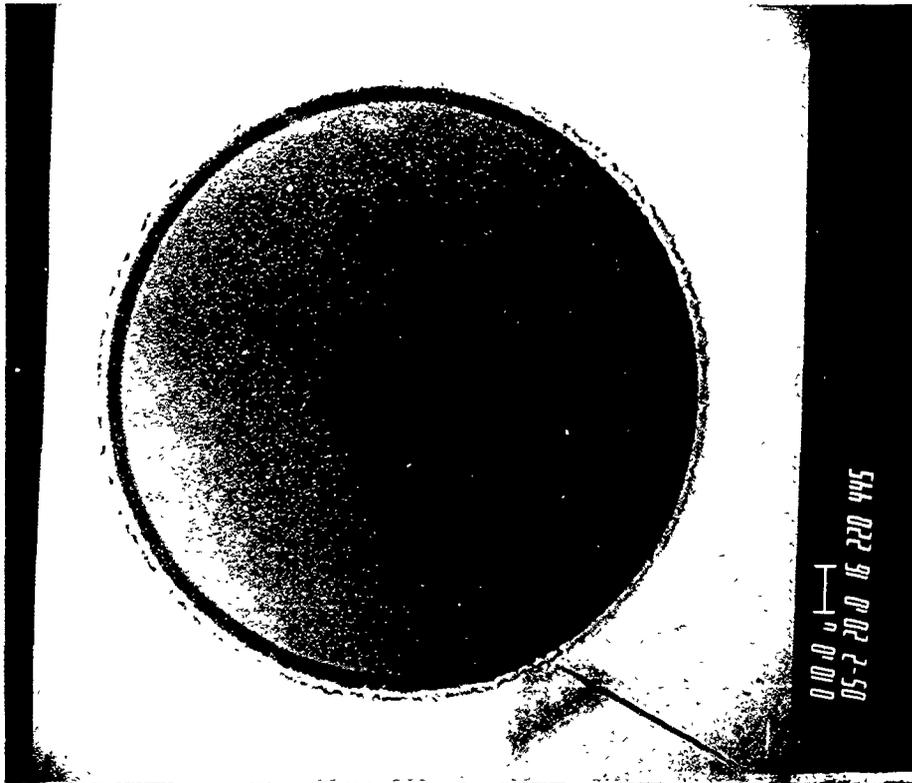
Figure 44. Micrograph of the 90° Fiber-Reaction Zone of the Low Frequency 438 MPa Specimen Exposed to Temperature for 10 Hours
