WEAR ANALYSIS OF DIESEL ENGINE FUEL INJECTION PUMPS FROM MILITARY GROUND EQUIPMENT FUELED WITH JET A-1

**INTERIM REPORT
BFLRF No. 272**

**Belvoir Fuels and Lubricants Research Facility (SwRI)
Southwest Research Institute
San Antonio, Texas**

**U.S. Army Belvoir Research, Development
and Engineering Center
Materials, Fuels and Lubricants Laboratory
Fort Belvoir, Virginia**

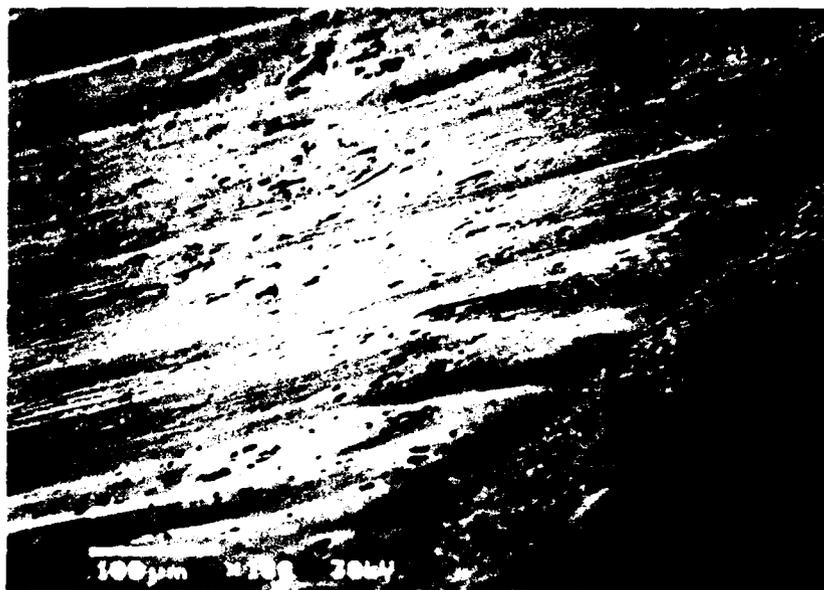
The rotor was seized close to the transfer pump, and the drive shaft was sheared. Slight discoloration of the rotor had also occurred close to the pumping plunger end. The transfer pump blades and liner were severely worn, probably equivalent in civilian vehicles to several hundred thousand miles of operation on diesel. The wear scar on the pump vanes was 32 micrometers

deep, with a Center Line Average (CLA) roughness of 1.21 micrometers. A Scanning Electron Microscope (SEM) micrograph taken at the edge of the wear scar is shown in Fig. 2. The step measured by the Talysurf profilometer may be seen toward the right of the figure. Longitudinal wear tracks were ploughed into the surface, and the very porous nature of the sintered material is clearly visible.

Figure 2. SEM micrograph taken at edge of wear scar on face of transfer pump vanes

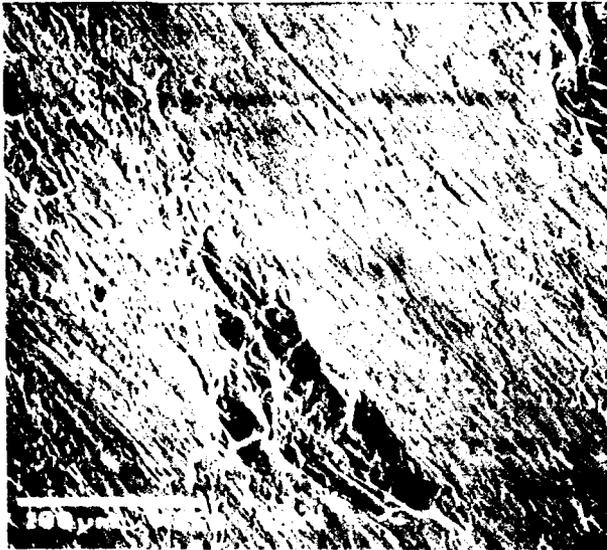
The transfer pump liner was discolored at the area corresponding to the fuel outlet port. The surface topography in this area was slightly pitted, with some evidence of plastic deformation as shown in Fig. 3a. Elongated wear tracks were formed on the surface of the liner emanating from the scuffed area, as shown in Fig. 3b. These tracks were probably cut by adhesive wear debris that was formed during scuffing.

a. Scuffed area close to fuel outlet

Figure 3. SEM micrographs of transfer pump liner

Evidence of transient scuffing was visible on several transfer pump liners operated on Jet A-1. The surface of the scuffed liners was discolored and, in some instances, slightly pitted close to the fuel outlet ports, as shown in Fig. 3. The surface of a badly scuffed liner provided by the pump manufacturer is shown in Fig. 6. Considerable plastic deformation and surface pitting were present. These pits were probably formed by adhesive wear during lubricant failure and scuffing. Microscopic examination of the slightly scuffed liners from the current batch of pumps shows isolated areas with a similar but less severe wear mechanism.

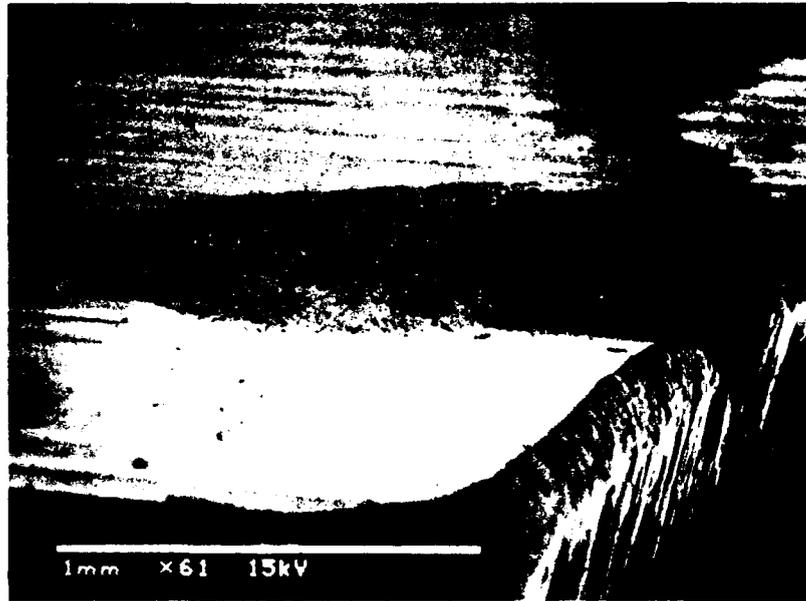
small amount of metal had been chipped from the slots in the rotor, which retains the transfer pump vanes, as shown in Fig. 4. The location of the fractures coincided with the point of contact between the vanes and the rotor and was probably caused by severe side loading on the pump vanes. Such loading is known to cause seizure of the pump rotor.

Figure 4. SEM micrograph of chipped pump rotor

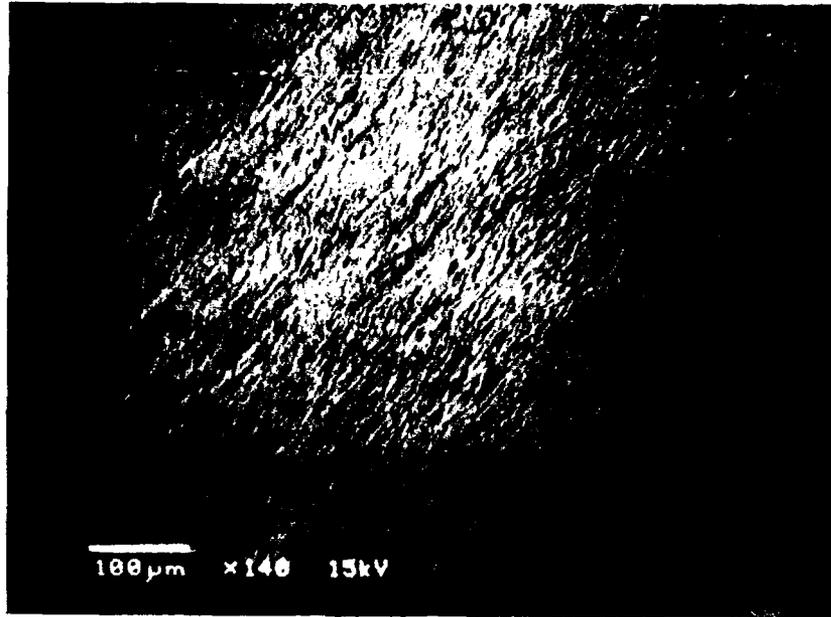
No drive shaft was provided, and the rotor was seized close to the transfer pump. Unlike previous pumps studied, the transfer pump was not severely worn; little visible wear was present on the vanes, and the contact area was smooth as shown in Fig. 5. As a result, no measurable wear scar could be located by the surface profilometer. The liner and retainers also showed little visible wear, although the liner was slightly blackened close to the outlet port. On the present pump (DC series), these components are fabricated from M-2 high-density steel, which corresponds to the arctic conversion kit for the DB2 pump.

Figure 5. SEM micrograph of worn area on upgraded (arctic) transfer pump vanes
