MTL TR 91-25

FAILURE ANALYSIS OF THE APACHE MIXER PIVOT SUPPORT

July 1991

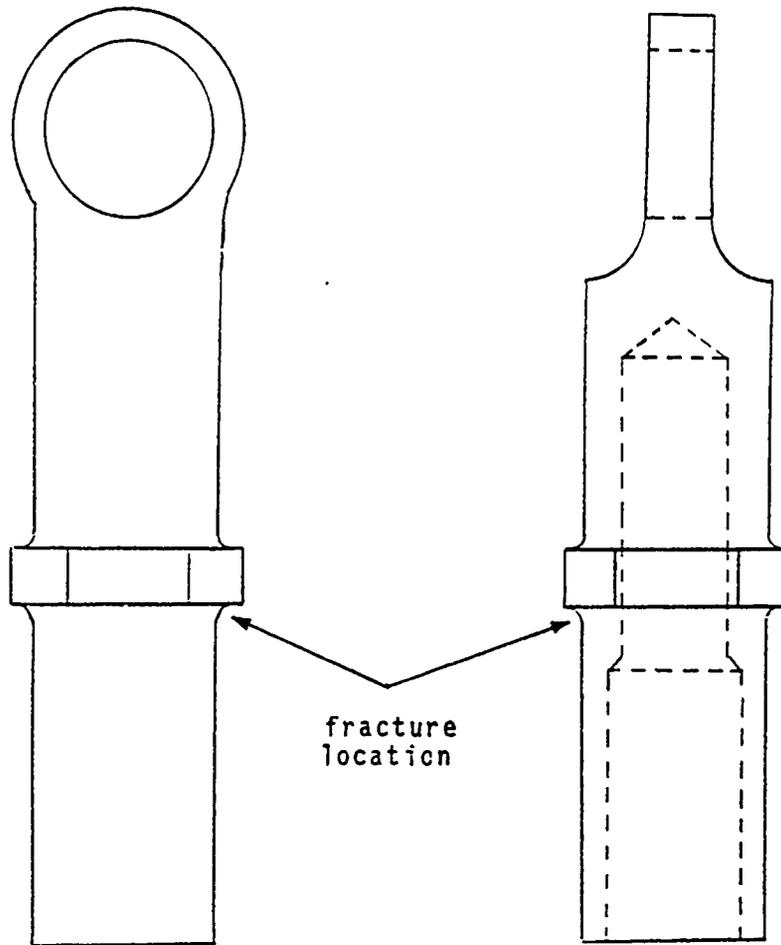
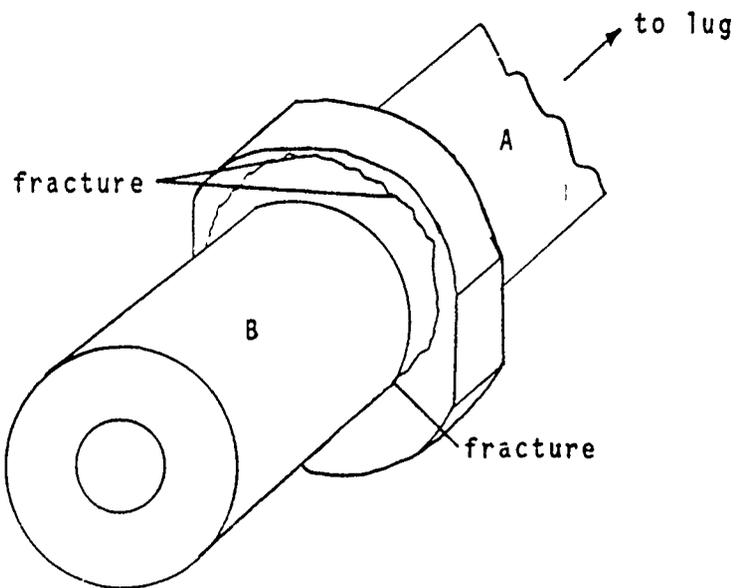
Figure 2 is a schematic of the mixer pivot support, showing the location of the failure. The failure site had been previously analyzed for stress concentrations by McDonnell-Douglas and was not identified as the most critical area. Other regions on the part were calculated as having higher stress concentrations (Kt values). Figure 3 shows the broken component in the as-received condition. Figure 4 was photographed after rotating the mixer pivot support 180°. The upper half (Part A) of the component which contained the bearing was in relatively good condition, as compared to the lower half (Part B). The surface coating of Part A was intact and the serial numbers and manufacturing identification data were easily distinguishable. There were no obvious signs of corrosion or mechanical damage to Part A. In contrast, however, Part B showed significant wear on surfaces that contacted the bushing. These regions are characterized by dark stains (designated by the arrows) in the macrograph. The cadmium coating appeared to have been almost entirely worn away during service and severe corrosion pitting had occurred in these areas.

Figure 2. Schematic of mixer pivot support showing location of fracture.

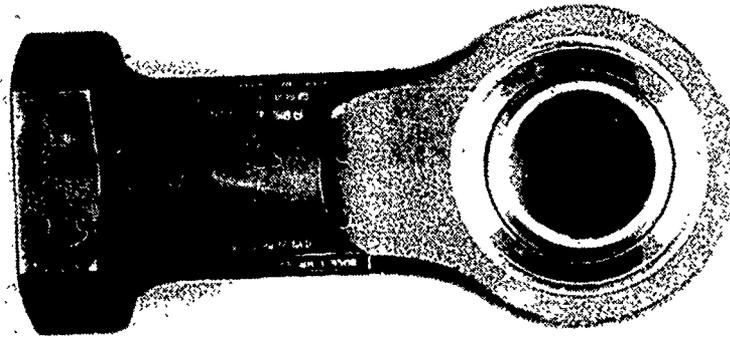
Figure 3. Shows the mixer support in the as-received condition.

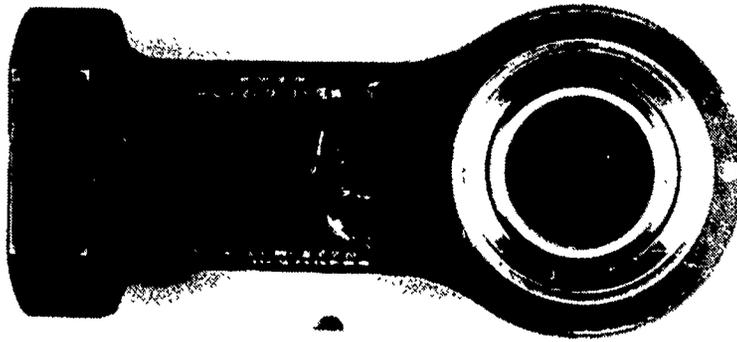
Figure 4. Shows the part in the as-received condition rotated 180° from Figure 3.

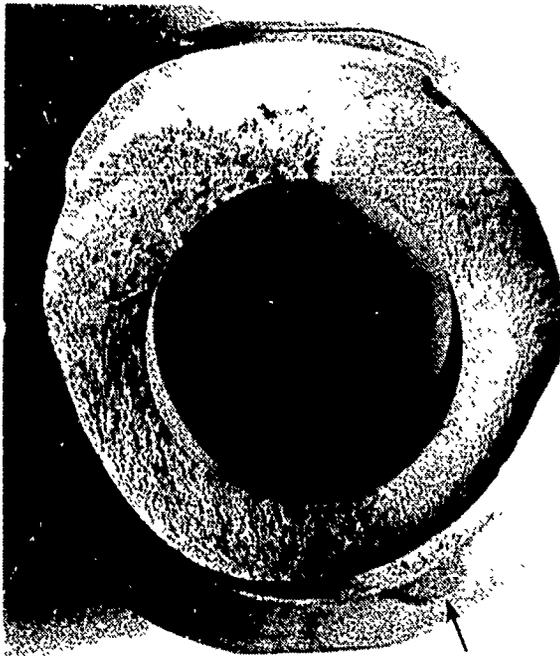
Figure 8A is a fractograph of Part A which was taken by exposing the fracture surface under a series of various light sources which were directed onto the macroscopic features at very acute angles. Normally, such a photograph consists of a single exposure but due to the

complexity and geometry of the fracture, four separate exposures were taken and subsequently blended together with light to obtain the contrast needed to reveal the important features of the fracture surface. Figure 8B is a schematic of fracture Face A which identifies the crack initiation site and traces the fracture path. The fracture plane intersected the radius at the crack origin. The radial lines and chevron patterns indicated that the fracture proceeded from the bottom right of the photograph (as designated by the arrow) up along both sides of the central hole. Where the two fractures meet at the top, a ridge is visible. This suggested that the fracture, indeed originated at the bottom radius, as illustrated.

Figure 8A. Optical fractograph of Face A
(arrow identifies crack origin).

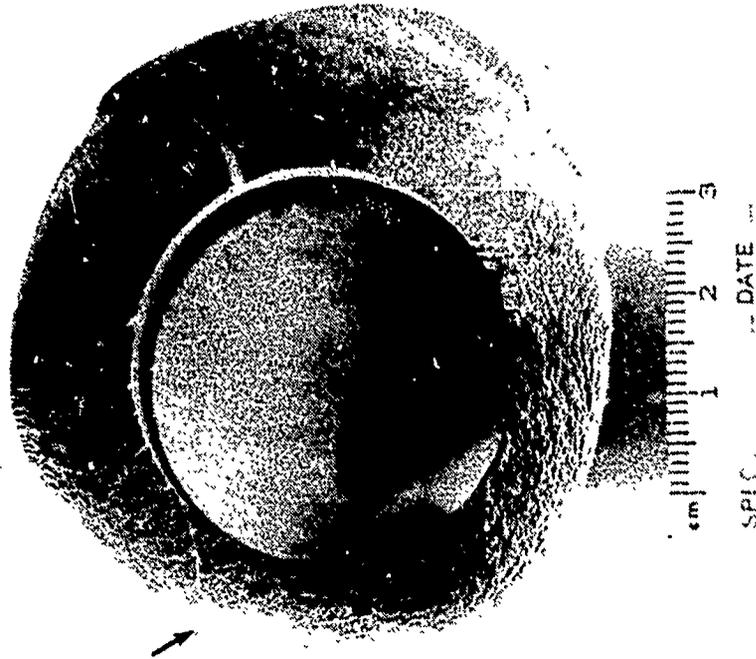
Figure 9A is a fractograph of Part B which also reveals the crack origin and direction of propagation. The fracture face was badly smeared in many areas, as indicated by the bright spots on the photograph. This may have been caused by improper handling of the fractured component prior to examination, possibly the result of forcing both halves of the fracture faces together. Damage may have also occurred when the component was removed from the aircraft or after it had failed. In all cases the surface smearing is attributable to a post-fracture incident. An important feature of the fracture, located at the very top of the photograph, is a shear lip region where final fracture had occurred. Both Faces A and B contained surfaces that were very flat-faced in appearance, displaying no signs of plasticity, which is often associated with a brittle fracture. The shear lip zone, however, showed evidence of ductility. The existence of a shear lip zone served to further substantiate the location identified as the crack origin, since final fracture would tend to occur in an area opposite the initiation site on this component.

Figure 9A. Optical fractograph of Face B (arrow identifies crack origin).

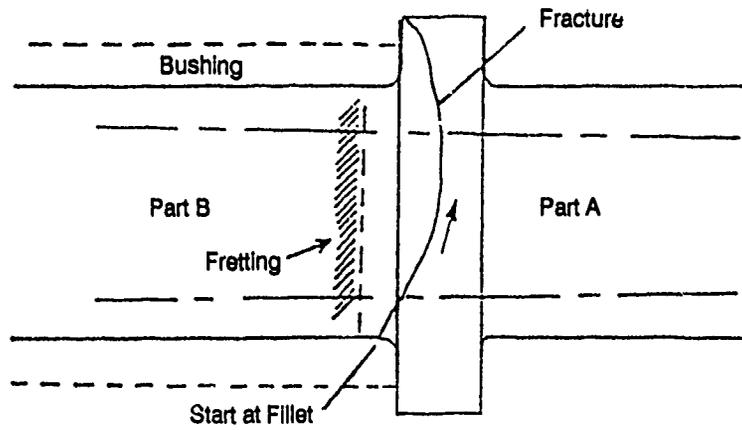
Figure 12 is a schematic which defines the area of fretting and its location relative to the fracture plane. It is important to note that the region of severe fretting was located just below the fracture plane and crack origin. Figure 13 is a macrograph of the crack initiation site located on fracture Face A. Again extensive corrosion pitting had occurred in this region. Figure 14 shows the corrosive attack at higher magnification. The entire area had experienced severe attack.

Figure 12. Schematic showing location of fracture and fretting.

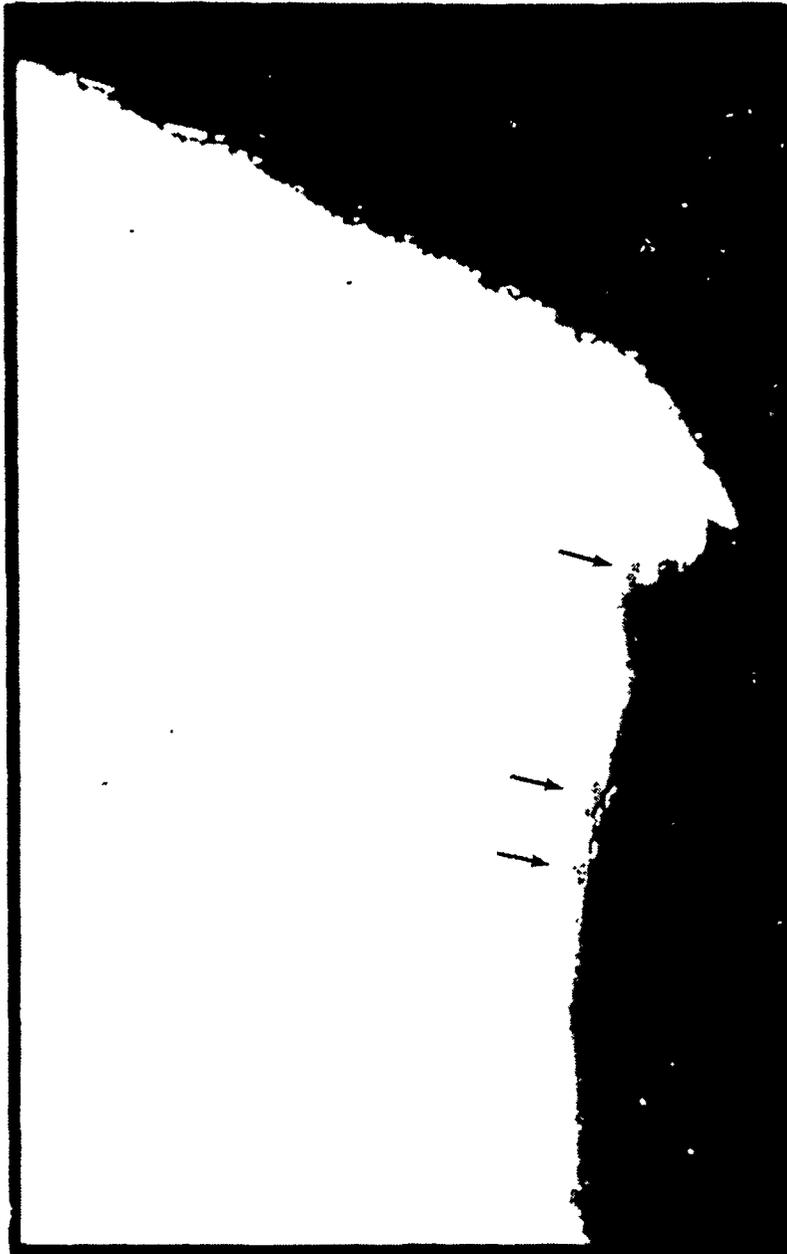
Figure 18. Cross section of crack origin taken through fracture Face B, in the as-polished condition. Mag. 50X.

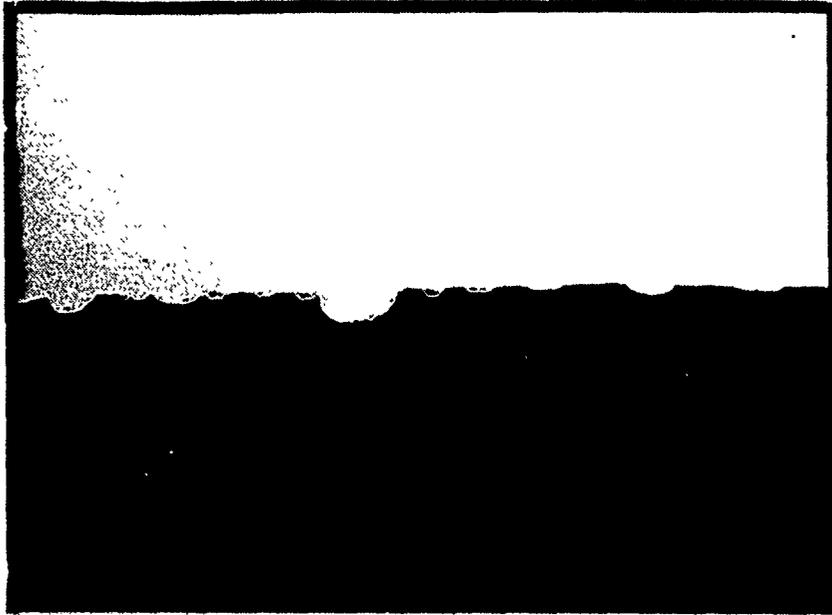
Figure 23 shows the pitted metallographic specimen in the as-polished condition. The large pit located in the center of the photograph has been magnified in Figure 24. The pit depth was approximately 18 mils. Figure 25 shows the same pit after the specimen was etched in a 1% Nital solution. Note the banding which extends horizontally across the photograph.

Figure 23. Shows pitted cross section, refer to Figure 15A for location. Mag. 10X.

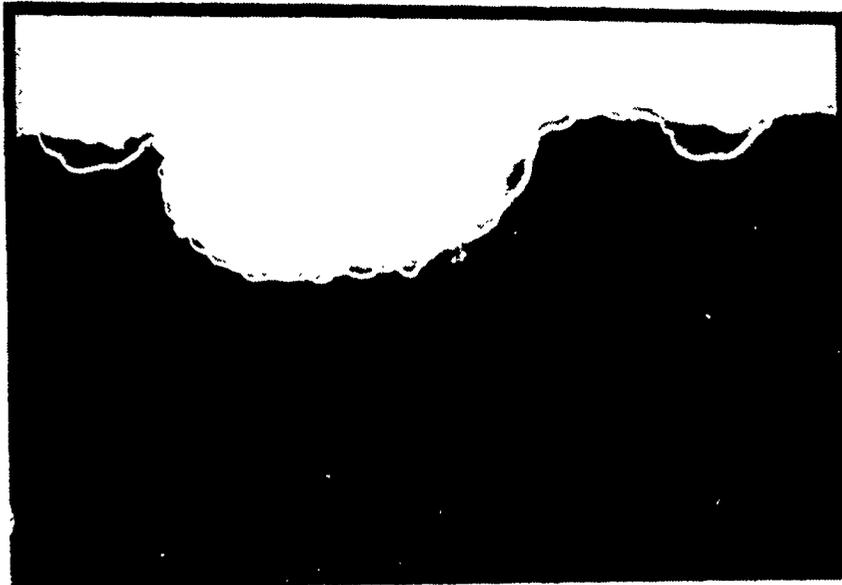
Figure 24. Shows large pit as seen in center of Figure 23. (Pit depth ~ 18 mils). Mag. 50X.

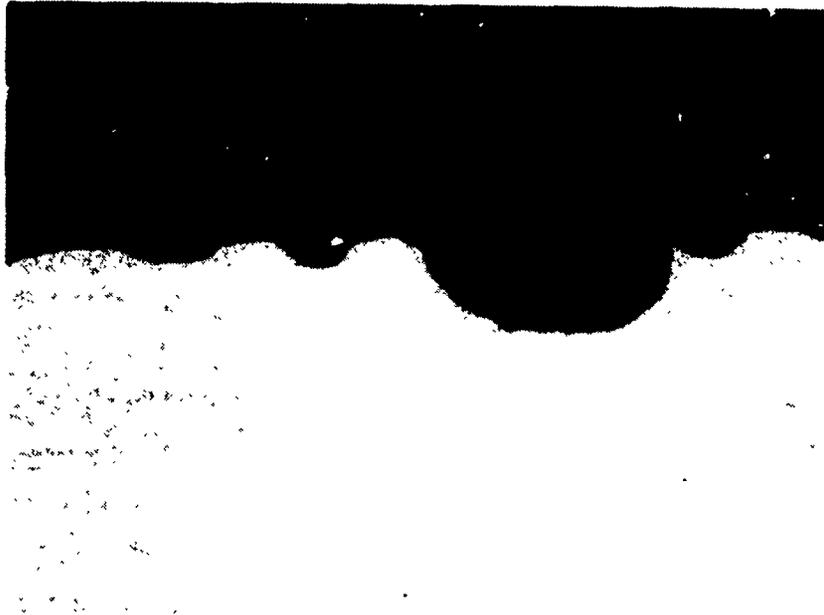
Figure 25. Shows pitted cross section after etching.
Note evidence of banding. Mag. 25X.

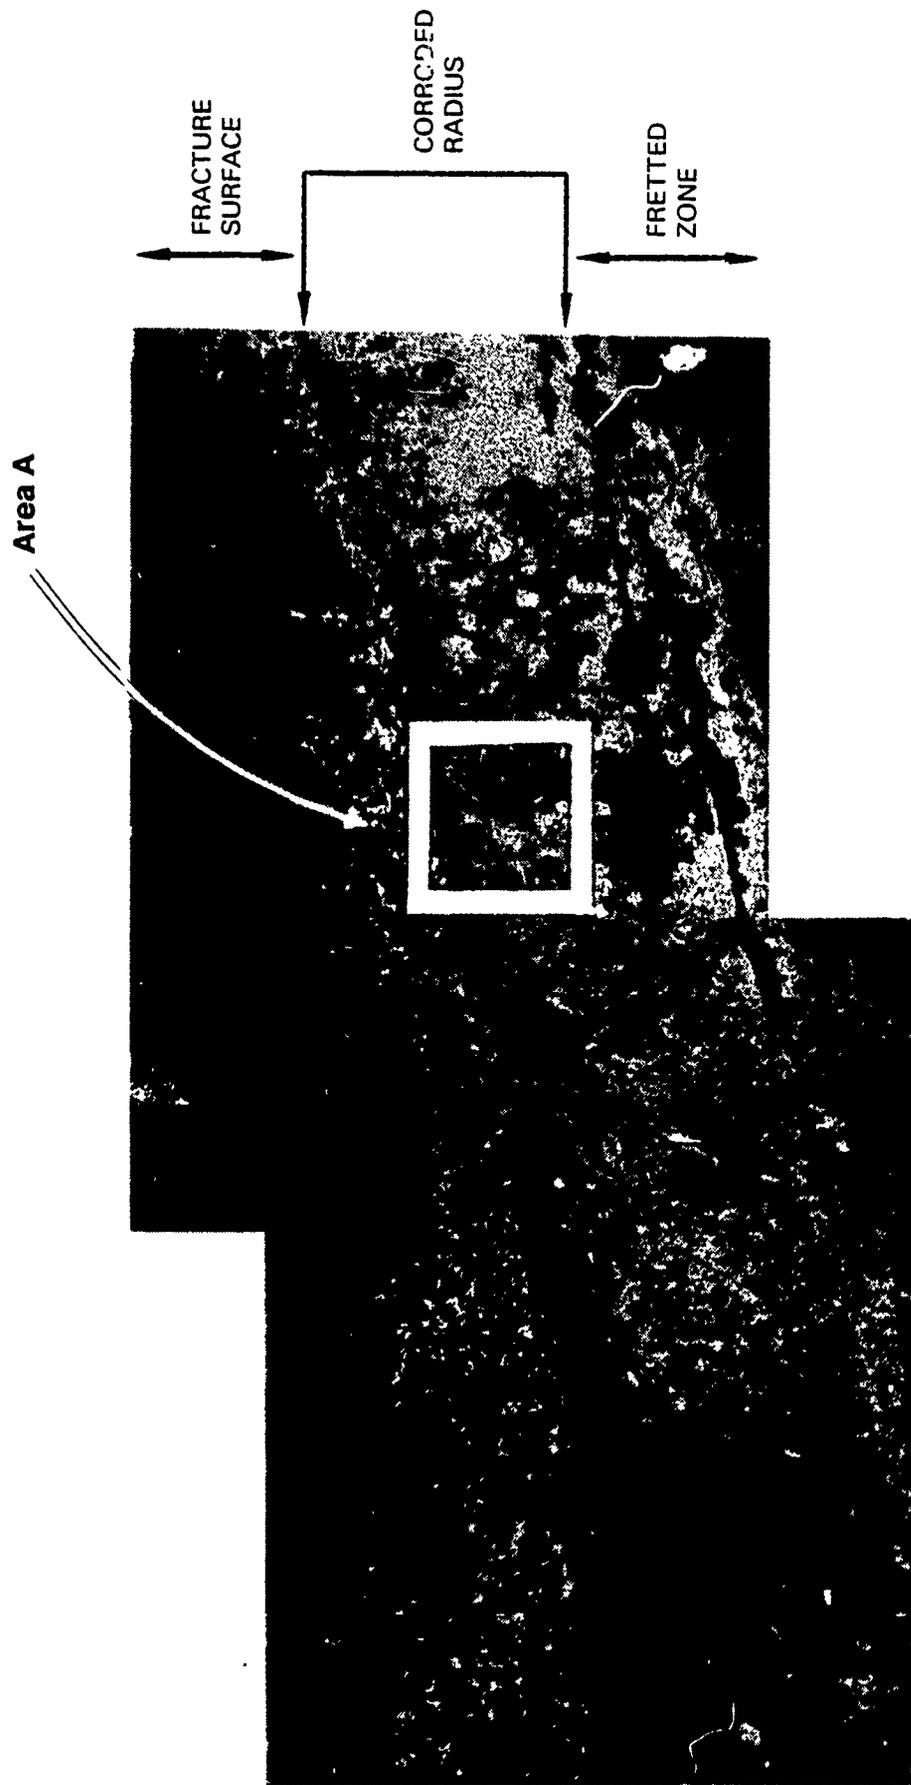
The fracture surfaces of the component were examined utilizing the SEM. Figure 29 is an SEM photograph of the crack initiation area located on fracture Face A. The fracture surface and corroded radius have been identified in the photograph. Extensive corrosion pitting was found along the edge identified as the crack origin, but as Figures 30 and 31 show, the exact point of crack initiation was difficult to resolve because of mechanical damage. Figures 30 and 31 represent area A of Figure 29. Note the smeared edges, as defined by the pairs of arrows in the SEM photograph, and the deep corrosion pits. Some of the pits were found to contain cracks, as revealed in Figure 32. Figure 33 was taken for comparative purposes and shows an area containing part of the fracture surface and the radius, where no corrosion was observed. A significant contrast in the condition of the surface finish of the radius can be seen when Figure 33 is placed alongside Figures 30 and 31. Corrosion did not occur at the radius viewed in Figure 33 because the protective cadmium plating was still intact. Figure 34 shows an SEM micrograph of the cadmium plating and the resulting energy dispersing spectroscopy (EDS) spectra obtained when the coating was analyzed. The major peaks of the EDS spectra were as anticipated. Cadmium was detected, representing the cadmium topcoat, and chromium was detected, most likely due to a final sealing procedure performed subsequent to the coating operation. A trace of silicon was also found and may be attributed to a number of various factors, including but not limited to surface greases, oils, or sand. Figure 35 shows an SEM micrograph taken within a pit and the chemical constituents in the region. The iron represents the base metal while cadmium represents the plating. Oxygen was also detected and is associated with an iron-oxide (corrosion product) or sand (SiO_2). A trace of calcium was found and could be representative of surface contamination due to handling. Silicon was detected in larger quantities. Close examination of surface particles revealed the presence of sand on fracture surfaces and within pits, as shown in Figure 36.

Figure 29. SEM of crack origin of fracture Face A. Mag. 13X.

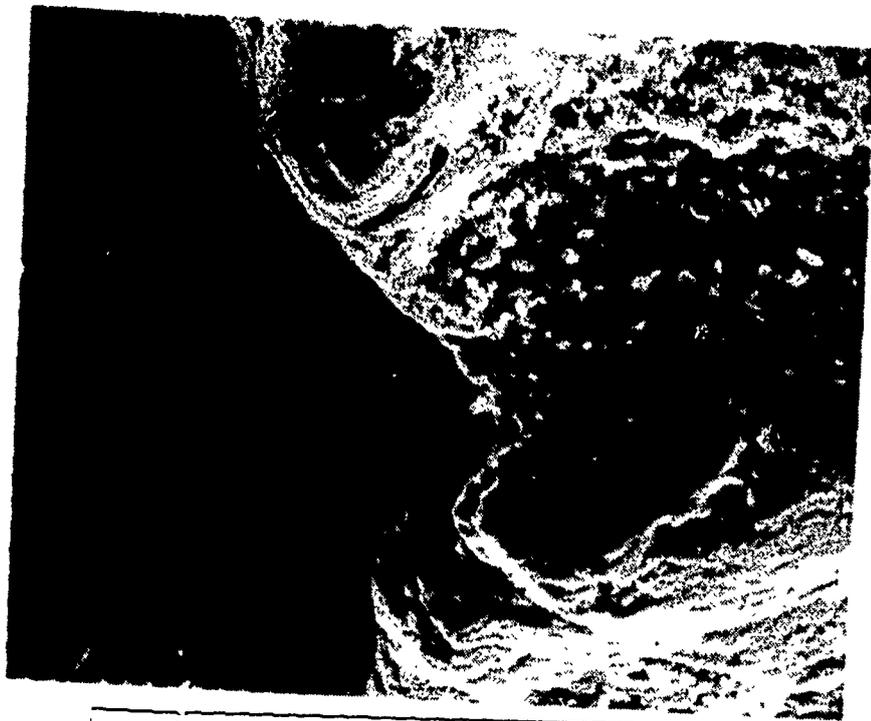
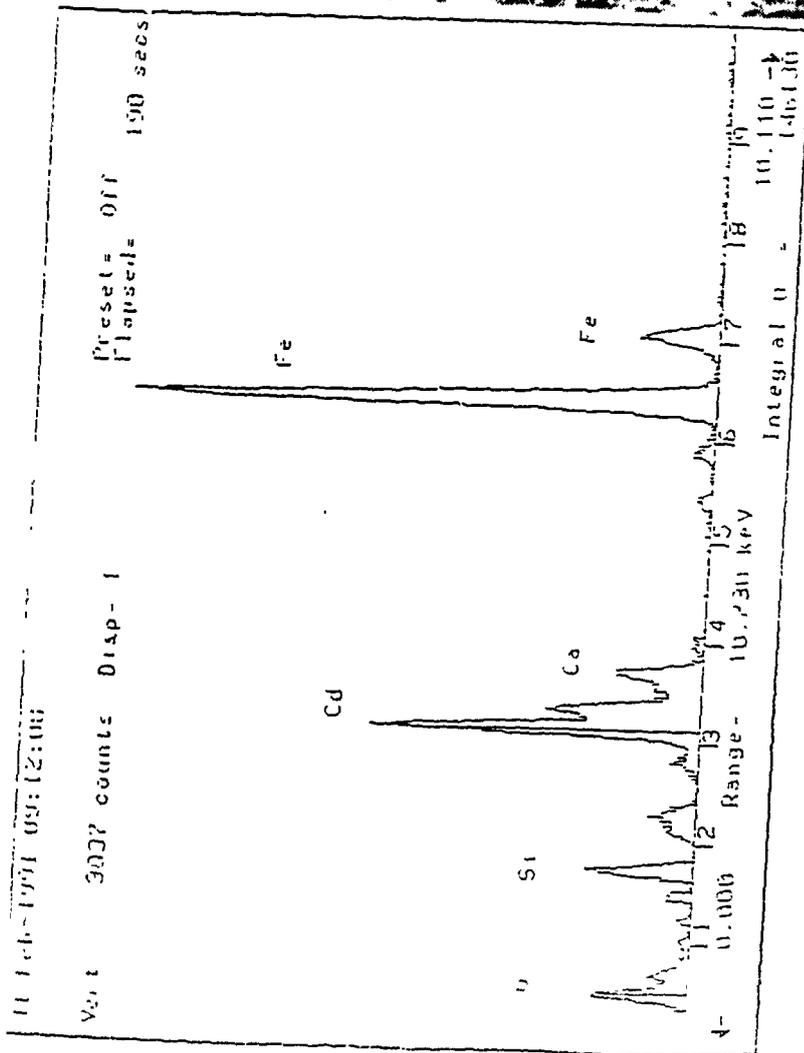
Figure 35. EDS spectra revealing chemical constituents within a pit.

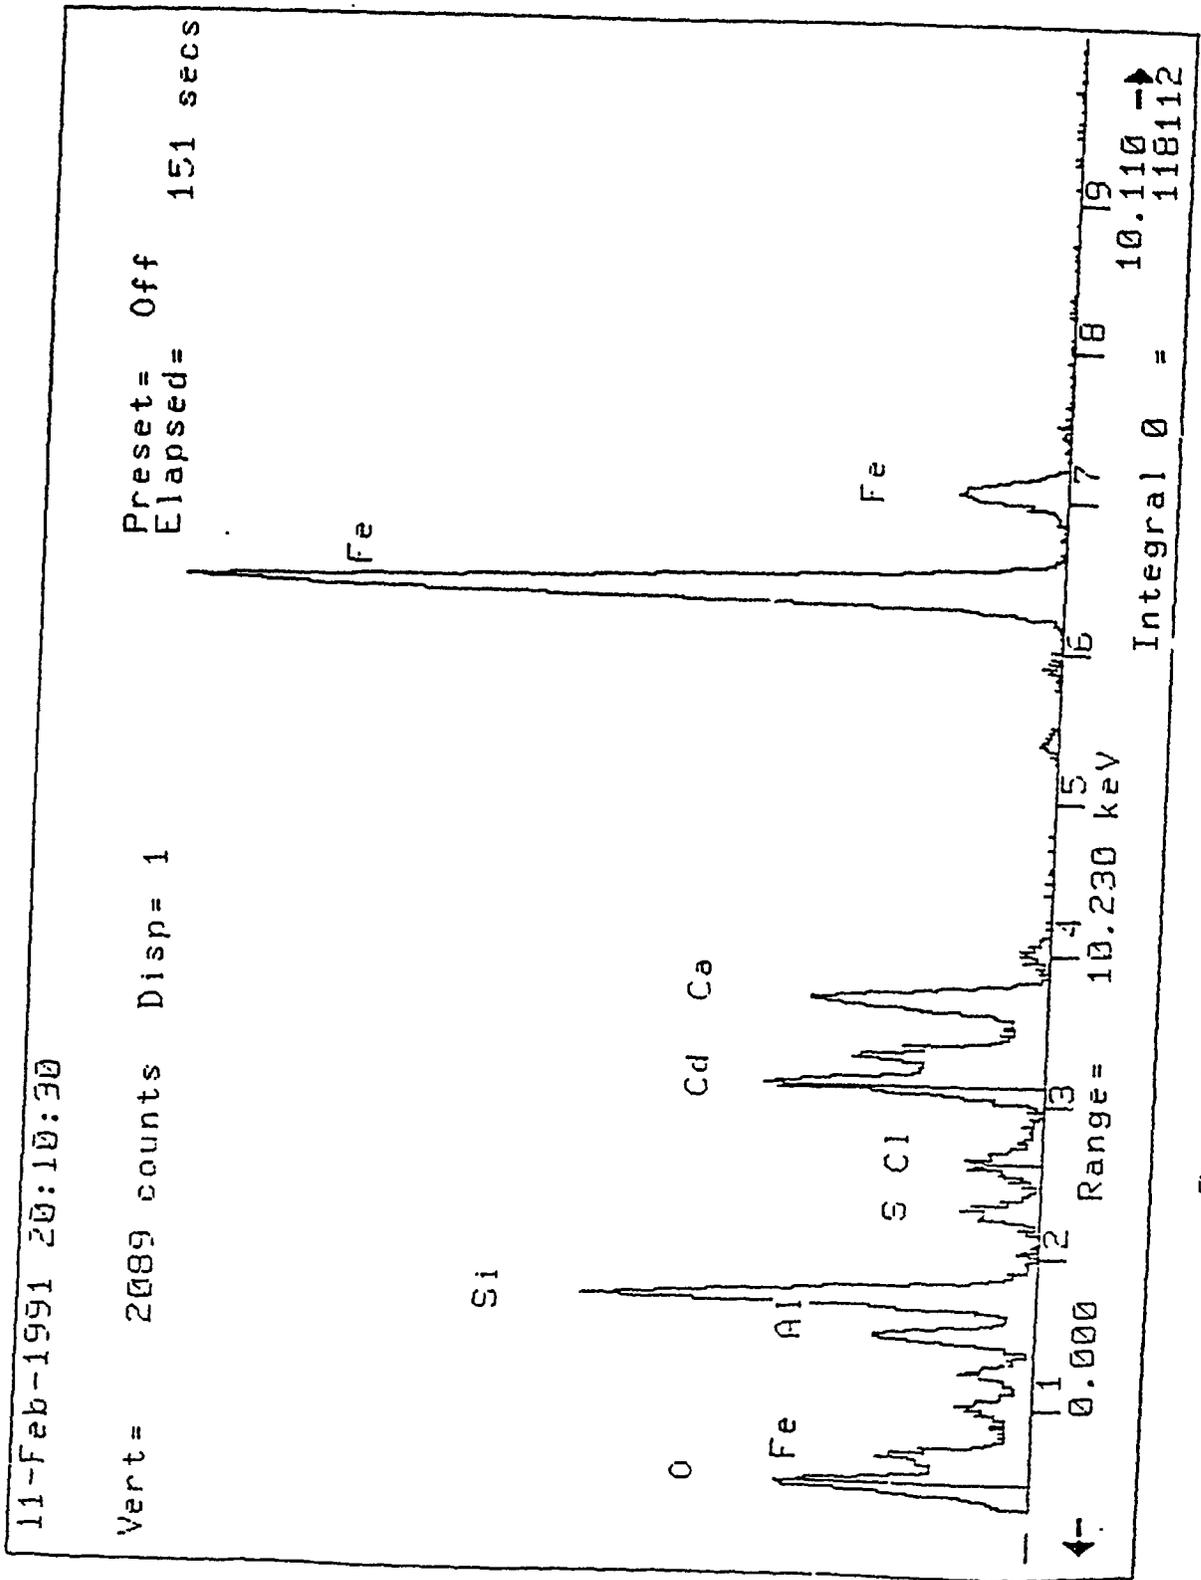
Figure 37. EDS spectra from within a pit adjacent to fracture.
