DOT/FAA/RD-90/17

Analysis of Rotorwash Effects in Helicopter Mishaps

May 1991

Final Report

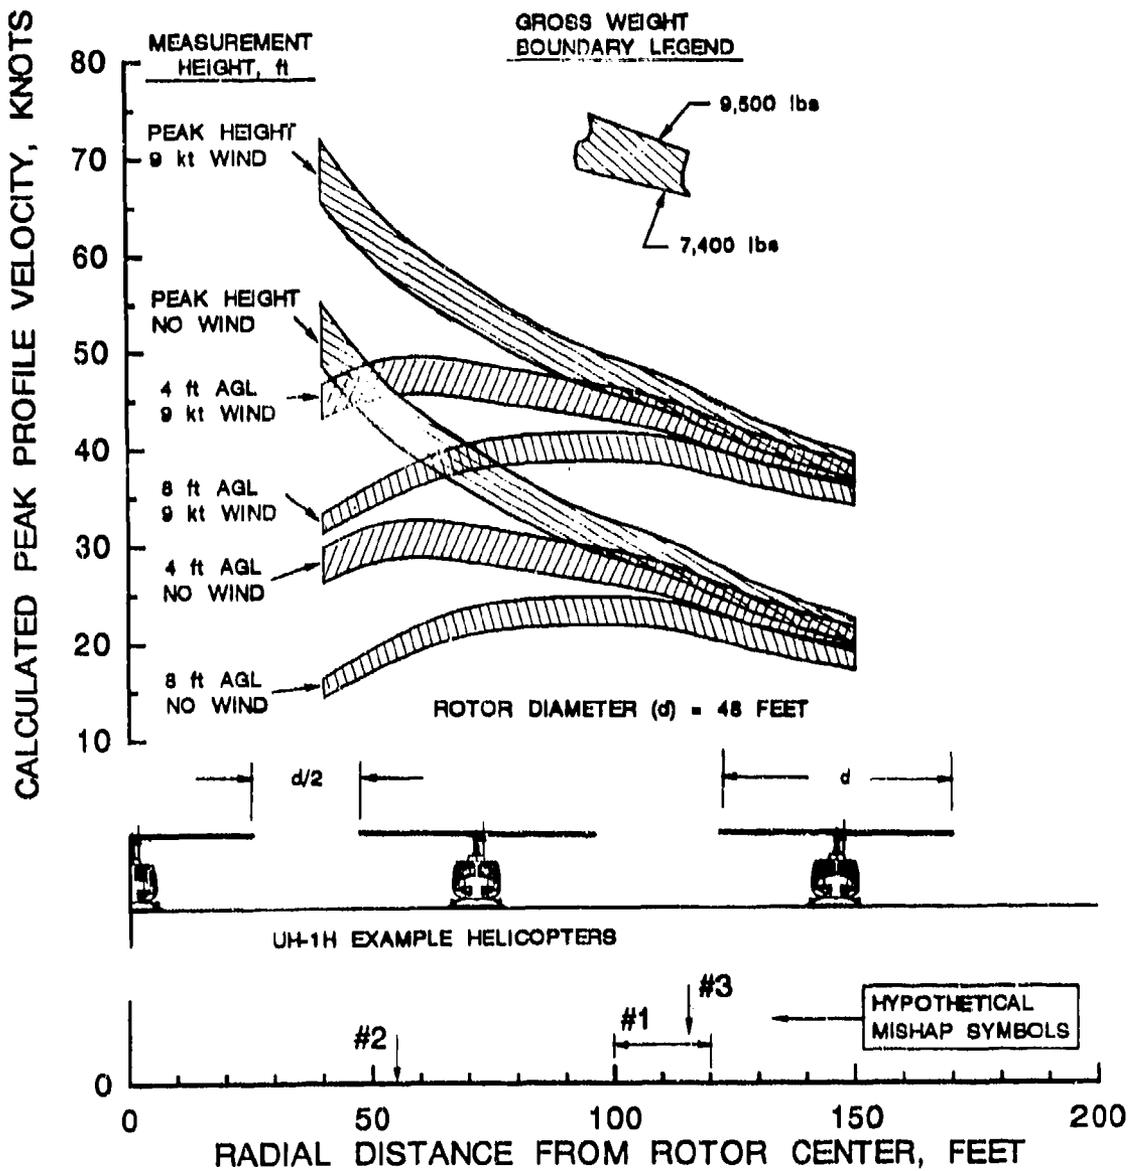
profile where the maximum peak velocity occurs (which increases in value as distance from the rotor increases). When plotted for both wind conditions and gross weights, these data form six bands of plotted results. The upper and lower range of values along each band are for the maximum and mid gross weight configurations respectively. Below the plotted data are several pictures of small UH-1H helicopters. These helicopters are positioned along the independent axis so that the rotor tips are spaced one-half of a rotor diameter apart when the rotor blades are indexed perpendicular to the fuselage centerline. These pictures provide visual information on spacing requirements when several helicopters operate in close proximity to one another. Position data derived from the mishap summaries are then marked along the independent axis at estimated positions where damage is reported to have occurred. While some mishaps may be marked at a specific location, the majority of mishaps are assumed to occur within some range, i.e., 100 to 120 feet, as shown for the hypothetical mishap #1 in figure 2.

FIGURE 2 BELL UH-1H PREDICTION CHART FOR DOOR/ACCESS PANEL AND ROTOR BLADE/TAILBOOM STRIKE MISHAPS

The distance at which the critical velocity profile characteristics are exceeded for the mishap involving the UH-1H and the automobile is determined from figure 2. If the peak hover velocity curve for a 0 knot wind is reviewed, the 47 knot threshold is not exceeded unless the oil drum is less than 42 feet away. This result would be expected, since the probability of a no wind condition is small. Along the 9 knot wind curve, the peak velocity is exceeded at distances less than approximately 90 to 100 feet. This result would indicate that the ambient wind occurring during the mishap was probably less than 5 knots. Unfortunately, the actual wind was not recorded. It would also be presumptuous to assume that this analysis approach is so exact as to be capable of predicting the actual wind condition. However, when one considers the large number of

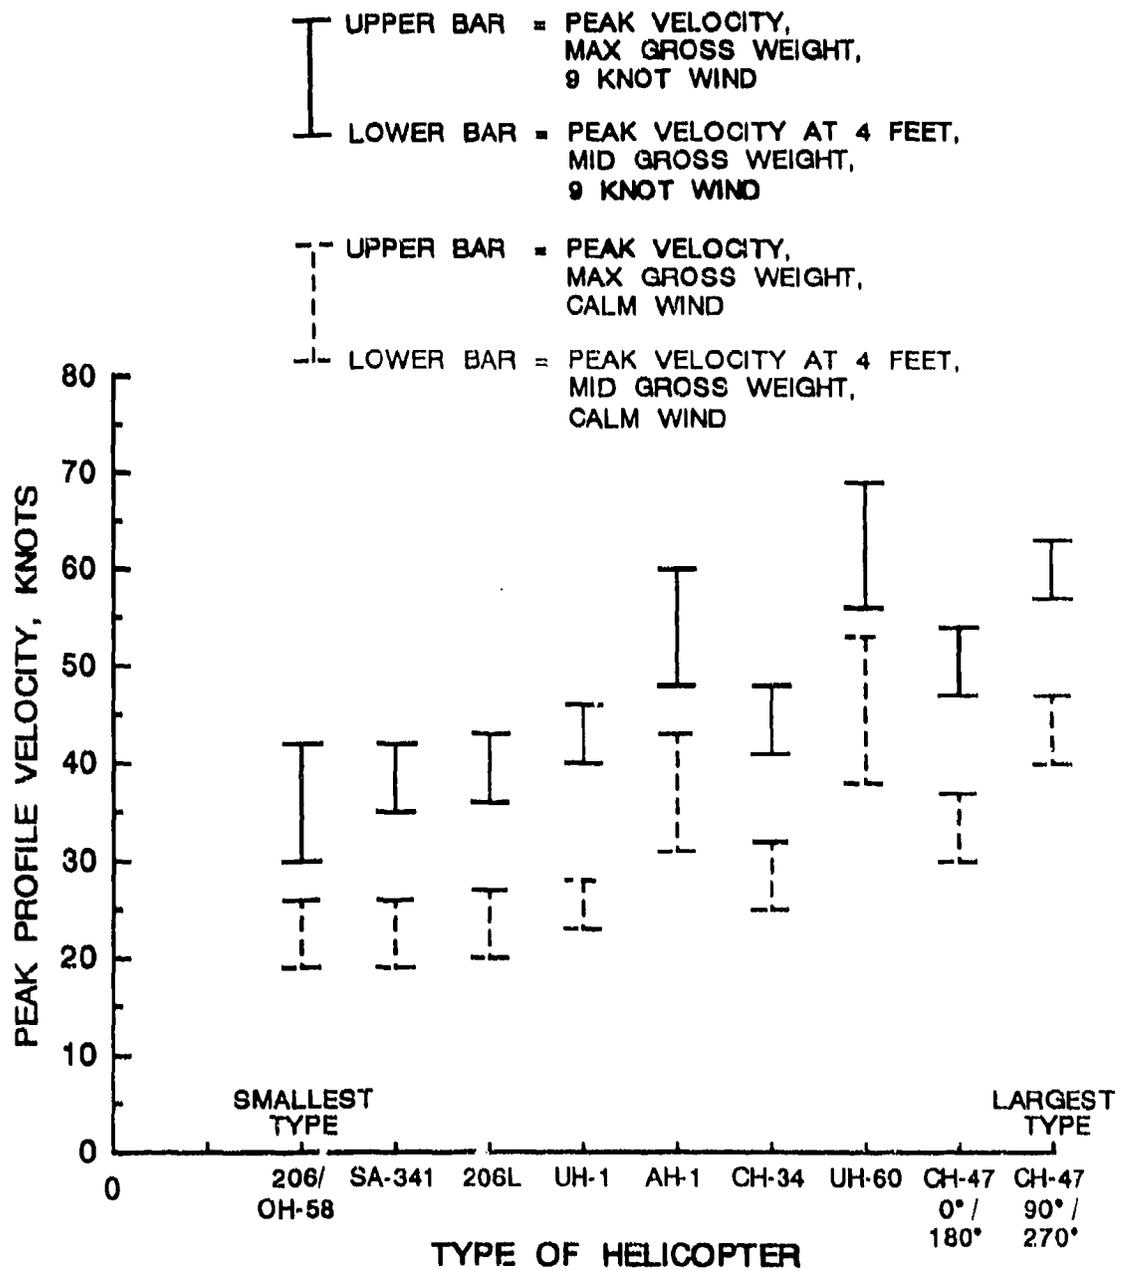
The top bar for each range of velocity values presented in figure 4 represents the estimated maximum peak profile velocity for the maximum gross weight. This maximum peak velocity varies in height above the ground as a function of position with respect to the center of the rotor. The lower bar represents the peak velocity estimated for the mid gross weight at a constant 4 foot height above ground level. The 4 foot height is in close proximity to the height above ground of most rotorcraft doors. One generally accepted approach for merging the available data and estimating one

FIGURE 4 ESTIMATED THRESHOLD ROTORWASH VELOCITY RANGES FOR THE MISHAPS INVOLVING DOOR AND COWLING DAMAGE TO HELICOPTERS

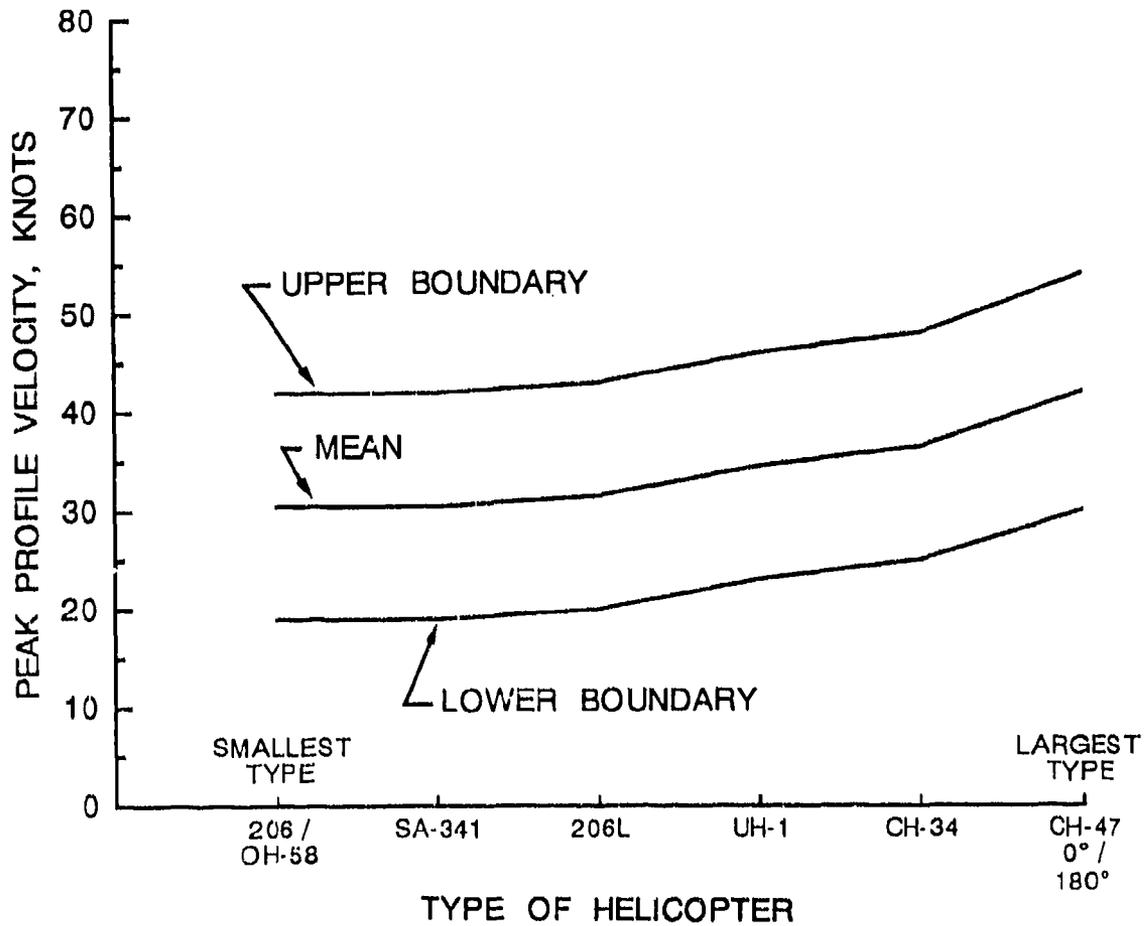
One can assume in analyzing the figure 7 data that the probability of the threshold rotorwash value being near the lower boundary (mid gross weight, 4 foot height, 0 knot wind) is small because the wind is rarely calm. Also, the use of this boundary would result in the specification of large separation distances in the presence of ambient winds. These large separation distances would be highly restrictive to what presently appear to be very safe heliport operations. Likewise, the upper boundary (heavy gross weight, 9 knot wind) would appear not restrictive enough. This is because separation boundaries would be based on a large value of threshold velocity, the most liberal interpretation of available mishap data. Also, no proof exists that even the majority of the reported mishaps occurred in 9 knot crosswind conditions. Therefore, although based on data influenced by several key assumptions, a logical deduction is that the threshold rotorwash velocity

FIGURE 7 ESTIMATED THRESHOLD ROTORWASH VELOCITY MEAN VALUES AND RANGES USED IN THE FINAL ANALYSIS OF MISHAPS INVOLVING DOOR AND COWLING DAMAGE

value is between the lowest estimated mean value, approximately 30 knots, and the lowest estimated upper boundary value, approximately 40 knots.

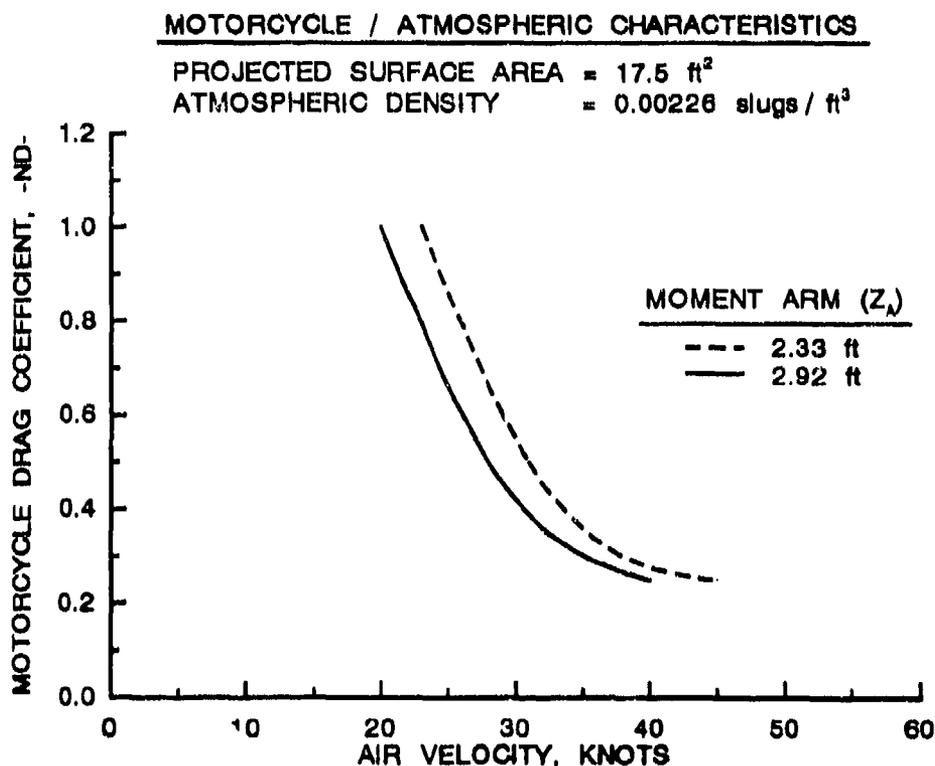
FIGURE 16 ESTIMATED THRESHOLD OVERTURNING VELOCITIES FOR A MOTORCYCLE AS A FUNCTION OF DRAG COEFFICIENT AND APPLIED MOMENT ARM LENGTH

If the drag coefficient in figure 16 is assumed to be that for a solid flat plate, approximately 1.0, then the critical velocity is predicted to be between 20 and 23 knots, depending on which moment arm is selected. At the other extreme, a drag coefficient of 0.25, the predicted critical velocity is 40 to 45 knots. The critical velocities for a drag coefficient of 0.5, probably the most realistic value, vary from 28 to 31 knots. One must keep in mind that the applied velocity in this case is a uniform velocity over the whole projected surface area.

The reported separation distance in the second accident, which involved the Harley-Davidson, was 70 to 75 feet. The critical overturning velocity for a drag coefficient of 0.5 (28 to 31 knots) is just slightly exceeded by the calculated S-76 peak velocities for a 0 knot wind condition (32 to 38 knots). With the wind at 9 knots, the estimated S-76 velocities (48 to 54 knots) just slightly exceed the critical values required for the lowest evaluated drag coefficient (40 to 45 knots). Even though correlation is much improved for this mishap, the conclusions discussed in the previous paragraph are equally applicable to this particular scenario.
