NAVSWC TR 91-492

NONDESTRUCTIVE EVALUATION OF A GRAPHITE ALUMINUM COMPOSITE SPACE RADIATOR PANEL

BY NEIL M. FELDMAN AND JOHN V. FOLTZ

DECEMBER 1991

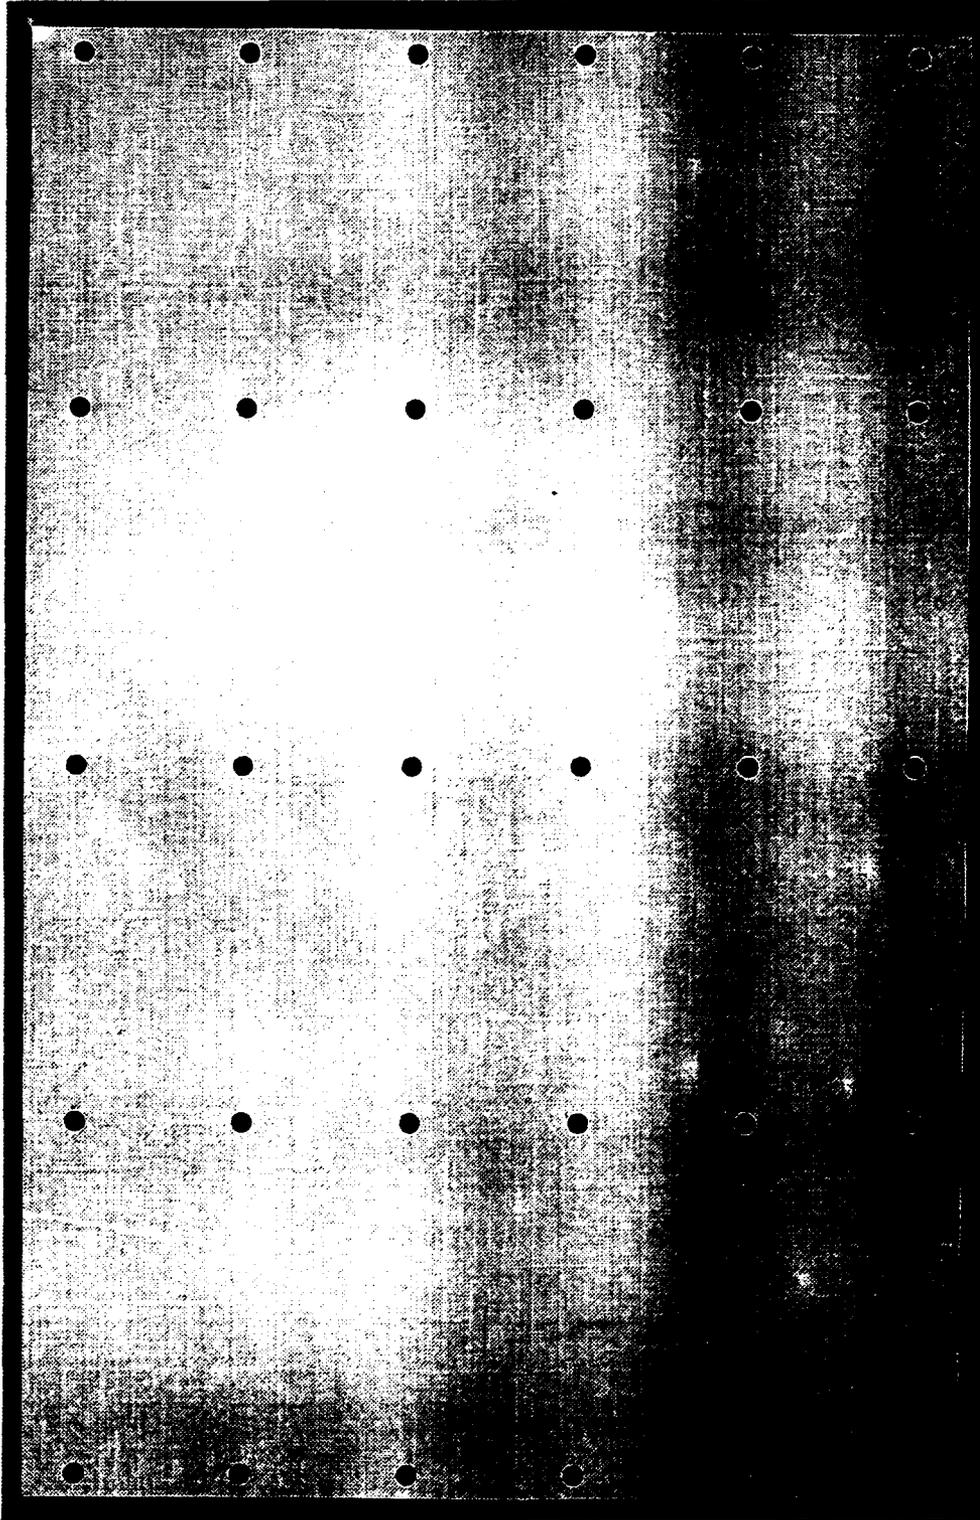
Figure 14. White dots are exhibited all over the panel which can be attributed to two phenomena. The first would be that the nickel-plating process produced a very rough surface leaving small bead-type bumps on the surface of the panel. The other case for the white areas on the film is that the microdimples or pores were nickel-plated over, giving a very thin layer of nickel over the pore. The pores are filled with nickel, and since nickel has significantly higher absorption than aluminum and graphite, the nickel indications on the radiograph can be seen easily. Around the machined holes are prominent white bands which are attributed to a layer of pure nickel on the inside diameter of the drill holes (Figure 14). The nickel bands on the radiograph are an excellent method of checking the uniformity of the thickness of the nickel-plating process.

FIGURE 14. RADIOGRAPH OF COMPOSITE AFTER NICKEL PLATING

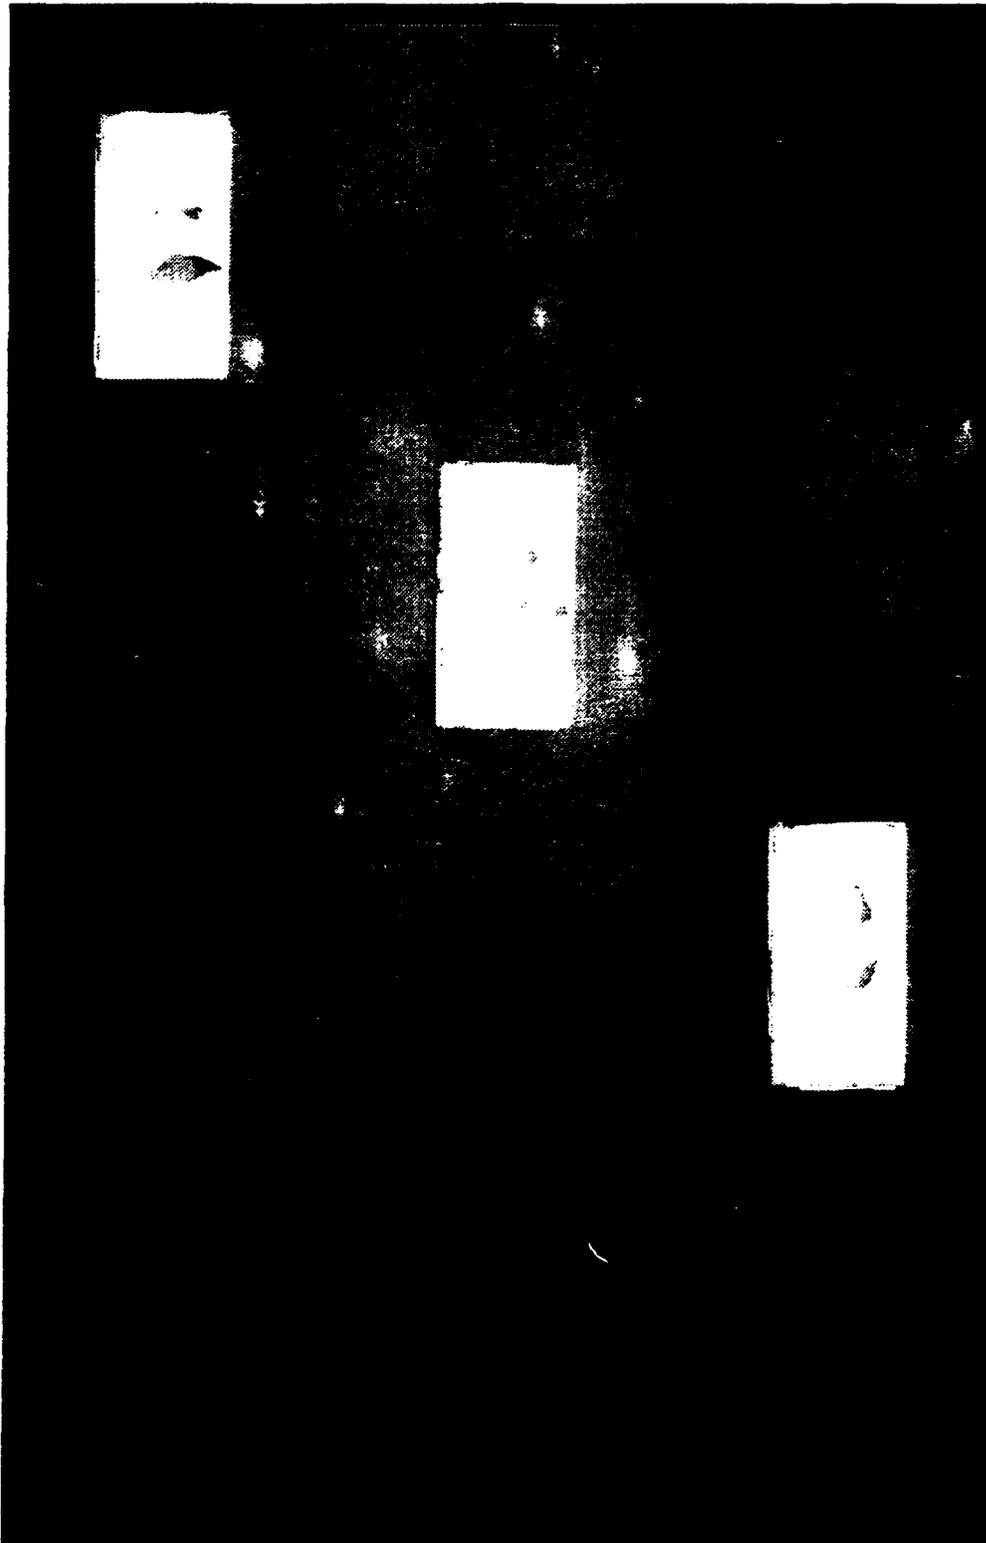
The radiograph in Figure 15, taken of the composite after the qualification tests, showed no change in the composite in comparison to the previous radiographs. Three mirrors glued to the composite appear very clear in the radiograph. The epoxy, which is the dark area shaped like a distorted square under each mirror, shows up on the radiograph in Figure 16. The black areas are areas of porosity within the epoxy.

FIGURE 15. RADIOGRAPH OF COMPOSITE AFTER QUALIFICATION TEST

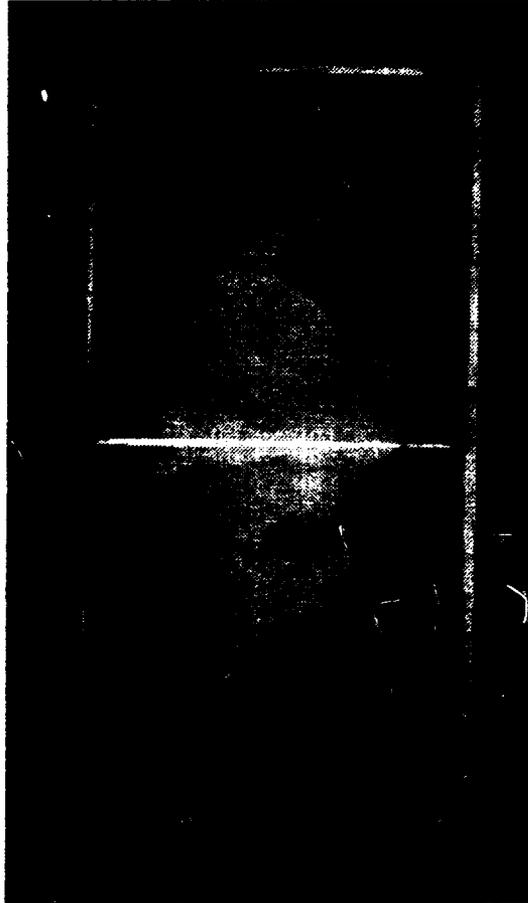
FIGURE 16. RADIOGRAPH OF THERMAL CONTROL MIRRORS

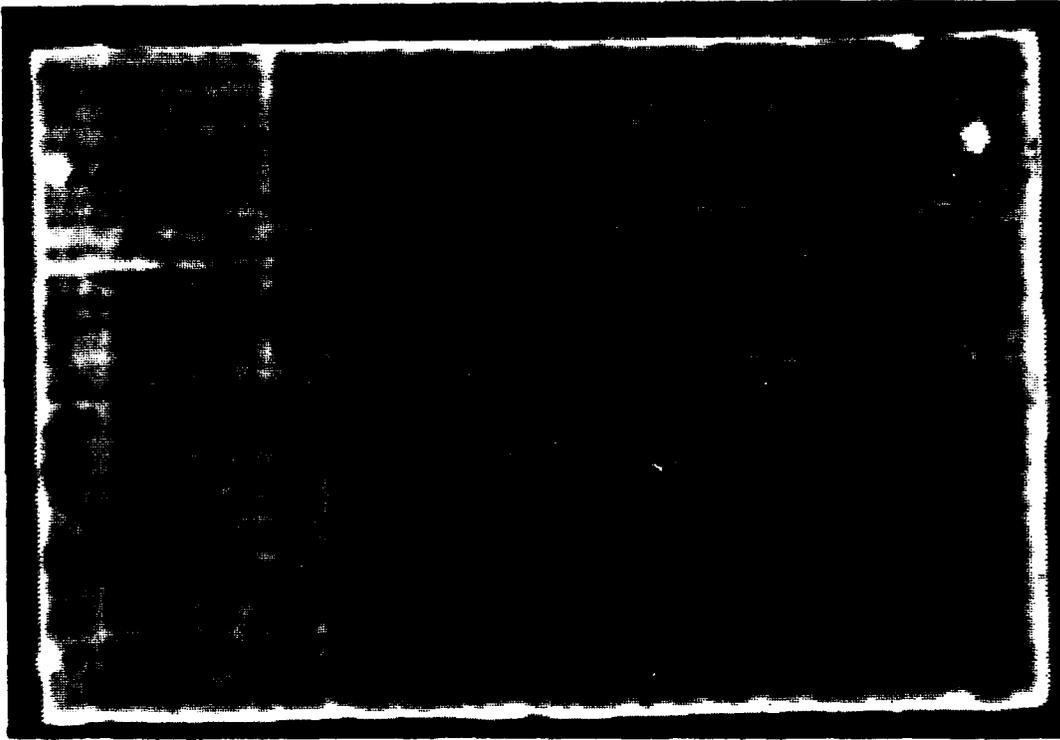
FIGURE 19. GREY SCALE C-SCAN OF PANEL AFTER FABRICATION

FIGURE 20. COLOR SCALE C-SCAN OF PANEL AFTER FABRICATION

The C-scan in Figures 19 and 20 has some irregularities within the panel. The 0° and 90° fiber directions can be seen in the C-scans. There is approximately a 3 to 4.5 dB attenuation difference in signals between some of the regions within the panel. On the left side of the panel there are areas exhibiting approximately 8.5 dB additional attenuation. Visual inspection of the panel edges, on this side revealed delaminations. In Figure 20 starting from the upper left side of the panel is a white spike which appears to be a delamination evaluated

from the ultrasound data and visual inspection. This area is where the entire signal is attenuated approximately 19 dB. In Figures 21 and 22, the holes can be seen in the C-scan after the panel has been machined. The holes are white because of the RTV adhesive attenuating the ultrasound signal. The panel for Figures 21 through 25 is rotated 180° around the 0° axis changing the orientation of the C-scans, but leaving the ultrasound parameters unchanged. This change in orientation occurred because the reference number on the panel was cleaned during the machining process, and Ni plated over. In Figure 22 the delaminations in the left region of the panel appeared to be reduced in severity in the C-scan. But, the delamination in the left side of the panel is unchanged in its signal attenuation. The center and right region of the panel is more homogenous in signal strength, areas of anomalies seem to have lessened in severity. The reasons for this phenomenon will be represented in the discussion. From the C-scan the panel appears to be in good structural shape.

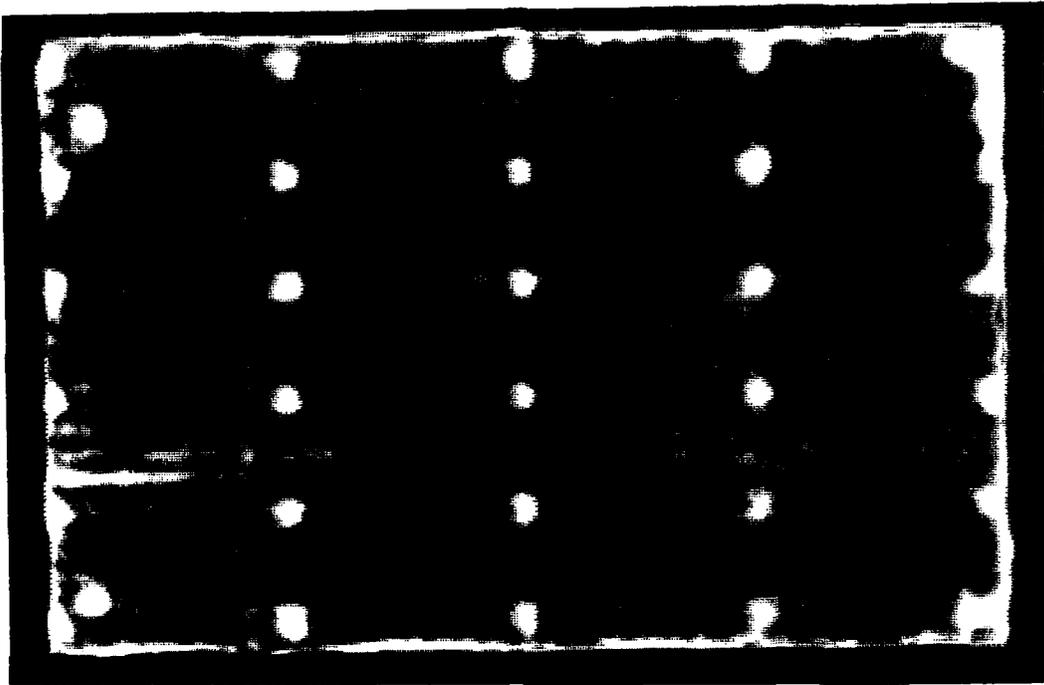
FIGURE 21. GREY SCALE C-SCAN OF PANEL AFTER HOLES WERE MACHINED

FIGURE 22. COLOR SCALE C-SCAN OF PANEL AFTER HOLES WERE MACHINED

The composite panel's soundness appeared to improve in the subsequent C-scans after the holes were machined. A hypothesis is that this phenomena is attributed to the panel's physical layup properties during fabrication. When the composite is fabricated a residual stress is created by the aluminum shrinking and the graphite fiber tending to remain in its original form during the cool down process. The graphite fibers are under compression while the aluminum is under tension. When the holes are machined there is a relaxation of the membrane stresses in both materials created by the free surface around the holes and decreasing with distance from the free surface. If there is a delamination within the composite the delamination could lead to a bending moment between layers. When some of the compression is released by the drill holes the relaxation allows the delamination to close.

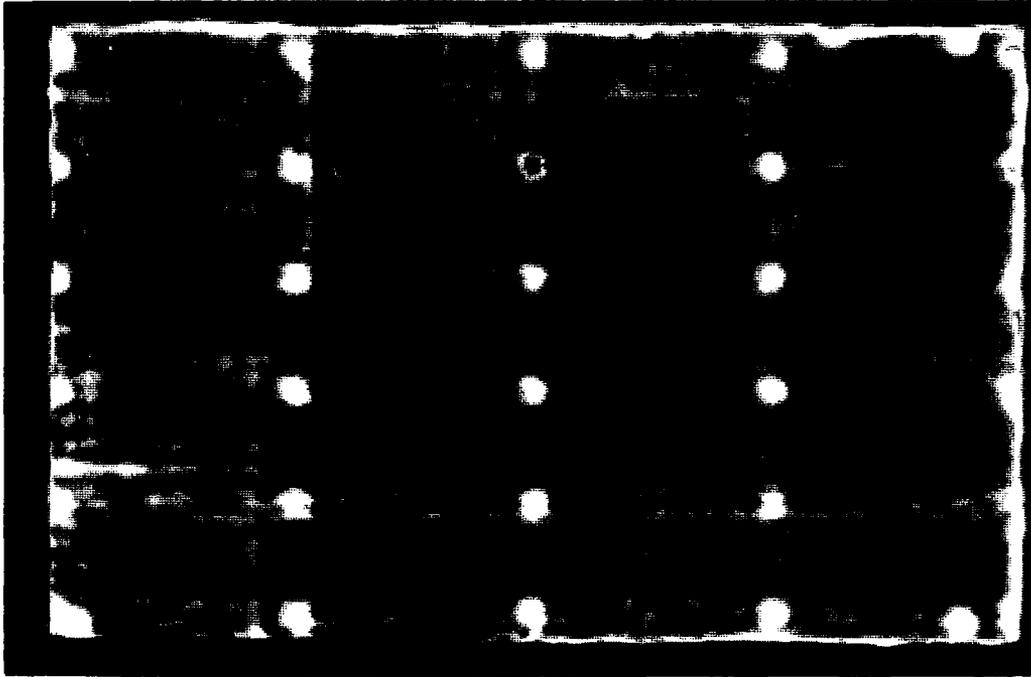
FIGURE 23. GREY SCALE C-SCAN OF PANEL AFTER NICKEL PLATING

FIGURE 24. COLOR SCALE C-SCAN OF PANEL AFTER NICKEL PLATING

The C-scans in Figures 23 and 24 were conducted after the panel went through the process of being nickel plated. The panel appeared to be unchanged from the nickel-plating process.
