MTL TR 92-26

# LAV ARMOR PLATE STUDY

MARTIN G. H. WELLS, REBECCA K. WEISS, and  
JONATHAN S. MONTGOMERY  
METALS RESEARCH BRANCH

April 1992

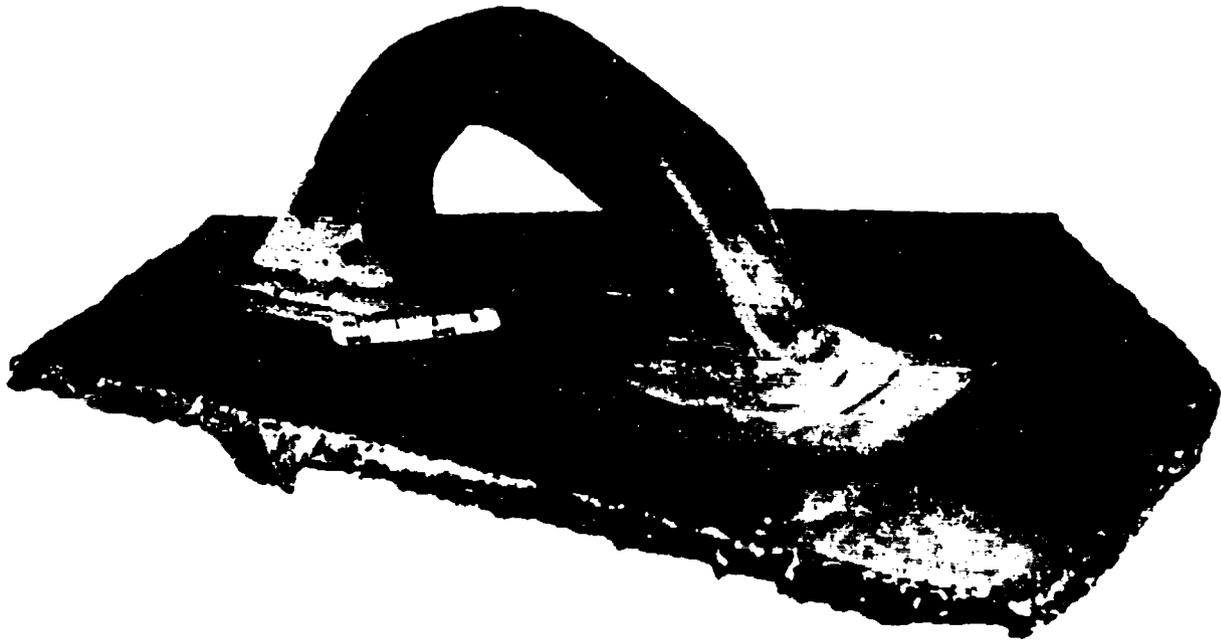
The eyes, about 1" x 1-1/4" in cross section, are welded to the vehicle side panels (7.31 mm thickness). A view of one of the eyes is shown in Figure 1a, and a cross section of the weld in Figure 1b. The three-pass weld can clearly be seen; it consists of an initial root pass followed by a second pass along the high hard armor plate, and finally a third pass against the eye.

Figure 1. (a) Lift-eye, and (b) Weld cross section of DDGM test specimen no. 2.

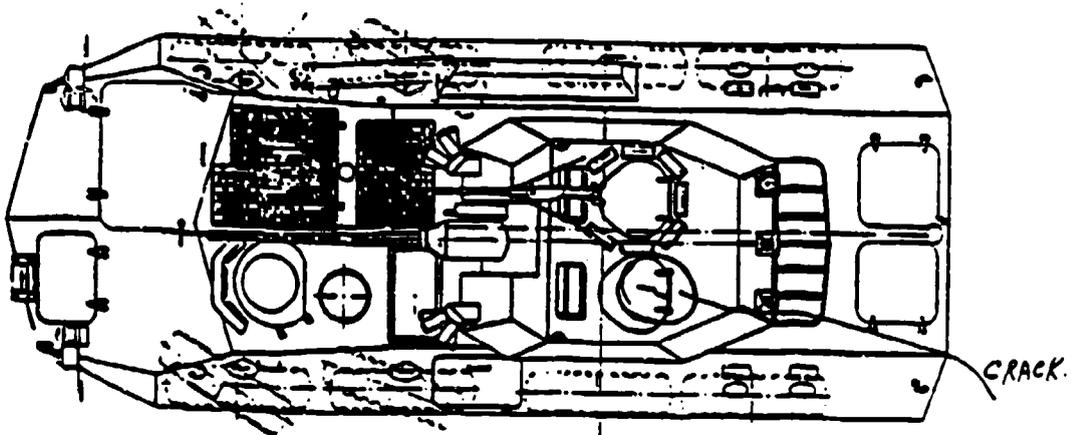
A cracked turret hatch cover from a vehicle Model Number 25MC,DDGM S/N LAV 612, USMC S/N 521765 was received for evaluation. A copy of the field service report of the crack in this hatch is given in Figure 6. The crack length when the hatch was replaced on 15 July 1987 was 8 inches.<sup>4</sup> The crack has since grown to over 12 inches and may be seen starting at the weld at the rim and travelling into the center (see Figure 7a). During cut-out of the crack origin region, binding of the saw occurred and it was evident that considerable residual stress was being relieved. A macrograph of the rim weld and micrograph of the structure of the weld region are shown in Figures 7b and 7c, respectively. Again, there is a layer of martensite next to the weld metal. Typical microhardness traverses across a weld region are shown in Figure 8. This sample was taken from the weld between the right upper front quarter panel and the main front glacia from the LAV that was dropped at Camp LeJeune (now at MTL). As this is a two-pass weld, two traverses were performed: the first just below the front surface (first pass), and the second just below the back surface (second pass). Moving from the weld metal to the base plate, the wide variation in hardness is readily apparent. The weld nugget is quite soft; then, after the fusion zone, there is a layer of very hard fresh (as-quenched) martensite in the base metal heat-affected zone (HAZ) that resulted from re-austenization during welding. The base metal HAZ hardness then drops into the region that did not see a high enough temperature excursion to be re-austenitized and so instead became heavily tempered. Following that, the steel is progressively less tempered during the welding operation and the hardness rises asymptotically to that of the (unwelded) base plate.

- CRACK LENGTH 8.00 INCHES.
- START/STOP POINT Crack started at the
- COMMENTS back edge of hatch and moved to  
the center of the plate.  
-Hatch was replaced by DDGM.

Figure 6. Field service report for cracked hatch.

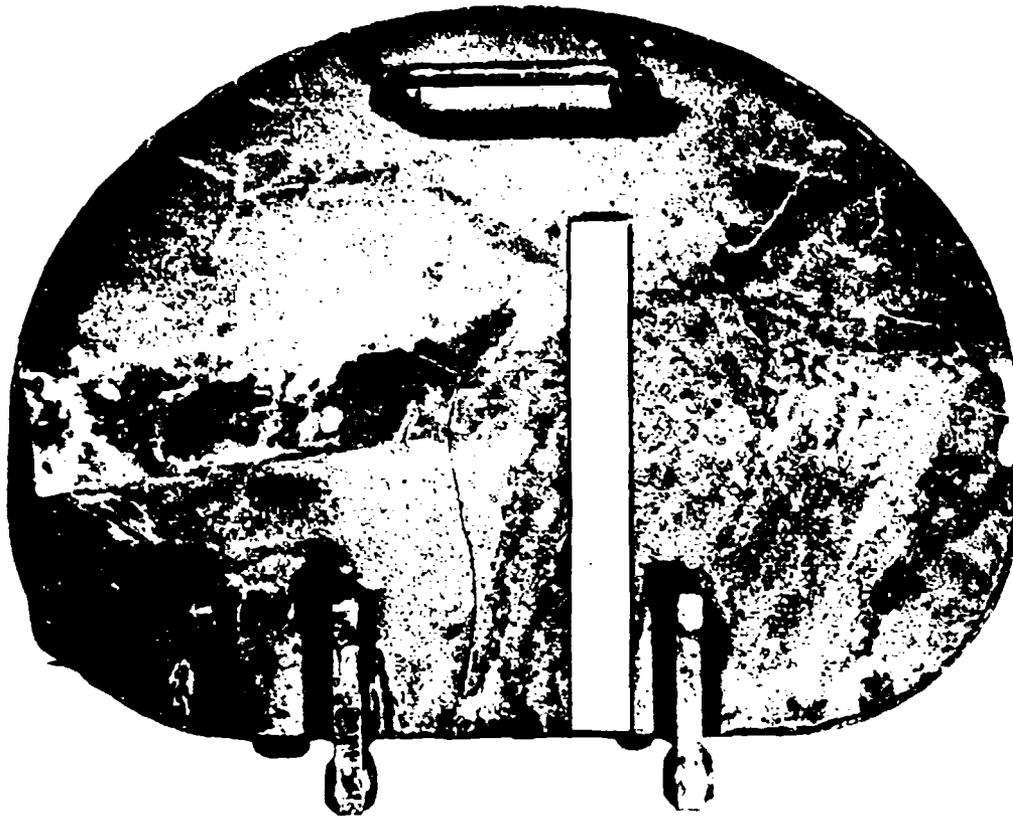
The cracking observed initiating from free-cut plate edges was often very similar to that observed in previous studies.<sup>5,6</sup> It was concluded that much of the cracking occurring in LAVs from free-cut plate edges may be attributed to environmentally-assisted cracking. For this mechanism to operate, the following conditions are necessary:

Figure 7 (a) Cracked turret hatch cover, (b) Macrograph of edge of cracked hatch cover, and (c) Optical micrograph of HAZ

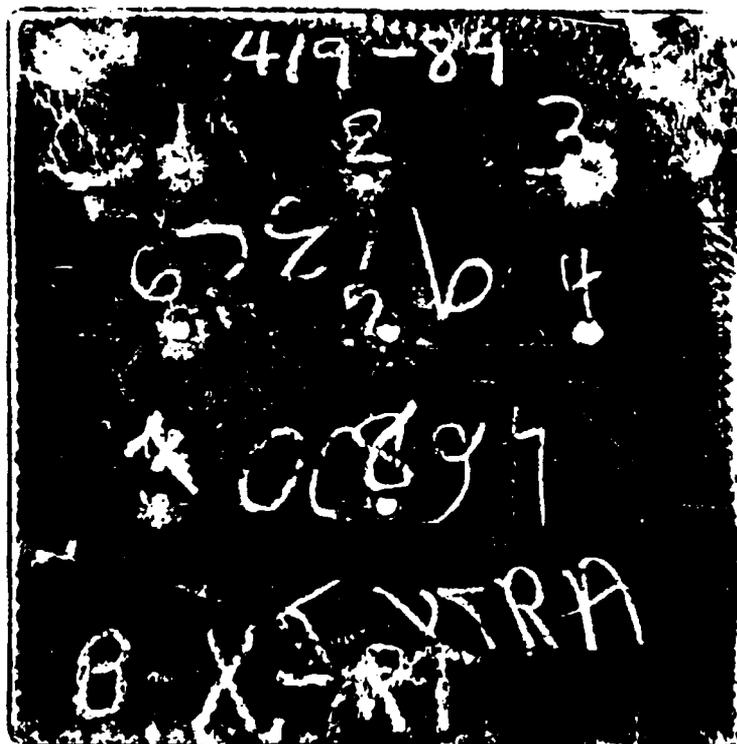
The  $V_{50}$  values are close to the velocities obtained from the handbook,<sup>7</sup> with some values slightly above and some slightly below the nominal. A typical tested plate is shown in Figure 10. The penetration mode is by plugging for those projectiles with velocities exceeding  $V_{50}$ . The ballistic limit increases slightly at colder temperatures. No cracking was observed and all  $V_{50}$  values are well above the muzzle velocity of an AK47 or similar rifle, i.e., 2380 ft/s. The  $V_{50}$  of the 7.31-mm XH plate was higher than that for the regular hardness plate of the same thickness. This is not surprising since many past studies have shown that ballistic penetration resistance of steel correlates most closely with hardness.<sup>8</sup> The 7.62-mm ball threat would not penetrate the 9.71-mm thick plate at the velocities attainable and, thus, no valid  $V_{50}$  could be determined.

Figure 10. Photograph of 7.31-mm XH plate after ballistic test against 7.62-mm M1943 ball at 0° Obliquity at room temperature, showing partial and full penetrations by plugging.

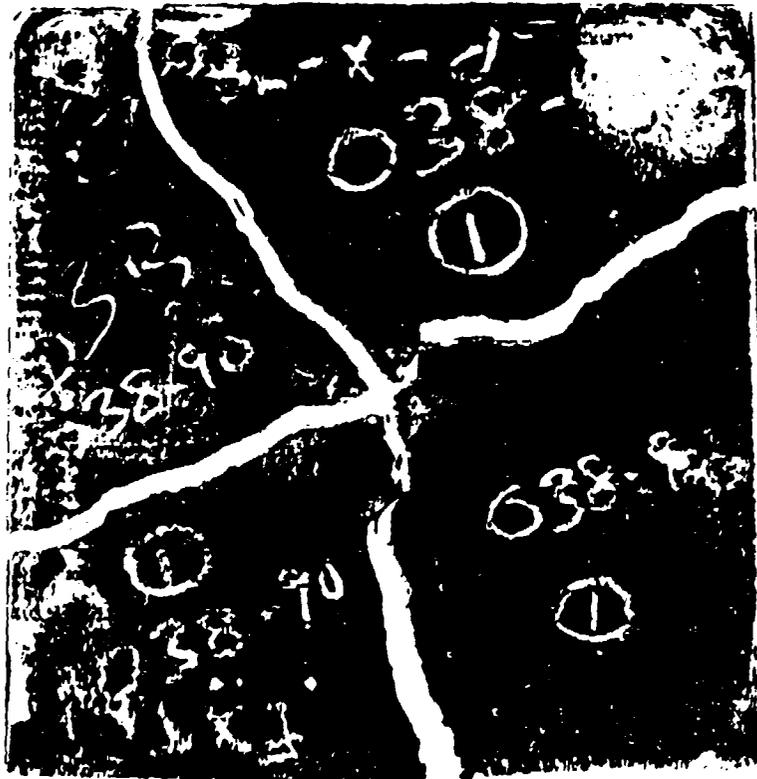
While  $V_{50}$  values were obtained, the primary purpose was to obtain a measure of cracking/shattering resistance. Shattering is defined where the plate is broken into two or more pieces, while cracked plates exhibit cracks emanating from or adjacent to the projectile impact point. Both of the plates with a hardness of 48 HRC, i.e., 6.31 mm and 9.71 mm, did not exhibit any cracking tendency when tested at either room temperature or -40°F. However, both the 7.31-mm plates (the so-called normal and XH materials with 50 HRC and 51 HRC, respectively) cracked under the 20-mm proof round impact at both room temperature (72°F) and at -40°F. Examples of cracked and shattered plates are shown in Figures 11a and 11b, respectively. Thus, in this case, ballistic behavior at room temperature is indicative of behavior at subzero temperatures, i.e., no drastic change occurs and, hence, room temperature testing can be used to indicate any cracking tendency. However, this may not be generally true for other armor plate, other thicknesses, other obliquities, or other projectiles.

Figure 11. Photograph of 7.31-mm plate after ballistic testing against 20-mm proof round at 0° Obliquity, showing plate cracking and plate shattering.

The ballistic study has shown that steel with higher hardness (and carbon content) is more prone to cracking. The Charpy V-notch impact toughness is also improved at lower hardnesses. Thus, this study has confirmed experience at DDGM that higher hardness (i.e., higher carbon steel) should be avoided. It is recommended that the Canadian Material Specification, CMS-18, be employed for future purchases of high hard armor steel for the LAV. The lower carbon content and restricted hardness range specified in CMS-18 is a step in the right direction, although it is likely that further modifications will occur in the future as experience is gained. Because of this tighter specification, initial cost of the steel will be higher, but lifetime vehicle costs should be lower.
