**REPAIR, EVALUATION, MAINTENANCE, AND
REHABILITATION RESEARCH PROGRAM**

TECHNICAL REPORT REMR-GT-18

**EVALUATION OF THE REHABILITATION PROGRAM
FOR RELIEF WELLS AT LEESVILLE DAM, OHIO**

Final Report

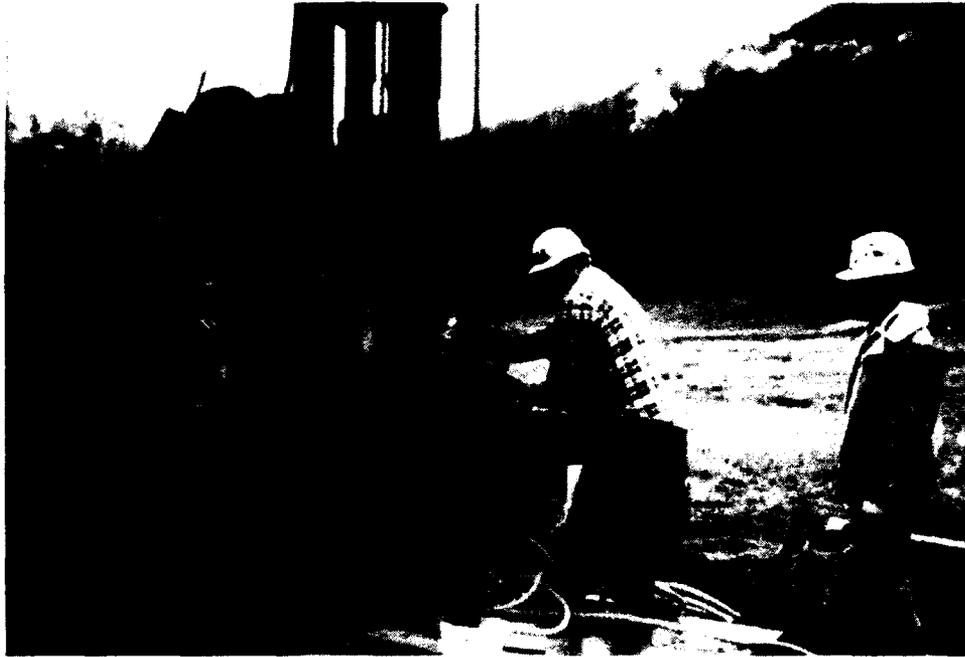
Photo 27. Bailing well to remove accumulated sediment
