1. AGENCY USE ONLY (Leave blank)		2. REPORT DATE Aug 1993		3. REPORT TYPE AND DATES COVERED
4. TITLE AND SUBTITLE M825A1 WHITE PHOSPHOROUS MALFUNCTION INVESTIGATION RELATED TO THE M739/M739A1 SAFING AND ARMING MODULE			5. FUNDING NUMBERS

6. AUTHOR(S) Saman F. Khoury				
7. PERFORMING ORGANIZATION NAME(S) AND ADDRESSES(S) ARDEC, AED Fuze Division (SMCAR-AEF-F) Picatinny Arsenal, NJ 07806-5000			8. PERFORMING ORGANIZATION REPORT NUMBER Technical Report ARAED-TR-92031

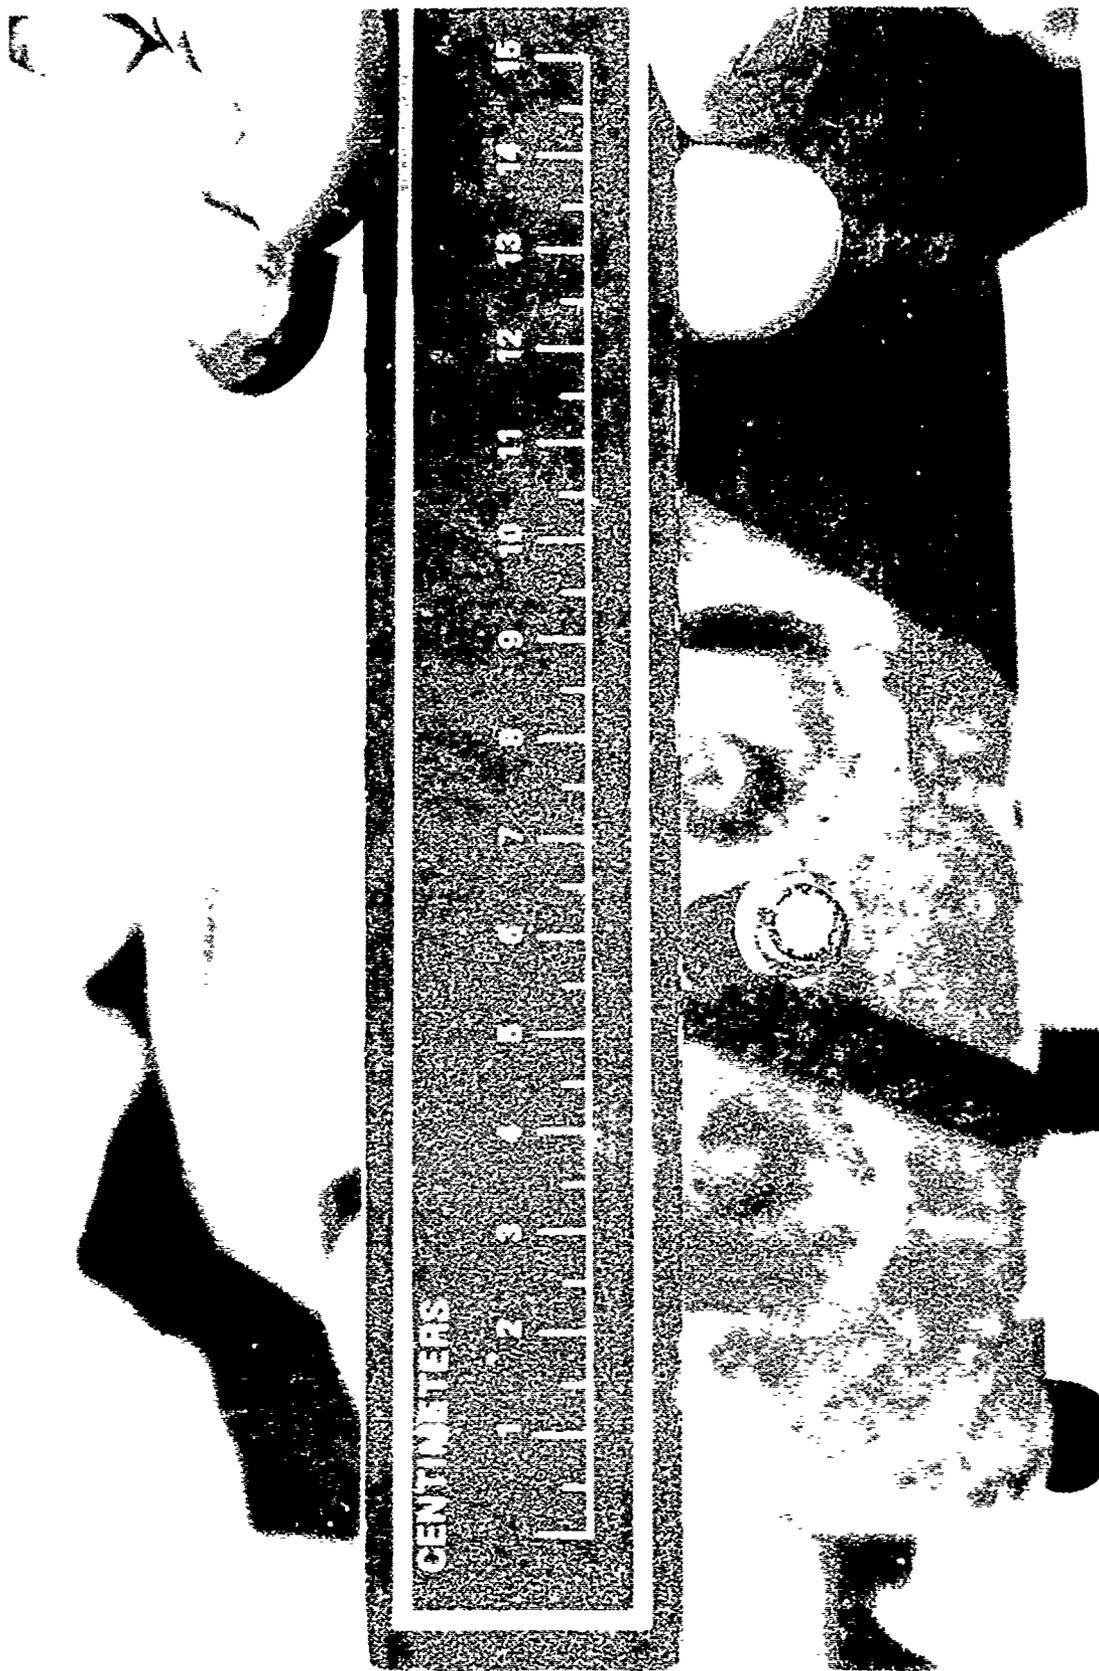
Figure 2. M825A1 recovered burster, lot PB-89J000E005

Examination of the burster in the dud unit showed that the composition (Comp) A-5 explosive did not detonate (fig. 2); however, approximately 1 in. of the Comp A-5 was missing. The burster well and burster were mangled as shown on figure 3. Metal parts examination of the streamer showed evidence of Comp A-5 burning rather than detonating. Both rounds did not function high order as intended.

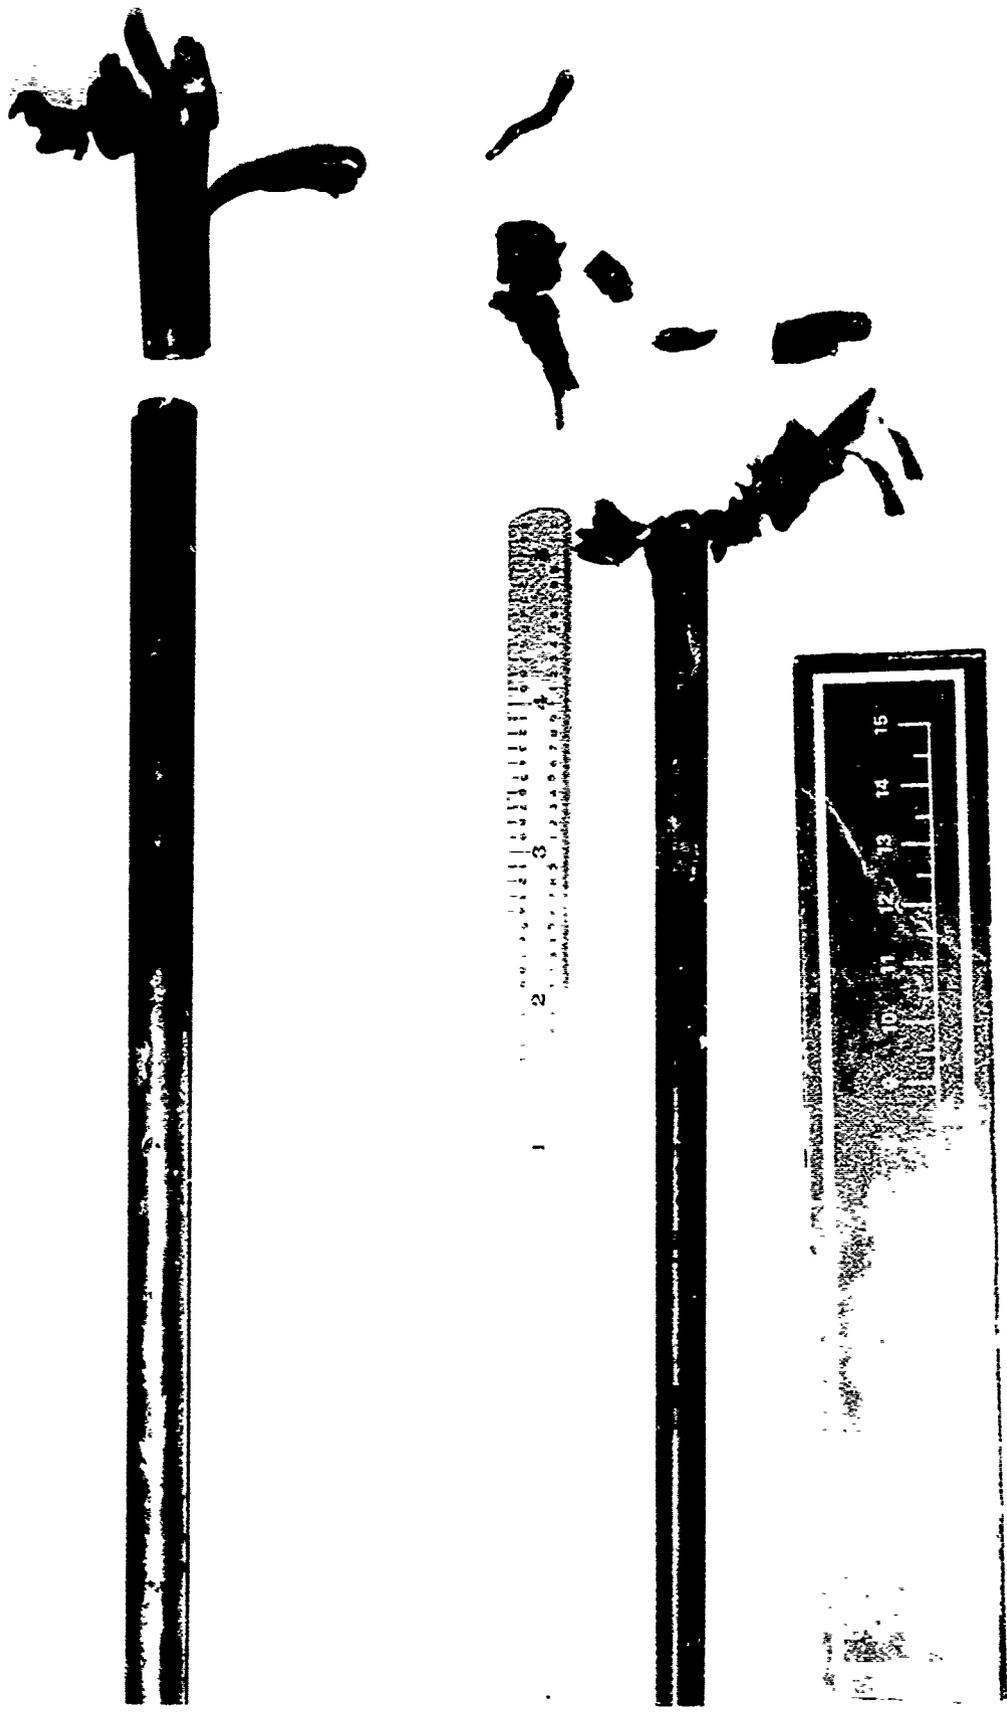
Figure 3. Damage on recovered dud, M825A1, lot PB-89J000E005

1. Examination of recovered "dud" canisters at Dugway Proving Ground, reveal considerable metal damage to the top end of both the burster and burster well for approximately 1.5 - 2.0 inches column length. It is not certain whether or not the missing composition A5 explosive in the short length (1.5 - 2.0 inches) detonated or was blown away, the remaining 16.5 - 17.0 inches of burster contained undetonated A5 material.

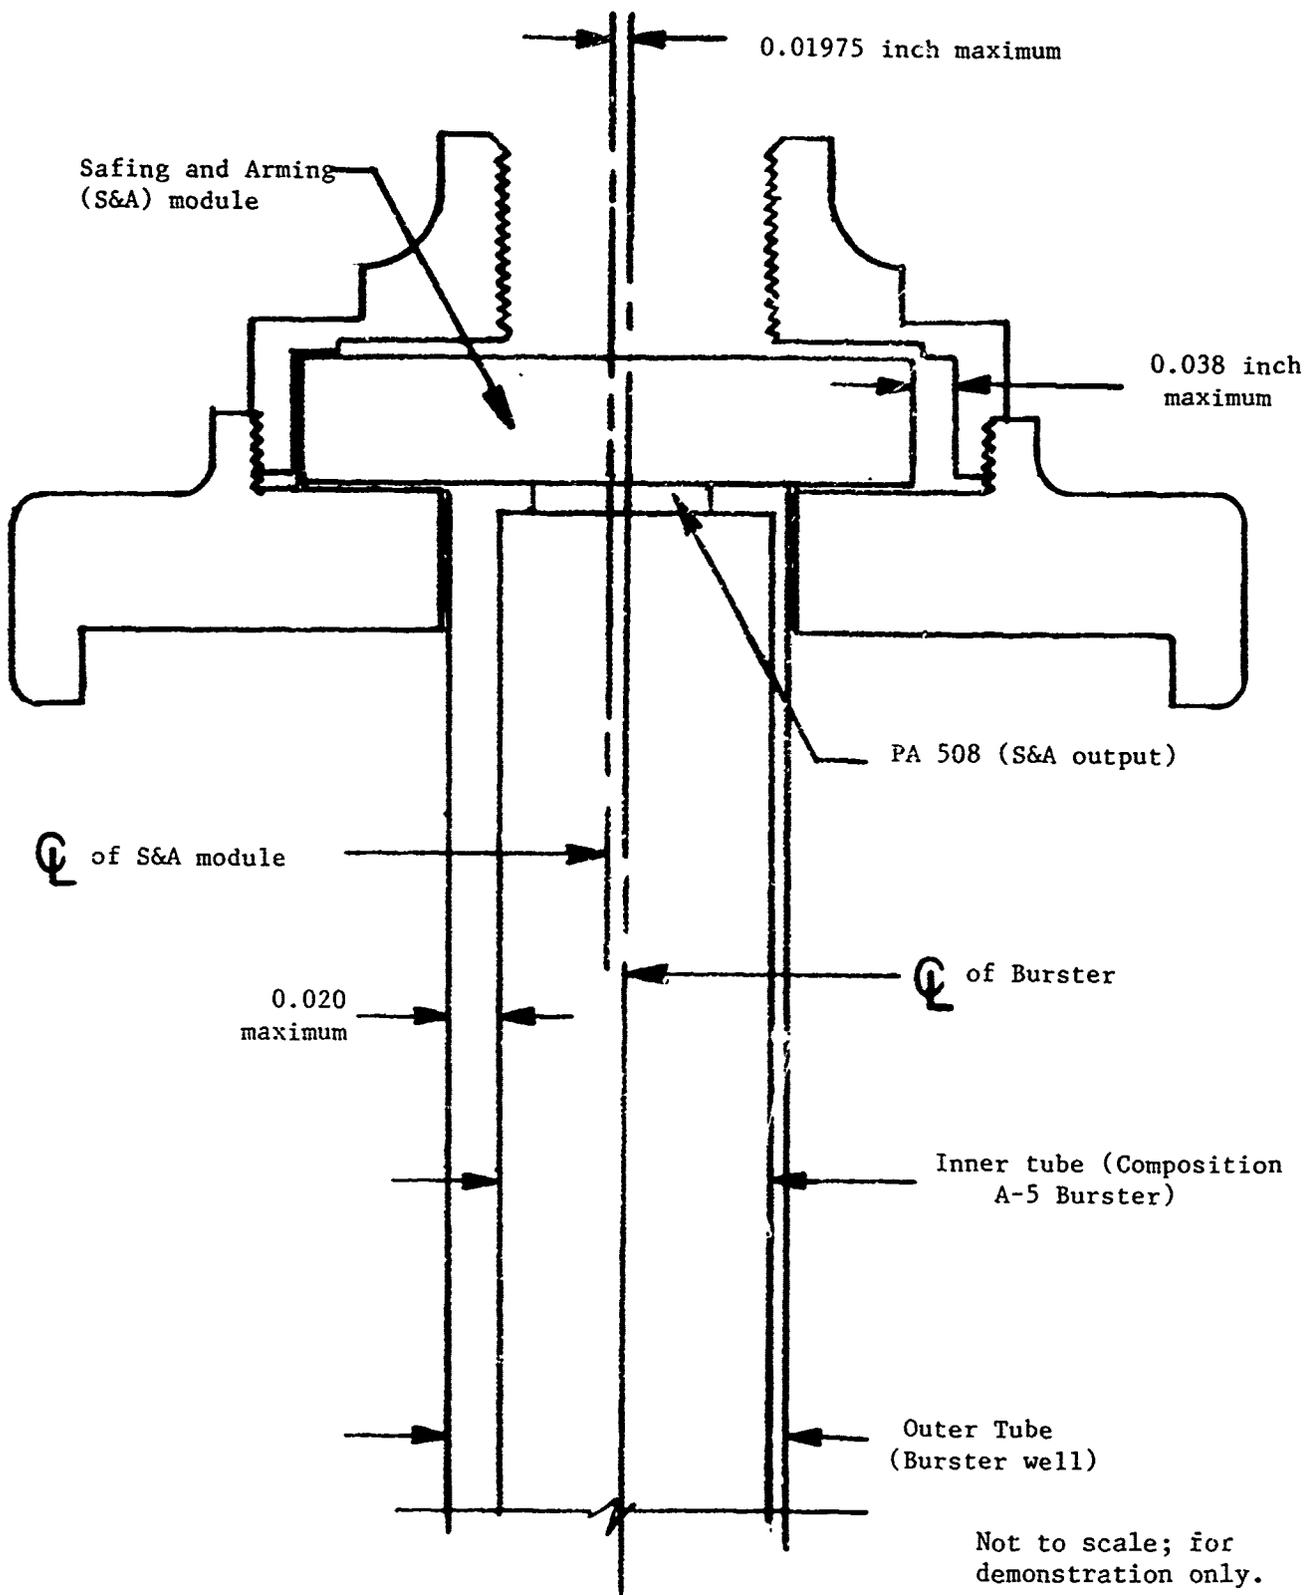
Figure 4. Horizontal tolerance M825/M825AI assembly

The study focused on horizontal and vertical tolerances between the burster, S&A, and front plate assembly. The study of the horizontal tolerances revealed that the burster and the well may be off center by a maximum of 0.01975 in. It also revealed that the burster and the well may have a maximum side gap of 0.020 in. However, the PA-508 (S&A output lead) is always covering 100% of the Comp A-5 in the burster (fig. 4). Therefore, there was no need to examine this further. The vertical tolerances revealed that a maximum gap between the S&A output and the Comp A-5 is 0.015-in. minimum and 0.17-in. maximum. The maximum gap was determined by assuming that the felt disc is not assembled. An illustration is presented in figure 5. These data were provided to the ARDEC Energetics Division for their gap testing. Their test results showed that this gap variation has no effect on the S&A to burster output.

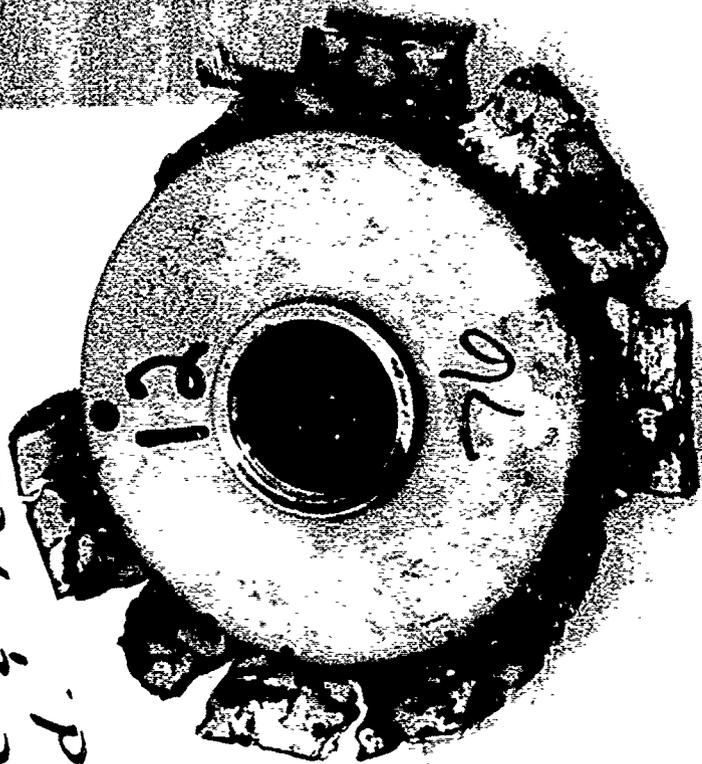
Figure 9. Cocked M739/M739A1 safe and arm, M825A1 assembly

The unit used for the cocked S&A test yielded an output hole dimension of 0.525 in. by 0.496 in., measured 90 deg apart. An adapter was fabricated to ensure that the S&A remained in a tilted position. The gap between burster and the S&A lead was set at a maximum by placing a 0.017-in. shim. the felt disc was also removed from the burster in order to provide a vertical gap. This configuration is illustrated in figure 8. The S&A functioned the burster high order (fig. 9). The S&A output hole was measured to be 0.460 in. by 0.430 in., 90 deg apart. This damage was similar to the DPG recovered units. This penalty test clearly indicates that the S&A used in the M825A1 failures provided sufficient output to function the burster.

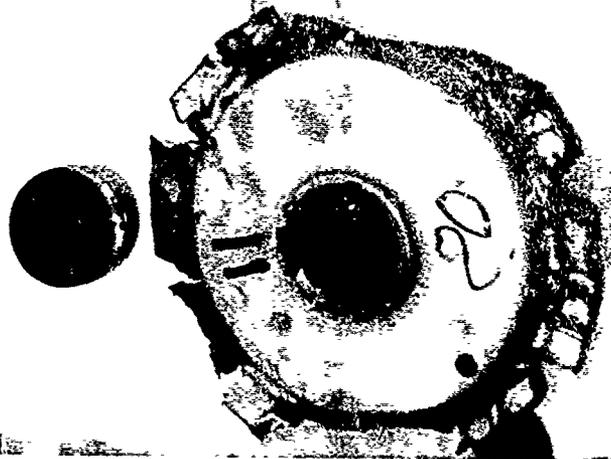
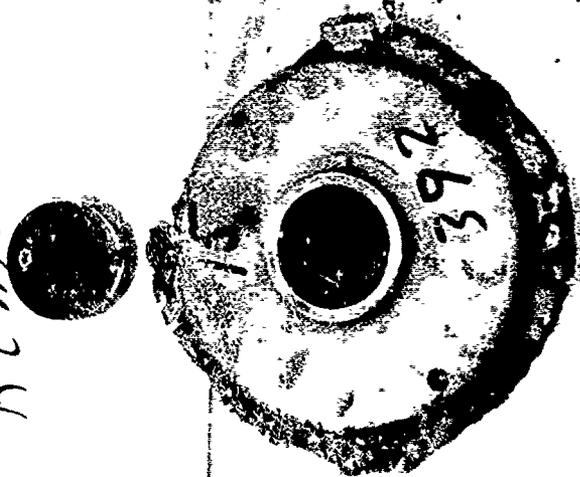
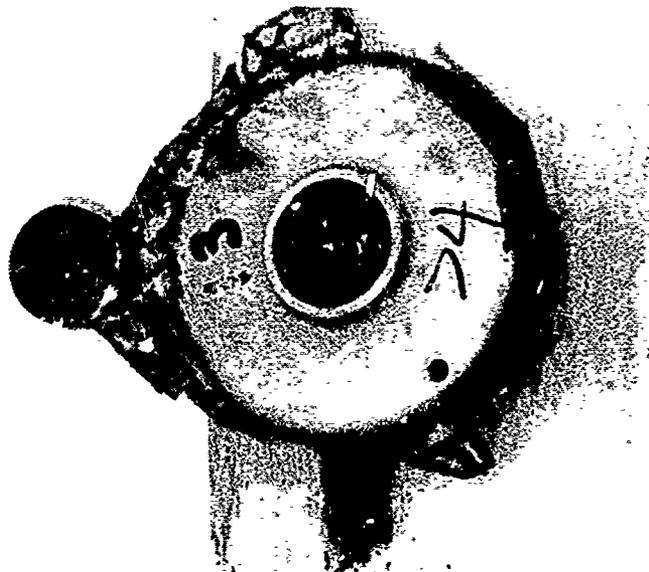
Figure 10. Damage comparison M825A1 assembly upside down burster versus normal assembly

Two S&A were assembled with upside down bursters. The felt disc was removed and the burster was inserted with the green end down. These units functioned high order and the S&A had larger output hole dimensions when compared to the properly assembled test unit (fig. 10). The upside down bursters yielded an S&A output hole of 0.494 in. by 0.571 in. and 0.473 in. by 0.709 in. It also yielded larger front plate assembly hole dimensions when compared to the properly assembled unit.

Based on the results of the tests, it is clear that the saving and arming used in the malfunctioned M825A1 projectiles have not contributed to the failures. Tests show that under worst case scenarios using gaps and malassembled units, sufficient energy to function the burster high order was obtained. It was also interesting to note that the upside down bursters yielded the best output. This may be related to the manufacture of the burster. The Comp A-5 in the burster is recessed by a minimum of 0.07 in. and a maximum of 0.09 in. at the top while flush at the bottom. This indicates that a more controlled pressing is required at the top of the burster.

4. The results of the upside down burster should not be ignored and should be further analyzed by CRDEC. This office feels that the upside down burster results gave an indication that the design and manufacturing of the burster is the main source of the problem.
