Technical Report HL-93-7
August 1993

Scour Protection for Dam No. 2, Arkansas River, Arkansas

Hydraulic Model Investigation

*by John E. Hite, Jr.
Hydraulics Laboratory*

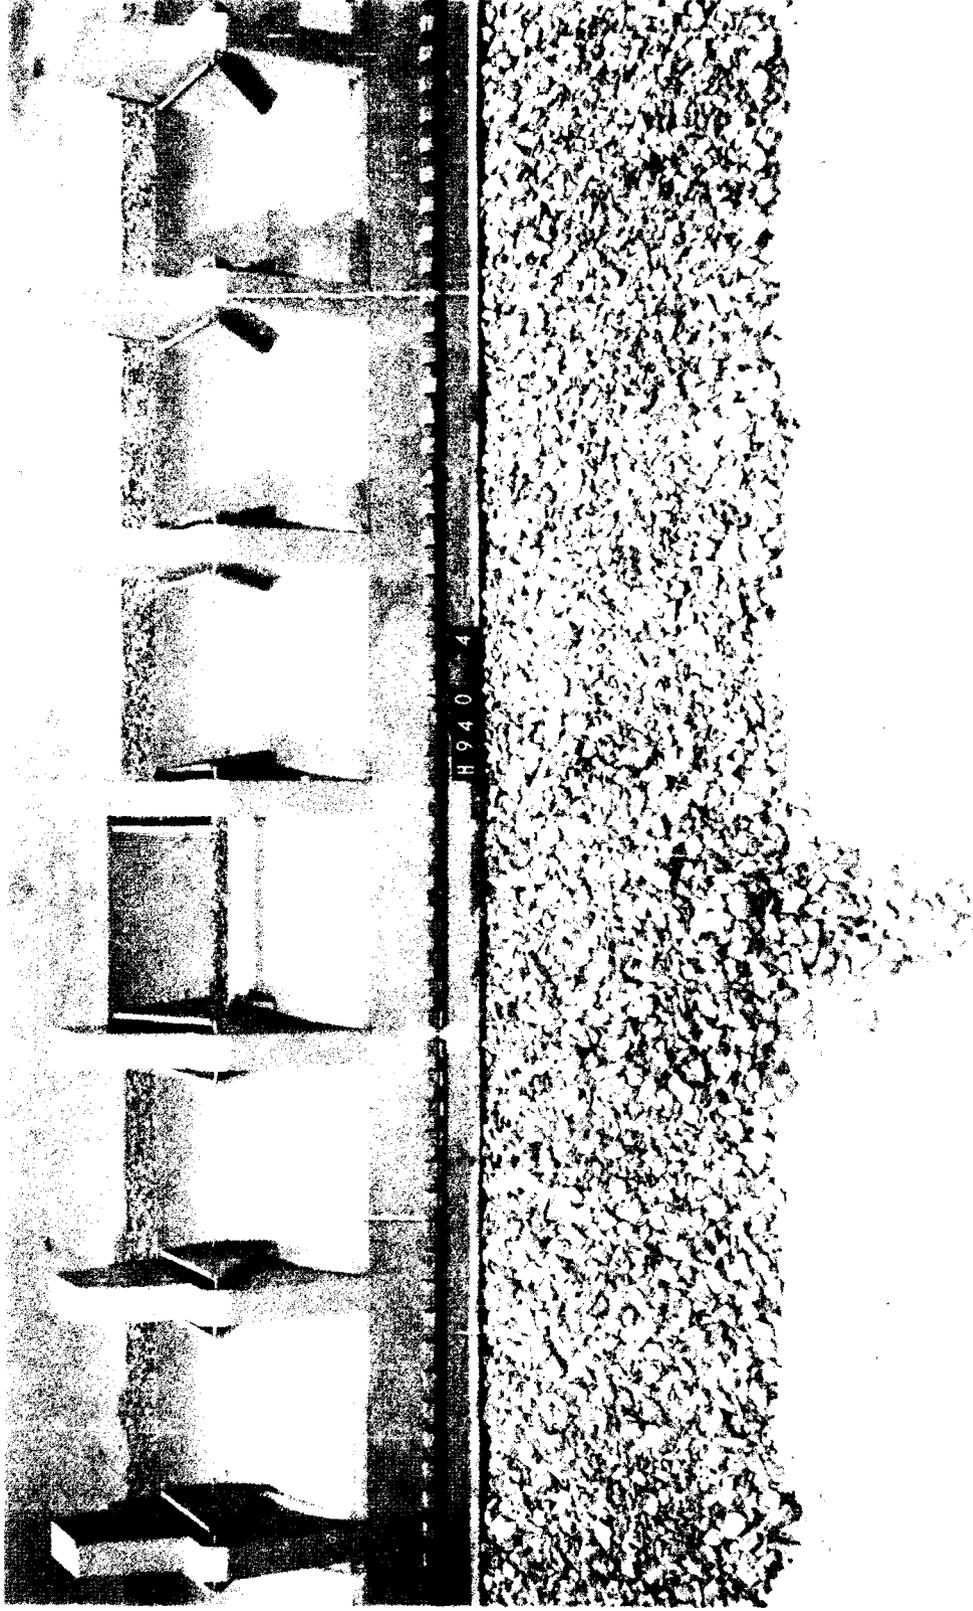
Tests 1-5 were conducted with gate 8 opened 14 ft and the pool and tailwater conditions shown in Table 1. A 14-ft gate opening was considered to be representative of a gate opened half-way. The tests were conducted by setting the appropriate discharge with a high tailwater, lowering the tailwater to the desired elevation, running this condition for a specified time period, turning off the discharge, and draining the model slowly so the riprap and scour pattern would not be disturbed to observe if riprap displacement had occurred. Riprap No. 7 downstream from the stilling basin was found to be unstable with pool el 162 and tailwater el 135 (Test 5, Table 1). The tests indicated that gate openings of 14 ft and greater should not be allowed with the tailwater lower than el 140. Results from Test 5 (Table 1) are shown in Photo 1.

Photo 1. Failure of Riprap No. 7 and scour in the exit channel after 6 hr (prototype) of operation with gate 8 opened 14 ft, normal upper pool el 162, and tailwater el 135

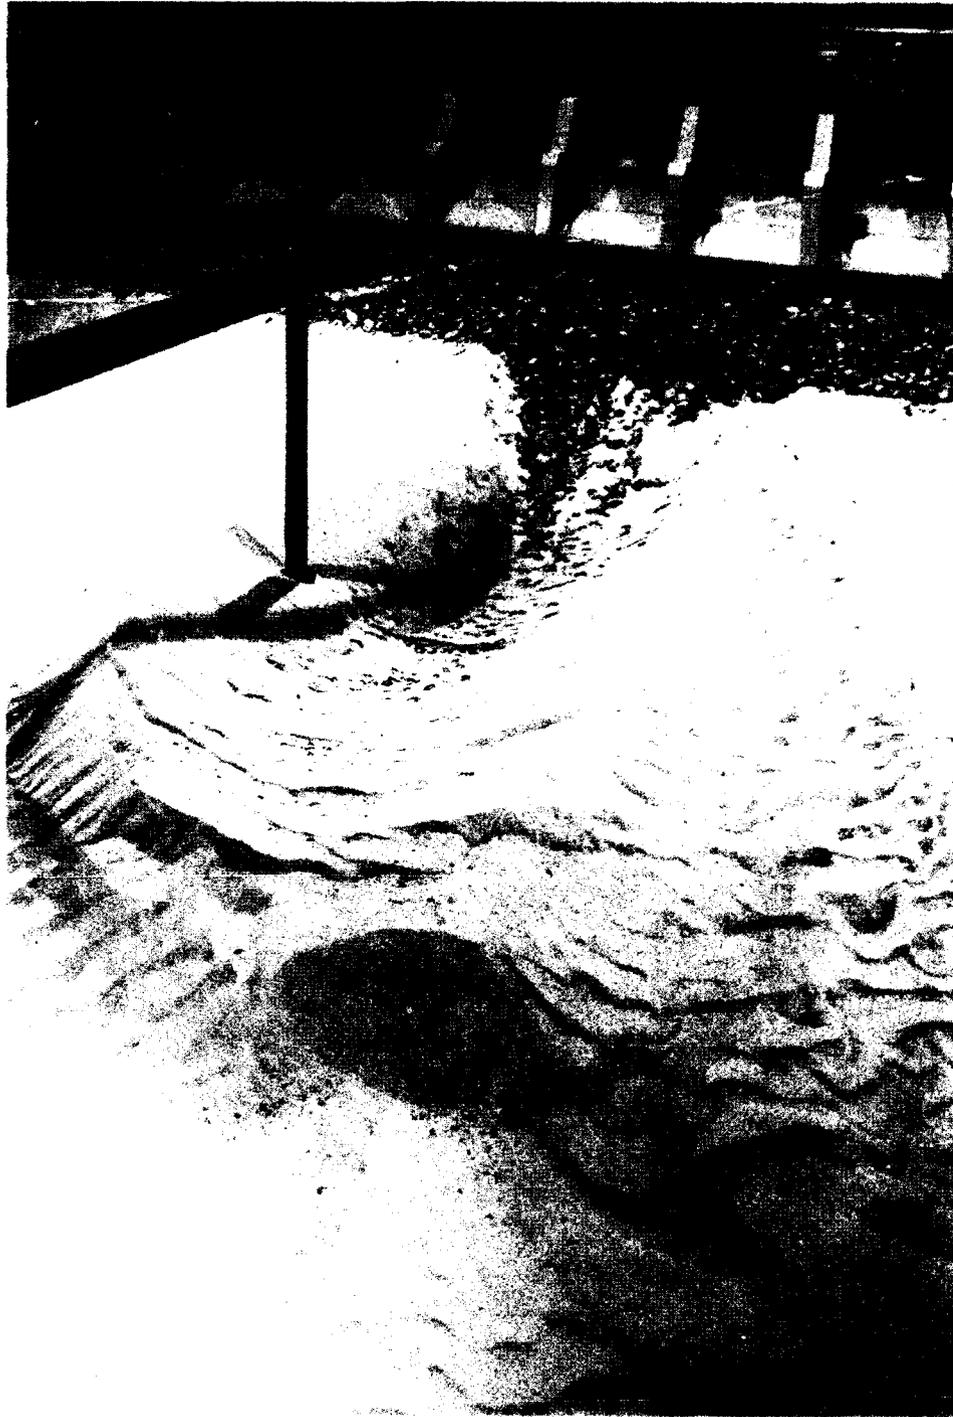
Tests were conducted to determine the stability of Riprap No. 7 downstream from the stilling basin for flow conditions caused by normal upper pool (el 162), one gate fully open, and various tailwater elevations. The riprap was found to be unstable for tailwater elevations below 150. Results from Test 8 (Table 1) are shown in Photo 2.

Photo 2. Failure of Riprap No. 7 and scour in the exit channel after 6 hr (prototype) of operation with gate 8 fully opened to the normal pool and tailwater el 145

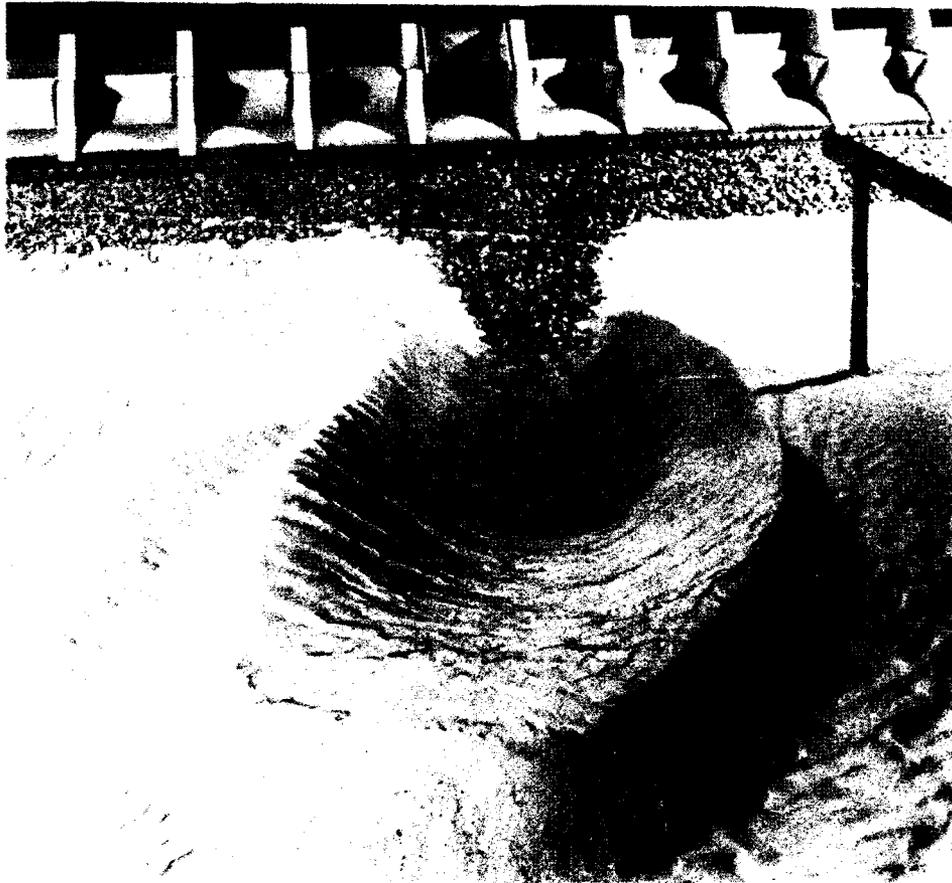
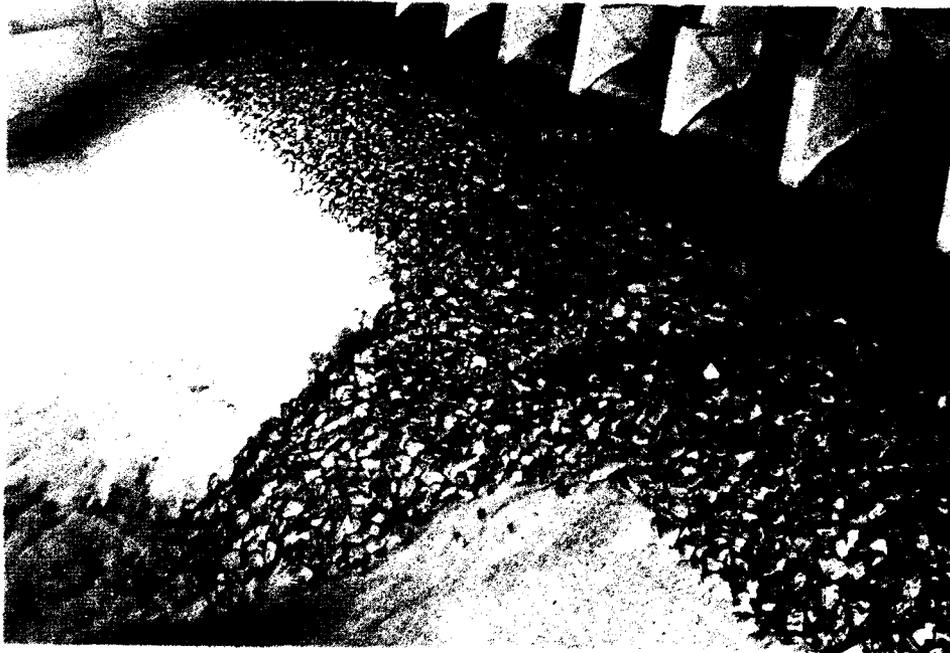
Riprap No. 7 was then tested under abnormal conditions. The first of these tests (Test 9, Table 1) reproduced pool (el 170) and tailwater (el 147.5) elevations that existed during the December 1982 barge accident. The riprap failure for this condition was severe, as shown in Photo 3. The test was conducted with gate 10 fully open for a duration of 4 hr 30 min prototype time (45 min model time).

Photo 3. Failure of Riprap No. 7 and scour in the exit channel after 4.5 hr (prototype) of operation with gate 10 fully opened, upper pool el 170, and tailwater el 147.5

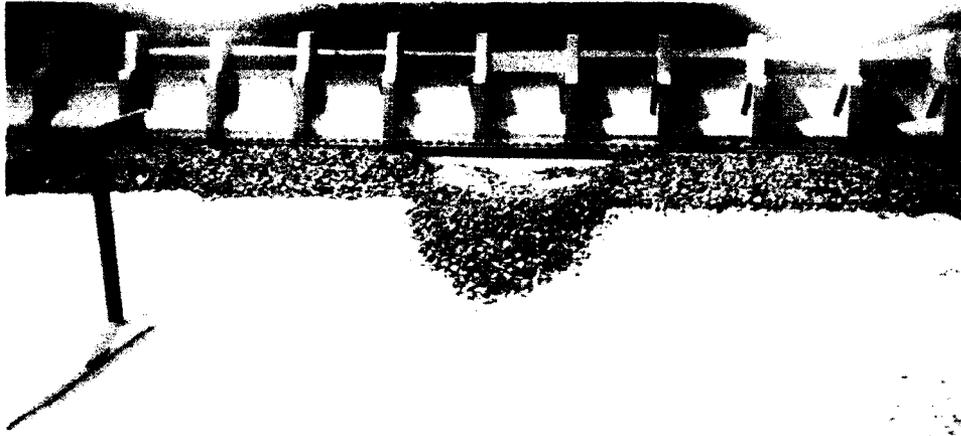
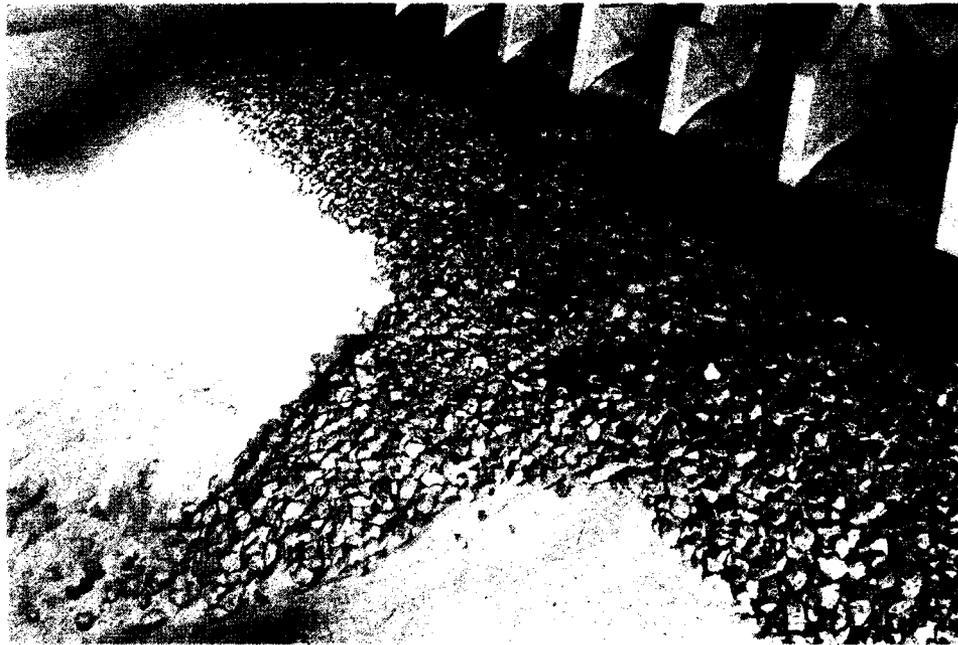
Previous tests had shown that Riprap No. 7 would fail with one gate fully open, normal pool, and tailwater elevations lower than 150. Engineer Technical Letter 1110-2-290¹ suggests that new project stilling basin design conditions include one gate fully open with normal headwater and minimum tailwater (gate misoperation). This type flow condition was observed to determine the adequacy of the existing stilling basin and the effects of this type flow on the Riprap No. 7 (Test 16, Table 1). The riprap was tested with the normal pool elevation, an extremely low tailwater elevation of 122 (3 ft

Photo 4. Failure of Riprap No. 7 and scour in the exit channel after 8 hr (prototype) of operation with one gate fully open, normal upper pool elevation, and tailwater el 122

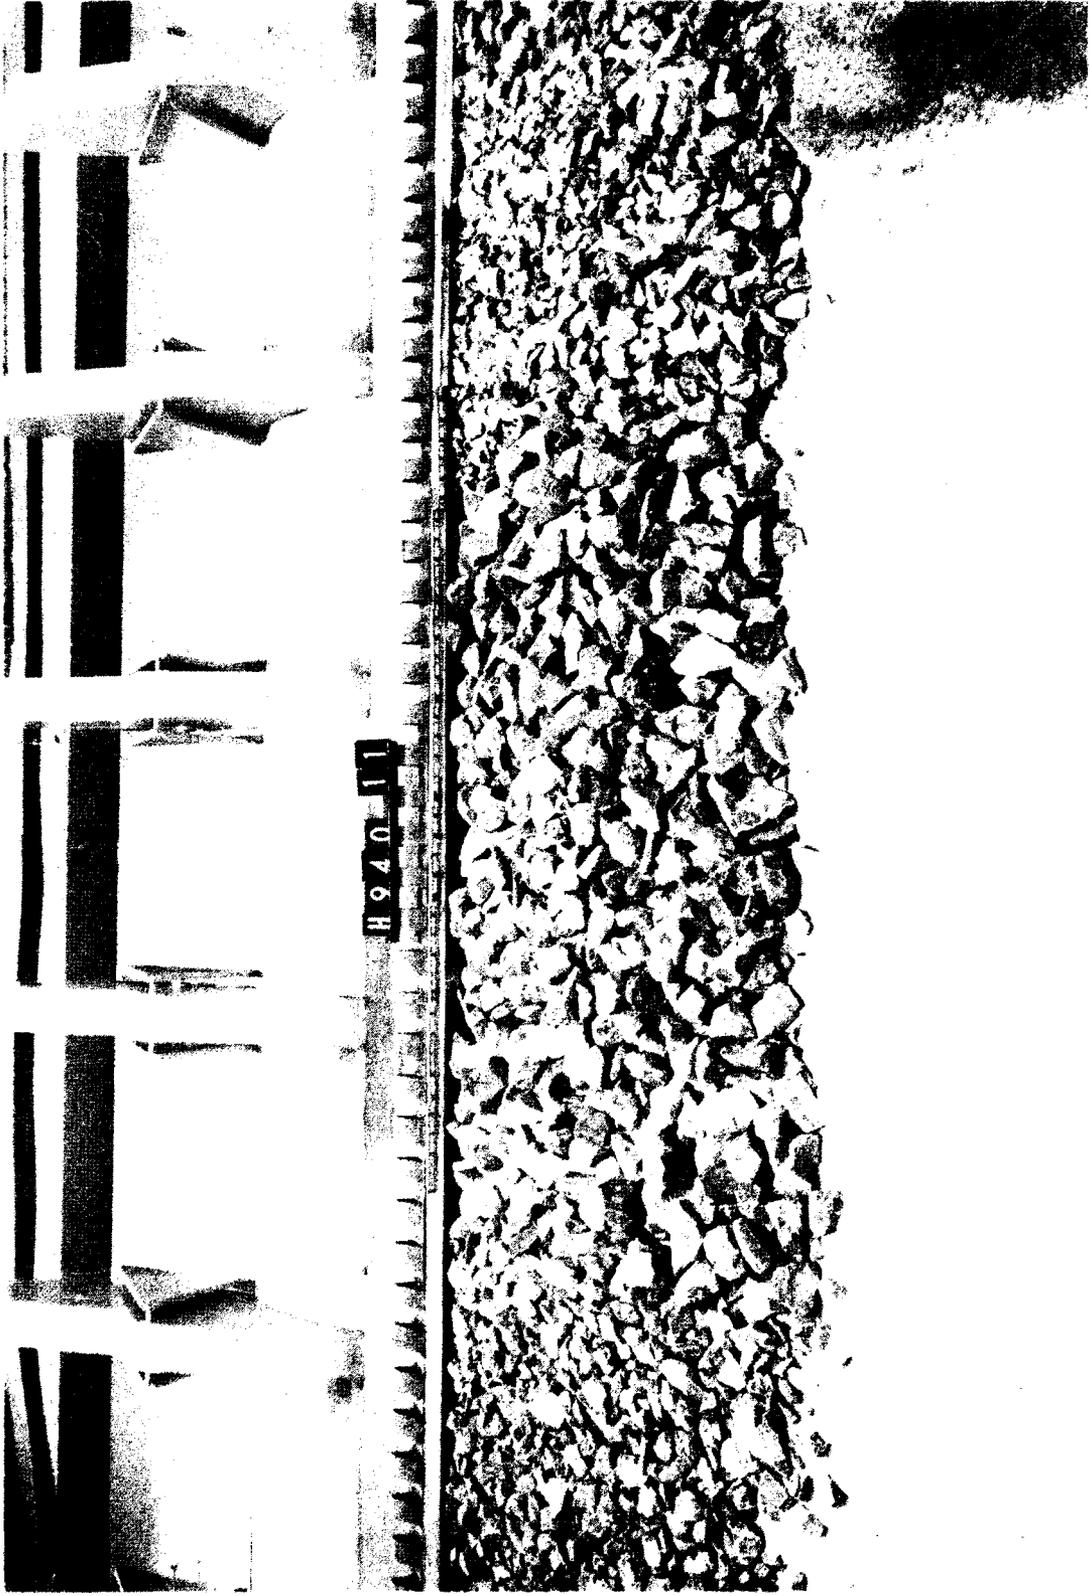
Since failure of the type 2 scour protection occurred with tailwater elevations much higher than the minimum tailwater anticipated at the project, structural modifications were made downstream from the existing stilling basin. The type 3 design shown in Photo 6 consisted of barges, 175 ft long by 26 ft wide by 12 feet deep, filled with grouted rock and placed downstream from the existing stilling basin. This design was tested in an attempt to provide a secondary stilling basin. The basin extended 220 ft downstream as shown in Plate 5 and contained a 6-ft-thick blanket of Riprap No. 7 offset 4.5 ft below the top of the barge for a distance of 125 ft downstream from the end of the barges. The type 3 scour protection design remained stable when tested for 8 hr with one gate fully open, normal upper pool elevation, and tailwater el 118.

Photo 5. Type 2 scour protection design placed downstream of one gate bay

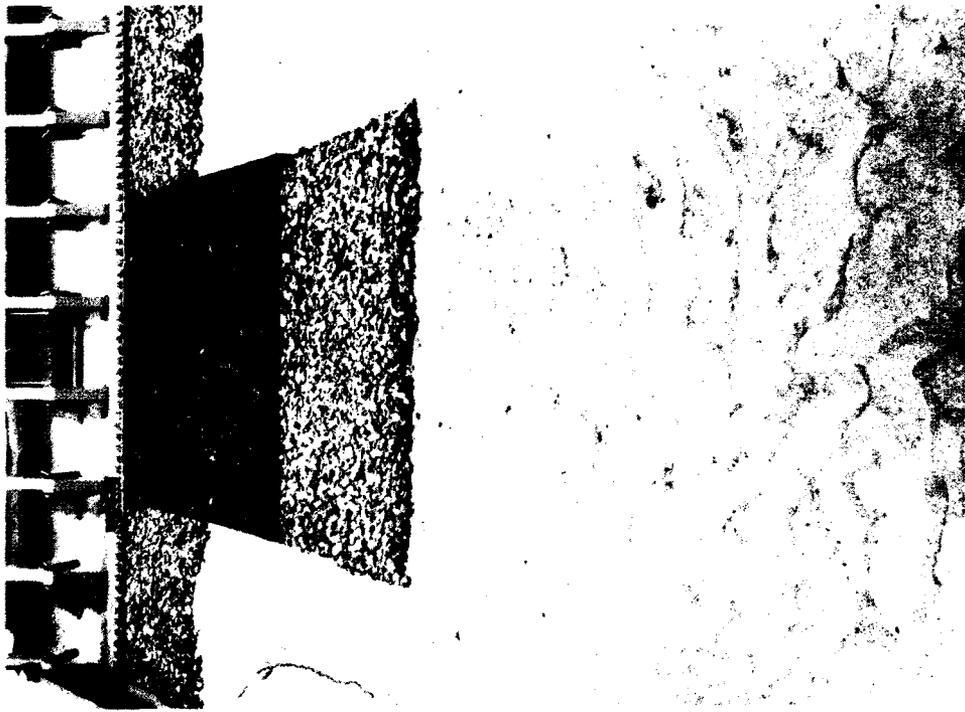
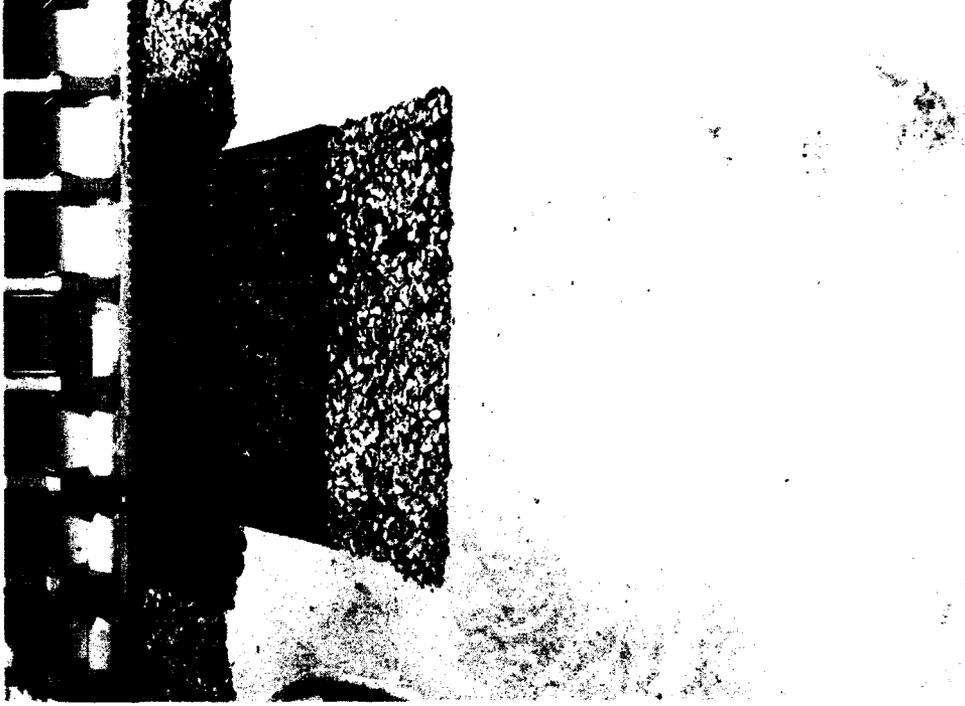
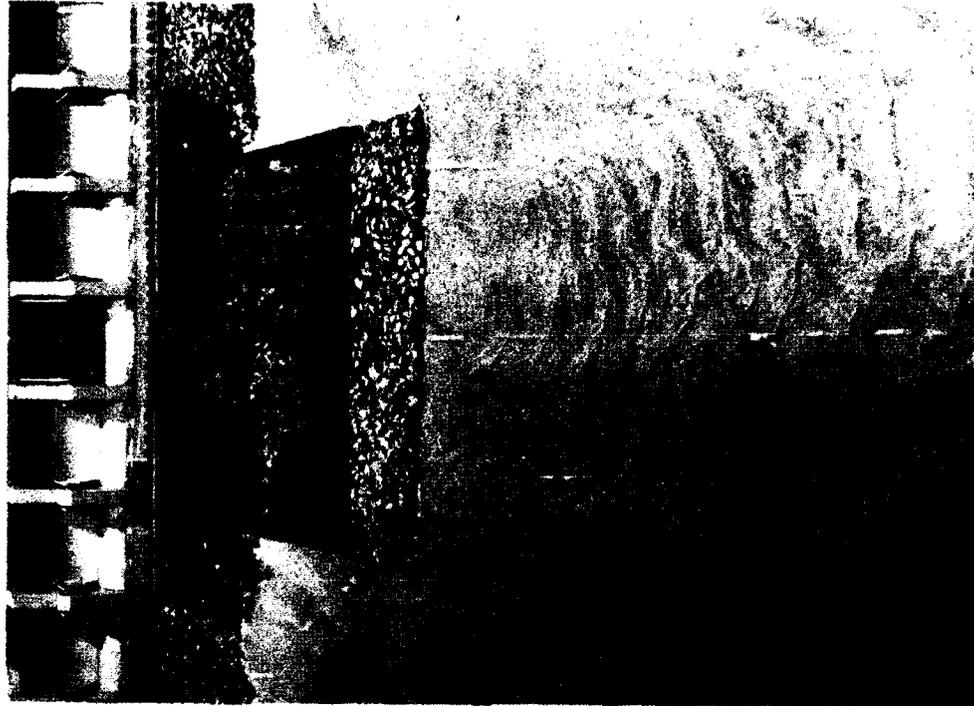
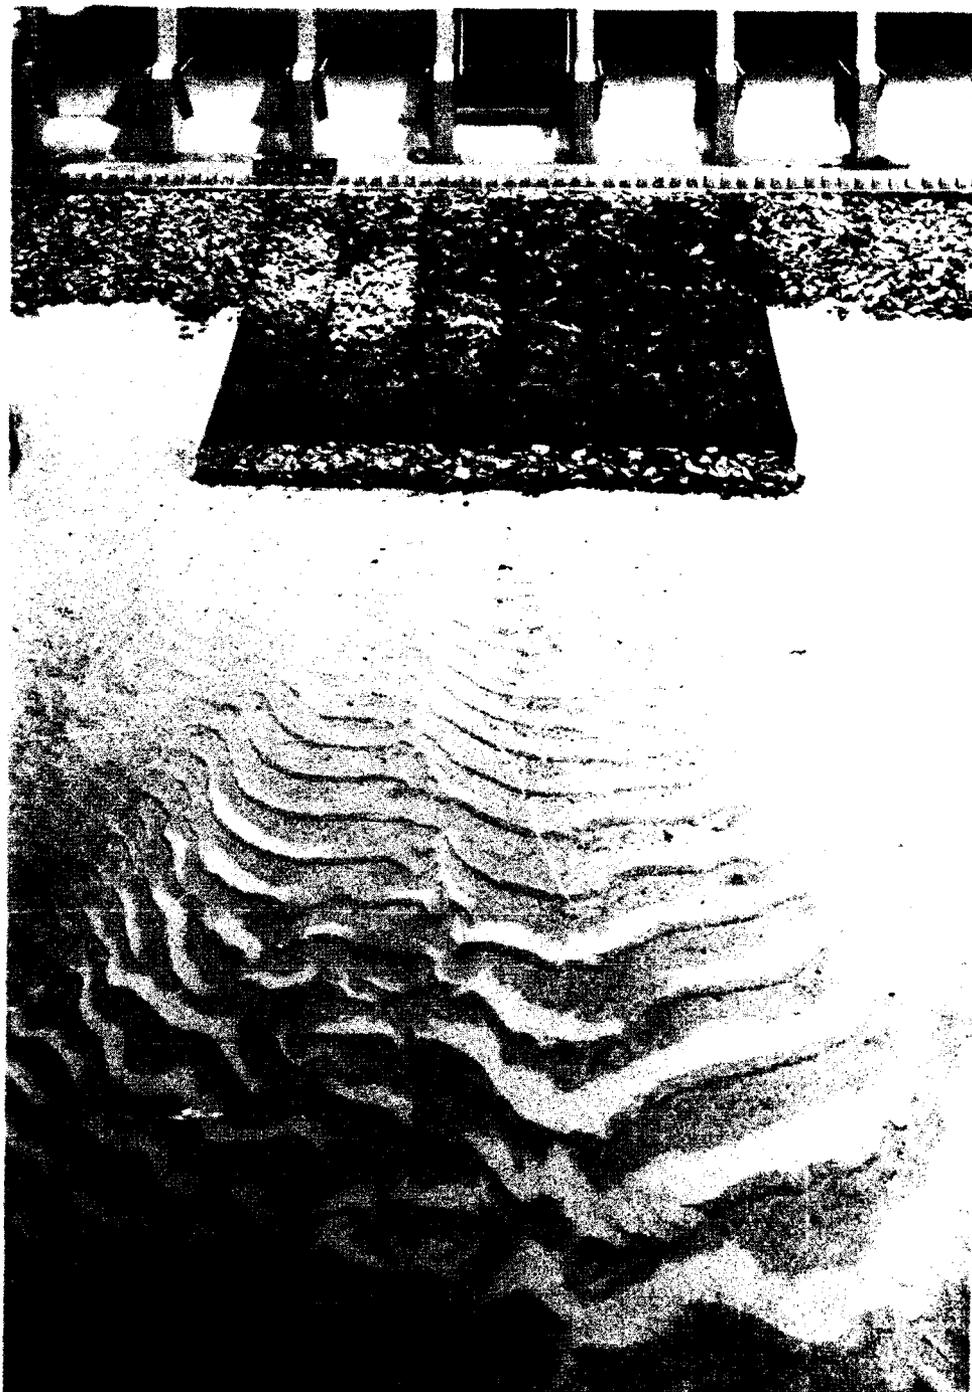
Tests were then conducted to determine the minimum length of Riprap No. 7 needed downstream of the barges. Each of these tests was conducted for 8 hr (prototype) with gate 13 opened fully to the normal upper pool and a tailwater el 113. The results shown in Photo 12 indicated scour downstream from the riprap protection was not excessive for any of the blanket lengths tested. Riprap protection downstream from the barges is essential to prevent local scour and undermining of the end of the barges. The scour observed in the model is only a relative indication; however, the potential exists for greater scour to occur in the prototype.

Photo 12. Scour in exit channel after operations with normal upper pool, one gate fully open, and tailwater 113, for various lengths of Riprap No. 7 placed downstream of barges (Sheet 1 of 3)

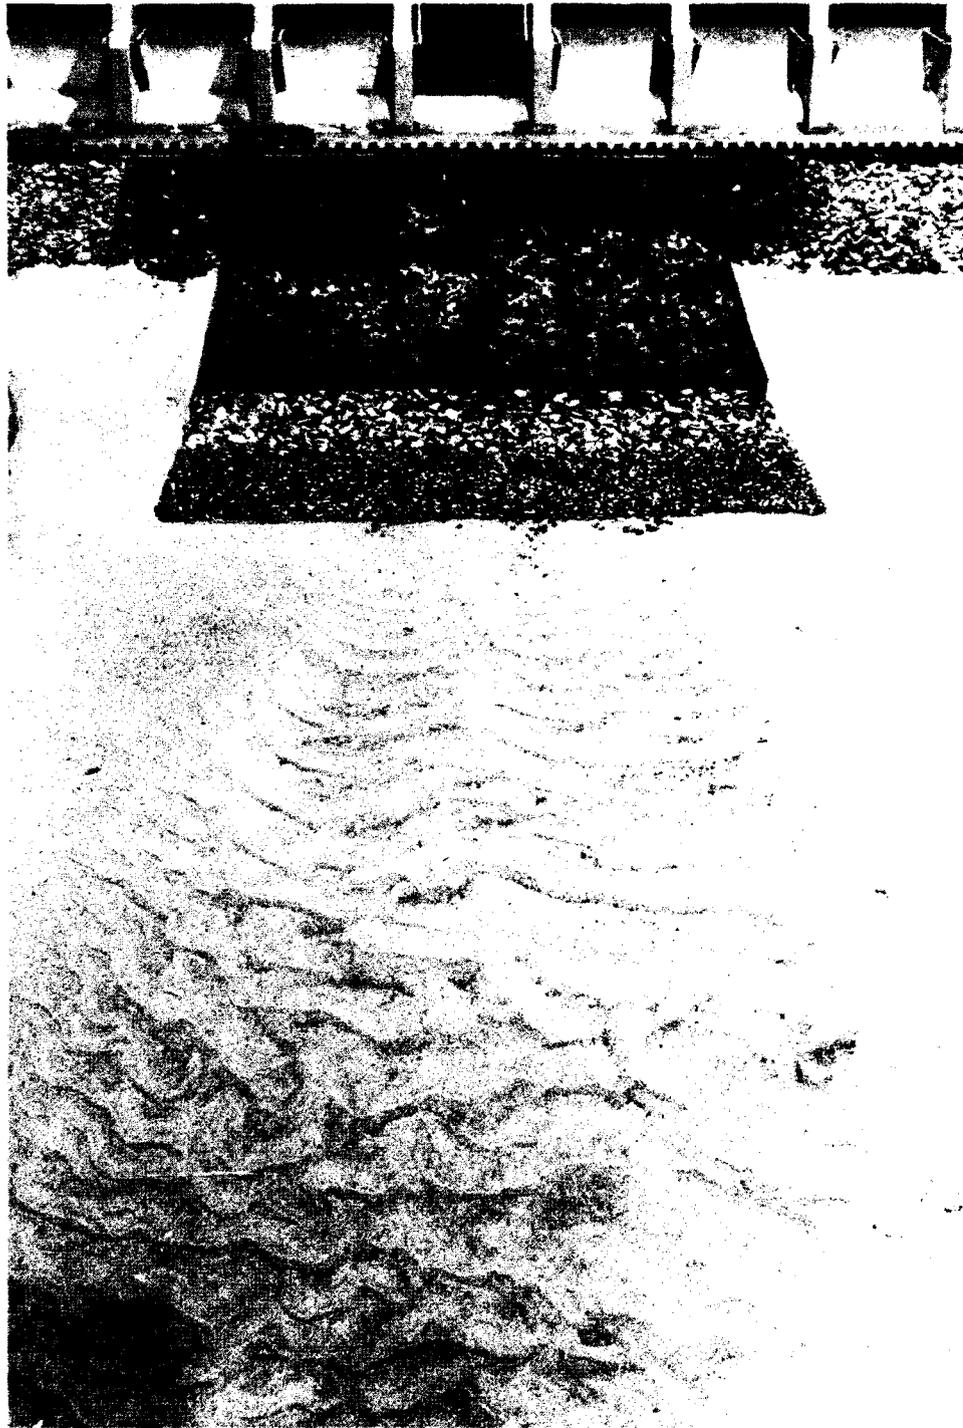
To provide protection for the area immediately downstream from the barges, Riprap No. 7 was placed at el 87 for a length of 50 ft, followed by a 50-ft-long blanket of Riprap No. 8. Riprap No. 8 consisted of a 36-in.-thick blanket of stone with a D_{50} size of 16 in. and the gradation shown in Plate 8. The purpose of placing the smaller Riprap No. 8 was to reduce the local turbulence above the stone protection downstream of Riprap No. 7 and to transition a less turbulent flow condition on the natural channel bottom. These modifications were designated the type 9 scour protection design. This design was tested with gate 13 opened fully to the normal upper pool and tailwater el 113 for 8 hr (prototype). The results shown in Photo 13 revealed that the riprap was stable and scour was minimal.

Photo 13. Type 9 scour protection design after 8 hr (prototype) of operation with normal upper pool, gate 13 fully open, and tailwater el 113

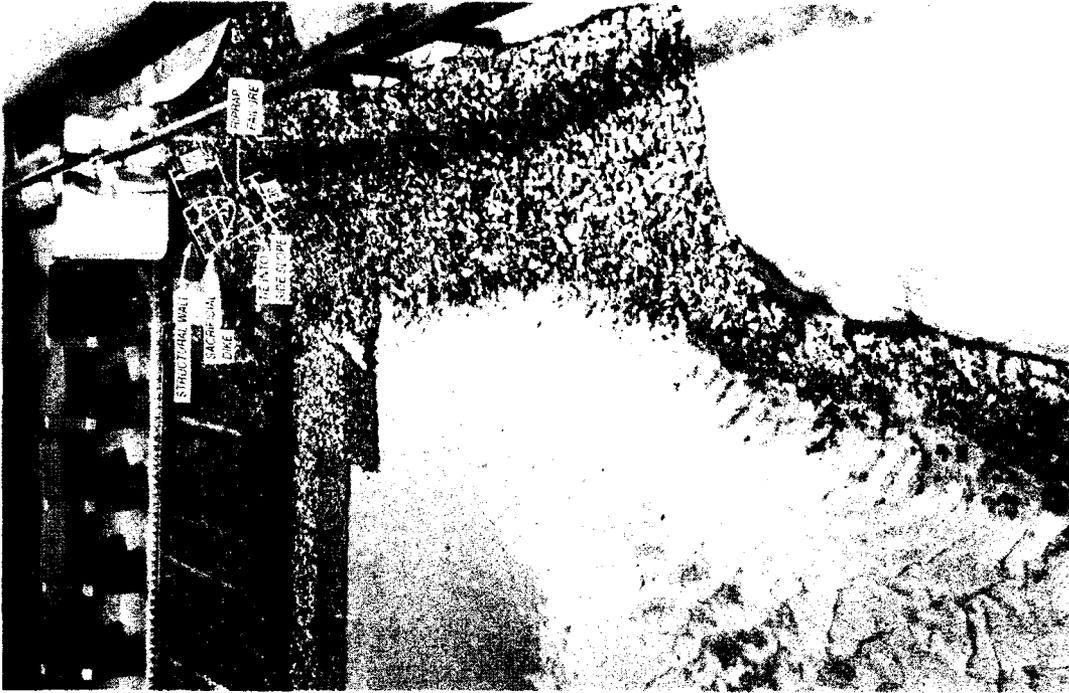
extended an additional 320 ft farther downstream on the left bank, providing side slope protection 600 ft downstream from the end of the training wall. This was done to move the disturbance caused by the transition from the Riprap 7 to the nonerodible material on the side slope farther downstream. A test was conducted for 8 hr (prototype) with gate 1 opened fully to the normal upper pool and tailwater el 130. Riprap was displaced in several areas and the filter was exposed about 94 ft downstream from the training wall as shown in Photo 17. The toe of the left side slope was undermined for the entire length causing riprap on the side slope to fail.

Photo 17. Failure of Riprap No. 7 on left bank

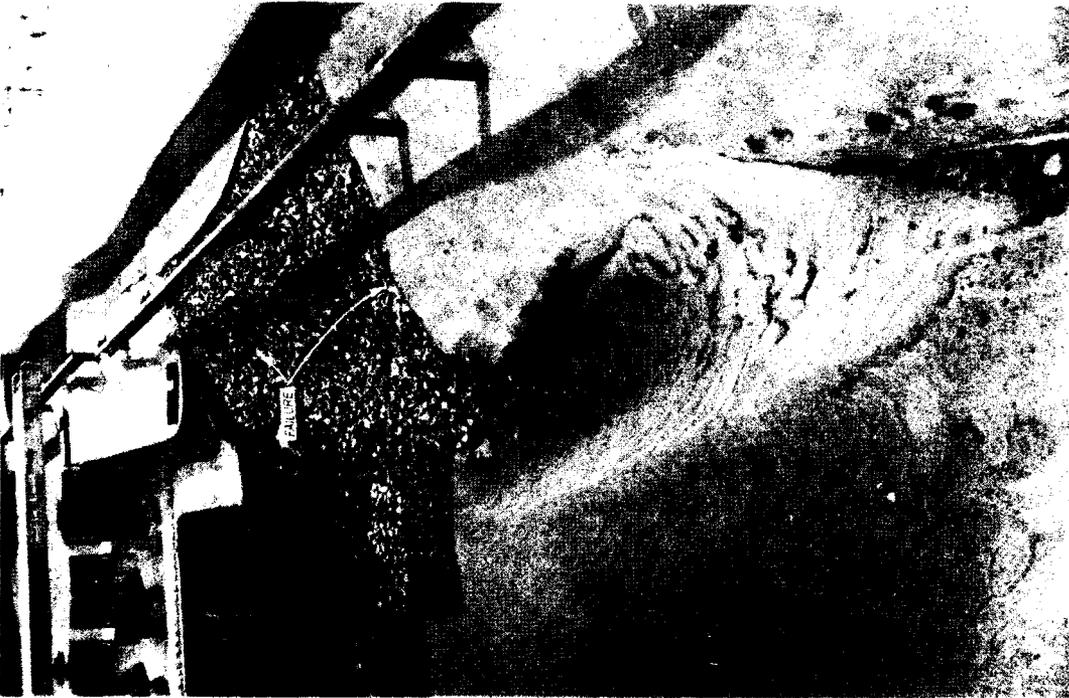
A test was then conducted for 8 hr (prototype) with gate 1 opened fully to the normal upper pool and tailwater el 113 to determine the stability of Riprap No. 7 on the side slope for this flow condition. Some of the riprap in the sacrificial dike (approximately 40-60 ft downstream from the training wall) was displaced, but overall, the riprap held favorably. The riprap was considered adequate protection if a flow condition of this nature could be brought under control and improved in an 8-hr period.

Photo 16. Failure of Riprap No. 7 on side slope

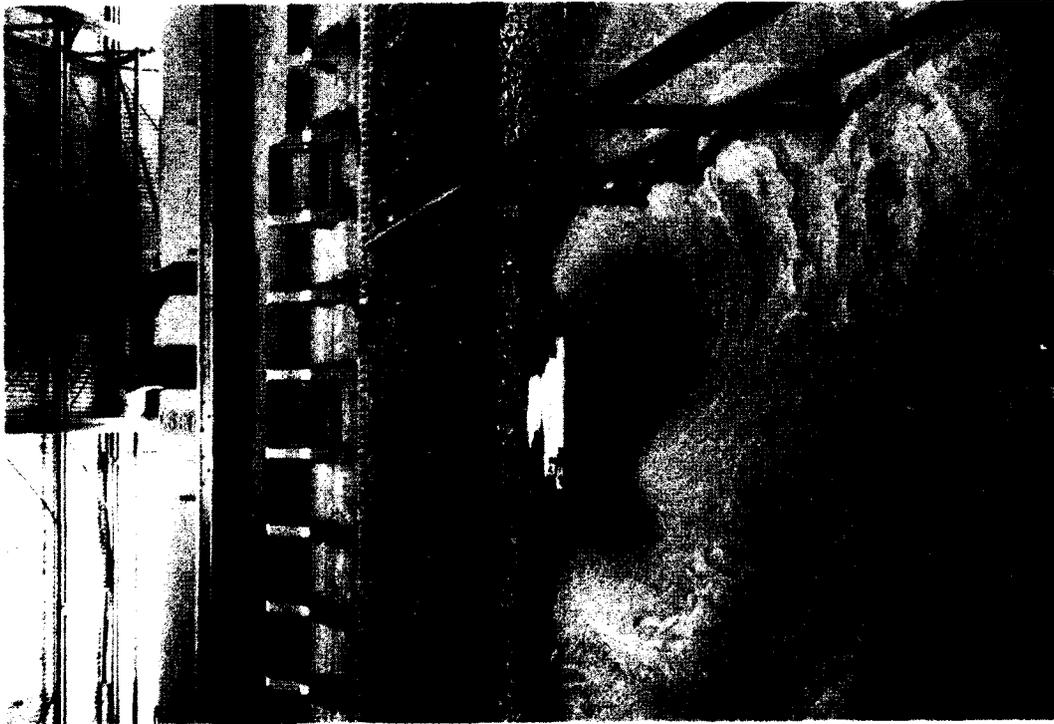
A test was then conducted downstream from gate 10 where the barges were 6 ft higher than their original placement. Riprap No. 8 downstream from the barges failed during this test due to the flow conditions that occurred with gate 10 opened fully to the normal upper pool and tailwater el 135. The entire 50-ft blanket was washed away as shown in Photo 18. An additional 50 ft of Riprap No. 7 (total length of 100 ft) followed by 50 ft of Riprap No. 8 was placed downstream from gate 10 and the test repeated. Again, the Riprap No. 8 was washed downstream. Riprap No. 8 was replaced with Riprap No. 9 ($d_{50} = 24$ in.). The gradation of this riprap is shown in Plate 11. A test was conducted for 8 hr (prototype) with gate 10 opened fully to the normal upper pool and tailwater el 135. Riprap No. 9 washed downstream as shown in Photo 19. Test results indicated that a significant amount of additional riprap will be required if the downstream ends of the barges are placed much higher than el 91.5. Since the Riprap No. 9 failed with the tailwater at el 135, tests were not conducted with lower tailwater.

Photo 18. Failure of Riprap No. 8 downstream from a group of raised barges

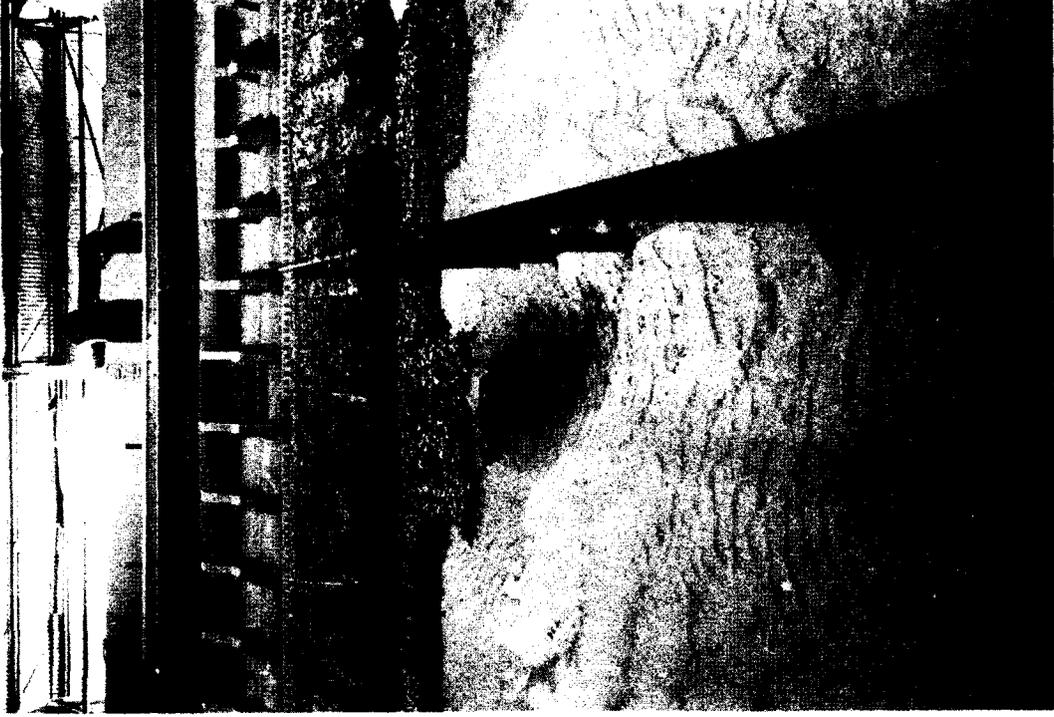
Apparently, the group of raised barges caused the flow to attack the area downstream from these barges more severely than if the barges were lowered. An additional thickness of Riprap No. 7 was required at the downstream ends of the barges that had been raised 6 ft to prevent loss of material beneath the raised barges. The lateral transition of the riprap downstream from a barge raised 6 ft to a barge lowered 6 ft is not desirable due to the formation of

Photo 19. Failure of Riprap No. 9 placed downstream from a group of barges raised 6 ft higher than original placement

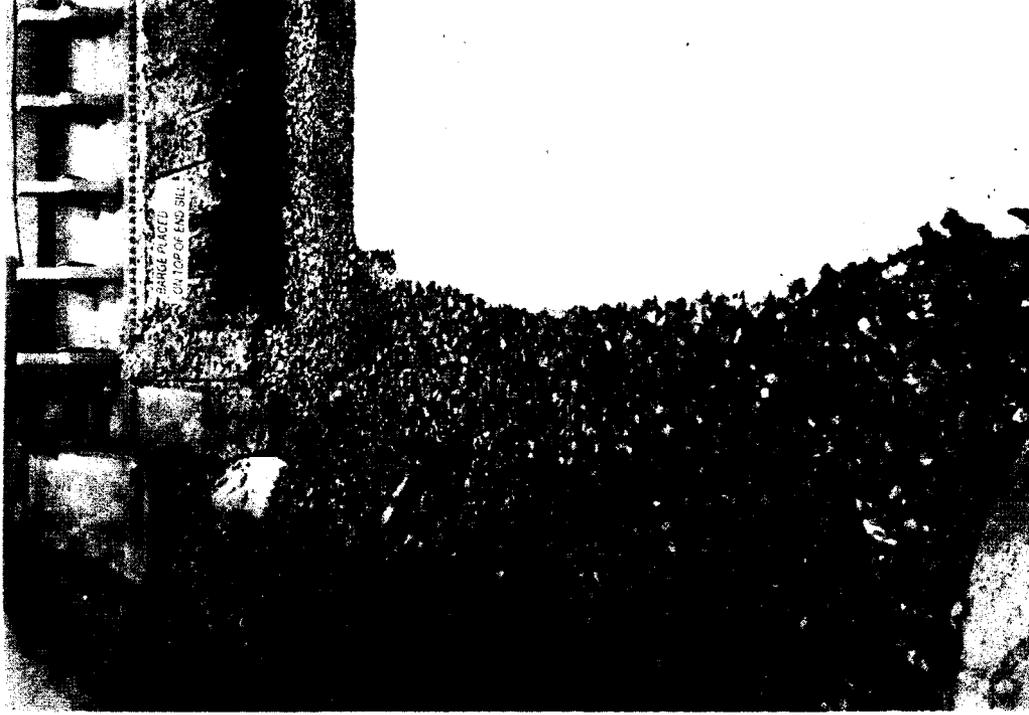
Tests were requested by the Little Rock District to determine the stability of the scour protection in case a barge was not placed properly and the upstream end of the barge became lodged on the end sill. A test was initiated with a barge between gates 15 and 16 placed on the end sill. The test was conducted for 2 hr (prototype) with gate 16 opened fully to the normal upper pool and tailwater el 113. Severe riprap displacement occurred along the side slope as shown in Photo 21. The raised barge concentrated flow downstream from gate 16 and prevented it from spreading out. This caused direct attack on the side slope riprap. Another test was conducted depicting this type placement behind gate bay 7. The same test conditions were observed, but for 8 hr (prototype), and no riprap failure occurred. The end of the barge acted as a baffle deflecting the jet upward and downstream, and the spray falling back to the water surface was not strong and concentrated. Therefore, riprap failure did not occur. The flow conditions caused by the raised barge are undesirable, and much emphasis should be placed on constructing the barge revetment as uniformly as possible.

Photo 21. Failure of Riprap No. 7 on right bank due to barge on end sill
