11. TITLE (Include Security Classification)
ARMY AIRCRAFT FIRE-DETECTION SYSTEMS OPERATION AND RELIABILITY.

**ARMY
AIRCRAFT
FIRE-DETECTION
SYSTEMS
OPERATION
AND RELIABILITY**

This report evaluates the results of a July 1993 study of fire indications on board Army aircraft. Although the focus was the aircraft fire-detection system, other areas involving "potential" fire, such as smoke and sparks, were included and evaluated.

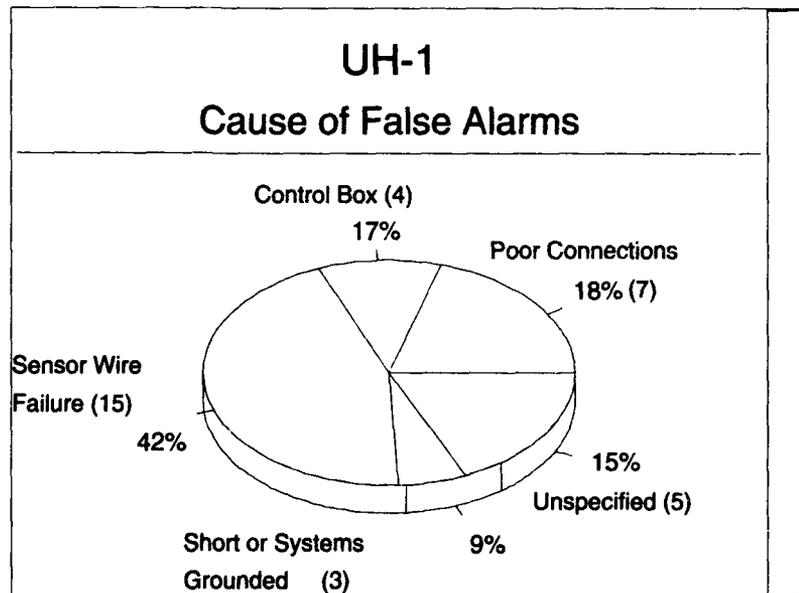
The UH-1 fire-detection system is manufactured by Edison; it has two sensing elements, each 215 inches long. The elements have a single-wire core design, which changes resistance as the element is heated. The element is held in place along the cowling by clamps and is interconnected into the system using connectors/cannon-type plugs. In the 34 fire-warning-system activations, the UH-1 crews landed immediately (as required) in all but two cases. All indications were false. The 34 fire-warning activations could be broken down as shown in the chart below.

The data for fire-warning-light indications has remained generally constant for the past 5 years, accounting for about half of all fire indications.

(2) Replacing or modifying sense elements used on the AH-1, UH-1, and OV-1 with elements having a minimum number of connections, which account for over 15 percent of all false alarms.

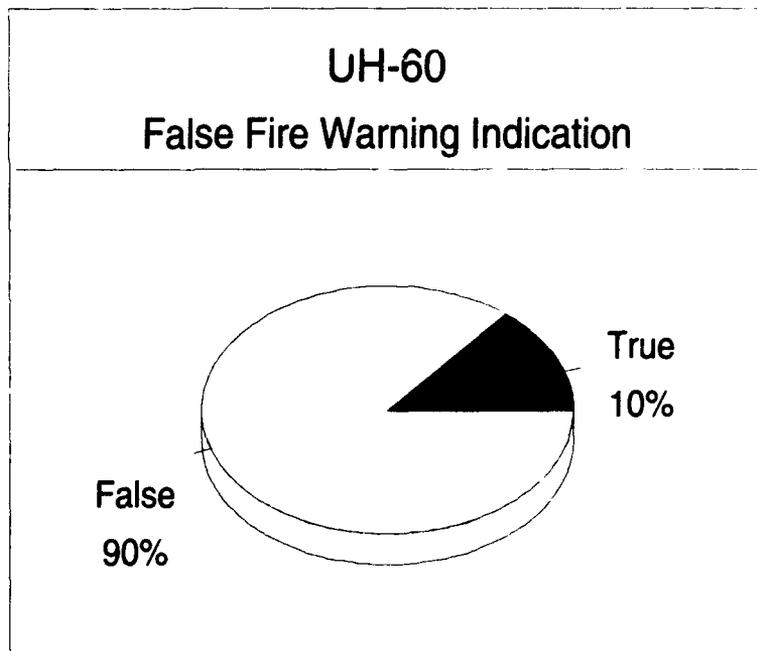
Four (about 10 percent) of the 48 fire-warning-system activations were accurate. Therefore, the false-alarm rate was about 90 percent. Of the four accurately triggered fire-warning activations, one was for the auxiliary power unit (APU) and the other three were for the engine. In two of the three related to the engine, the cause was a leaking fuel line or fitting where vaporizing fuel flashed into a fire. However, due to convective air movement, the fires would self-extinguish and de-activate the fire-warning light. In one of the two cases, the crew landed as soon as possible commensurate with the fire warning annunciation emergency procedures. However, in the second case, the crew considered the light a probable false

The causes of the fire indications could be broken down as shown in the chart below.

(1) Replacing outdated flame detectors currently installed on the UH-60, AH-64, C-12, and U-21 with sensing wire (which use a minimum number of connections), pneumatic detectors, or new generation flame detectors.

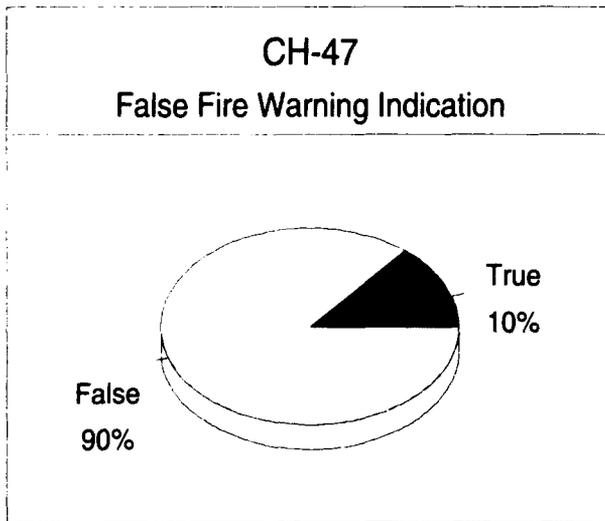
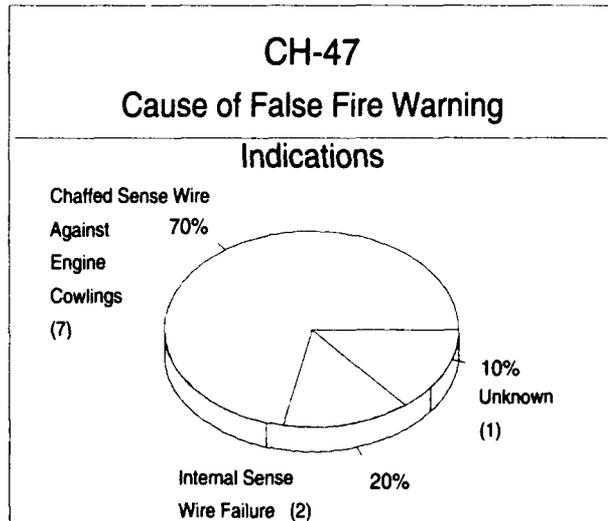
The CH-47 fire-detection system uses a sensing element manufactured by Fenwal. Each engine has three interconnected elements that are attached to the engine itself. The elements are of a core design whose ceramic-insulated center core resistance changes with heat. Of the 11 fire indications by the onboard system, only one was correct. The other 10 (about 90%) were false indications. The false indications resulted from the following:

| 7 | Chaffed sense wire against engine cowlings | 70% |

Seventy percent of the CH-47's high false alarm rate is easily affected by simple precautions (against chaffing) when the engine nacelles are closed.

d. Develop a program for the CH-47 engine nacelle cowling installation. The cowlings account for over 70% of all CH-47 false alarms due to chaffing against the sense elements.

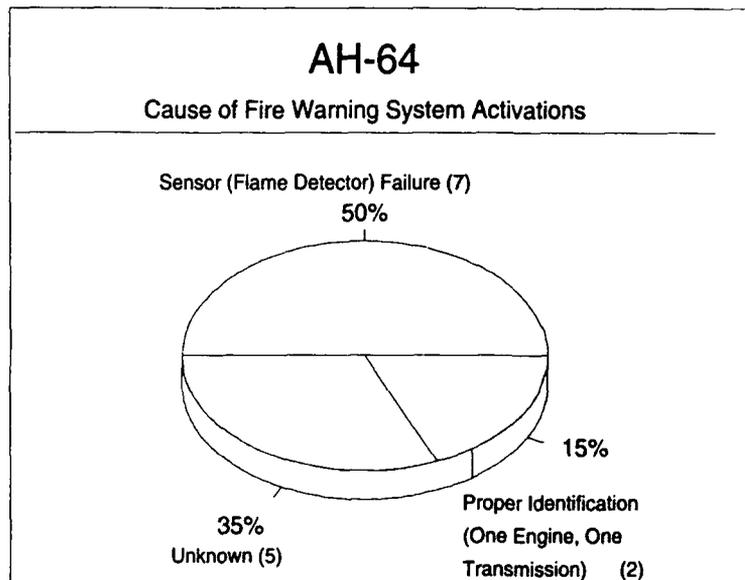
Of the 14 fire-warning activations from the fire-detection system, two fires were properly (system) identified and one of those two properly extinguished. The AH-64 has the lowest false-alarm rate of helicopters—about 85 percent. Its breakdown is as follows:

| 7 | Sensor (flame detector) failures | 50% |
| 5 | Unknown (not reported) failures | 35% |
| 2 | Proper identification (1 engine, 1 transmission) | 15% |
