US Army Corps
of Engineers
Waterways Experiment
Station

Technical Report SL-93-22
November 1993

Assessment of Accident at Radford Army Ammunition Plant

Final report

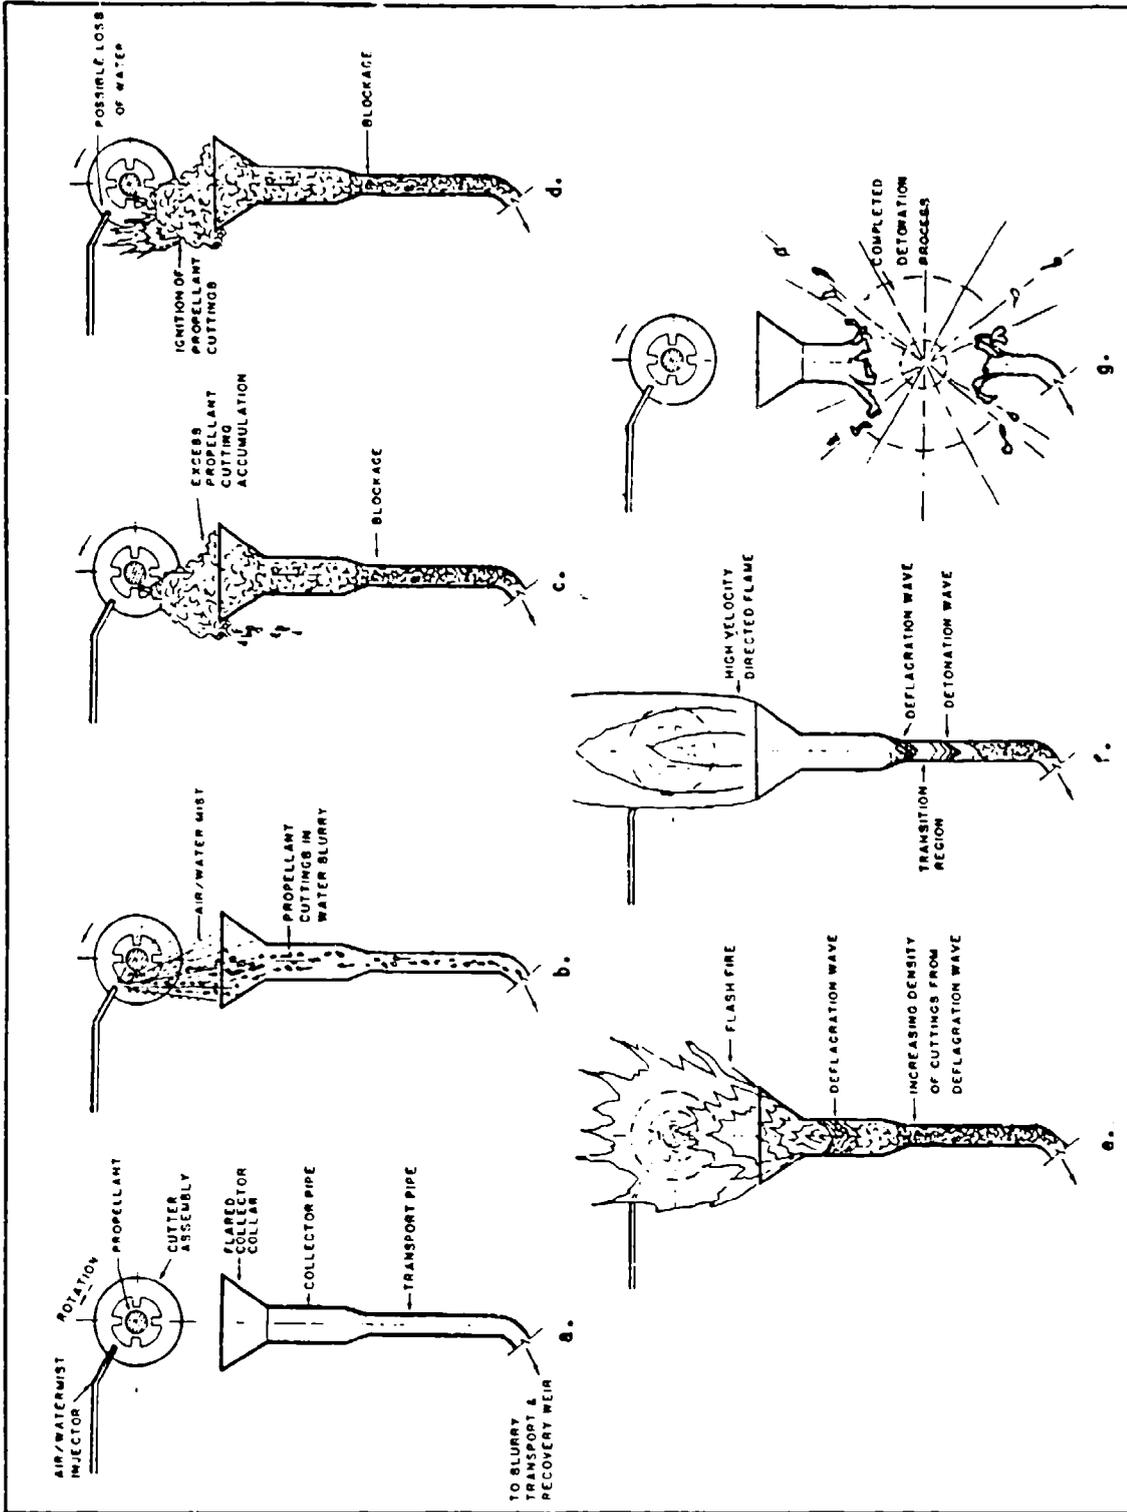
Figure 1. Postulated point of detonation and detonation sequence

- a. Cutting transport system failed (Figure 1c).
- b. Or did not remove the accumulated cuttings rapidly enough.
 - (1) The machinist may have been cutting the propellant at too rapid a rate.
 - (2) A portion of the propellant may have broken off and lodged in the removal pipe, causing a blockage.

- (3) The air/water mist system may have failed, leaving only dry, compressed air to remove the cuttings (Figure 1d).
- (4) Any combination of b(1) through b(3) could have occurred.

- c. An excess of propellant cuttings accumulated up to the vicinity of the cutter head (Figure 1d).
- d. The excess, dry cuttings were ignited (Figure 1d).

- (1) From excess heat build-up.
 - (2) From a spark.
 - (3) From static build-up and discharge.
- f. The subsequent deflagration propagated into the discharge pipe (which likely was full of dry propellant cuttings), Figure 1e.

- g. The deflagration velocity jumped to detonation wave speed (Figure 1f)
 - (1) If sufficient confinement was present.
 - (2) If the pressure remained or increased such that the detonation wave was sustained (Figure 1f).

- h. An explosion would have then been probable (Figure 1g).
- i. Sympathetic detonation of the remaining propellant "dowels" could have occurred (if it was not already consumed by the initial fire).
