NAVY EXPERIMENTAL DIVING UNIT

REPORT NO. 12-93

CONTAMINATED WATER DIVING SYSTEM (CWDS) EVALUATION

DECEMBER 1993

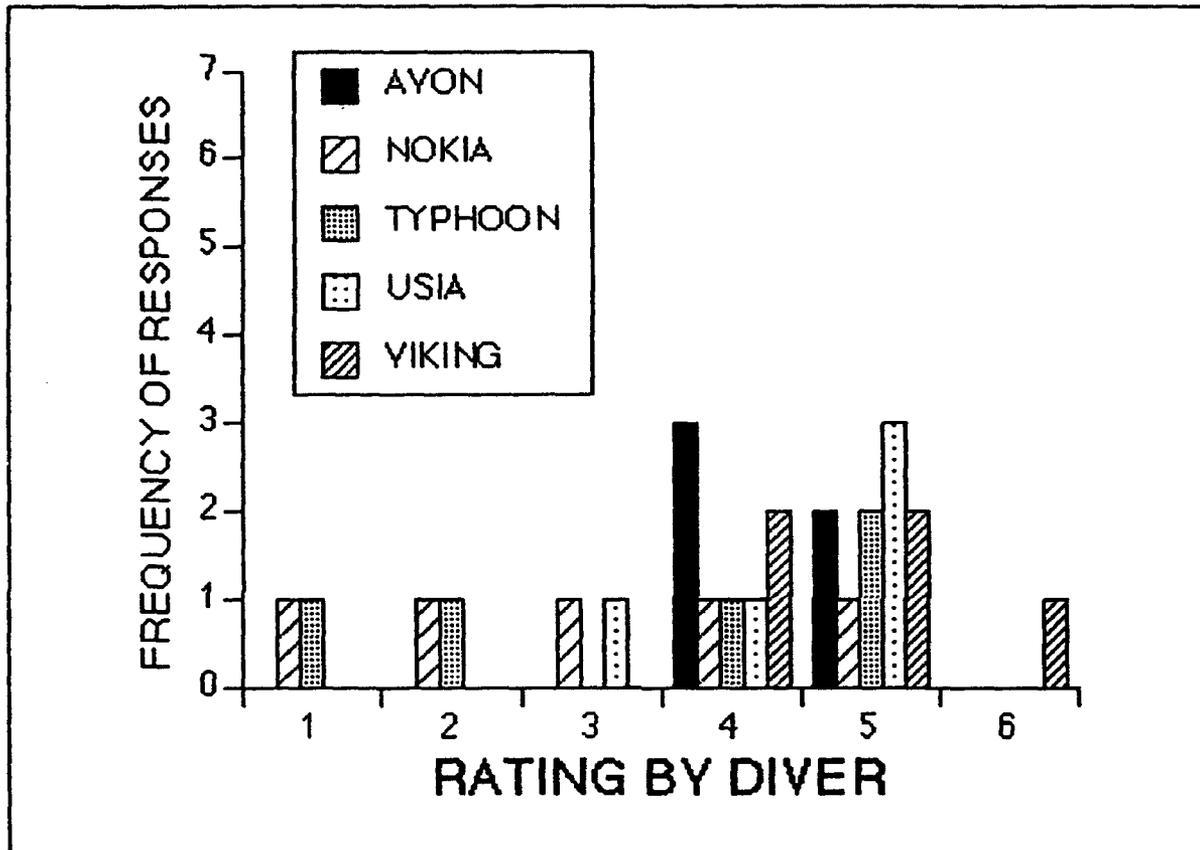
Figure 1

DONNING THE SUIT WITH ASSISTANCE FROM A TENDER (Figure 1): The Nokia suit received one *extremely poor*, one *poor*, and one *not quite adequate* rating (2). The Typhoon suit received one *extremely poor* and one *poor* rating (3). The USIA suit received one *not quite adequate* rating (4). The Ayon suit received one *adequate* rating (4), one *good* rating (5), and one *excellent* rating (6). The Viking suit received one *adequate* rating (4), one *good* rating (5), and one *excellent* rating (6).

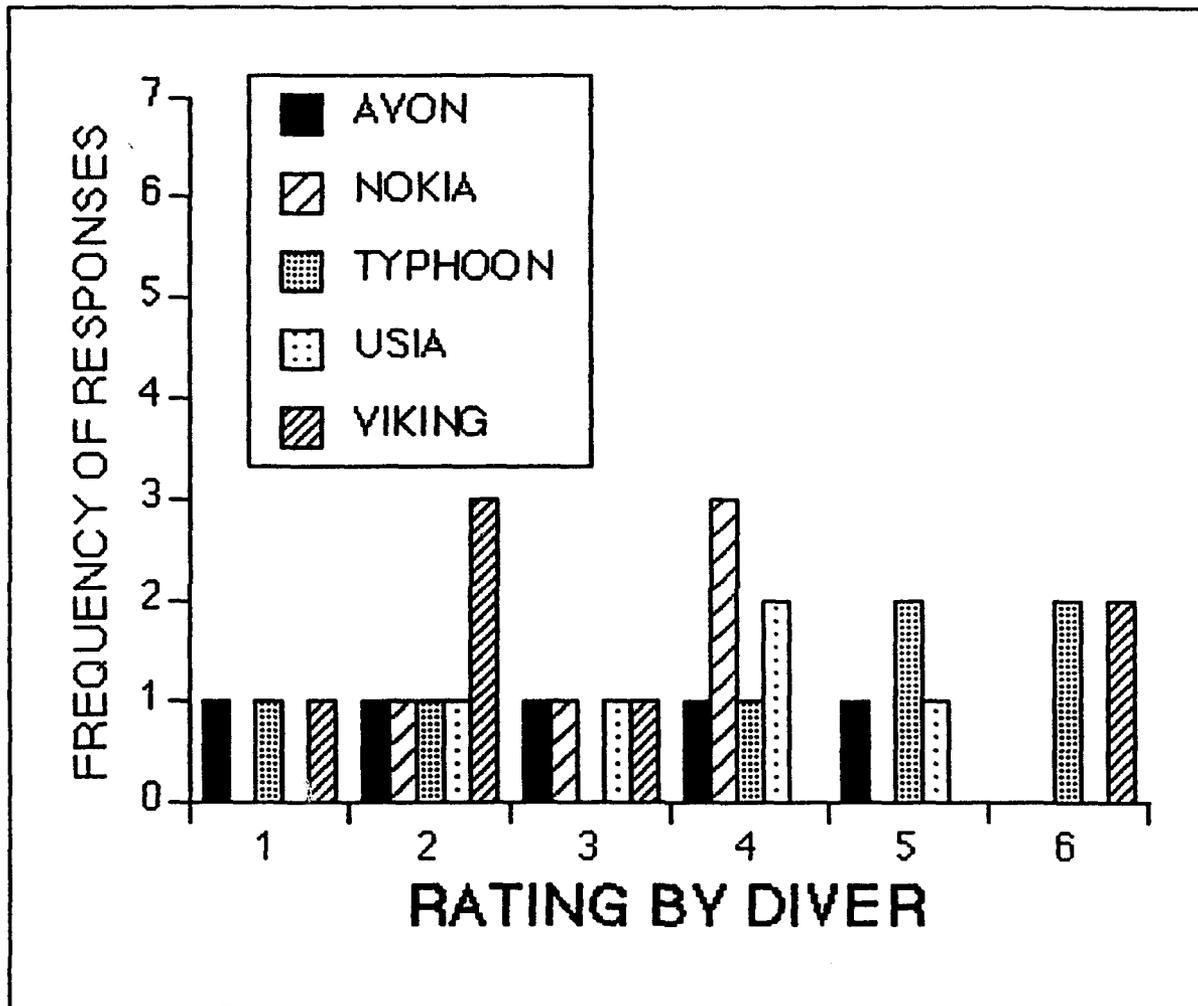
Figure 2

DONNING THE SUIT UNASSISTED (Figure 2): The Avon suit received one *extremely poor*, one *poor*, and one *not quite adequate* rating (2). The Nokia suit received one *poor* and one *not quite adequate* rating (3). The Typhoon suit received one *extremely poor* and one *poor* rating (5). The USIA suit received one *poor* and one *not quite adequate* rating (3). The Viking suit received one *extremely poor*, three *poor*, and one *not quite adequate* rating (2).

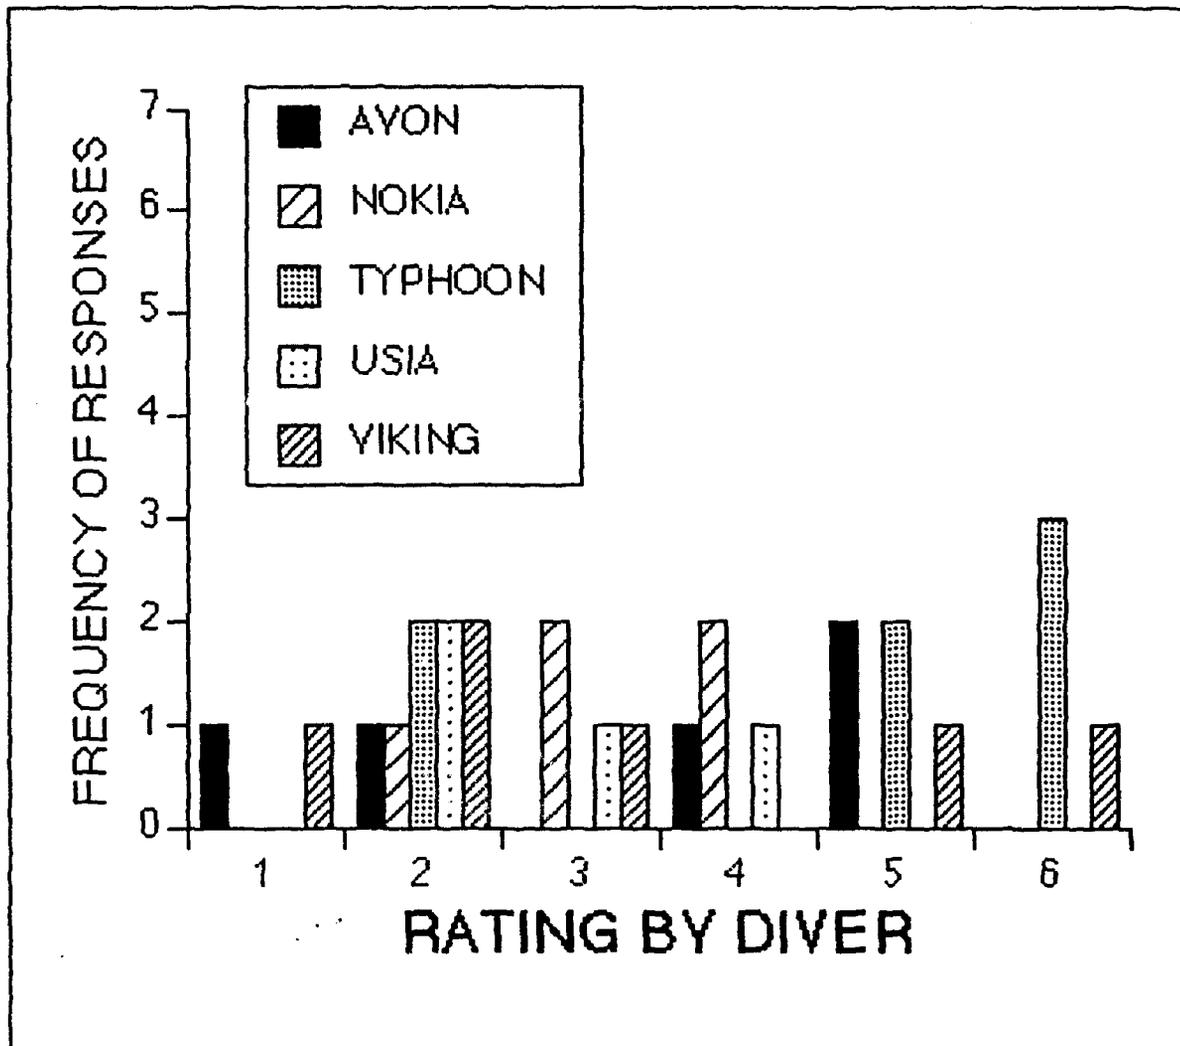
Figure 3

DOFFING THE SUIT UNASSISTED (Figure 3): The Avon suit received one *extremely poor* and one *poor* rating (3). The Nokia suit received one *poor* and two *not quite adequate* ratings (2). The Typhoon suit received two *poor* ratings (5). The USIA suit received two *poor* and one *not quite adequate* rating (1). The Viking received one *extremely poor*, two *poor*, and one *not quite adequate* rating (2)

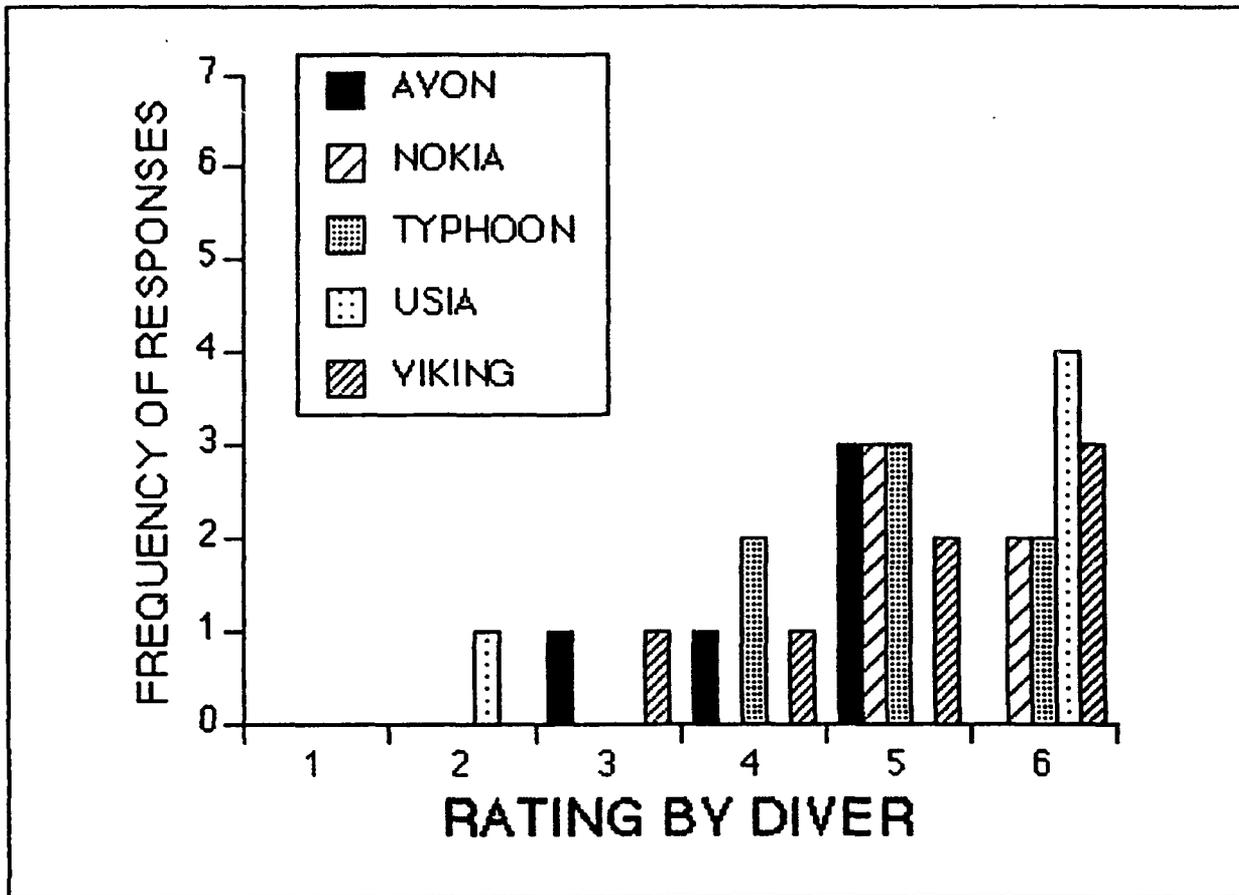
Figure 4

OVERALL COMFORT OF THE SUIT (Figure 4): The Avon suit received one *not quite adequate* rating (4). The USIA suit received one *poor* rating (4). The Viking suit received one *not quite adequate* rating (6).

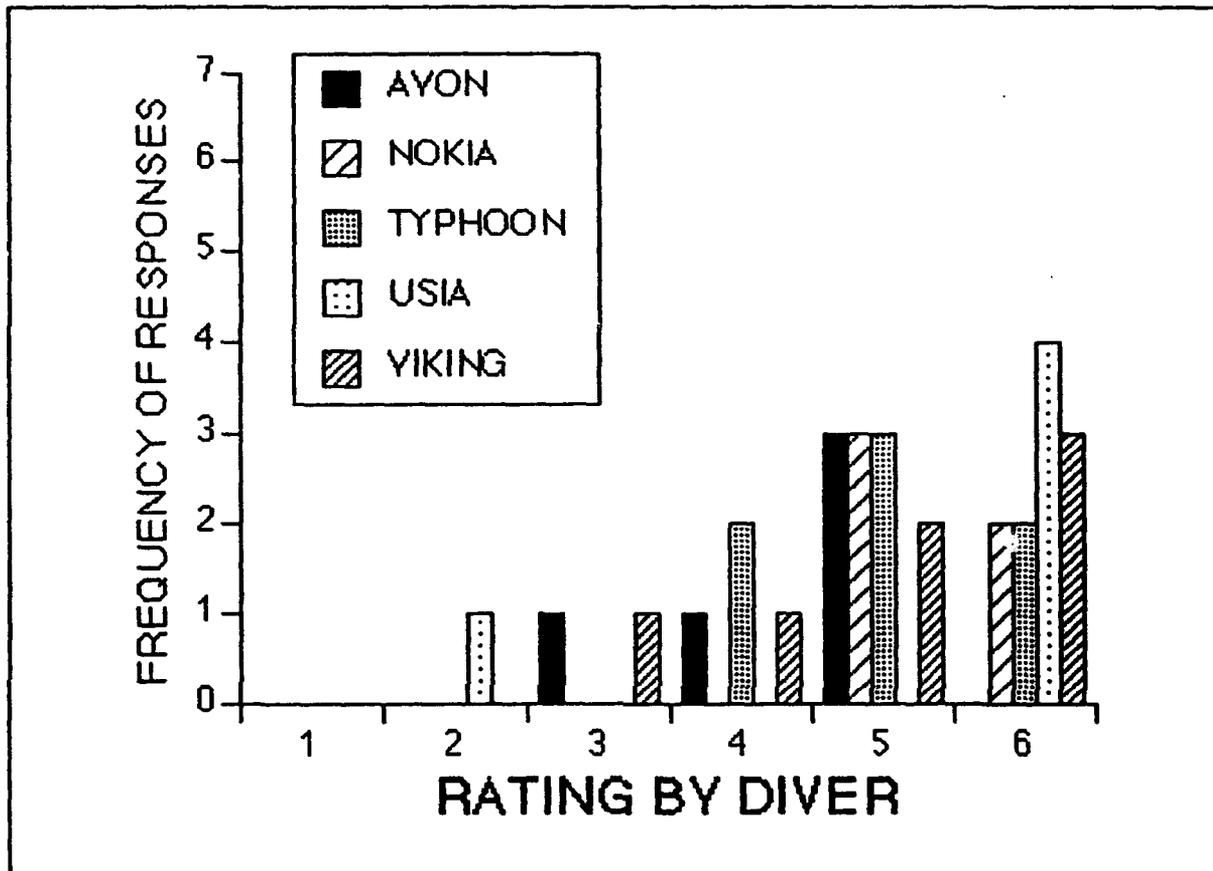
Figure 5

COMFORT OF THE SUIT IN TERMS OF BUOYANCY CONTROL (Figure 5):
 The Avon suit received one *poor* and one *not quite adequate* rating (3). The Typhoon suit received one *not quite adequate* rating (6); and the Viking suit received one *not quite adequate* rating (5).

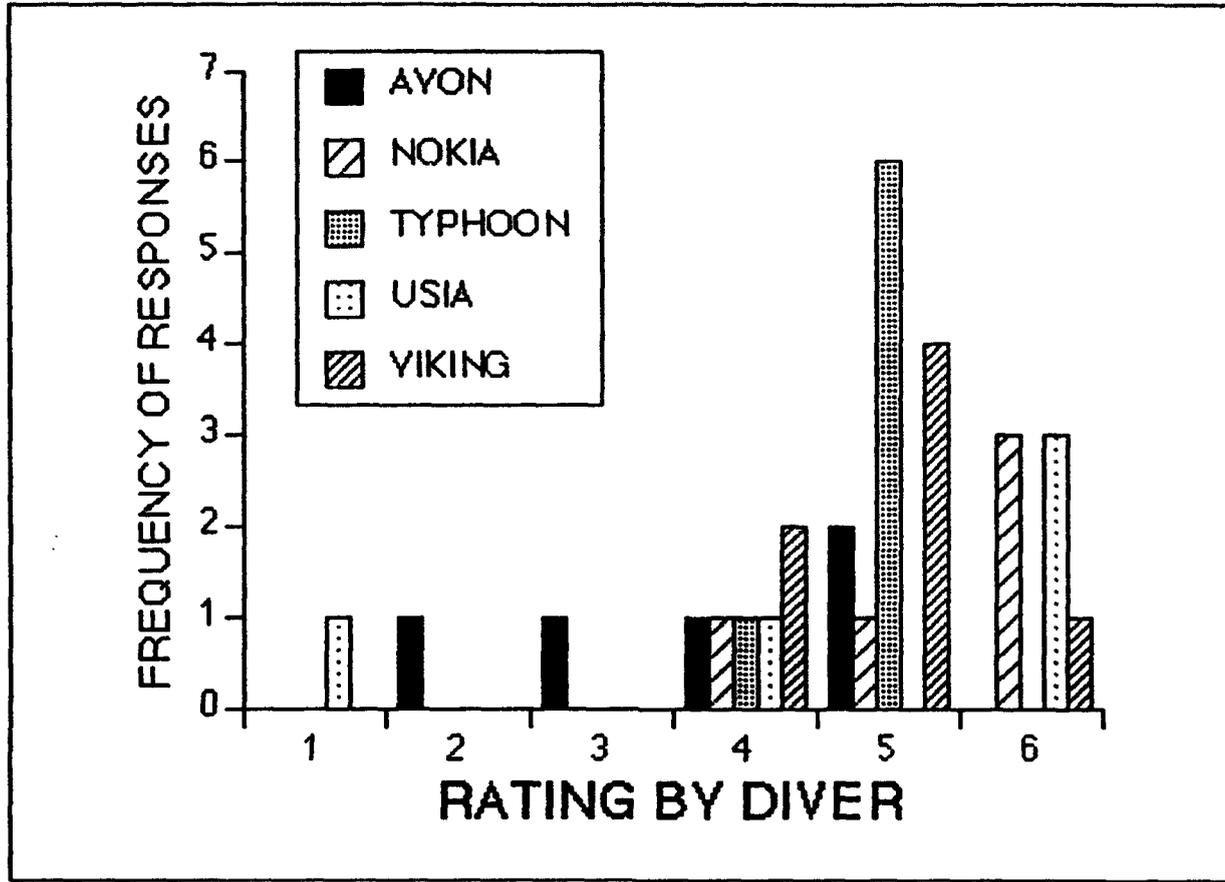
Figure 6

SIZE OF THE SUIT (Figure 6): The Avon suit received one *poor* and one *not quite adequate* rating (3). The USIA suit received one *extremely poor* rating (4).

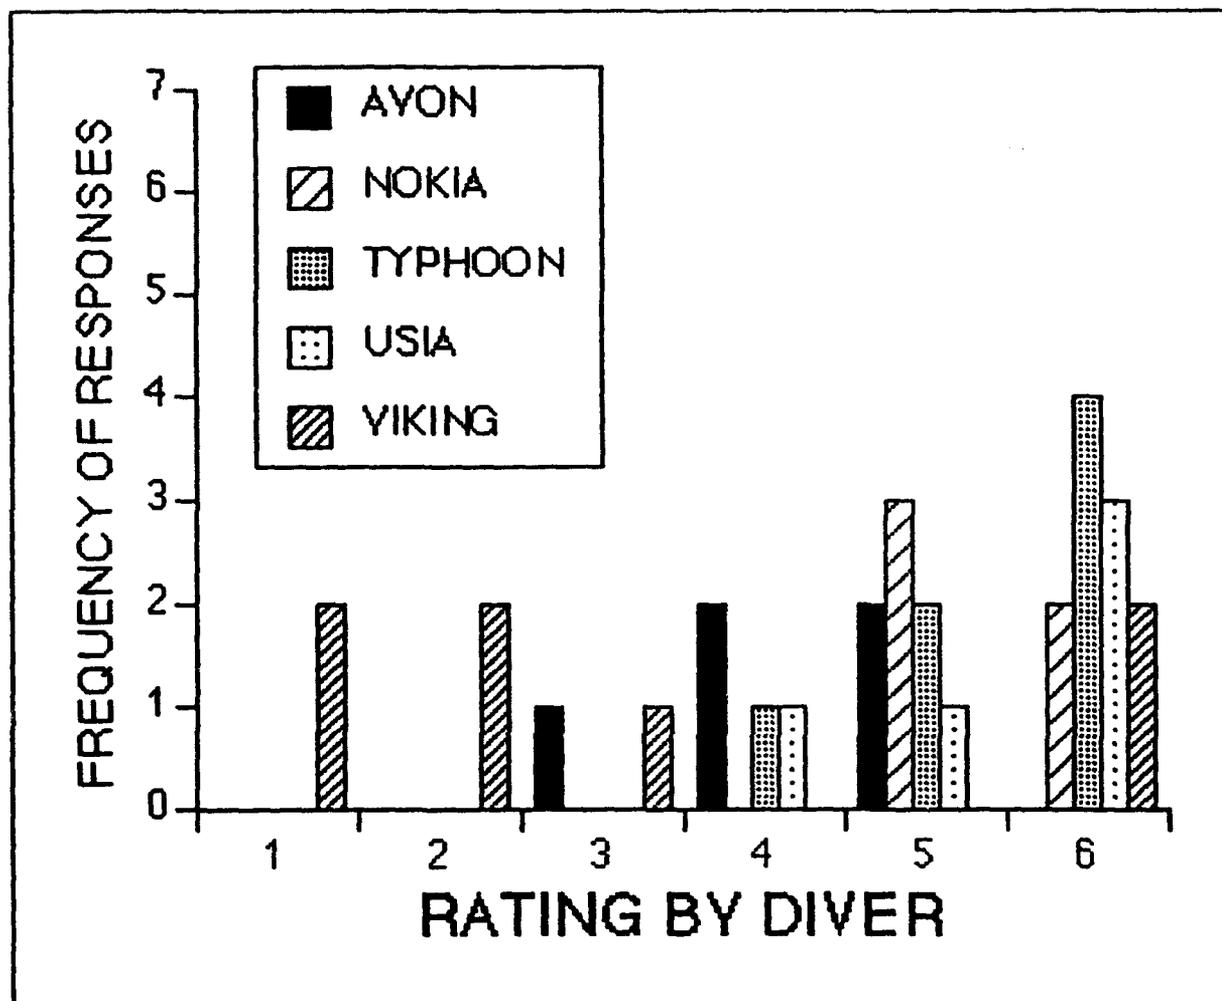
Figure 7

LOCATION OF THE INFLATION VALVE (Figure 7): The Avon suit received one *not quite adequate* rating (4). The Viking suit received two *extremely poor*, two *poor*, and one *not quite adequate* rating (2).

7) Three divers complained that the inflator valve was in a very poor position, increasing the possibility of accidental inflation from the weight-bearing harness strap, perhaps causing blow-up.

Divers complained about valve placement, particularly in the Viking suit. Nonetheless, valves can be easily relocated on existing suits by a qualified

technician, and manufacturers are generally very accommodating when receiving special valve location requests when new suits are being ordered.

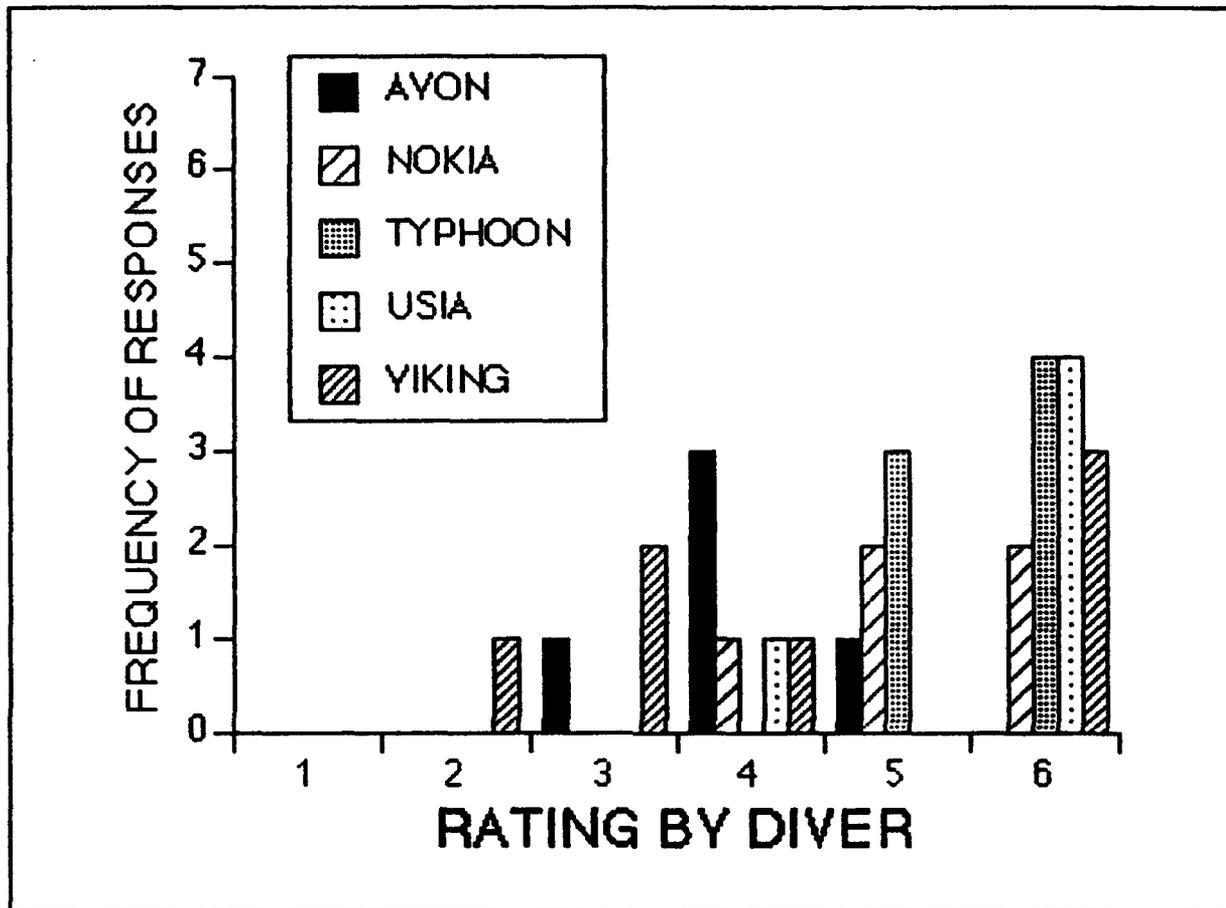
Figure 8

OPERATION OF THE INFLATION VALVE (Figure 8): The Avon suit received one *not quite adequate* rating (4). The Viking suit received one *poor* and two *not quite adequate* ratings (4).

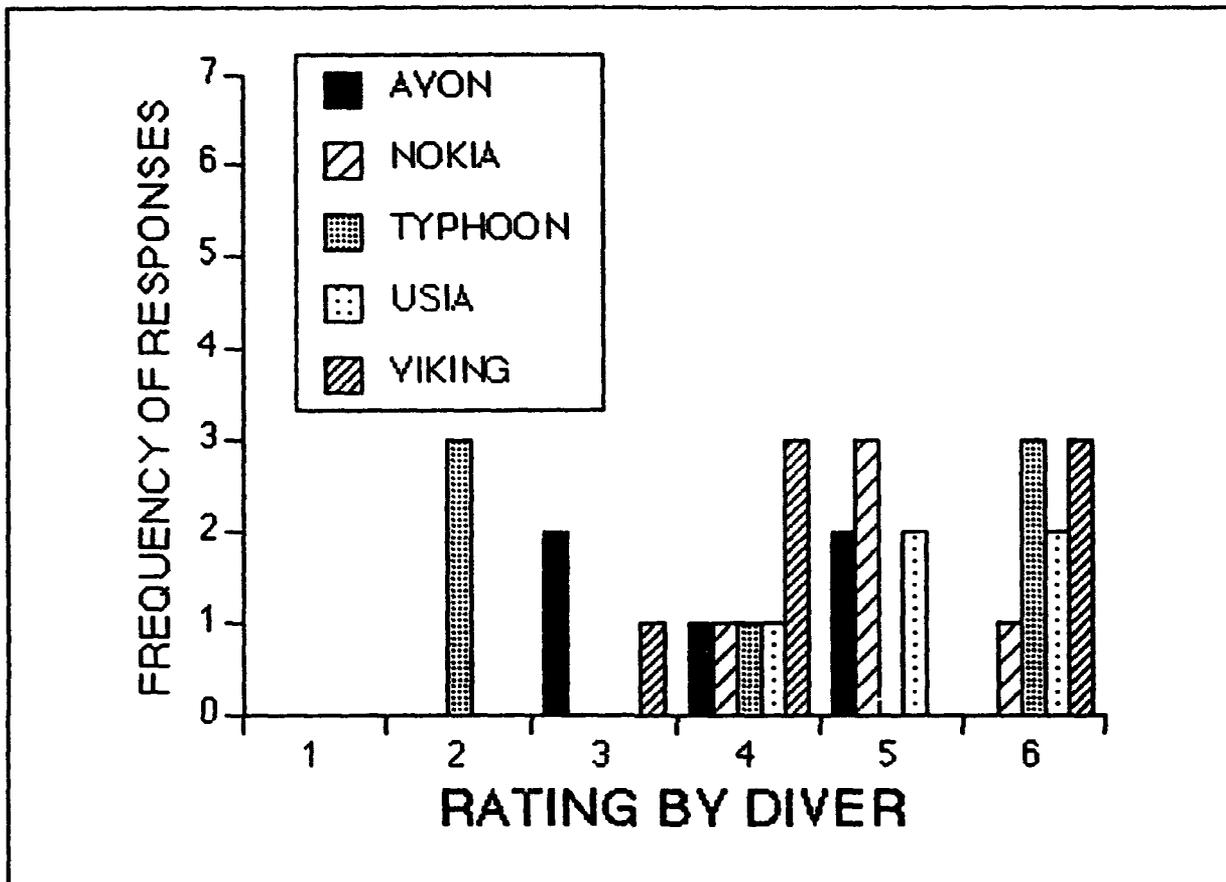
Figure 9

LOCATION OF THE EXHAUST VALVE (Figure 9): The Avon suit received two *not quite adequate* ratings (3). The Typhoon suit received three *poor* ratings (4). The Viking suit received one *not quite adequate* rating (6).

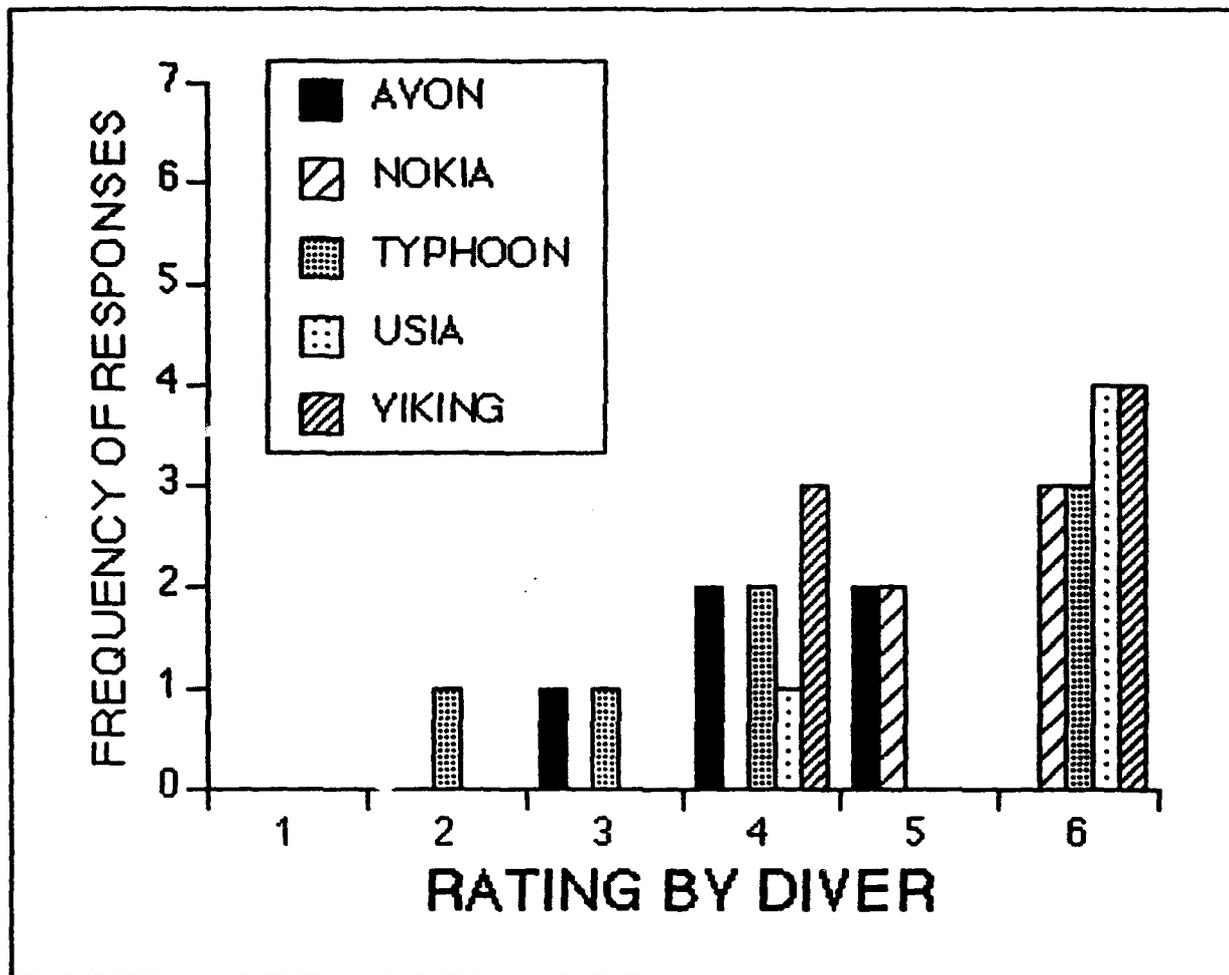
Figure 10

OPERATION OF THE EXHAUST VALVE (Figure 10): The Avon suit received one *not quite adequate* rating (4). The Typhoon suit received one *poor* and one *not quite adequate* rating (5).

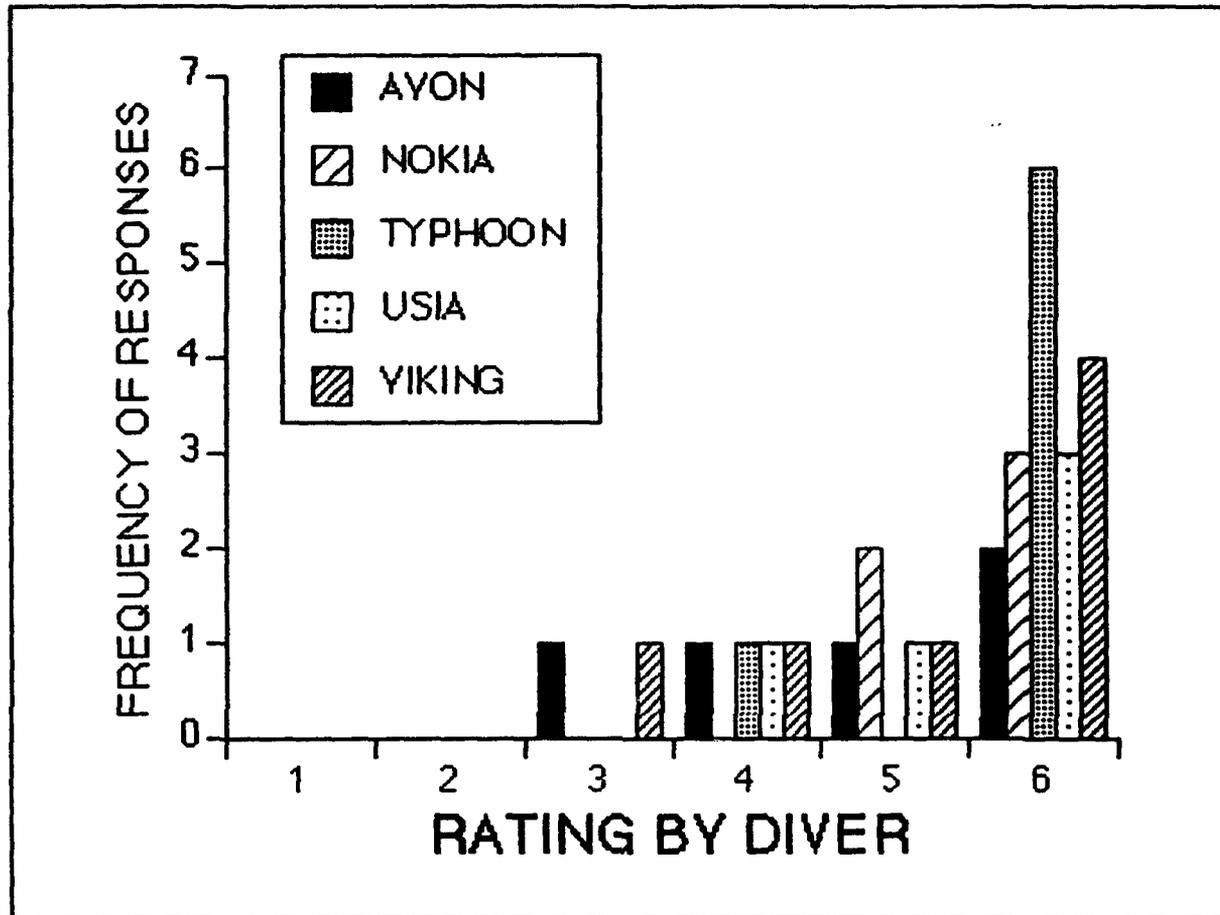
Figure 11

ABILITY OF THE SUIT TO KEEP THE DIVER DRY (Figure 11): The Avon suit received one *not quite adequate* rating (4). The Viking suit received one *not quite adequate* rating (6).

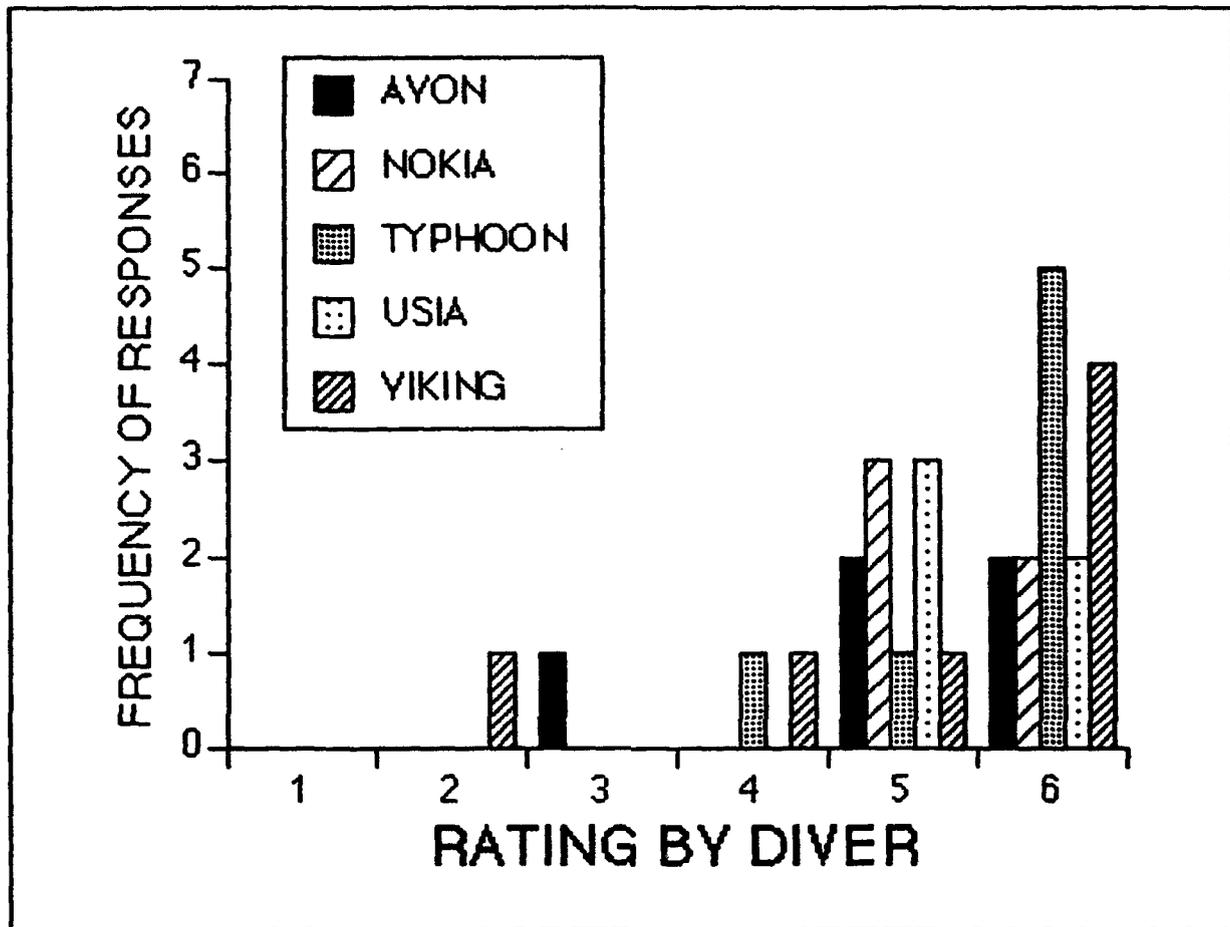
Figure 12

USE OF THE SUIT FOR CONTAMINATED WATER USE (Figure 12): The Avon suit received one *not quite adequate* rating (4). The Viking suit received one *poor* rating (6).

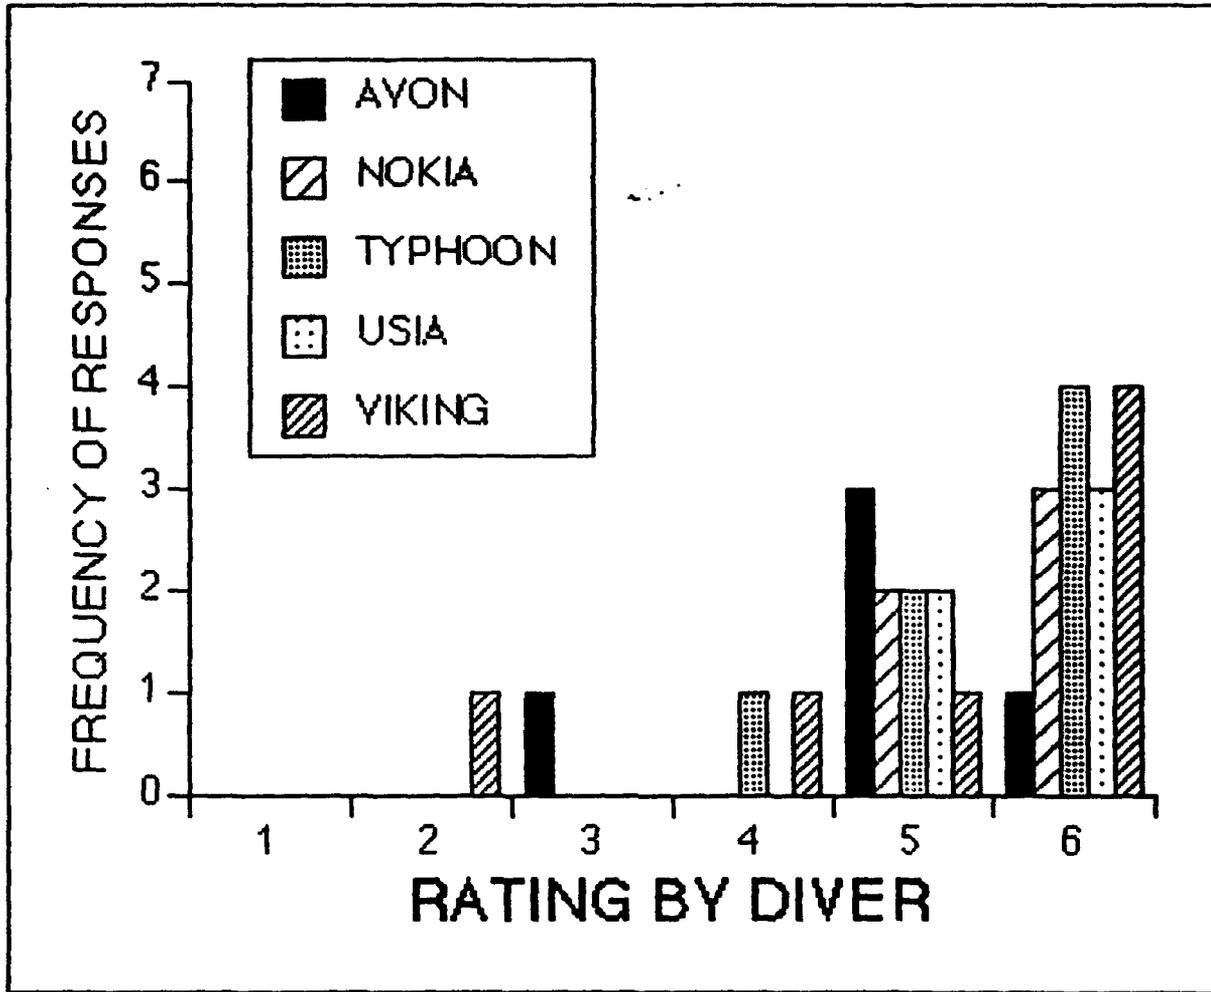
Figure 13

USE OF THE SUIT FOR COLD WATER DIVING (Figure 13): The Avon suit received one *not quite adequate* rating (4). The Viking suit received one *poor* rating (6).

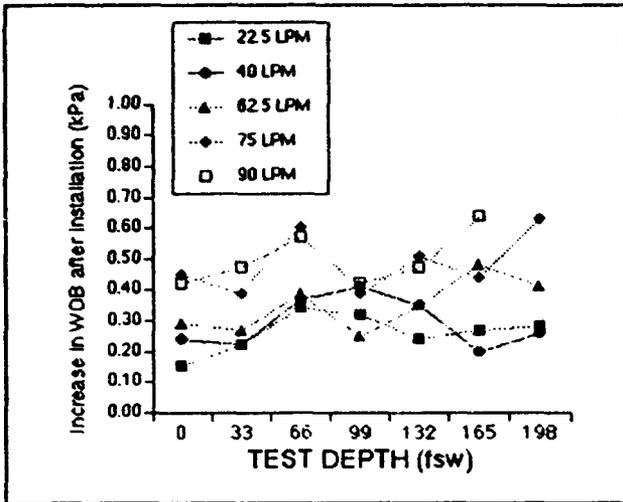
Figure 14

Results of WOB testing in the two MK 21 MOD 1 UBAs are summarized in Figures 14 and 15, and reported in Appendix B. The figures show the difference in WOB levels obtained from the regulators at each depth/RMV after installing the contaminated water kit, compared to levels obtained before the kits were installed.

The contaminated water kits magnified WOB levels somewhat in both UBAs, and in the worst-performing regulator WOB levels were elevated above 4 kPa at two depth/RMV combinations where this had not occurred before the contaminated water kit was installed.
