Research Report 13

**RESIDUAL STRENGTH OF COMPOSITES WITH MULTIPLE  
IMPACT DAMAGE**

JJ. PAUL  
S.C. GALEA  
R. JONES

MARCH 1994

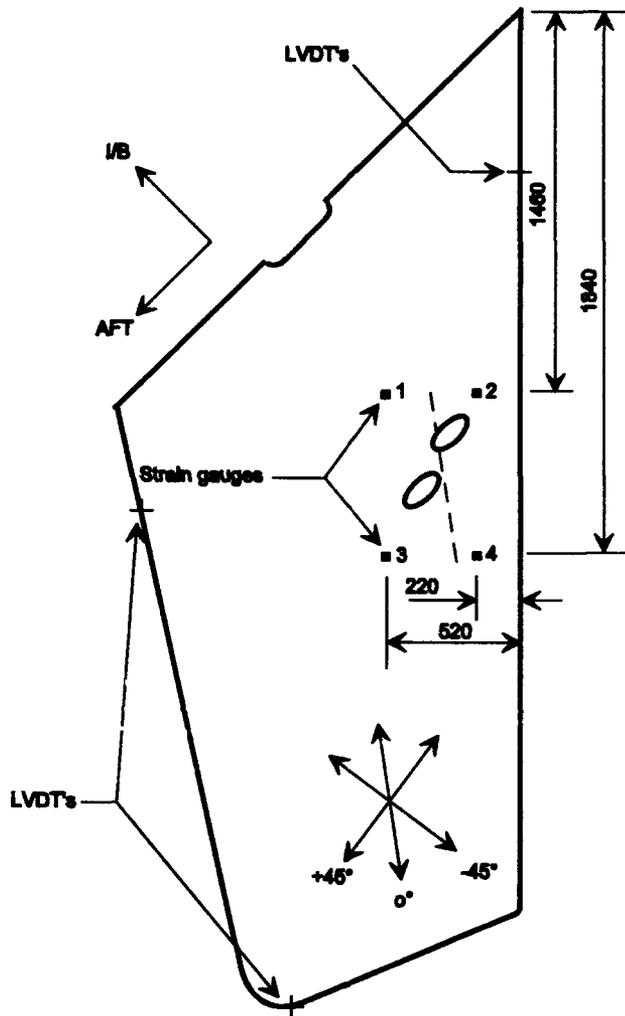
Four strain gauge rosettes were located in a rectangular pattern around the damage zone and in the corresponding location on the undamaged skin, see Figure 4. The gauges in each rosette were aligned in the direction of the  $0^\circ$  and  $\pm 45^\circ$  fibres. Two displacement transducers, on the upper and lower surface, were placed halfway between the inboard rosettes (1 and 2), in the  $0^\circ$  fibre direction, as seen in Figure 3. The gauge length of the displacement transducers was 385 mm. The strain gauge rosettes and displacement transducers were positioned so as to evaluate the change in compliance of the structure due to the damage.

The strain survey results for one loading cycle are shown in Table 3, for the case when a compressive load was applied to the damaged surface. The results for the case of tensile loads applied to the damaged surface are very similar. All strain values are presented in microstrain. Table 3 shows that there was no structurally significant difference between the strain gauge results, for strains in the 0° fibre direction, on the top (damaged) and the bottom (undamaged) surfaces except for gauge D2 which has a 24% to 27% reduction, depending upon the value of the RBM, due to damage. This may be due to the gauge being shielded by the damage. The compliance readings, tabulated at the bottom of the tables as 'U' for the undamaged surface strain and 'D' for the damage surface strain, show no significant difference between the top and bottom surfaces. This implies that the global compliance has not been affected by the damage and indicates that there is little structural degradation. This was confirmed by a thermal elastic evaluation of the damaged region, see [29].

Figure 4: Location of impact damage, strain gauges and displacement transducers on the CREDP F/A-18 horizontal stabilator.

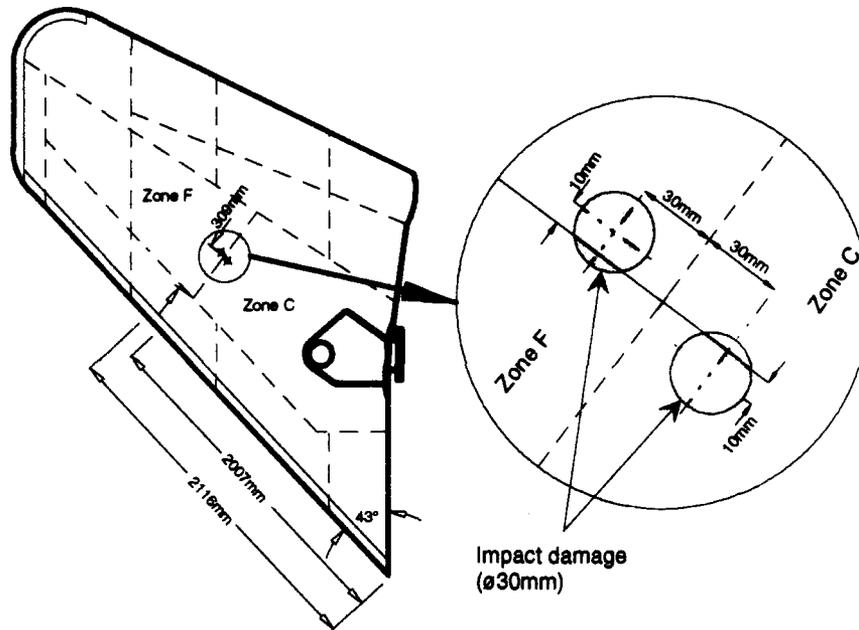
two sites on the top surface, thus inducing BVID in the composite skin. At each location the absorbed energy was approximately 12 Joules and the size of the damage was constrained to be approximately 30 mm in diameter. The distance between the two impact damage zones was approximately 30 mm (one diameter, as in the coupon test program). Of the two damage sites, see Figure 5, the one closest to the root was in a zone C which was classed as irreparable by the Structural Repair Manual (SRM). The second impact site was located in zone F. As such the SRM repair for the latter damage would have impinged into zone C thus, according to the SRM, this damage is also classed as irreparable. In zone C the ply configuration was [+45/-45/90/0/+45/0/-45/0/90/0/-45/0/45/0/90/-45/45], 17 plies, and in zone F the ply configuration was [+45/-45/90/0/+45/0/-45/0/90/-45/45], 15 plies, i.e. two 0° plies were dropped.

Figure 5: Location of impact damage on the IFOSTP F/A-18 horizontal stabilator.

An externally bonded doubler (patch) of dimensions 260 mm by 160 mm and ten plies thick, with a ply configuration of [+45/-45/90/0]<sub>S</sub>, was used to repair this damage. The doubler was designed to reduce the net section stress by approximately 35% thus reducing the stress at the damage locations to under 3000 µε at DLBM.
