August 1994

*Repair, Evaluation, Maintenance, and Rehabilitation Research Program*

# **Proceedings of REMR Workshop on Levee Rehabilitation**

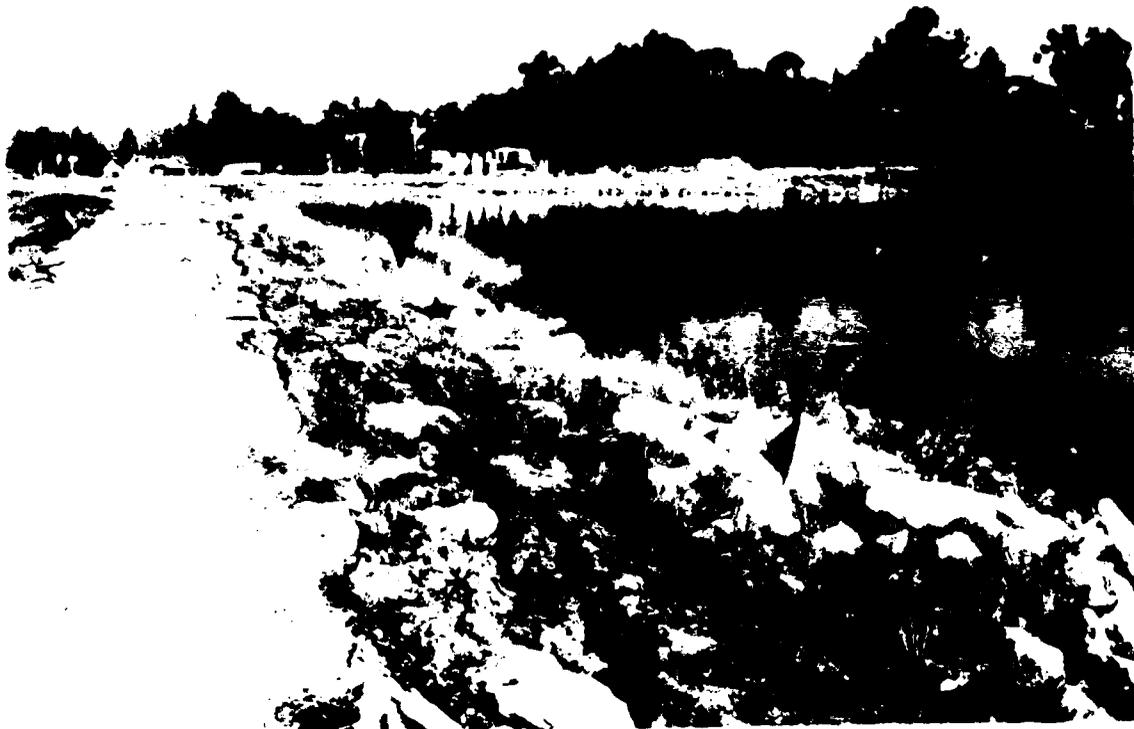
a. Closeup of cracks along crest of levee

Photo 1. San Lorenzo River levee, Loma Prieta earthquake damage

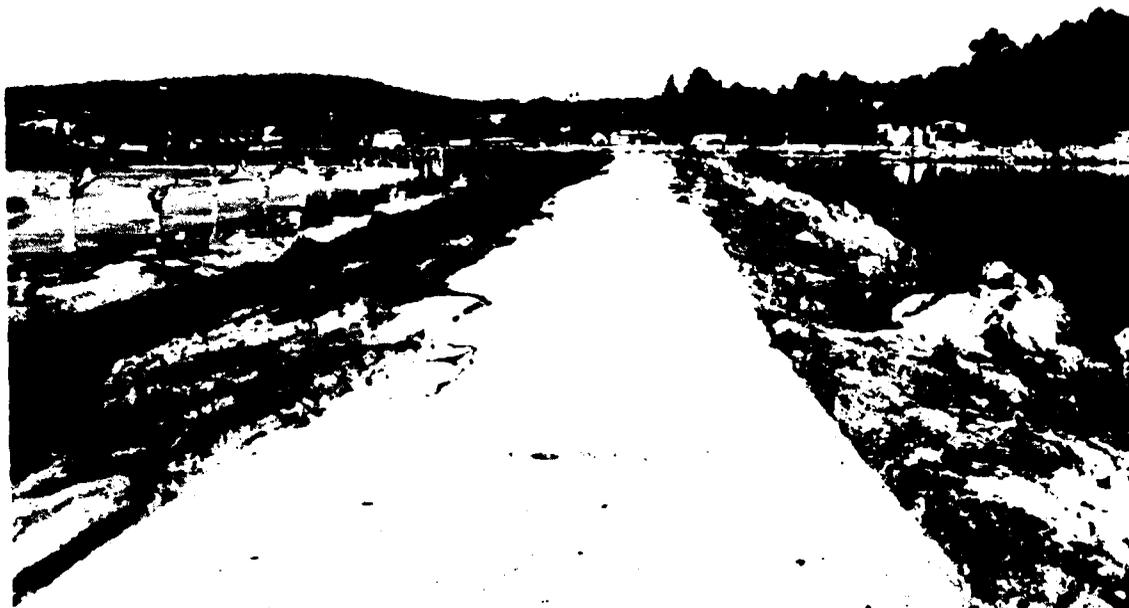
b. Damage along levee on right bank

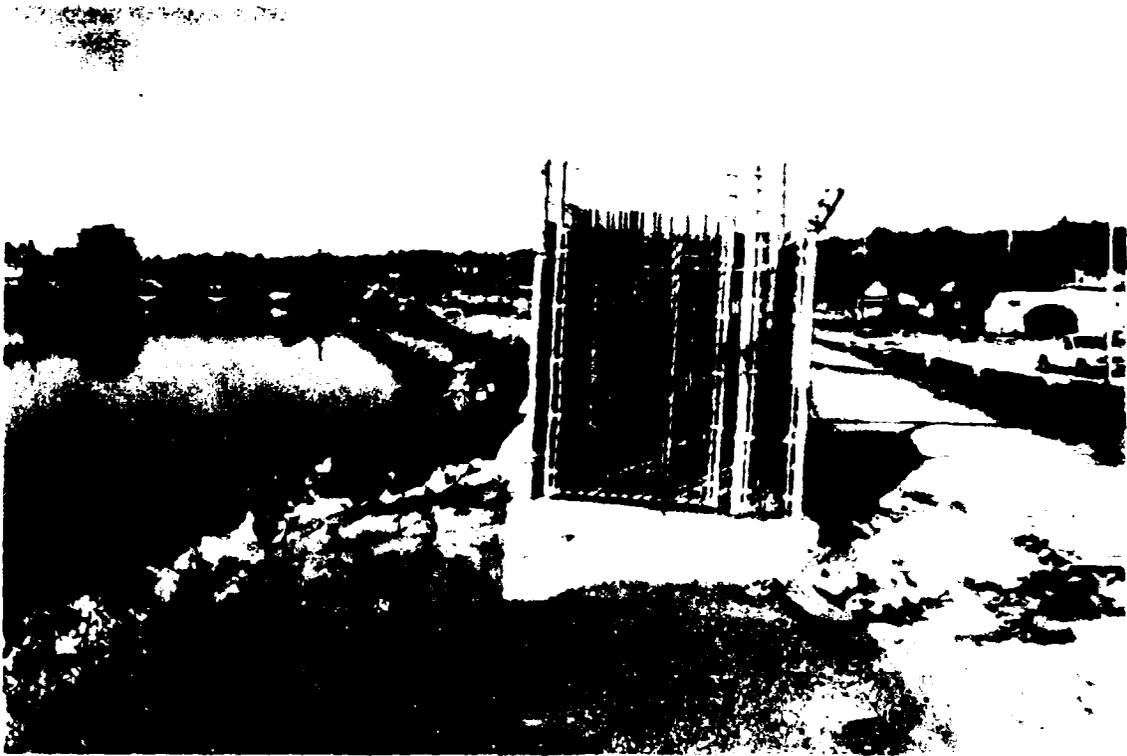
a. Damage at drainage structure, left bank levee (looking upstream)

Photo 2. San Lorenzo River, Loma Prieta earthquake damage

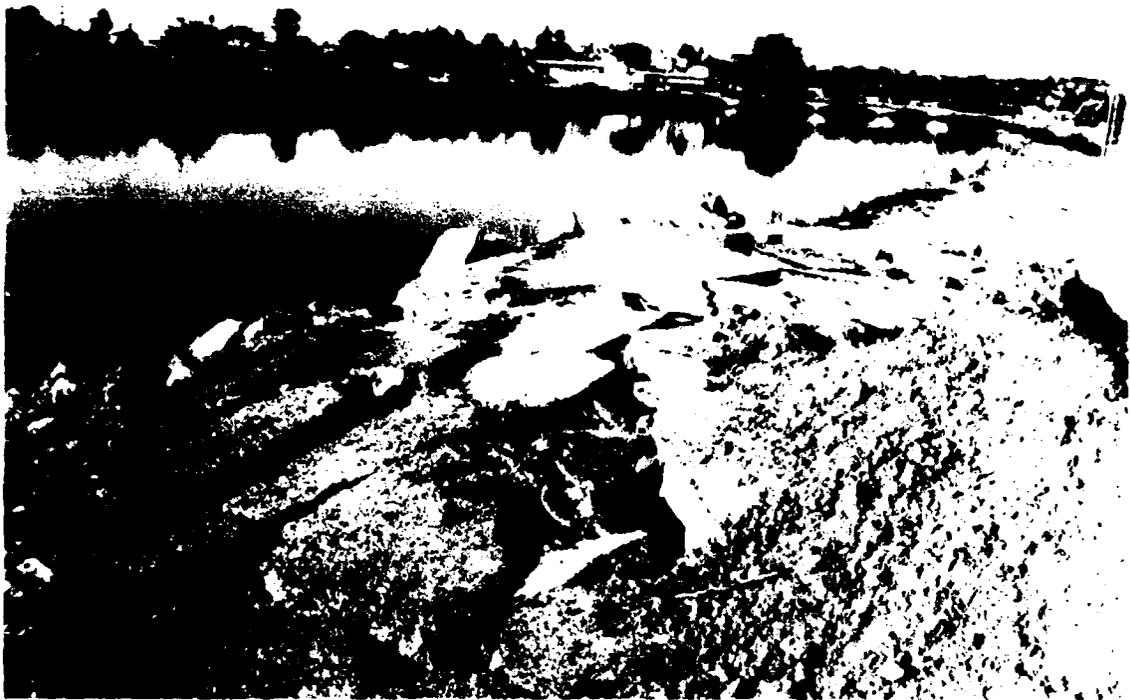
b. Damage to levee on left bank, San Lorenzo River, near mouth

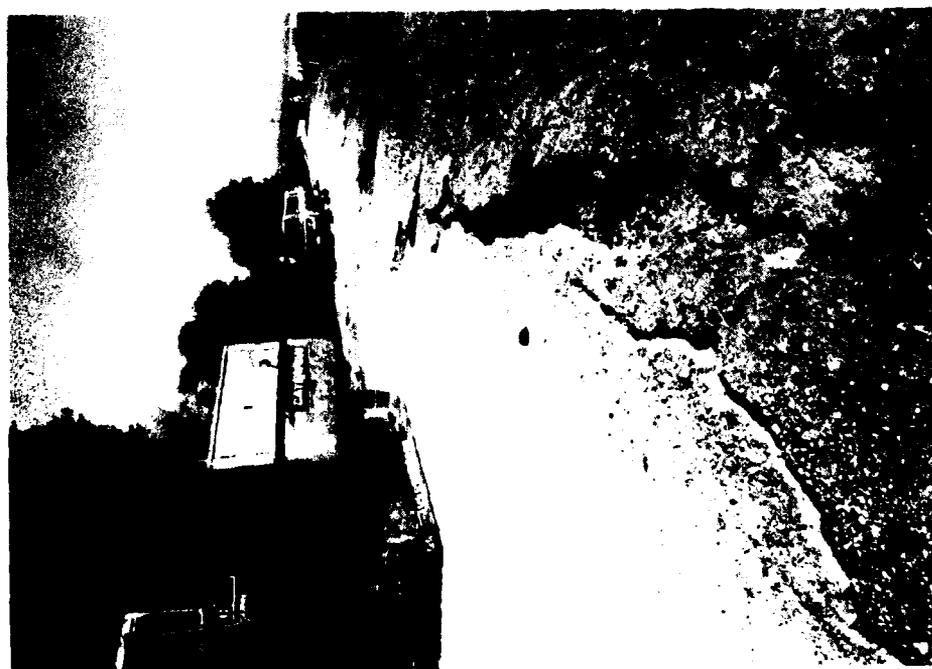
a. Cracks along crest

Photo 3. Typical damage to levees along Pajaro River
