DOT/FAA/CT-90/10

Fuselage Burnthrough from Large Exterior Fuel Fires

July 1994

Final Report

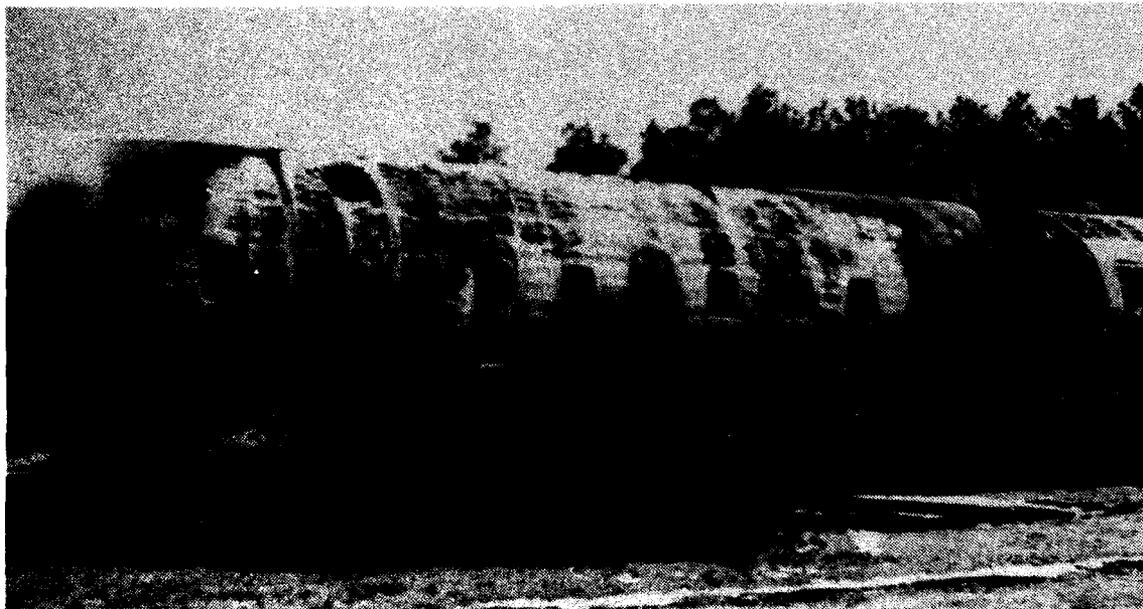
FIGURE 6. TEST 3 DC-8 CENTER SECTION FIRE DAMAGE

Skin Penetration. The skin aft of the wing (enclosing the wheel well) was completely melted away up to the top of the well (figures 6 and C-7). There was a small hole above the wheel well that went through the skin between the top of the wheel well and the cabin floor. Forward of the wing root the skin in the cheek area was melted through and the cargo liner was exposed. The liner was heavily charred but not penetrated. The window located directly above the trailing edge of the wing was completely consumed, allowing flame penetration into the cabin. The other windows exhibited varying degrees of damage but did not allow penetration. The skin both forward and aft of the wing above the melted sections was wrinkled and perforated. Both overwing exits were operable after the test. There was a 2- by 2-foot section above the trailing edge of the wing into the overhead section of the aircraft where the skin completely melted away.

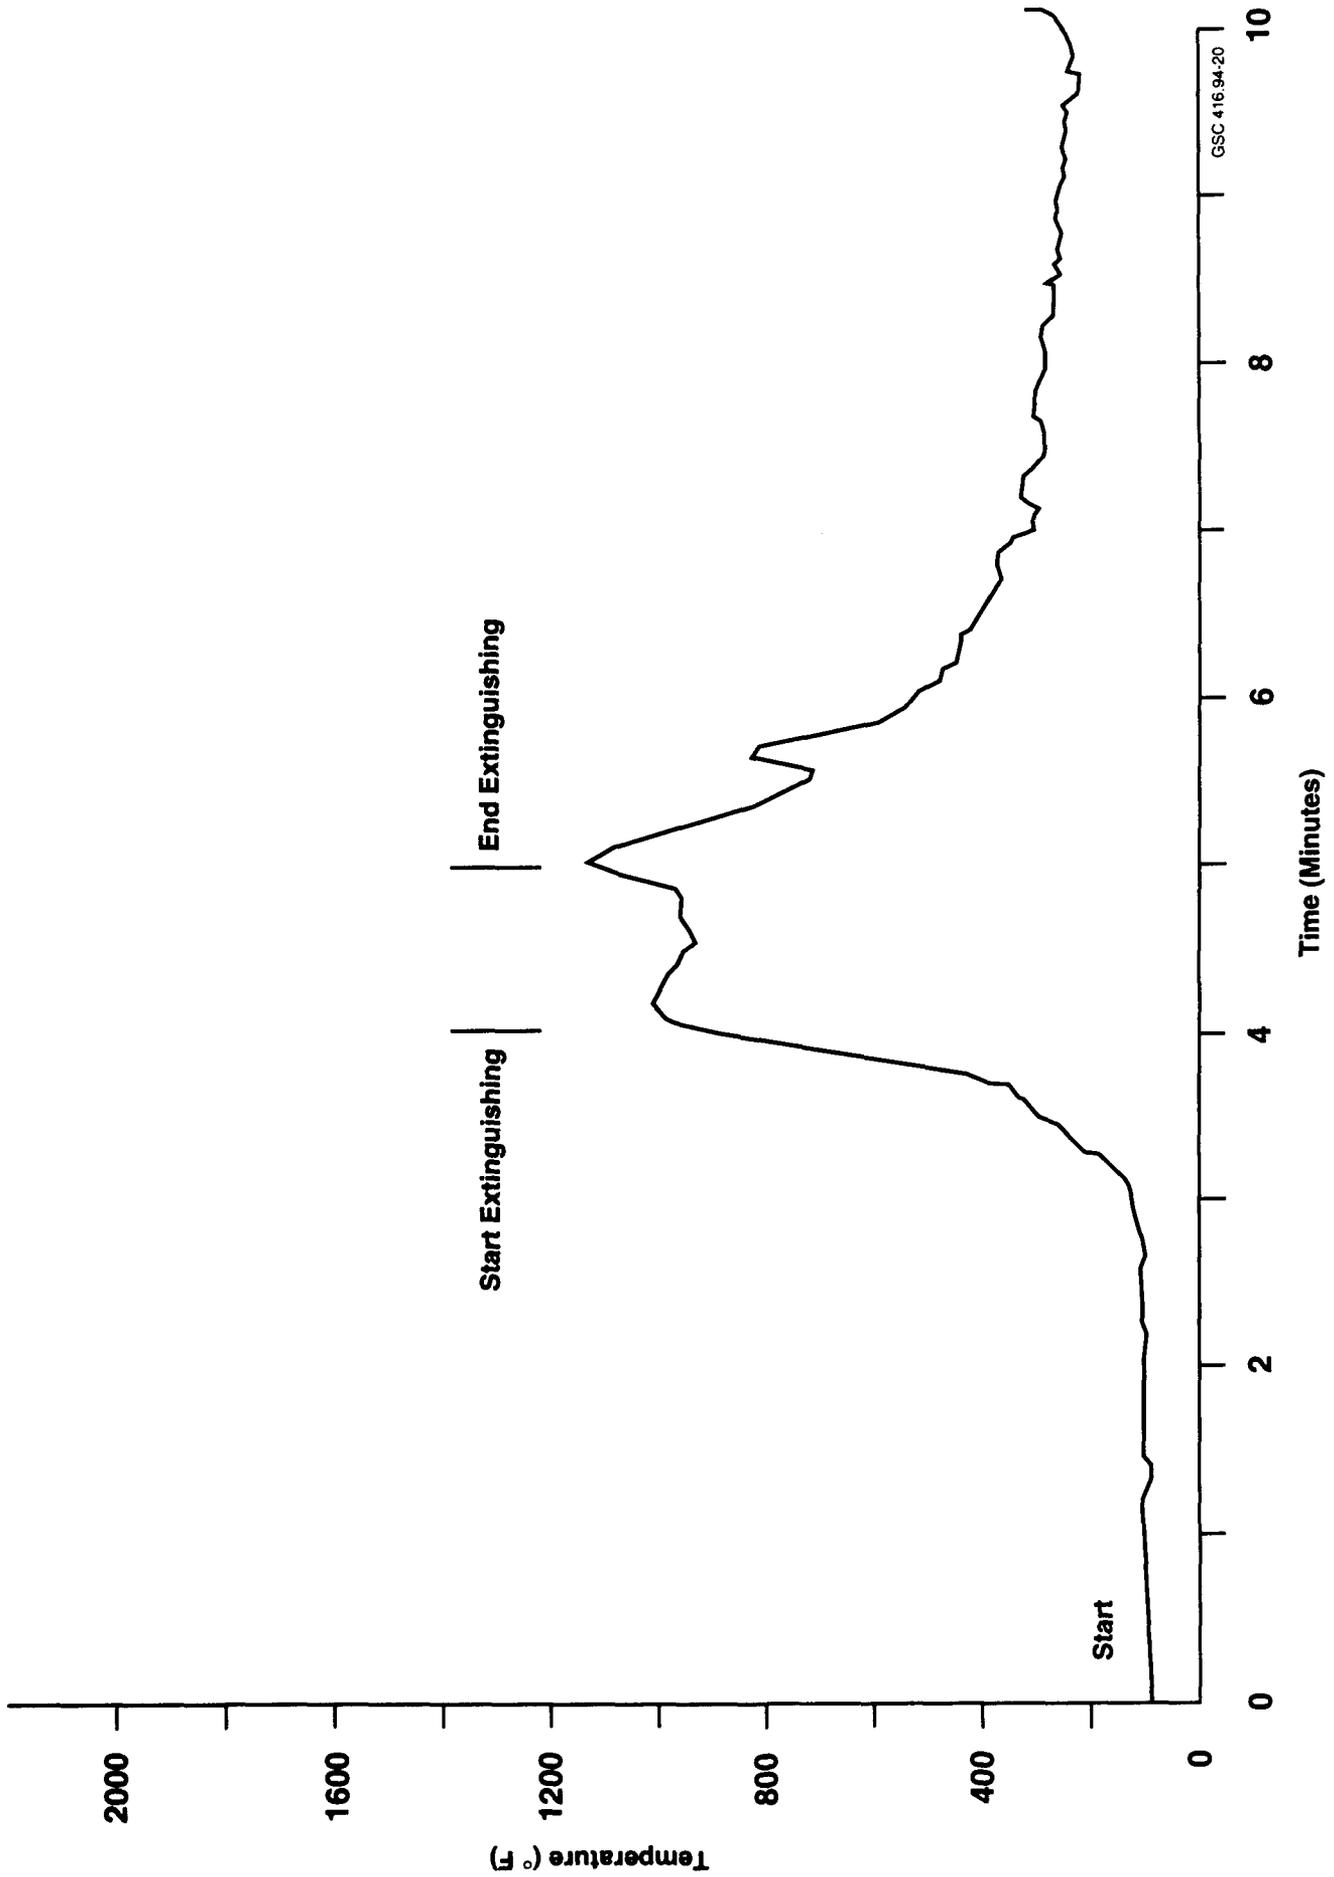
FIGURE B-9. TEST 2 AIR TEMPERATURE BETWEEN CABIN FLOOR AND THE CARGO COMPARTMENT AT STATION 270

Cargo Compartment. The fire breached the cargo compartment through the cargo door. The liner was blackened but not cracked where it was exposed in the cheek area. The interior of the compartment was sooted but undamaged. The area between the upper liner and the cabin floor was heavily sooted and the insulation charred but still intact. The temperature above the upper liner at station 270 reached a peak of 1100 °F (figure B-9). The cargo door was completely destroyed.

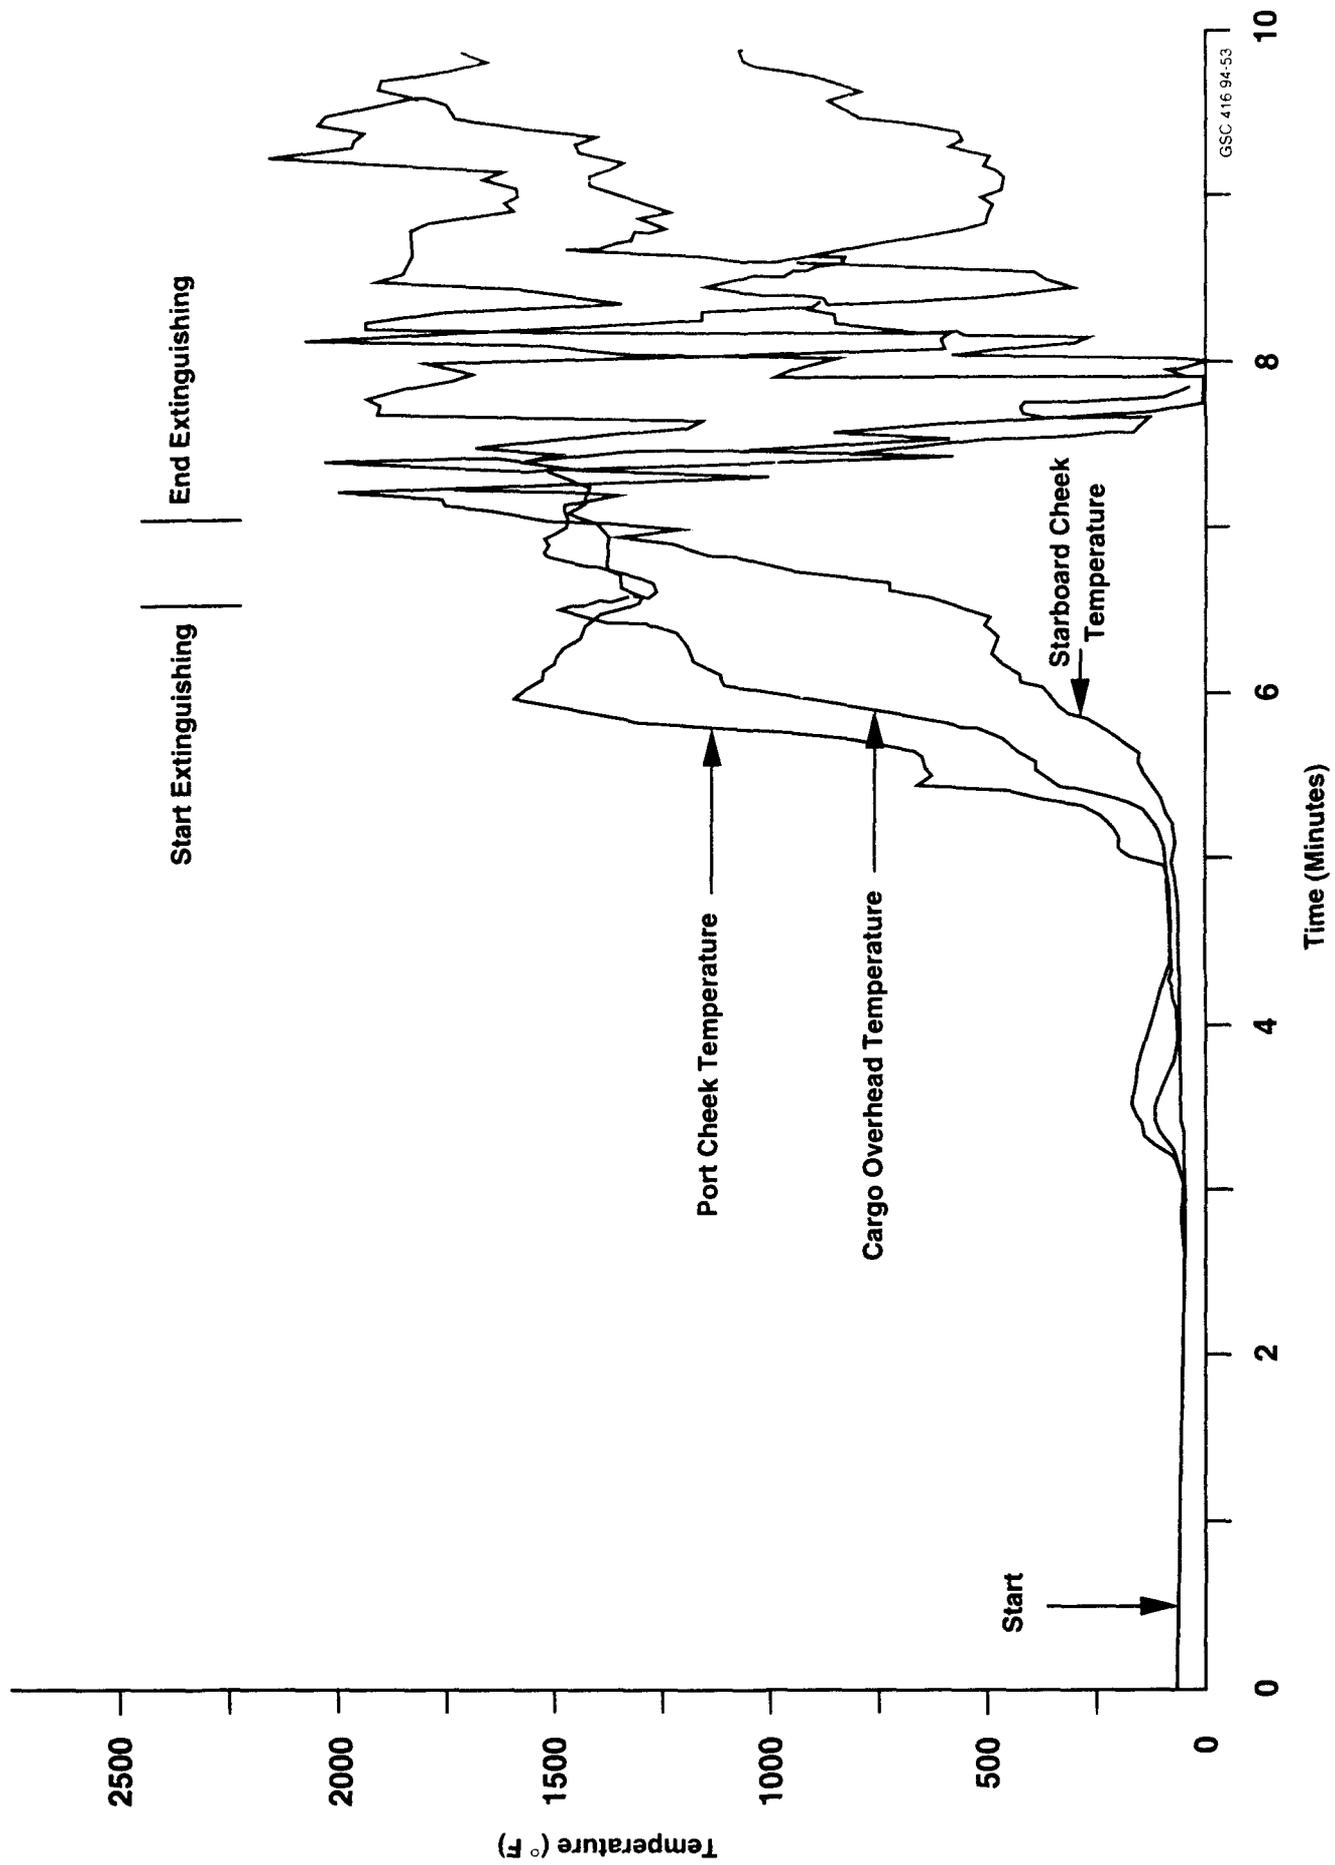
FIGURE D-19. TEST 4 PORT AND STARBOARD CHEEK AND CARGO OVERHEAD TEMPERATURE AT STATION 1182

destroyed as well as 50 percent of the cabin floor above it. The forward bulkhead remained undamaged due to the protective steel partitions. The starboard cargo hatch was scorched on the inside but undamaged on the exterior. The hatch was inoperable after the test. The air temperature in the cargo compartment measured at station 1182 remained ambient for approximately 4 minutes at which time it rapidly rose to 1100 °F, dropped off to 700 °F and then peaked at 1600 °F at the conclusion of the test (figure D-18). The temperature in the cheek areas and between the floor and the top of the cargo compartment measured at station 1182 remained close to ambient for 4.5 minutes and then peaked at 1600 °F near the end of the test (figure D-19).
