TECHNICAL REPORT ARCCB-TR-94030

FAILURE ANALYSIS OF 120-MM  
MORTAR BUSHINGS AND FIRING PINS

KATHRYN E. NOLL

AUGUST 1994

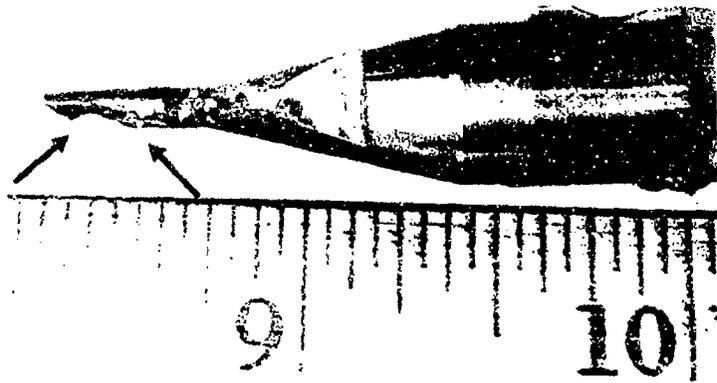
A visual examination was performed on the as-received firing pins and bushings in order to identify any significant features. Pins 1 and 2 displayed extensive damage toward the tip of the pin. Bushing 1 shown in the center of the bushing assembly in Figure 3 was also visibly damaged. The discoloration observed on the face of the bushing assembly is not considered unusual for components that have been subjected to firing tests. Pin 3 sustained minor damage (arrows, Figure 4), with the bushing assembly (Figure 5) displaying no visible damage to Bushing 2. The unfired pins (Pins 4, 5, and 6) were supplied for comparison with the fired pins. From the visual examination, there were no observable differences between the unfired U.S.-made and unfired Israeli-made firing pins.

Figure 1. Photograph of Pin 1, as-received, with arrows pointing to the damaged area.

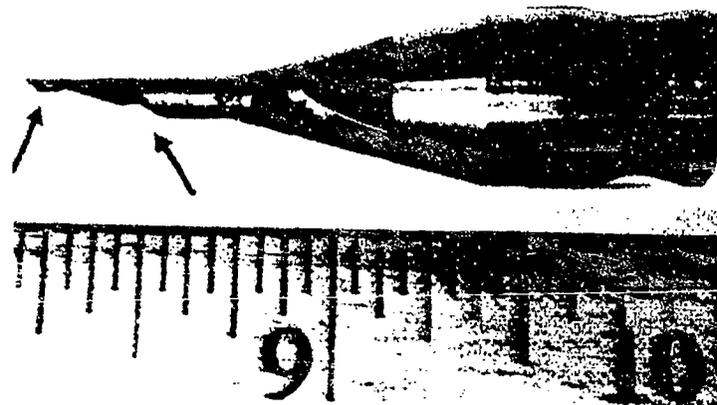
Figure 2. Photograph of Pin 2, as-received, with arrows pointing to the damaged area.

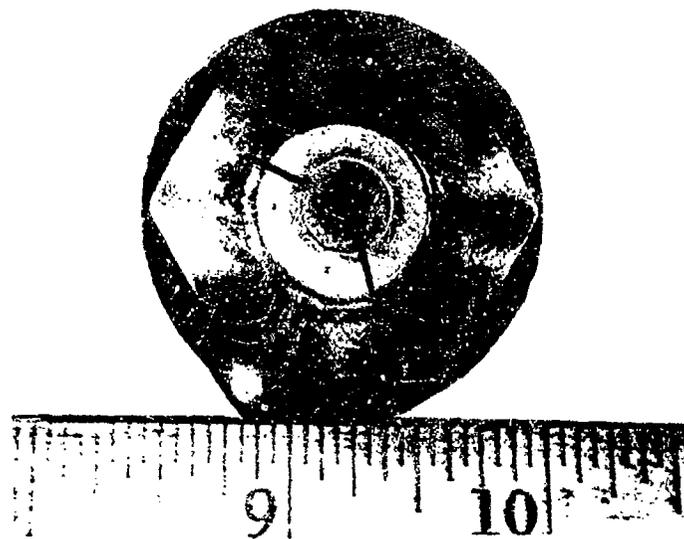
Figure 3. Photograph of bushing assembly, as-received, with arrows pointing to the damaged tungsten carbide of Bushing 1.

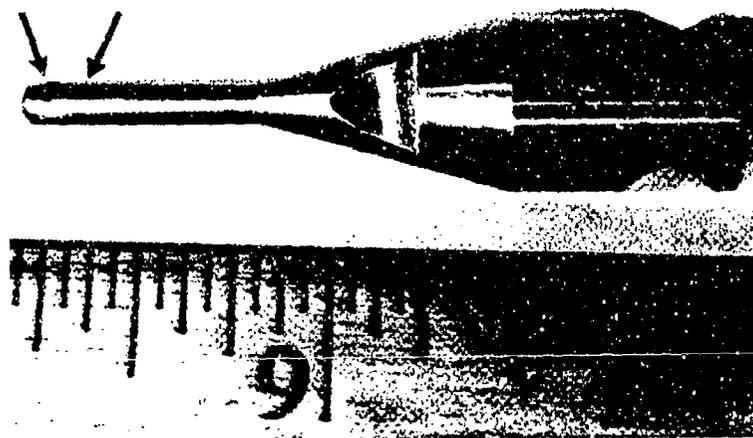
Figure 4. Photograph of Pin 3, as-received, with arrows pointing to the damaged area.

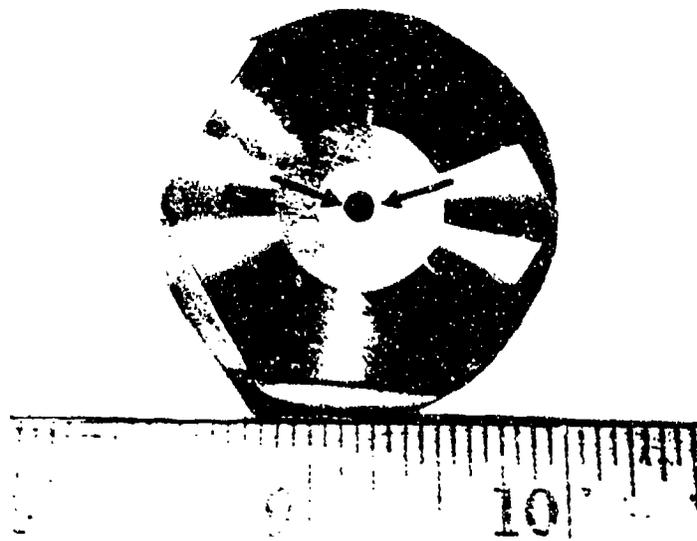
The hole in the U.S.-made bushings (arrows, Figure 9) was cut using wire electrical discharge machining (EDM). The Israeli bushing was cut with a conventional machining operation.

Figure 9. Photograph of bushing assembly, as-received, with Bushing 3 located at the center. Arrows point to the hole machined by wire EDM.

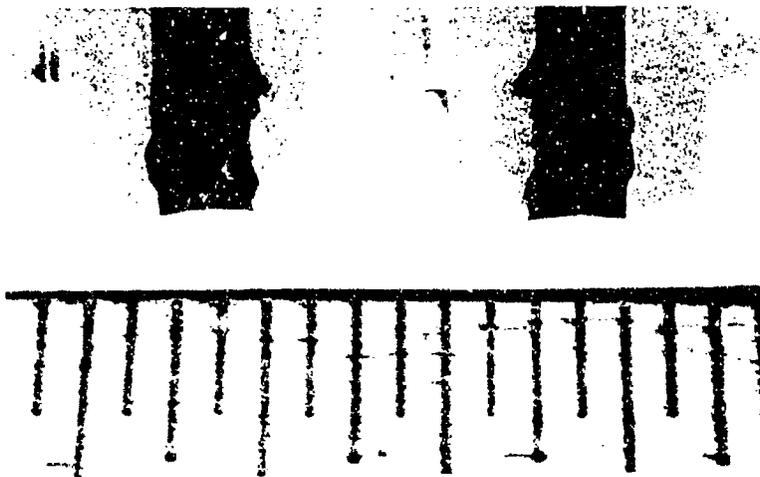
The bushing assemblies were then sectioned (Figure 10) and the bushings (arrows, Figure 10) were removed in order to further characterize the component. Overall photographs of the four bushings are shown in Figures 11 through 14. Bushing 1 sustained the more severe damage seen in Figure 11, with the inner diameter being affected down the entire length of the bushing. Bushing 2 experienced slight damage to the inner diameter of the bushing (Figure 12). Bushings 3 and 4 were supplied for comparison with the damaged bushings. From the visual examination, there were no observable differences between the proof-fired, U.S.-made and proof-fired, Israeli-made bushings (Figures 13 and 14, respectively).

Figure 11. Longitudinal view of sectioned Bushing 1 displaying the amount of damage sustained during firing.

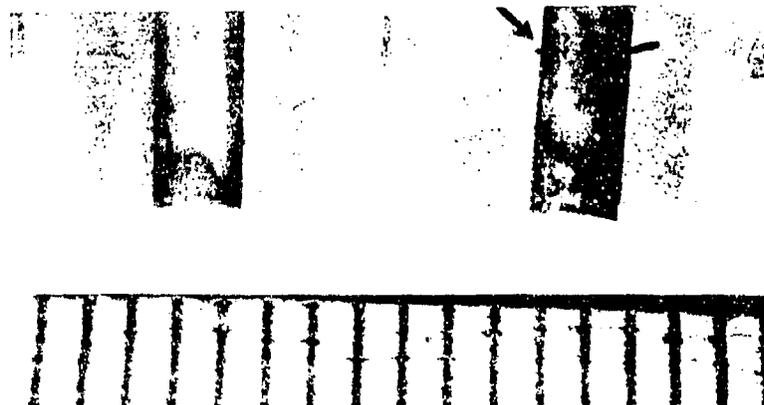
Figure 12. Longitudinal view of sectioned Bushing 2, with arrows pointing to the slight damage.

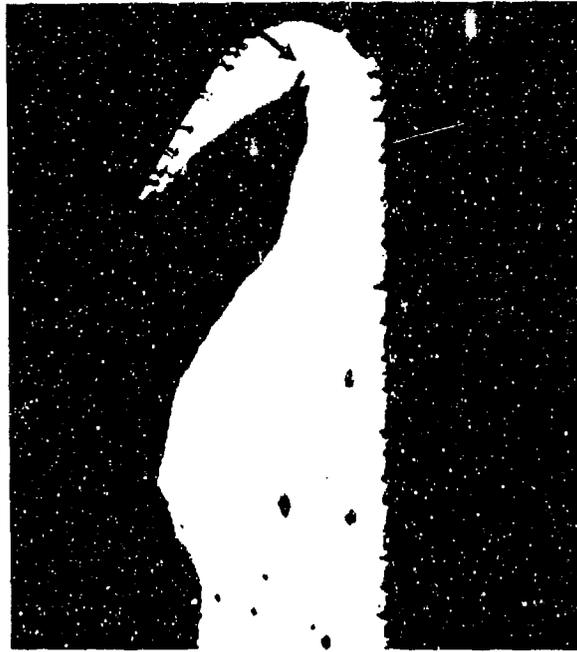
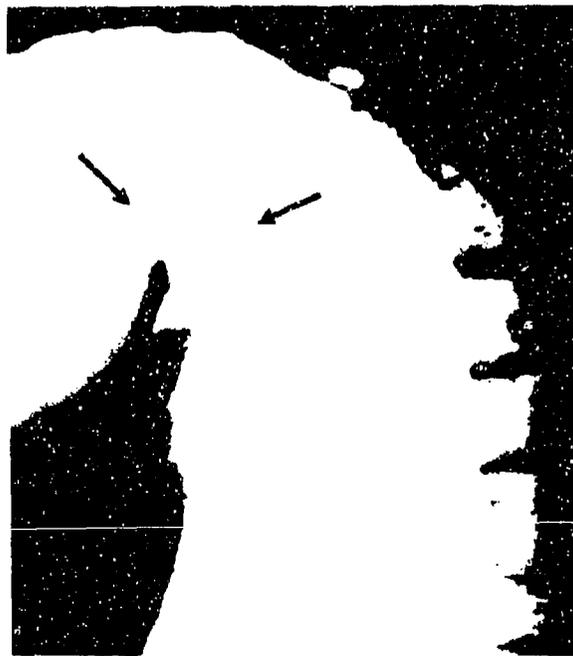
There were several areas, however, that did not exhibit this type of microstructure. The three fired pins displayed some microstructural variation near the damaged areas. Figures 17 and 18 show an as-polished and etched view, respectively, near the tip of Pin 1. The region displayed a much finer-grained microstructure than the rest of the material examined in Pin 1 (see Figure 16). Similar areas were also observed near the tip of Pin 2 and Pin 3 (Figures 19 through 22). The area shown in Figure 21b corresponds to the damaged region observed during the visual examination of Pin 3. This altered microstructure indicates that the three pins may have experienced some localized heating near the tip of the pins. Hardness measurements were taken in these areas and are described later in this report.

Figure 17. Photomicrographs showing as-polished view of Pin 1.  
Arrows point to location of microstructural variation.

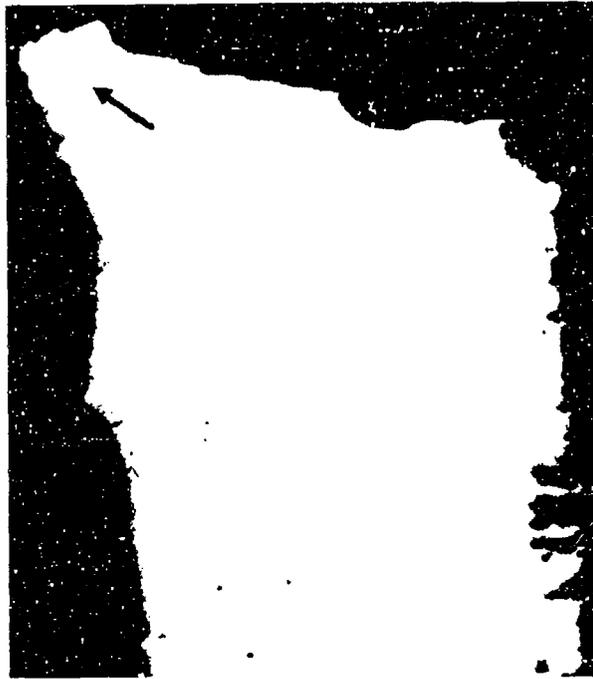
Figure 19. Photomicrograph showing as-polished view of Pin 2, at 400X. Arrow points to location of finer grained microstructure.

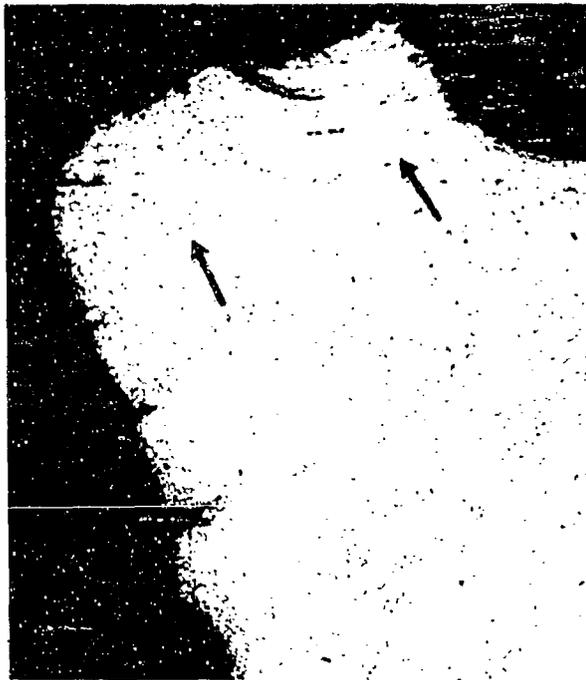
Area	HRC
Figure 18 (Pin 1)	33.5
Figure 20 (Pin 2)	33.0
Figure 22 (Pin 3)	32.0

Figure 20. Photomicrograph showing etched view of Pin 2, at 1000X. Arrows point to location of finer grained microstructure.

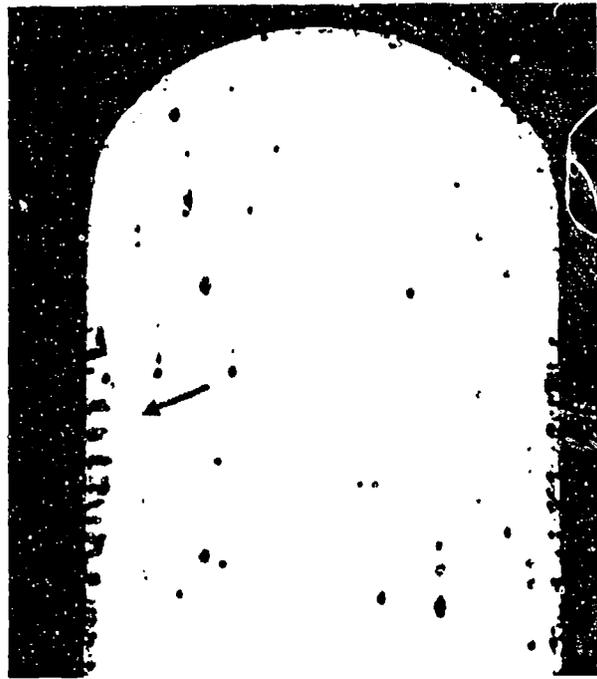
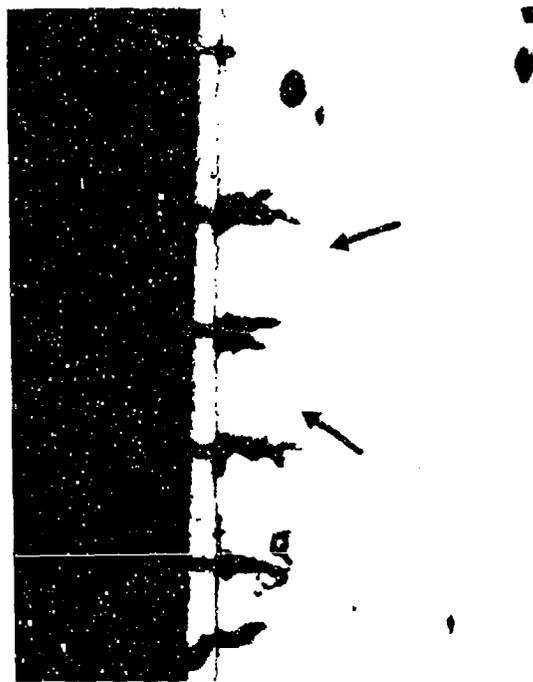
Figure 21. Photomicrographs showing as-polished view of Pin 3. Arrows point to location of microstructural variation.

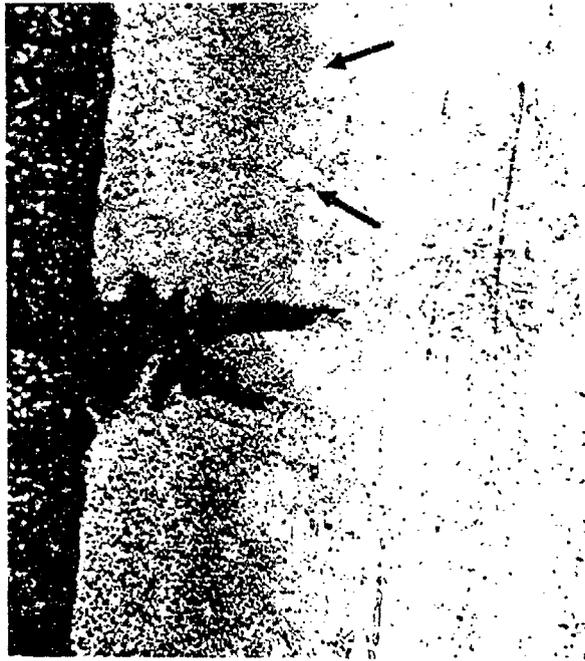
Figure 22. Photomicrographs of finer grained region (arrows) found in Pin 3. Shown in the etched condition.

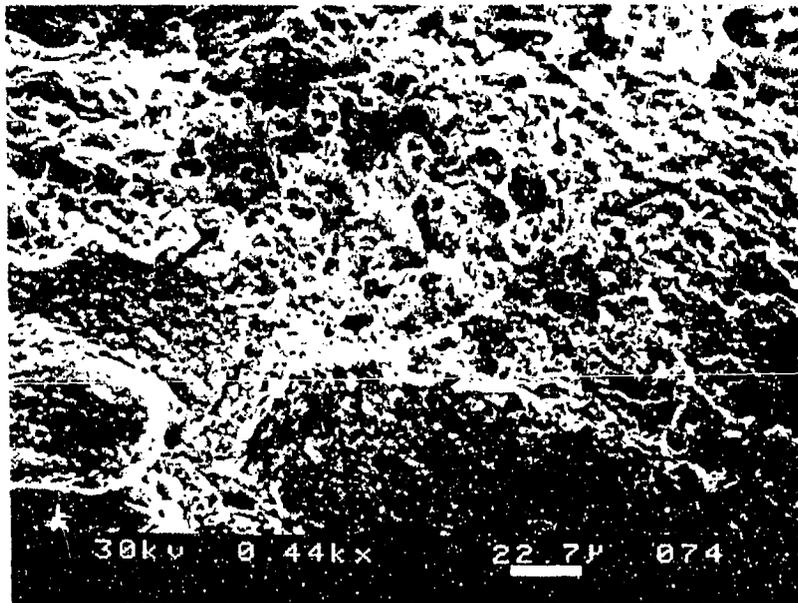
SEM was performed to further characterize the firing pins and tungsten carbide bushings. The three damaged pins are shown in Figures 28 through 30. A definitive fracture mode could not be determined for any of the firing pins. Pins 1 and 2 exhibited extensive damage with some regions displaying evidence of melting (Figures 28b and 29b). Pin 3 showed much less severe damage. Note the cracking network went beyond the damaged region (arrow, Figure 30b).

Figure 28b. Magnified view of Pin 1 showing area of melting, at 440X.  
Region was located at the tip of Pin 1.

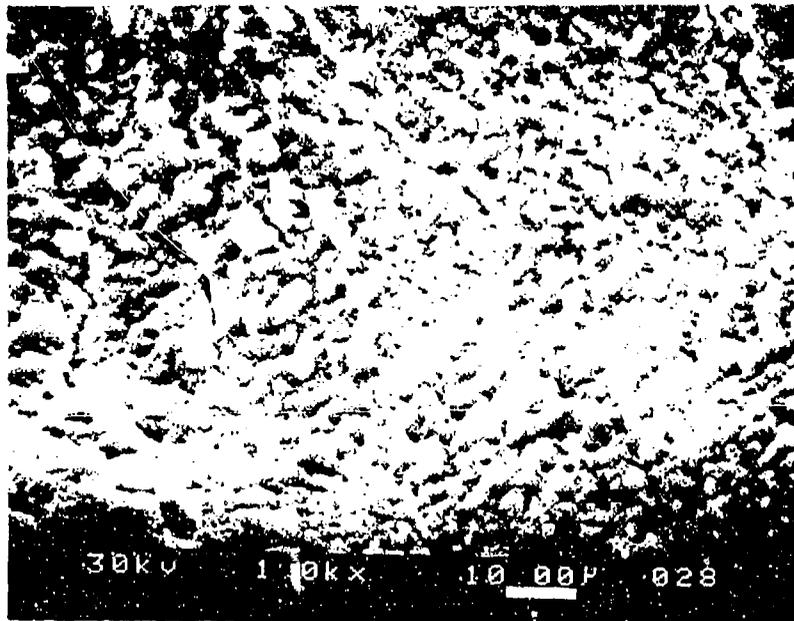
Figure 29b. Magnified view of Pin 2 showing area of melting, at 1000X.  
Region was located at the tip of Pin 2.

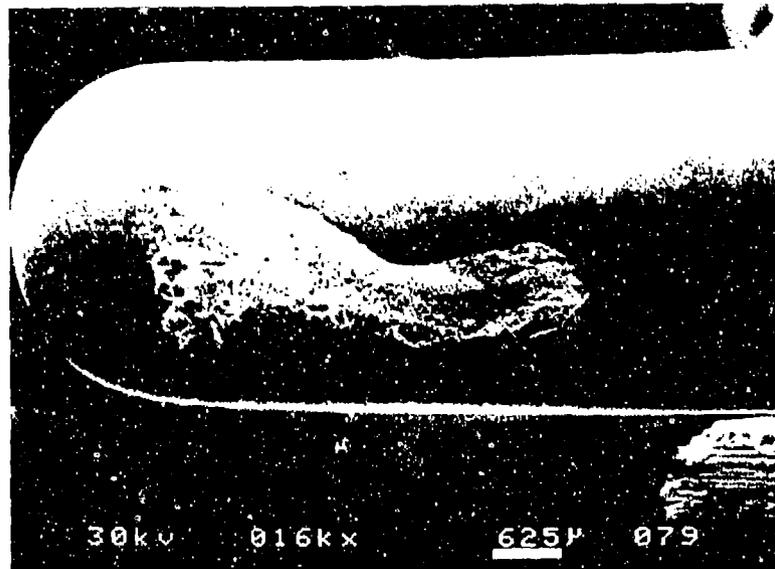
Figure 30a. SEM micrograph of Pin 3 showing the extent of damage, at 16X.

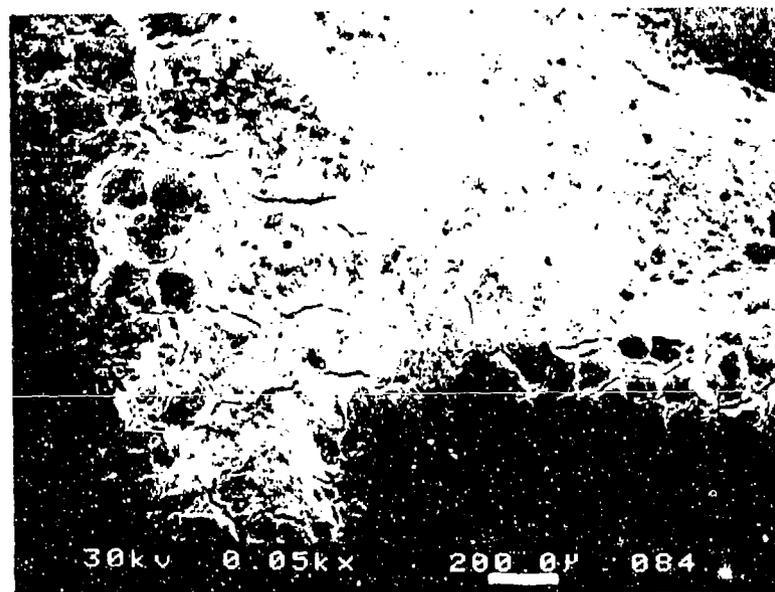
Figure 30b. Magnified view of damaged area in Pin 3, at 50X.  
Arrow points to the cracking network.

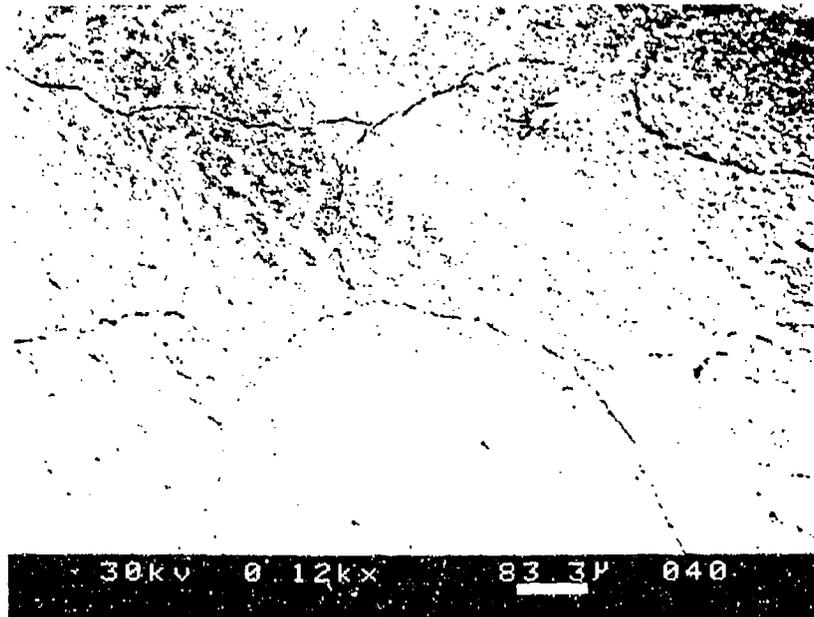
The four tungsten carbide bushings were examined and there were several noteworthy features observed. Bushing 1 (Figure 31) sustained considerable damage along the entire length of the inner diameter. Figure 32 shows the cracking network observed in the damaged regions. The cracking shown in Figure 33 was also seen in the other three bushings (Figures 34 through 36). Bushing 2 experienced slight damage to the inner diameter (arrows, Figure 34) and the cracking network was visible along the length of the bushing (see Figure 34b).

Figure 32. SEM micrograph displaying the cracking network observed in the damaged area of Bushing 1, at 120X.

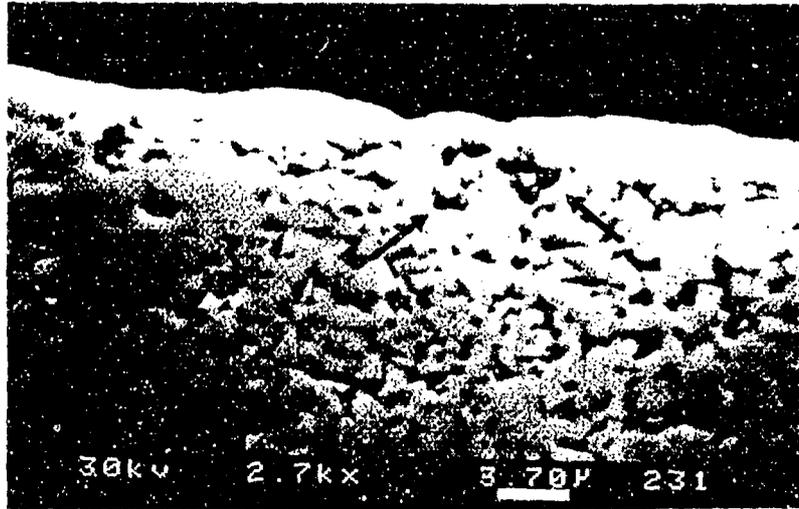
The EDM process also degrades the cobalt binder found in tungsten carbides. The cobalt binder holds the tungsten particles together in the material. The electrochemical reaction that degrades the binder causes a residue of loose tungsten particles to be left on the surface of the workpiece. Cross-sectional areas of the inner diameter of both Bushings 3 and 4 were examined are shown in Figures 39 and 40, respectively. There was a slight amount of degradation observed in the wire EDM surface of Bushing 3 (arrows, Figure 39).

Figure 39. SEM micrograph showing a cross-sectional area of the inner diameter of Bushing 3. at 2700X. Arrows point to slight degradation caused by the wire EDM process.
