Technical Report REMR-CS-46
March 1995

Repair, Evaluation, Maintenance, and Rehabilitation Research Program

Repair and Maintenance of Masonry Structures: Case Histories

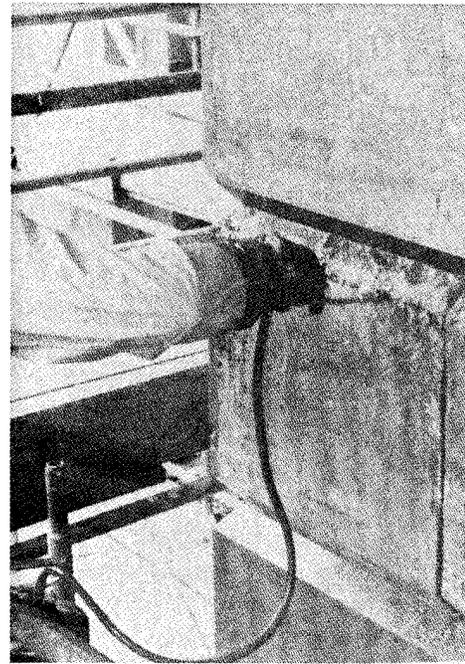
Figure 5. Application of stone strengthener to sandstone

Before the coating was begun, the stone was cleaned to ensure that no loose material was left on the surface. The coating material could be applied by brush, roller, or airless spray but was applied by the later method because of all the detail in the carvings of the stone. Since it was to be sprayed on, it was diluted with up to 15 percent fresh water to thin it for even application through the spray nozzle.

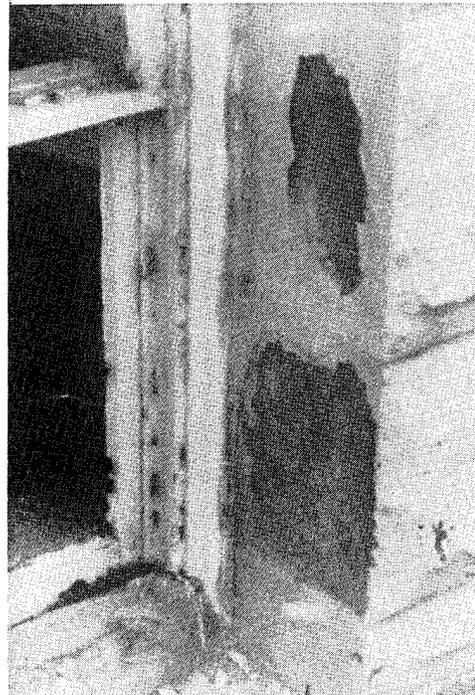
The cause of the peeling paint and wall paper, deteriorating brick, and spalling surfaces of the sandstone was excess moisture taken into the walls of the building. Moisture was coming from a number of different sources. Primarily, the exterior brick was taking in great amounts of water through the surfaces that were damaged by sandblasting during the 1950's. The blast cleaning had destroyed the vitrified surface of the brick. This vitrified surface tends to shed water rather than absorb it. Figure 9 shows some of this damage. This figure shows that the nozzle operator varied the distance of the nozzle from the surface of the wall such that when the nozzle got very close the damage of the sand hitting the brick was so bad that even 40 years later the path that the nozzle took is still visible.

Figure 8. View of wall showing spalling damage to sandstone

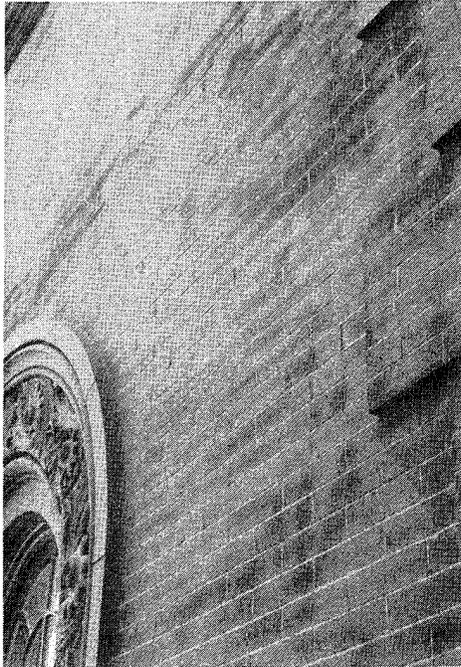
Figure 9. View of brick showing nozzle damage

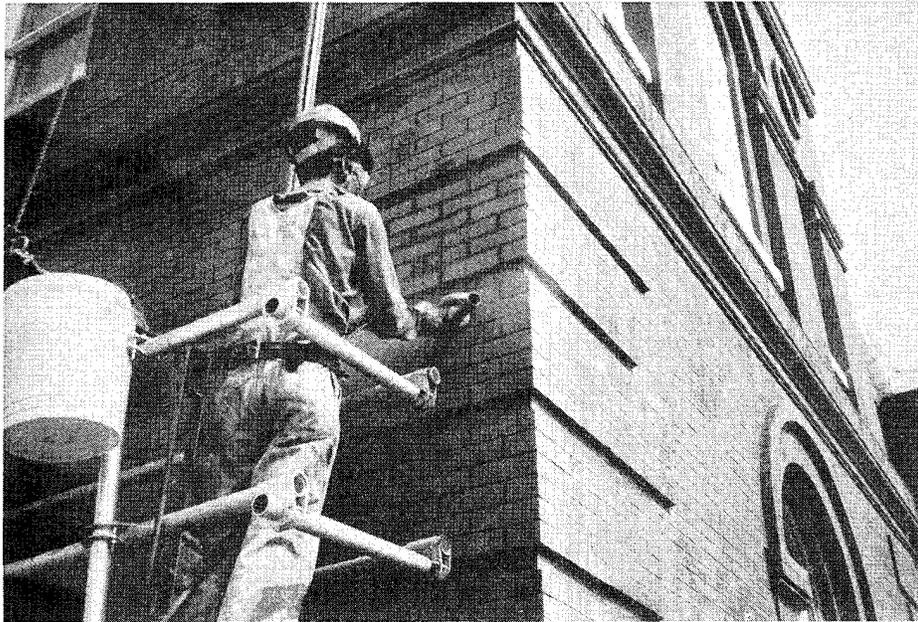
Figure 10. Worker routing bricks with small saw

The mortar used for the repointing was composed of 4 parts lime, 1 part portland cement, and 12 to 14 parts sand. This mixture was submitted and approved by the architect. The use of lime as binder in repointing mortar is encouraged because it produces a softer mortar than one made entirely from portland cement. Exactly matching a mortar to one that has been removed is not necessary (Mack, Tiller, and Askins 1980). The important points to remember about the replacement mortar are:

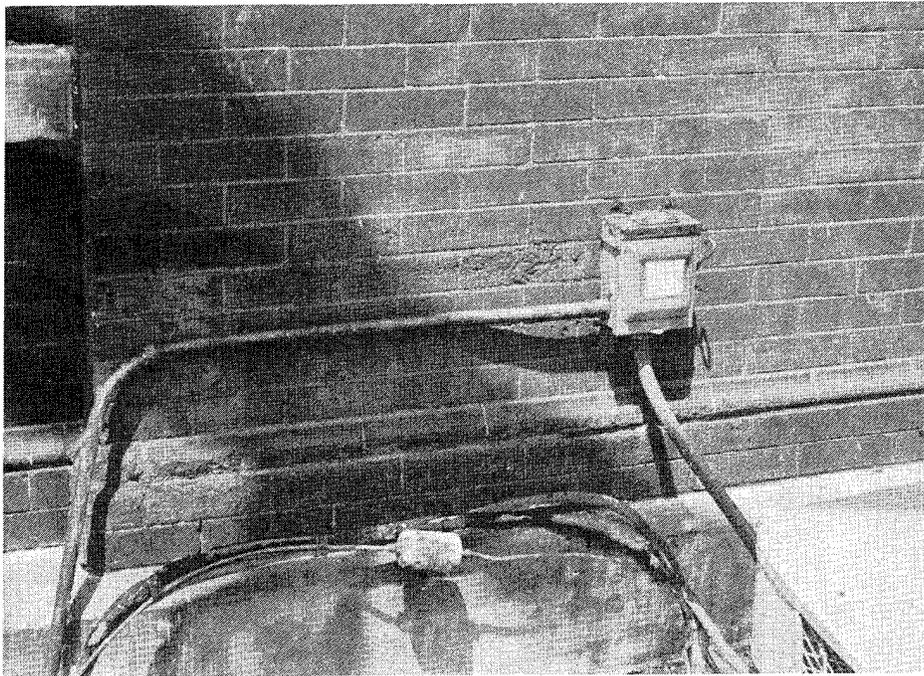
Figure 11. View of brick damage due to weathering

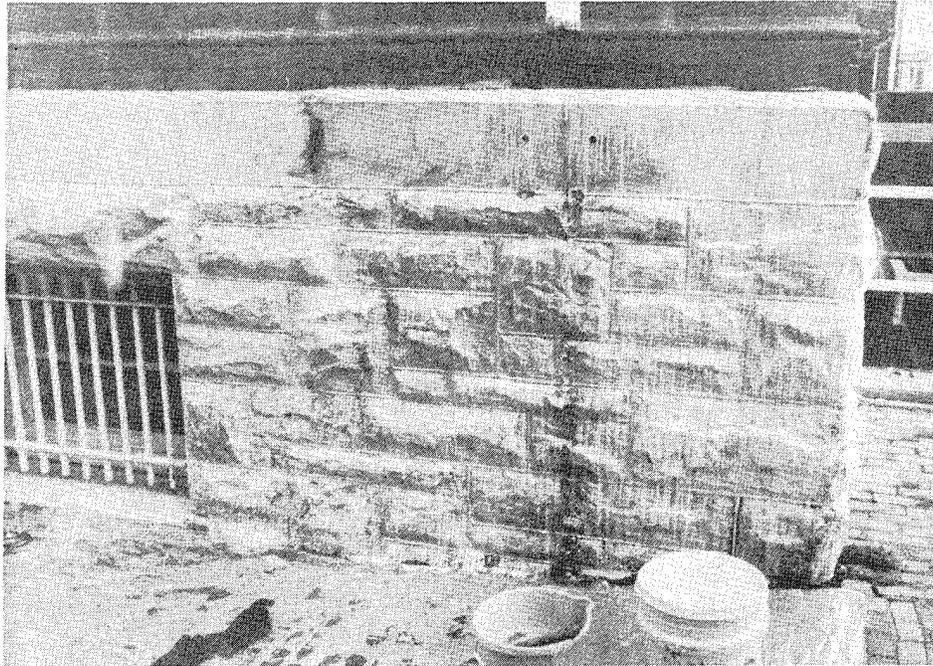
Figure 12. Limestone being cleaned with chemical spray

The rinsing procedure starts by flooding the treated area with a low-pressure water stream that removes the bulk of the acidic residue from the brick surface. This is followed with a medium pressure water spray (1,000 to 1,200 psi). The area to be rinsed is flooded from the bottom to the top. This ensures that the residues removed from the area will travel over surfaces that are already wet with water, and this will further dilute the chemicals in

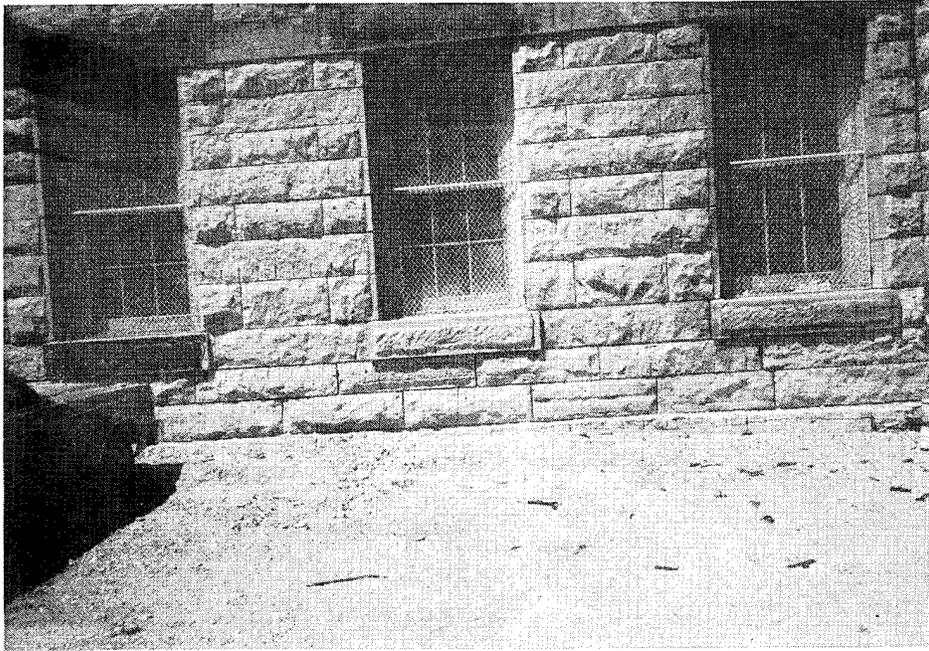
Figure 18. Sandstone sills during cleaning

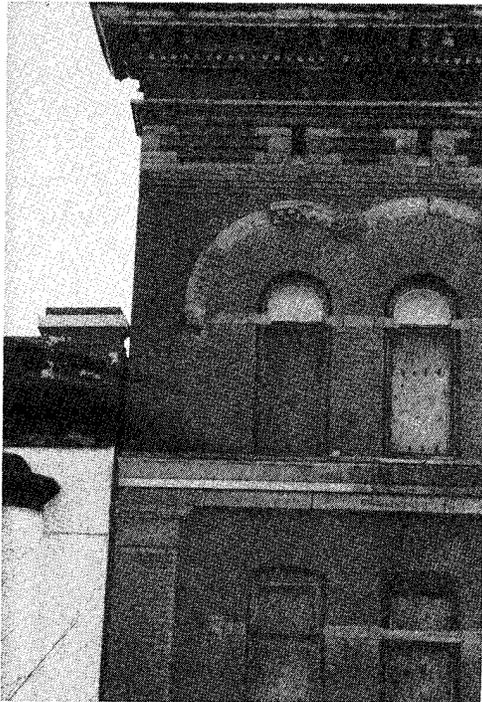
Figure 24. Deteriorated condition of
windows and sills

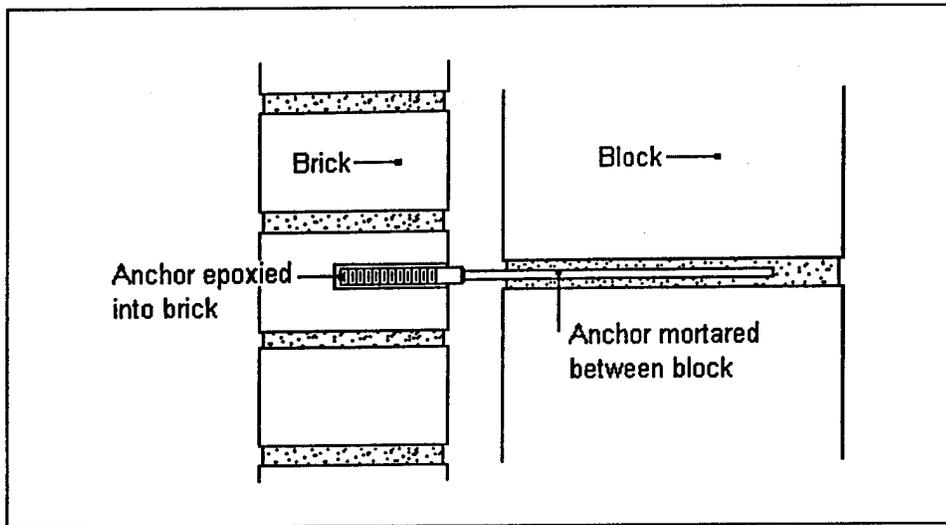
Figure 25. Sketch of anchor detail used to strengthen brick walls

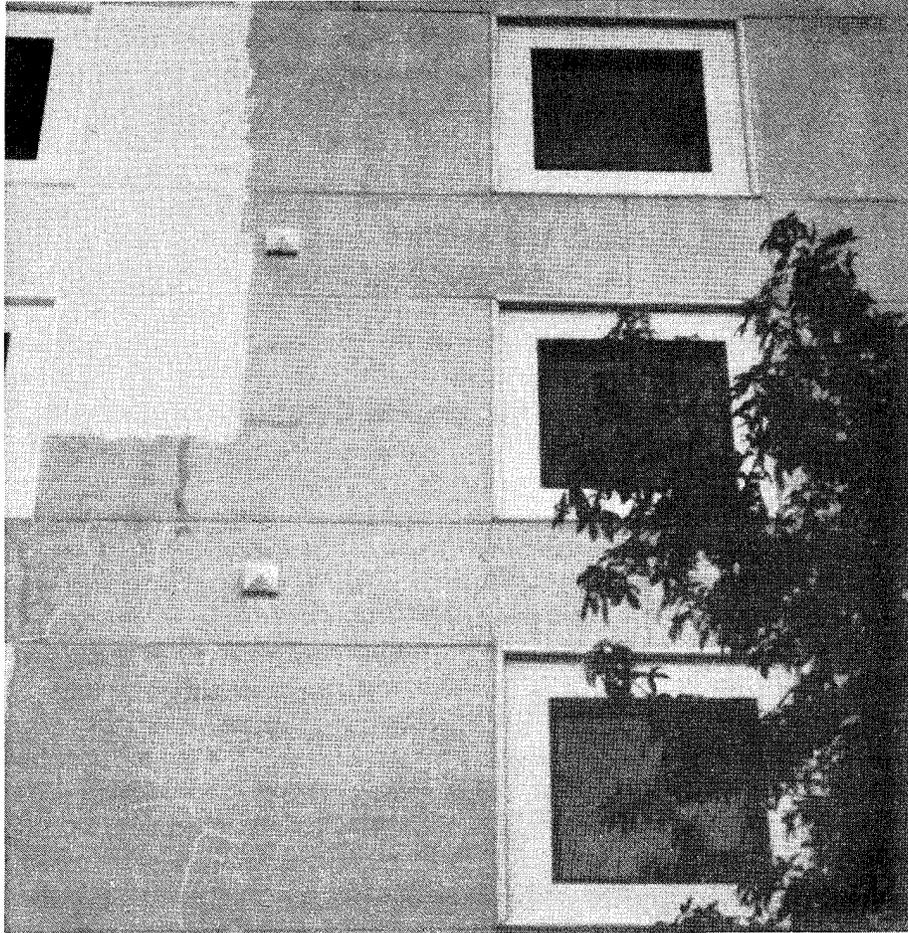
The engineering firm that was hired to evaluate the structure and provide a solution noted that much of the cracking was a function of problems with building expansion. There were expansion cracks and movement cracks on panels on all sides of the building. They found that the building had been built without planning for expansion joints between panels. Therefore, when

Figure 28. Vertical cracks in panels at left of window

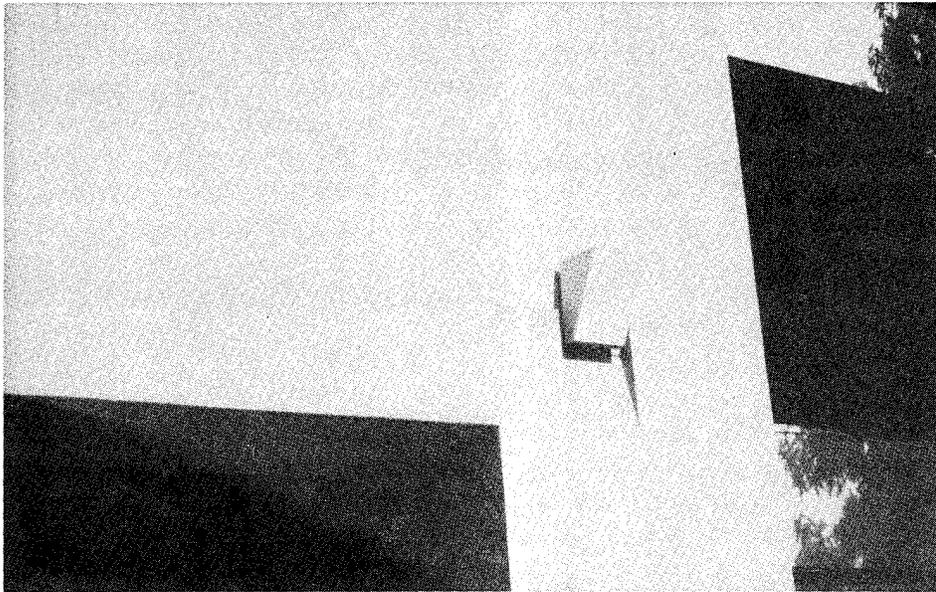
Figure 29. Cracking in panel at a corner

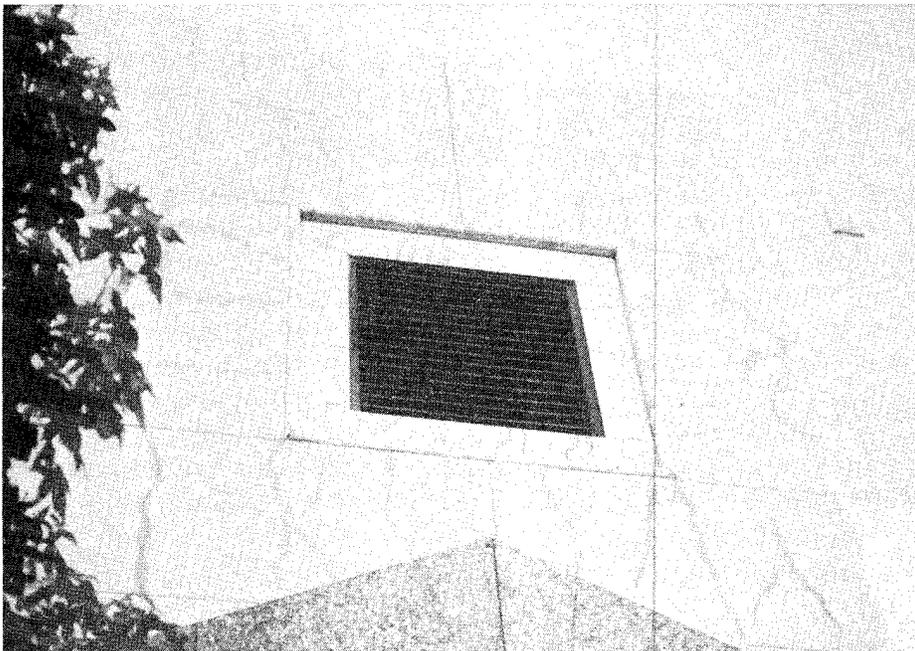
Figure 30. Shrinkage cracking in panels

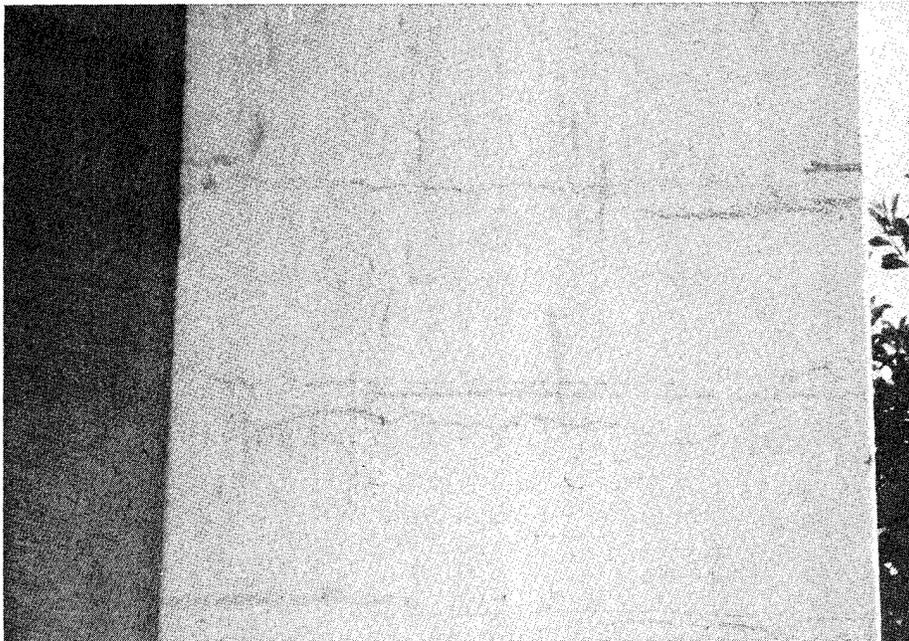
Figure 31. Cracked column panel showing smooth panel coating

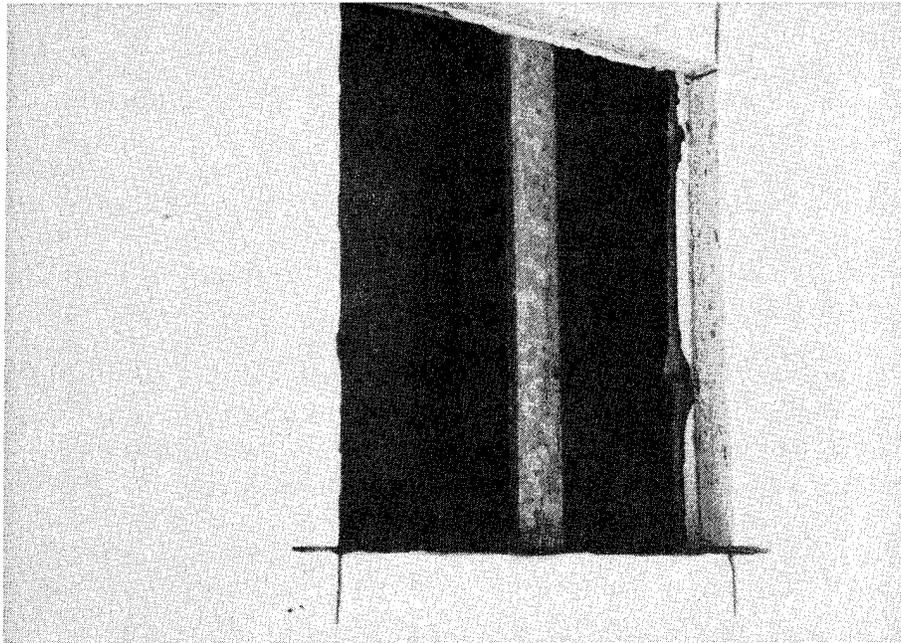
Figure 32. Smooth elastomeric coating applied on column panel

The method of applying the different elastomeric acrylic coatings depended upon the type of surface texture that was desired. In those areas where the coating was to be smooth and to be applied over an old smooth surface, the coating used was a high-flexibility, acrylic-polymer coating that was tinted to match the color of the building. The old smooth surface had been cleaned and all loose paint removed by the power washing. The smooth coating was then rolled on with conventional paint rollers and supplemented in difficult-to-reach areas by brush application. The first coat was allowed to dry for a period ranging from between 1 to 4 hr, depending upon ambient drying conditions. The first coat was followed by a second coat once the first had dried. Figure 32 shows this type of coating on one of the column panels. This provided a water-resistant, vapor permeable elastomeric coating.

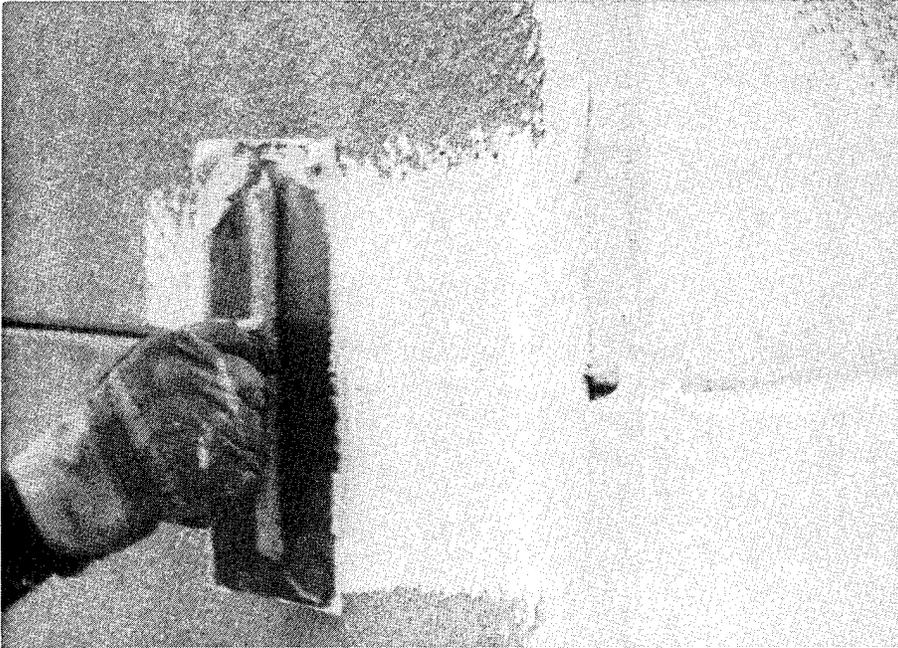
Figure 33. Application of the elastomeric base coat

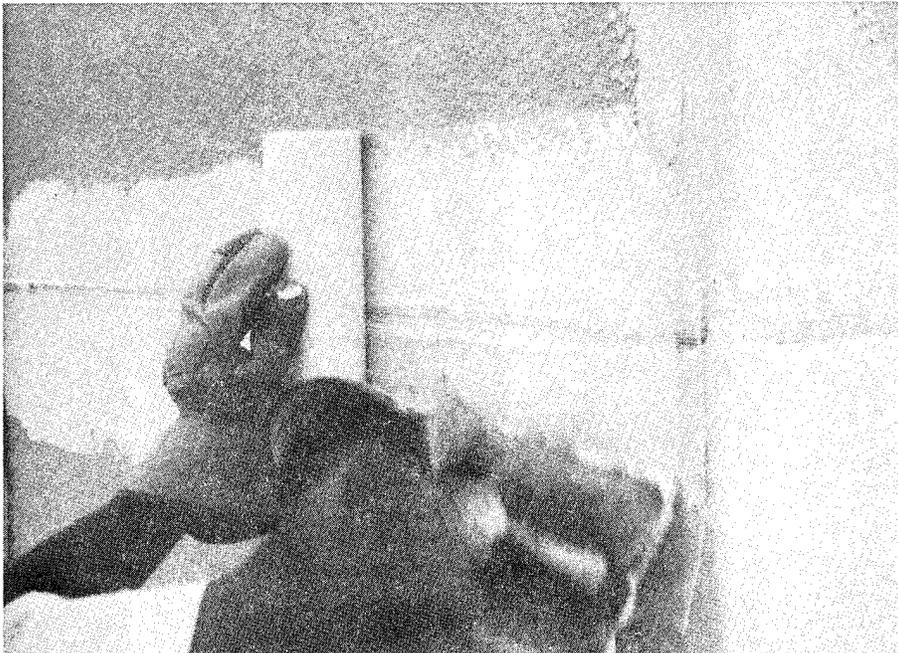
Figure 34. Trowelling of the mesh into place

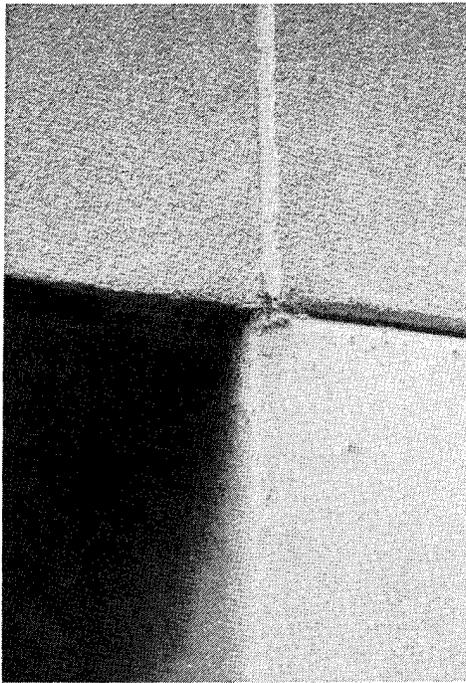
Figure 35. Contrast between base coat and finish coat

The final coating is the stucco-like coat. This coating is the same as the high-flexibility acrylic polymer coating with the addition of sand particles to the mixture. When trowelled onto the surface, this material simulates the cement stucco finish of the original building. It is also trowelled on in a 1/32-in.-thick coating. Figure 35 shows a corner detail in which the finished top coat is at the top of the figure and the base coat with the mesh is shown at the bottom.

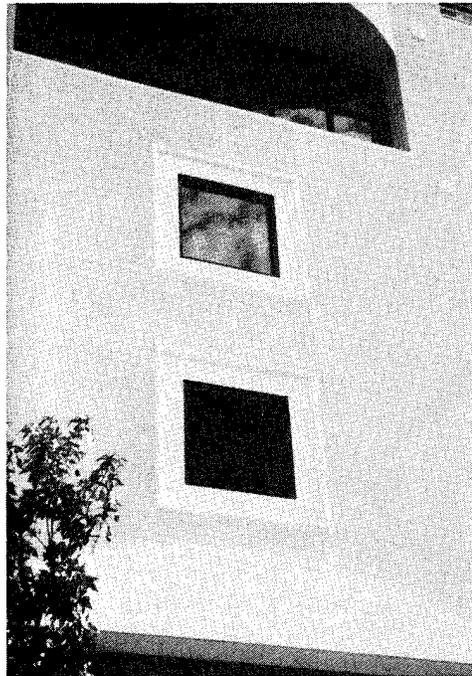
Figure 36. Repaired window frames

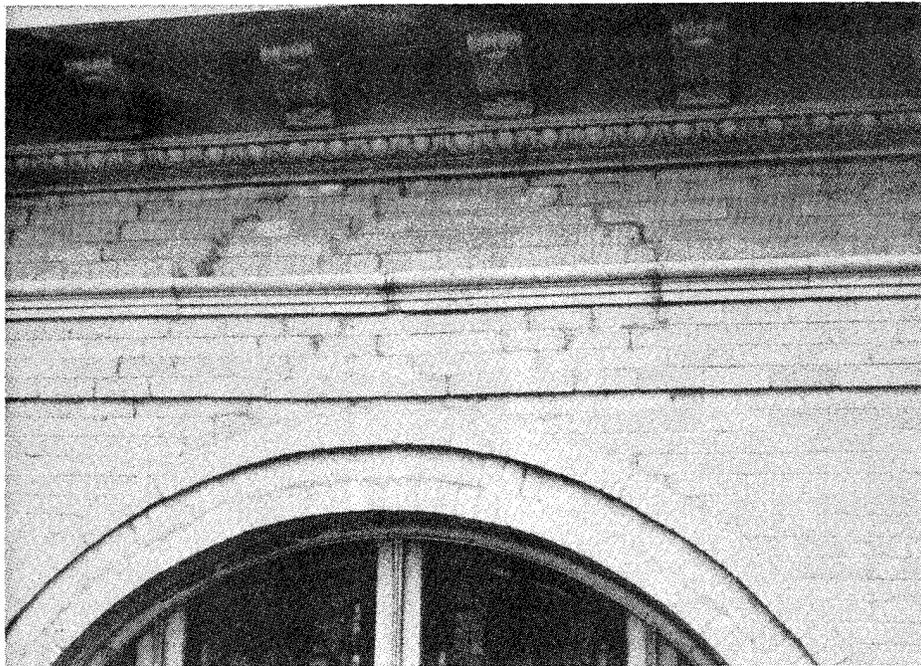
This case study is not only a restoration study, but also a structural study. The original reason for the restoration was to alleviate a problem of cracking in the east and west walls of the central chapel. Cracks in ceiling plaster over one of the wing chapels was the first reason to conduct a survey of the entire building. The building survey showed up a number of other cracks in the walls and the brickwork on the outside of the building. The major cracks were apparent in the east and west walls of the central chapel over the center of the most northern arch windows (Figure 39). The cracks were narrow at their base and became wider as they progressed up the wall. Some of the widest cracks could not be seen from within the chapel itself and had to be viewed from above the inside ceiling of the central dome. These cracks were on the order of inches wide and penetrated completely through the thickness of the wall. This led engineers to suspect that there was differential settlement of the building and that the front and back portions of the building were settling in different directions. A survey of elevations of the building was conducted and it was determined that the south face of the building had settled over 4 in. in relation to the north face.

Figure 39. Cracks over arch window in west facade

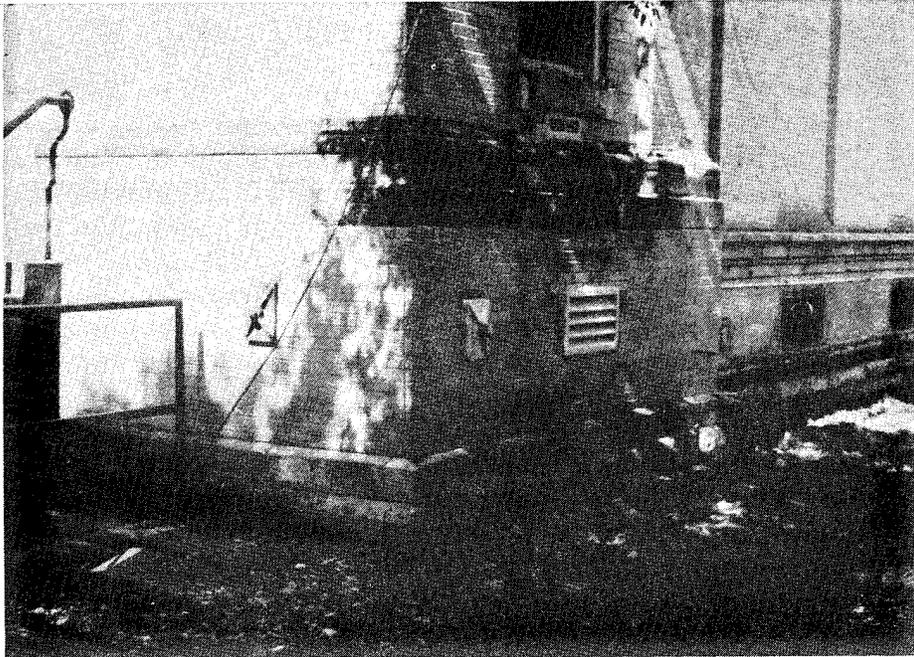
east-west direction (Figure 40). These had been in place from previous repairs. The tie rods that were to be installed during this renovation were to run north and south to address the separation of the building in this direction.

Figure 40. Existing tie-rod anchor in east facade at northeast corner

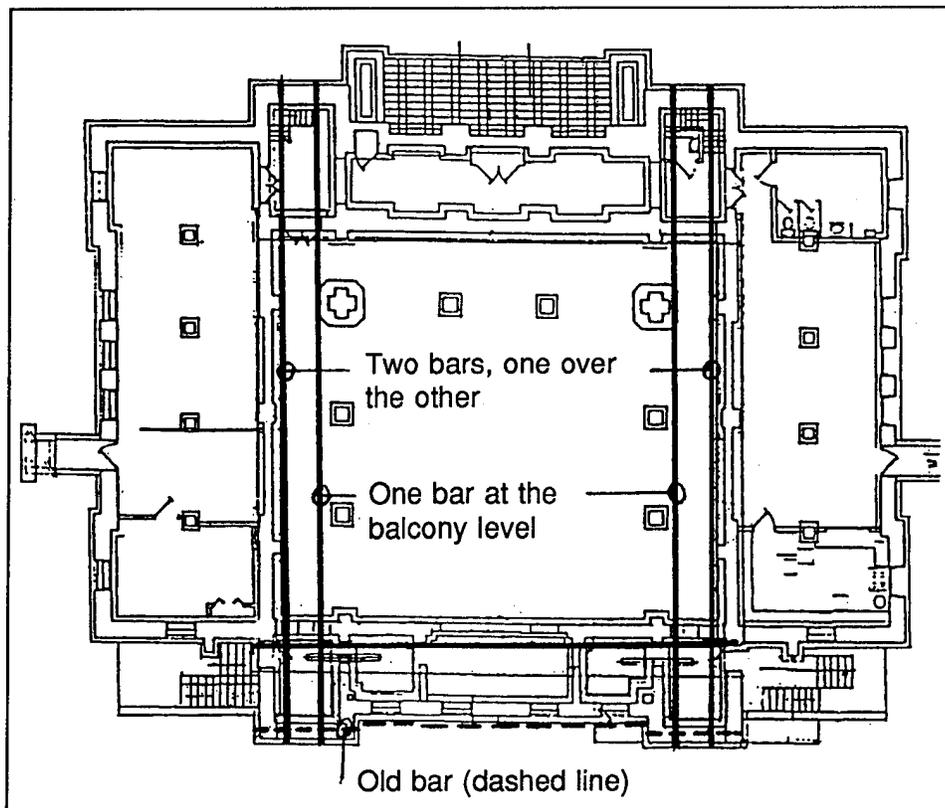
Figure 41. Plan of gift chapel showing location of tie rods

The design of the tie rods was based on trying to compensate for an overturning moment on the wall due to a 2-in. out-of-plumb condition of the north wall. The overturning moments due to the weight of the brick wall, the dead load of the roof bearing on the wall, and the live load of the roof bearing on the wall were summed and equated against a righting moment (one tie rod) at a height of 34 ft above the base of the wall. The tie rod and bearing plate were designed from the resulting force in the tie rod. Six such tie rods were

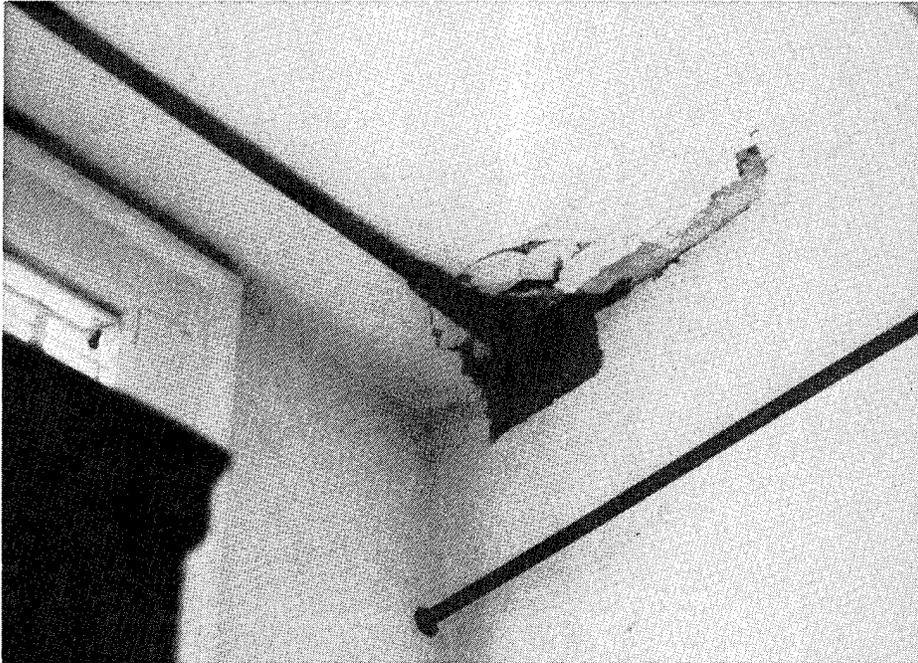
Figure 42. Two tie rods in the northeast corner of the chapel

In choosing the location of the rods, the engineering team gave much consideration to visibility, safety, and proper location. Consideration was given to routing the rods within the walls and inside the woodwork that runs around the balcony of the central chapel. However, the effort to accomplish such a feat was not economically feasible, and the rods were run adjacent to walls. Their final location was chosen so that their visibility would be limited. They were run near the floor, behind pews, and in corners between

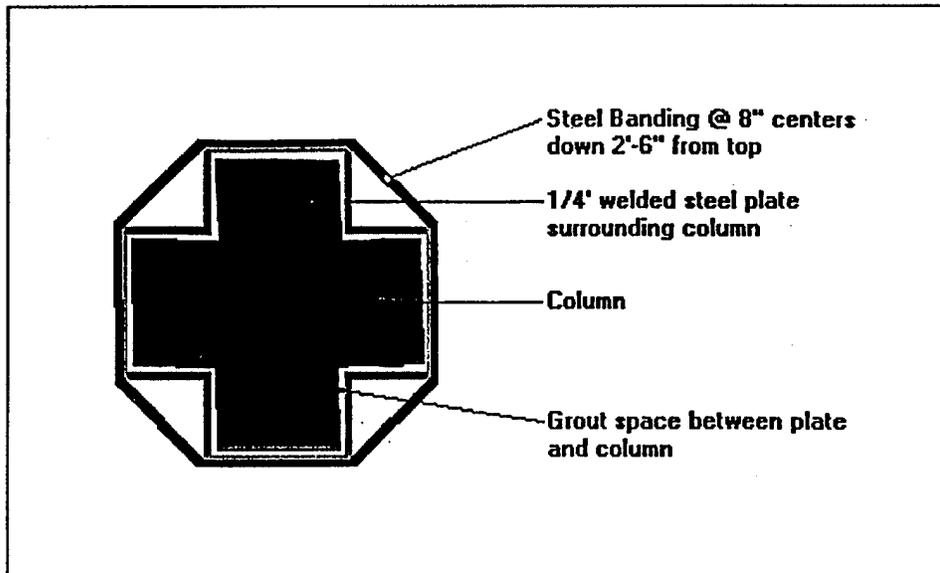
Figure 43. Sketch of repairs to the damaged columns

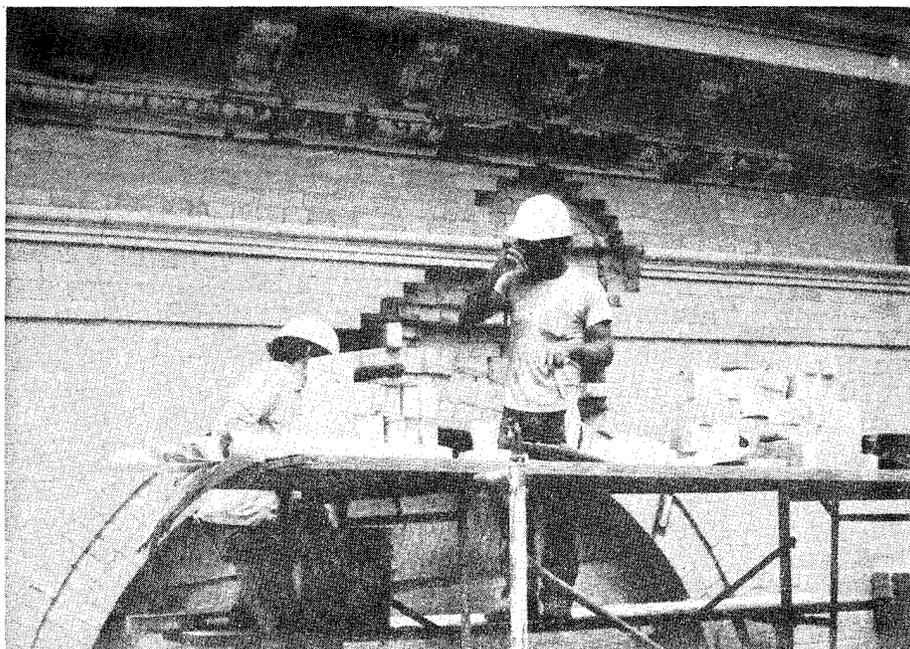
Figure 44. Rebuilding of arch window at northeast corner of central chapel

An arch-shaped form was built to use as a guide in replacing the bricks in the new arch. The masons reused any bricks that were not damaged during the dismantling of the wall. In instances where there was need for more bricks, they drew from a supply of bricks which they reclaimed when dismantling a brick chimney from the north facade of the chapel.

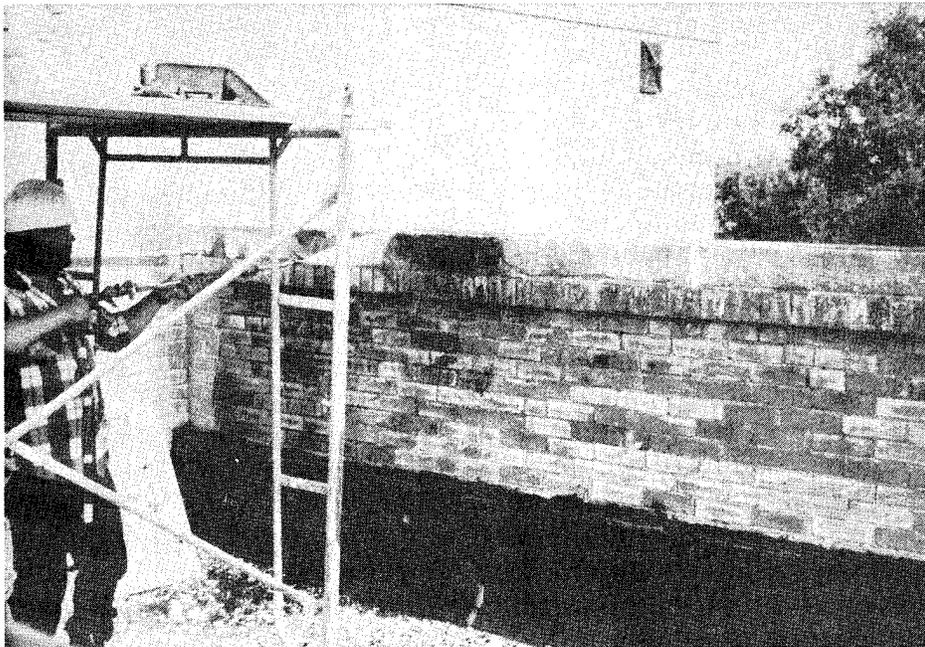
Figure 45. Medium pressure water cleaning of masonry

Masonry cleaning. While the masonry repair was going on, the chapel was being washed of the many years of dirt and grime it had collected. The contractor decided that the washing could be accomplished without using chemicals since the dirt on the bricks was only soil and some light coating of pollution. The decision to use no chemicals allowed him to wash before some of the repointing. He proceeded to wash with water at a medium pressure. Figure 45 shows a workman spraying the parapet walls on the roof of the east wing of the chapel. The water was sprayed on the bricks at a pressure of approximately 400 psi. This was considered strong enough to remove the grime and any loose mortar in the joints without damaging mortar that was strong. The entire chapel was washed from the top down to keep newly washed areas from being recontaminated from draining dirty water.

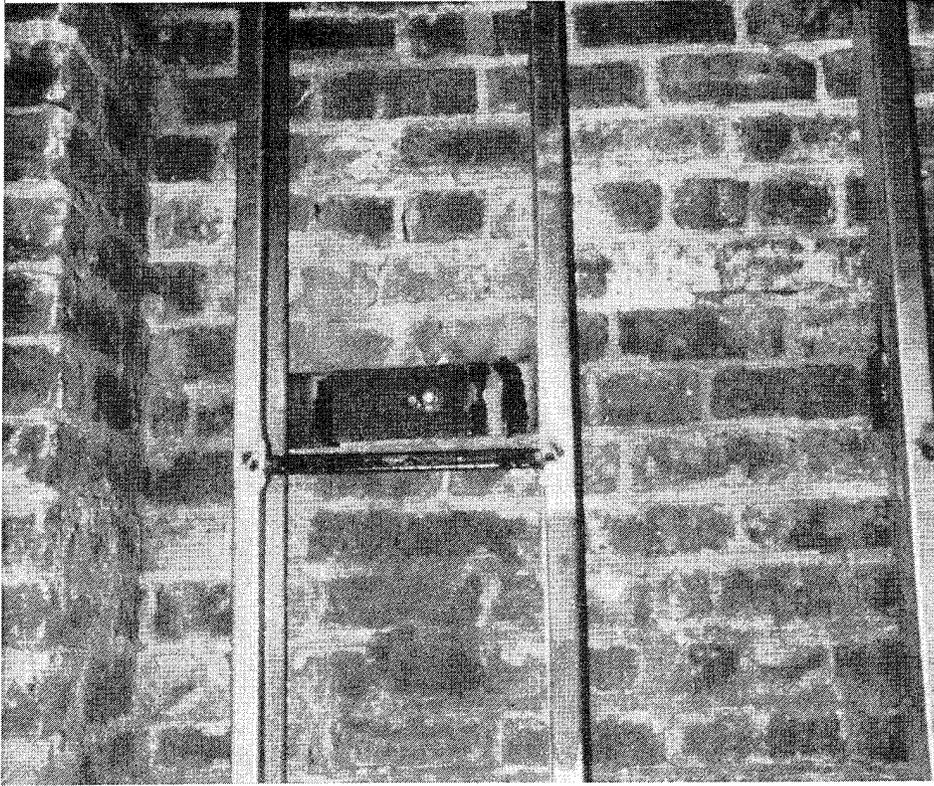
Figure 48. Overall view of structural studs and wall anchor

Tests were conducted to determine the strength of the epoxied bolts in the brick. Prior to the actual use of this system, three anchors were epoxied into brick test panels and were loaded to failure. One failed at 7,500 lbf, and the other two at 9,000 lbf, with all failures occurring in the anchor, not in the brick or in bond between the brick and the anchor. There were 4,900 bolts used in the wall renovation, and 520 of these bolts were subjected to pullout
