# NASA Contractor Report 3715

## DC-10 Composite Vertical Stabilizer Ground Test Program

J. M. Palmer, Jr., C. O. Stephens,  
and J. O. Sutton

CONTRACT NAS1-14869  
AUGUST 1983

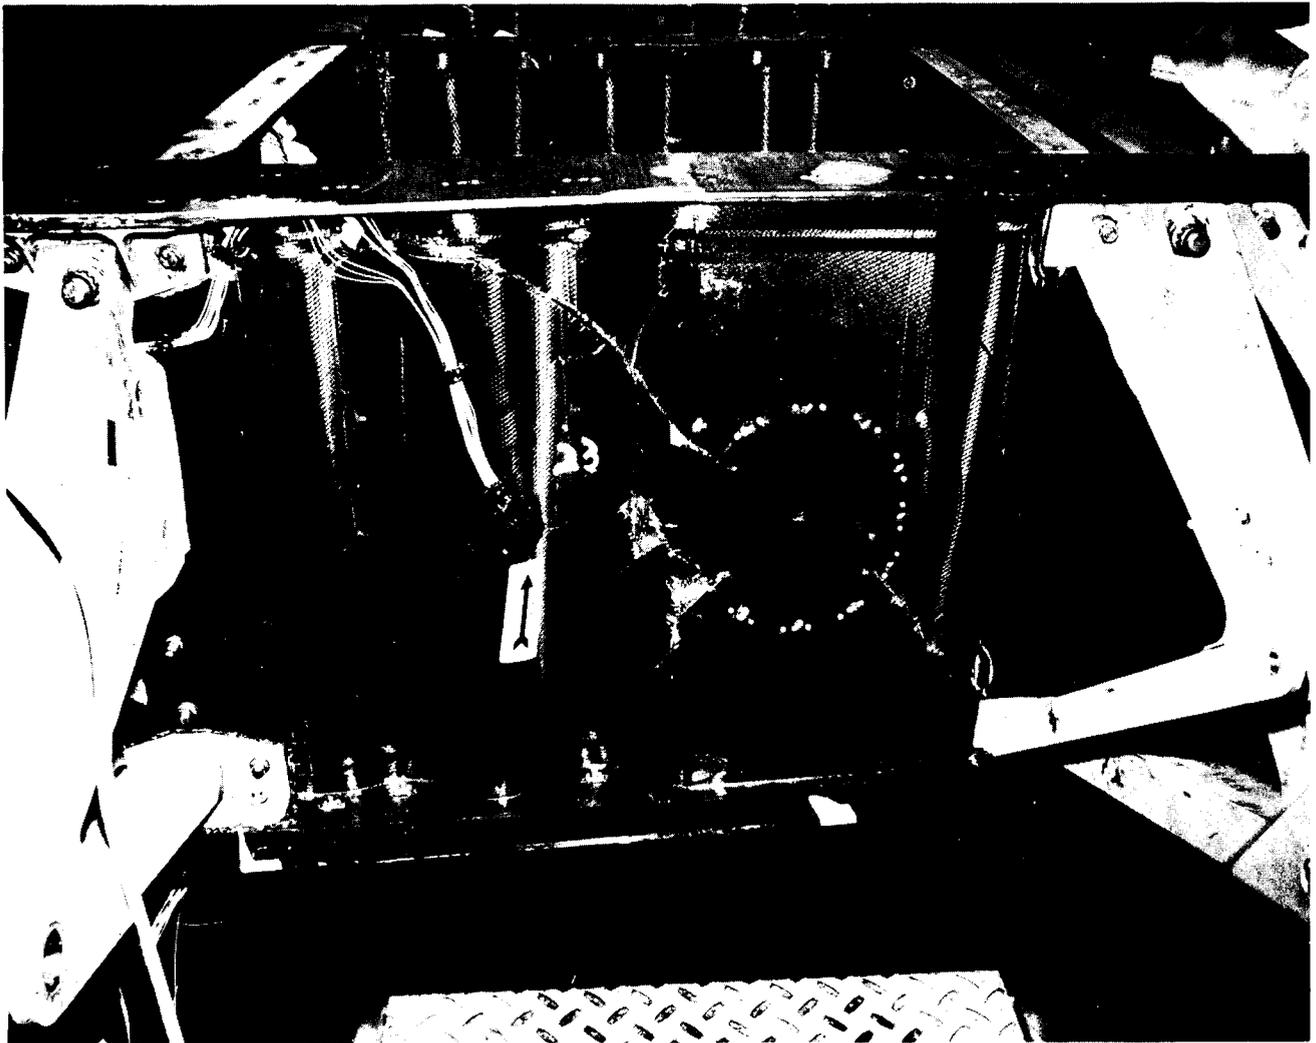
**FIGURE 19. FAILURE OF REAR SPAR WEB IN GROUND TEST UNIT**

Posttest visual examination of the specimen revealed structural failures in the rear spar web in the bay above the lower actuator cutout (Figure 19) and failures in the left-hand (compression side) skin panel. Following this preliminary survey of the damage, the specimen was removed from the test jig and returned to the manufacturing assembly area for more detailed damage assessment.

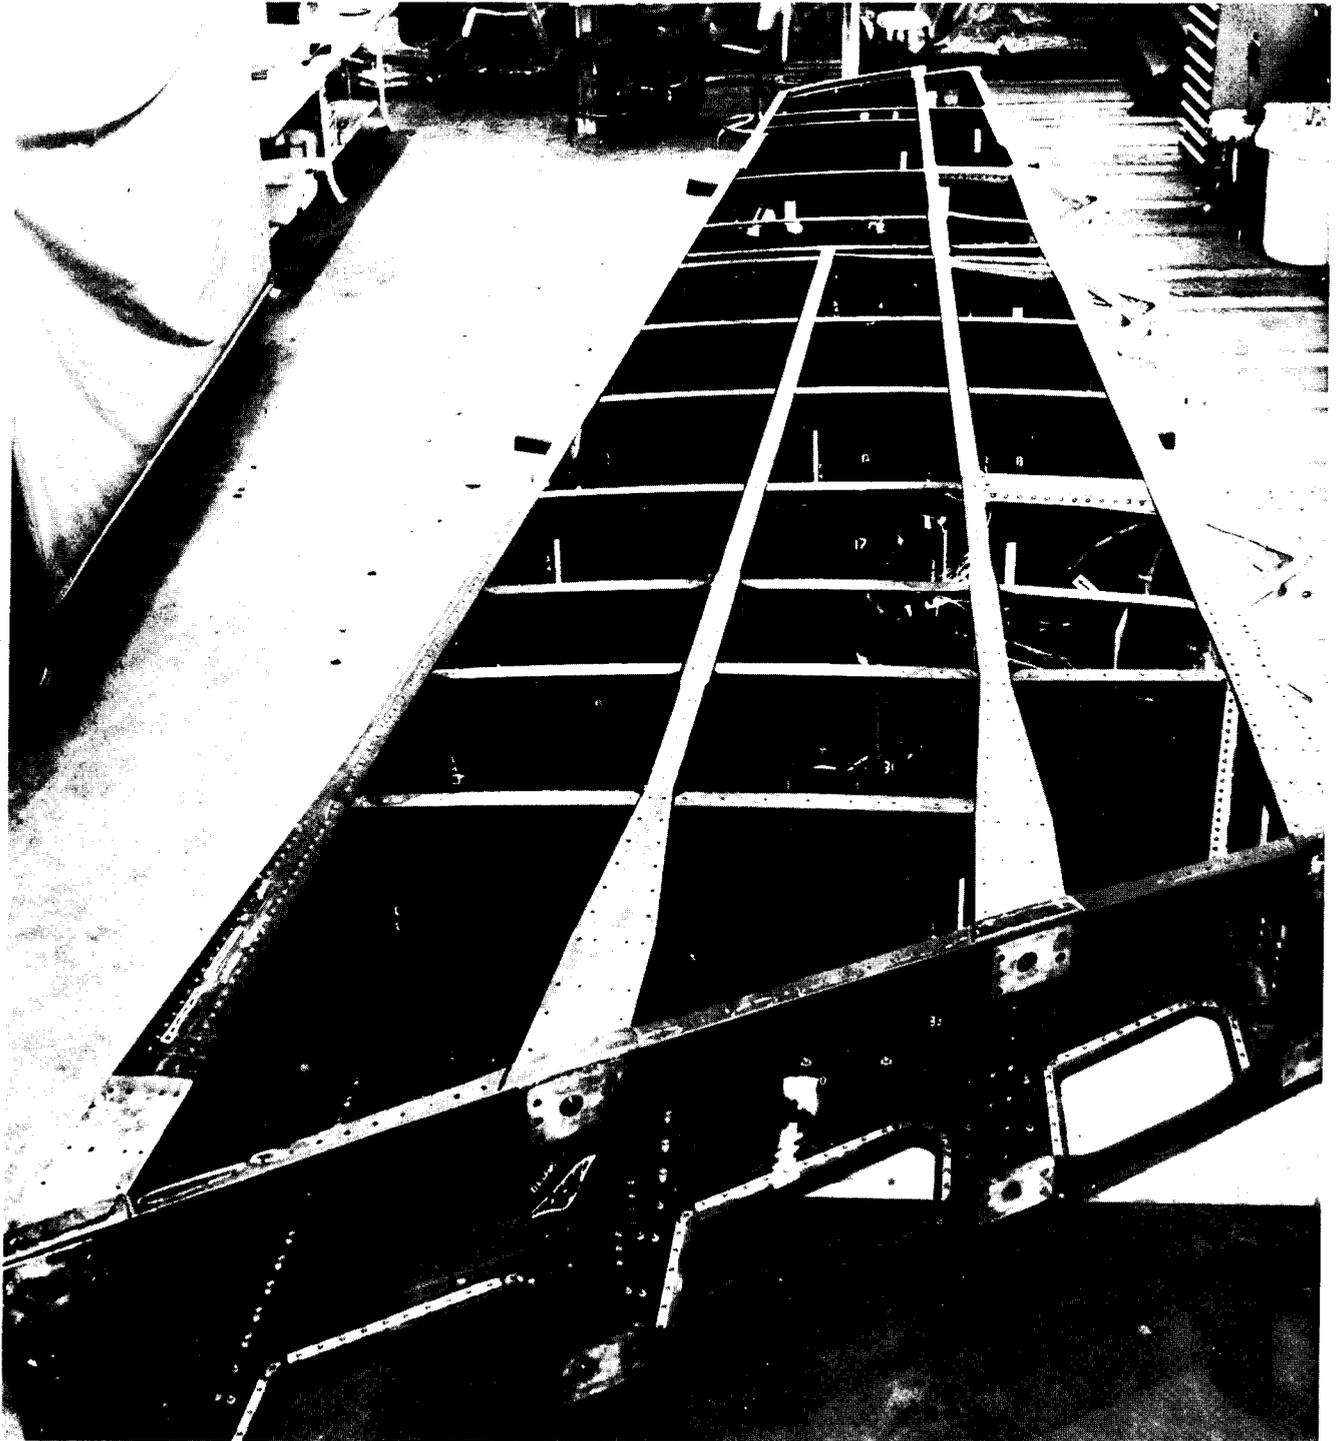
**FIGURE 20. GROUND TEST UNIT AFTER TEST FAILURE WITH LEFT HAND SKIN REMOVED**

The left-hand (compression side) skin panel was first inspected ultrasonically to detect any invisible damage. No significant damage other than that apparent by visual examination was found. This skin panel was then removed to allow a more detailed inspection of the damage to the substructure. Figure 20 is a view of the substructure after removal of the skin panel.

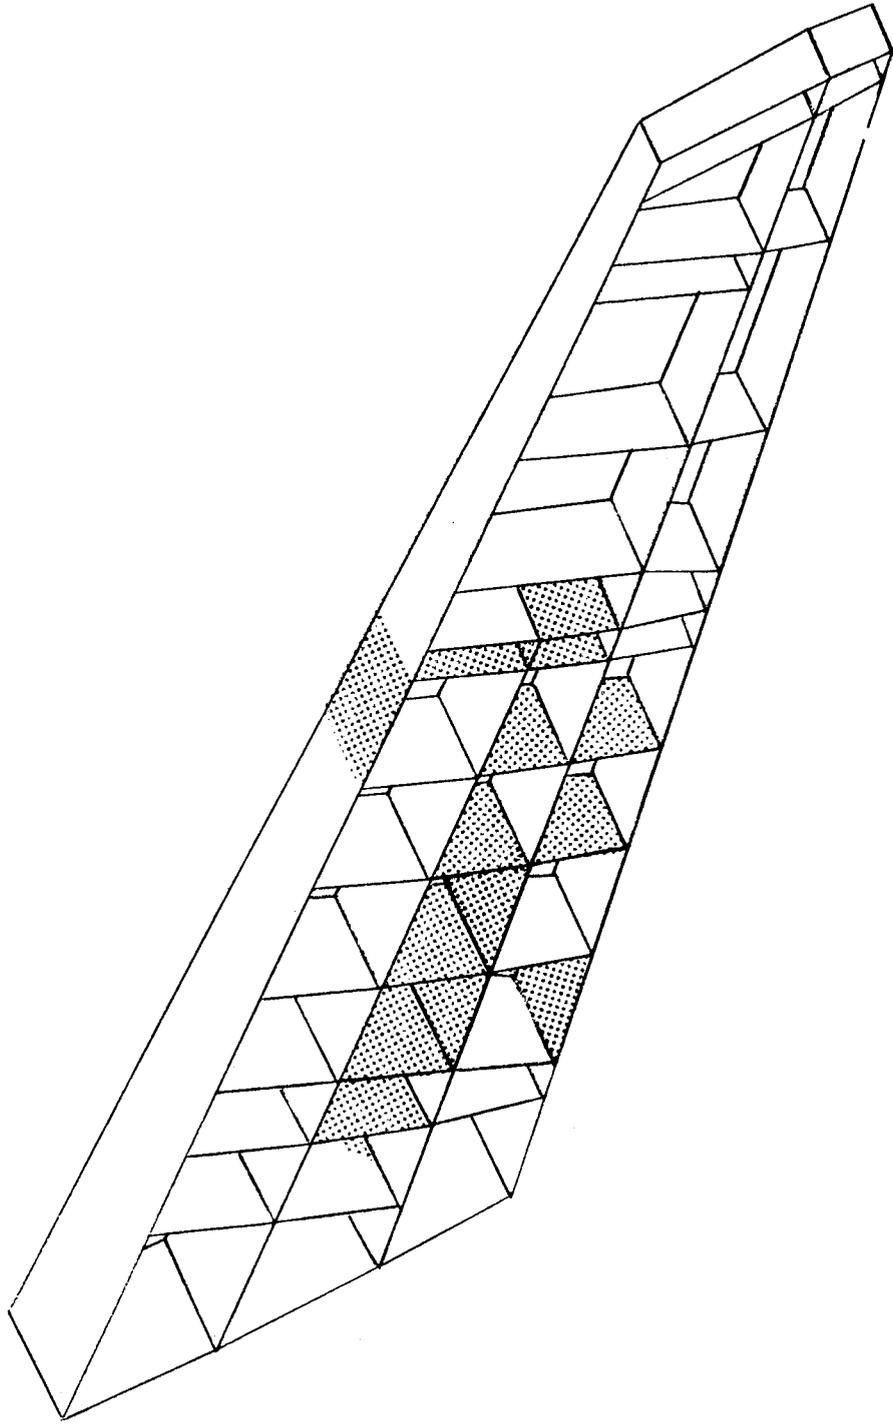
**FIGURE 21. LOCATION OF TEST FAILURES IN GTU SUBSTRUCTURE**

Failures were noted in the rear spar web and caps above the lower actuator cutout, the aft center spar web and caps, the forward center spar and front spar webs, and in a number of rib webs. Figure 21 is a sketch showing the location of the failed members in the substructure.

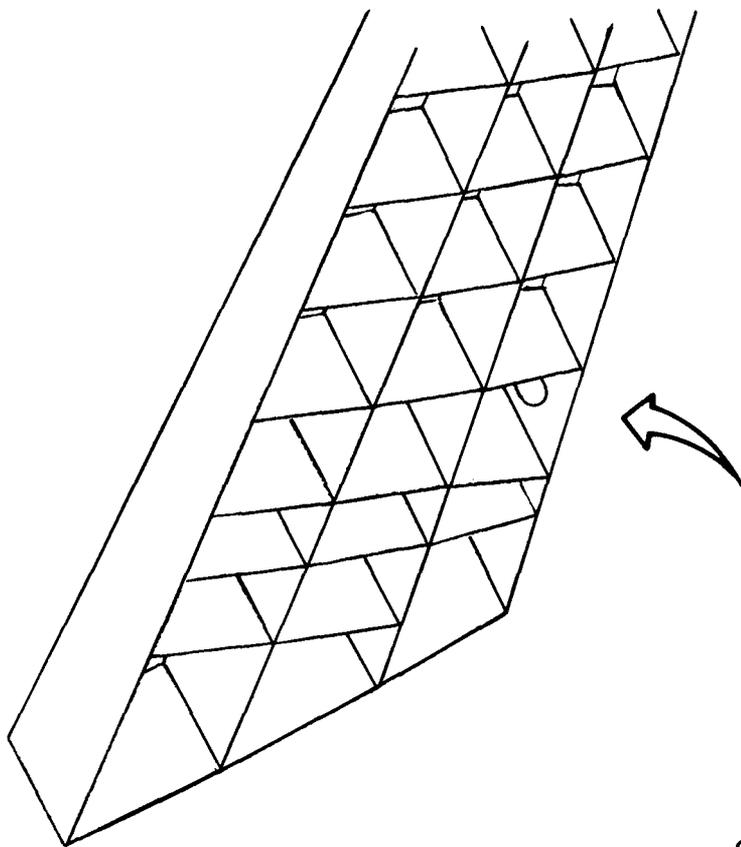
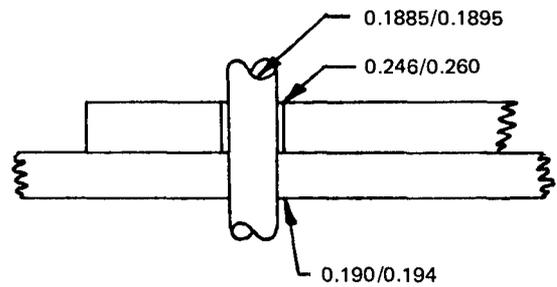
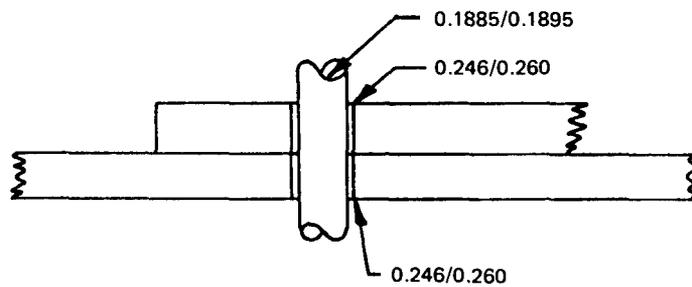
**FIGURE 22. FASTENER FIT IN CRITICAL REAR SPAR WEB DOORS**

1. The rear spar web in both specimens has a 4- by 5-inch hole at Z<sub>FR</sub> Station 342. This hole is reinforced by a cover plate attached with 12 fasteners. In the stub box, the holes in the rear spar web were of the appropriate size for the fasteners but the holes in the cover plate were 0.057- to 0.072-inch oversize. In the GTU the fastener holes in both the web and the cover plate were 0.057- to 0.072-inch oversize (Figure 22).

POSSIBLE SLOP = 0.0285/0.0385  
FAILED AT 144 PERCENT DLL

POSSIBLE SLOP = 0.0565/0.0715  
FAILED AT 100 PERCENT DLL

1. The failure of the rear spar web occurred as the result of higher-than-expected strains at the perimeter of the access opening in the rear spar web.
2. The strains were higher than analysis values because the cover over the access opening was not picking up load as designed.

3. The cover failed to pick up load as a result of improper quality of fit in the fasteners attaching the door to the web.

The relative quality of fit of the GTU and stub box specimens was considered to be the reason for the significant difference in failure load between the two.

The rework required to correct the initial failure condition had to eliminate the fastener fit sensitivity (including the effects of in-service wear) while retaining both the inspection access and weather protection features. At the same time, the rework had to be usable on parts that had already been built. The configuration that satisfied these constraints was a flat cover plate with a small reinforced flanged hole, bonded in place over each unreinforced access hole (Figure 30). By bonding the plate to the web, the effects of wear are eliminated, while the existing attachment fasteners, with improved fit quality, provided a fail-safe load path to protect against possible environmental degradation of the bond line.

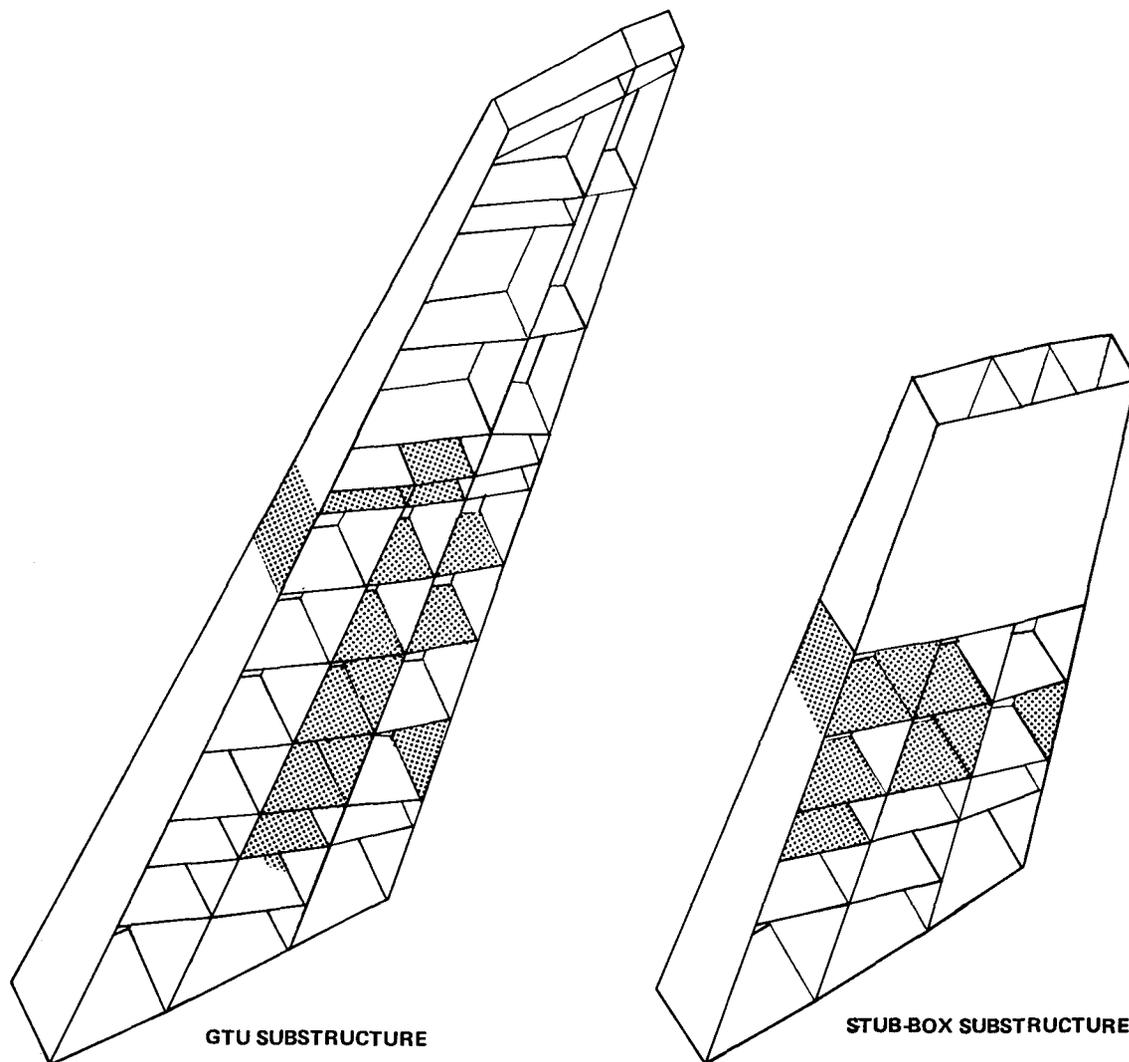
**FIGURE 23. COMPARISON OF TEST FAILURE LOCATIONS IN STUB-BOX AND GTU SUBSTRUCTURES**

Figure 23 is a comparison of the failure locations in the GTU substructure to those in the stub box subcomponent. The failed areas are in similar locations and differ only because of the influence of the boiler-plate dummy extension structure in the stub box.

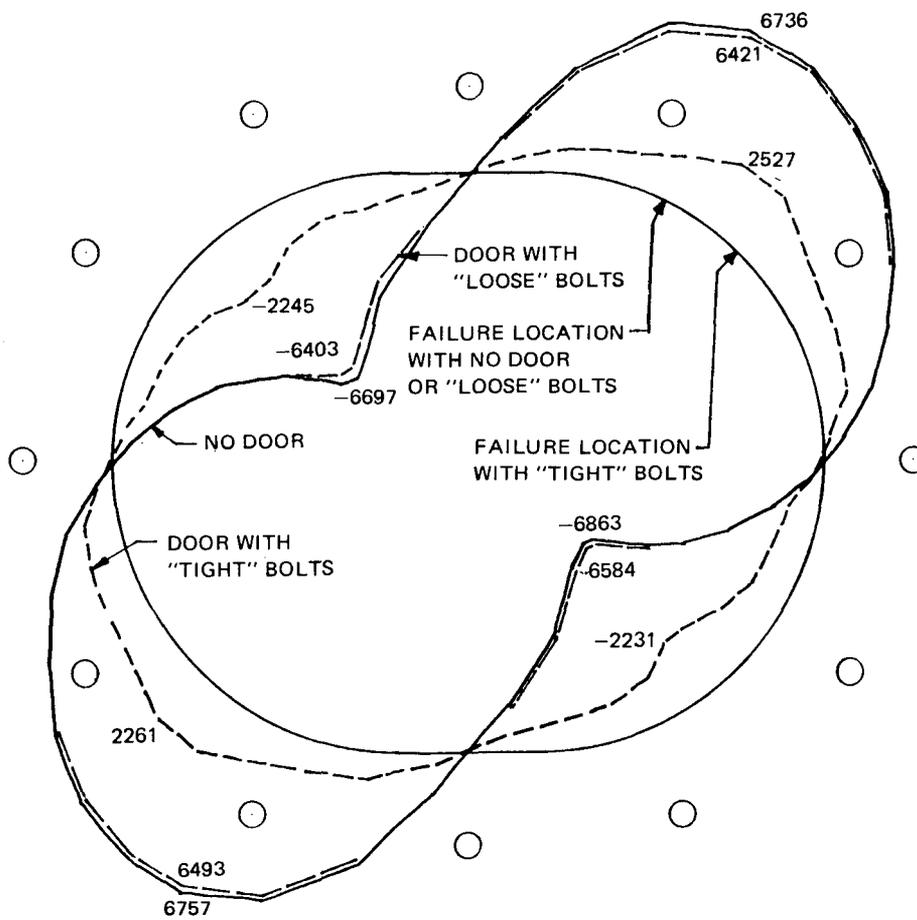
**FIGURE 25. LAMINATE MIDPLANE STRAINS AT REAR SPAR WEB ACCESS OPENING**

The second area of investigation was the covered cutouts in the rear spar web and the center bay of the ZFR Station 314 rib. A simple planar analysis indicated that the strains at the perimeter of the cutouts were not critical even with the door missing. However, it was recognized that the sine wave web produces significant out of plane forces at the hole which would modify those results. Accordingly, a detailed three dimensional NASTRAN model of the critical rear spar web was developed (Figure 24). Web shear, spar cap and bolted joint interface loads were applied to the model while the attachment of the door module to the web module was analytically varied from full shear effectivity to zero shear effectivity. A reference case with no door installed was also run. The results are shown in Figure 25, where the laminate mid-plane strains at the perimeter of the access opening are plotted for each quality of fastener fit. Clearly, if sufficient slippage between the door and web is available, the presence of the fasteners provides almost no relief from the maximum strains, while fully effective fasteners (i.e., a fully effective door) provides considerable support at the edge of the cutouts.

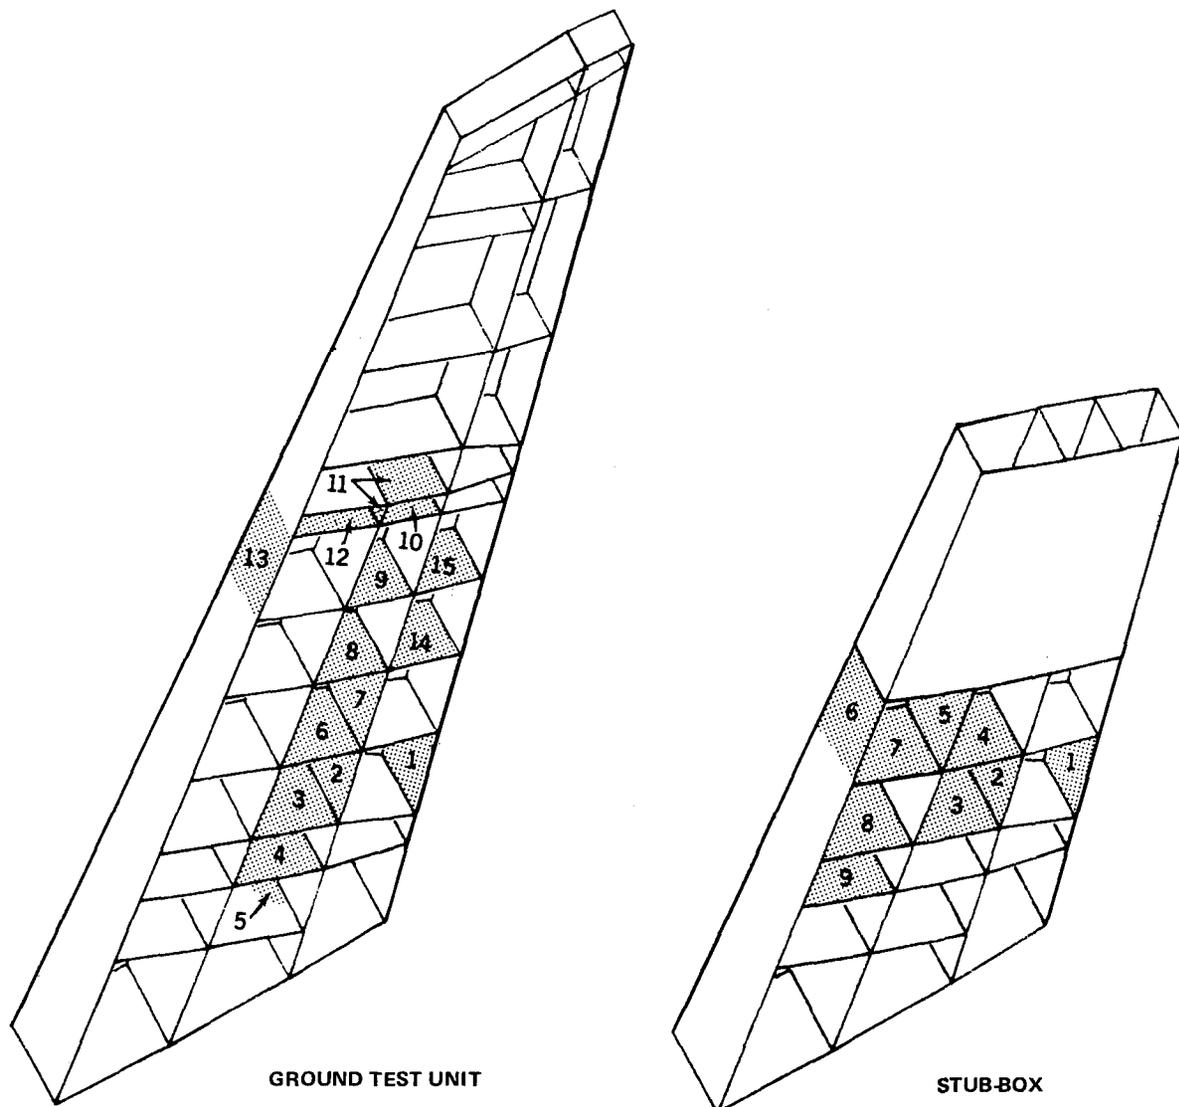
**FIGURE 27. ANALYTICAL FAILURE SEQUENCE**

The NASTRAN model for the stabilizer was modified to reflect an assumed failure in the rear spar web at Z<sub>FR</sub> Station 342 and was subjected to the appropriate load condition (maximum bending case). This analysis indicated a progression of failure to the aft center spar web between Z<sub>FR</sub> Stations 329 and 350. This failure progression was pursued analytically with the finite element model to determine the probable sequence of failure. Each structural element that subsequently indicated a negative margin was deleted from the model and the loads reapplied. A search was then made for negative margins in the remaining structure. In this fashion, a probable failure sequence was established for both test articles as shown in Figure 27. Each distinctive structural failure observed in the substructure of both test articles was predicted by this analysis.

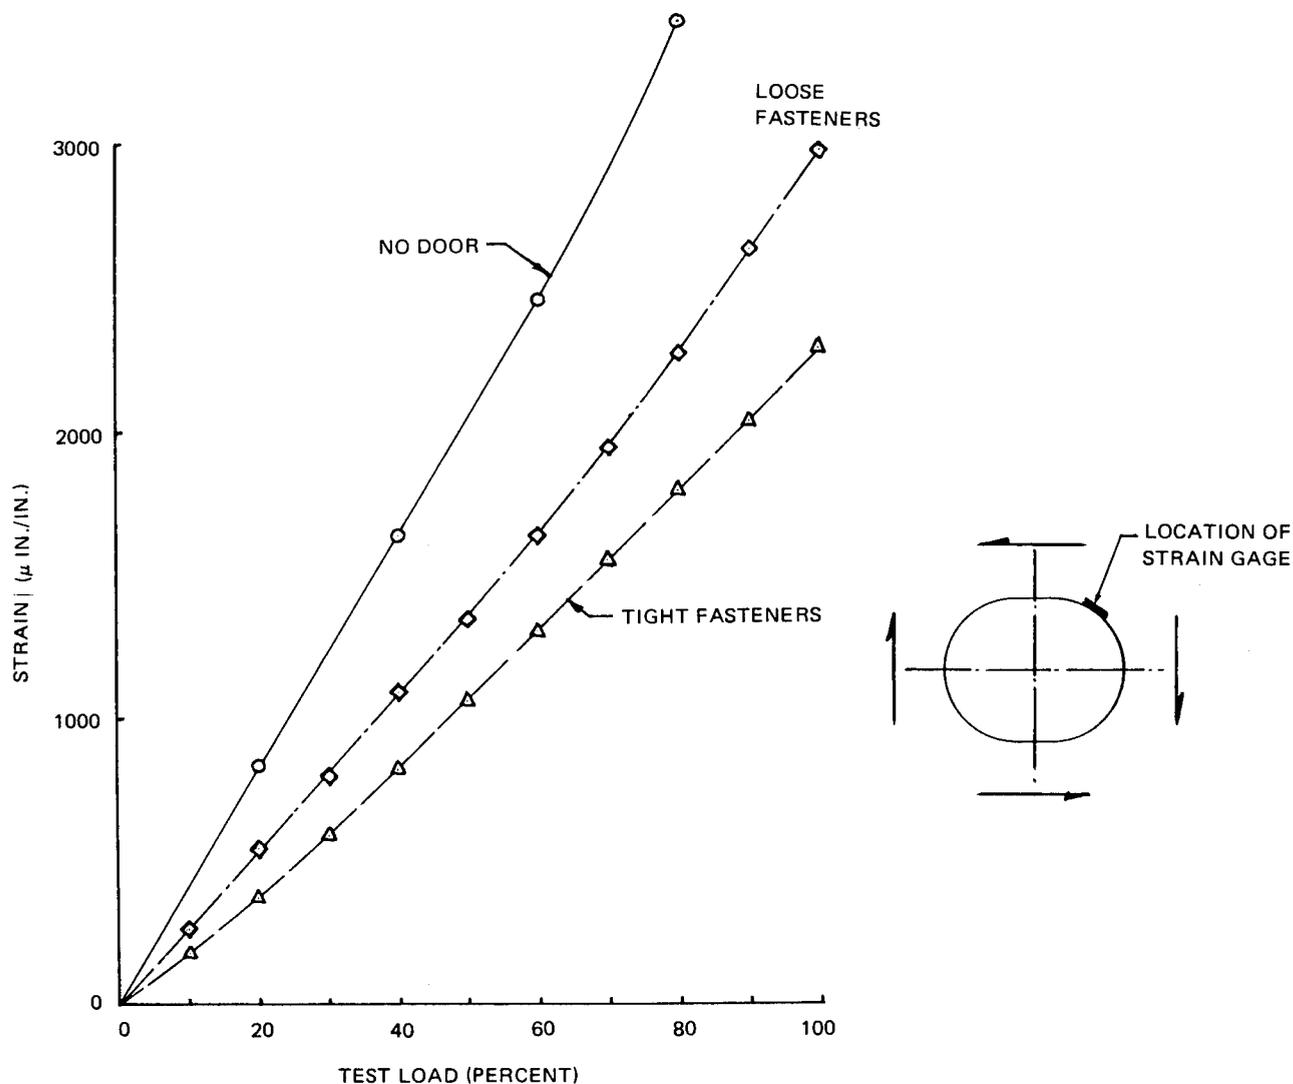
FIGURE 29. STRAIN AT PERIMETER OF CUTOUT IN AMC7855-5 RIB COMPONENT

The results of these tests are shown in Figure 29, where the maximum strains measured at the perimeter of the access opening are plotted versus load. Without a door attached, the hole perimeter strains were extremely high. With the tight fit holes, the perimeter strains were considerably reduced. When the door holes were drilled out, the strains increased, as was expected. When the web holes were drilled out (not shown) no additional effect was observed. This is consistent with the failure theory, in that once the fasteners lose contact with the holes, additional clearance can do no additional harm. Only after sufficient distortion had occurred to bring the intermediate fit configuration fasteners into contact with their holes would any difference become apparent. This load level was not reached during the test due to the risk of prematurely damaging the specimen.

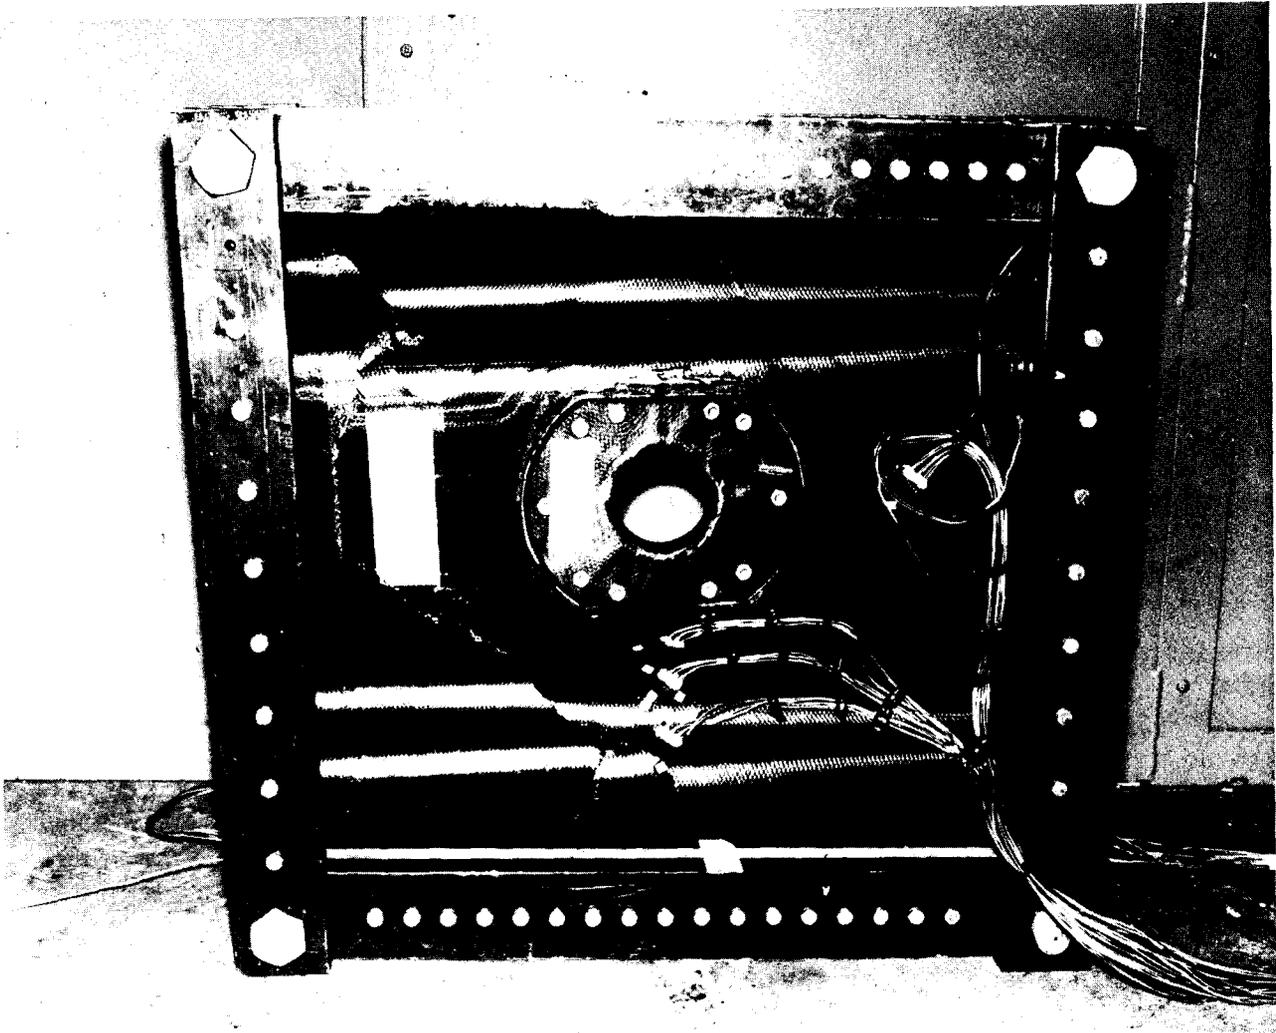
**FIGURE 32. AMC7855-5 RIB COMPONENT AFTER TEST SHOWING WEB FAILURE**

To test the validity of the concept, a flanged plate was made and installed on the AMC7855-5 rib test specimen (Figure 31). The panel was tested to failure, with failure occurring in the basic sine-wave web, well away from the opening (Figure 32). The strains measured at the perimeter of the hole with the bonded cover in place are shown in Figure 33.
