**FAILURE OF COMPONENTS ALTHOUGH THE
CAUSES ARE SIMPLE & WELL DOCUMENTED**

Massachusetts Materials Research, Inc.

1998

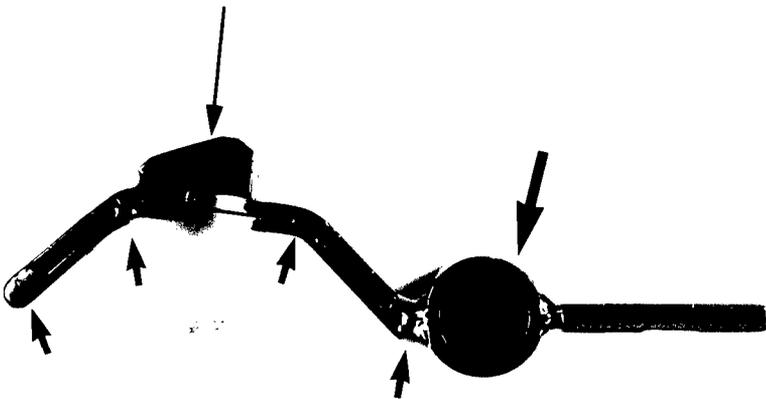
Investigation: A few fractured pawls were examined to determine the root cause of the failure. Figure 1 shows a new pawl finger as viewed from one side. The spring plate is "sandwiched" in the bracket and the two sides of the bracket are welded in four locations (small arrows). The longer arrow is pointing to the pawl weight and the thicker arrow is showing the fulcrum bushing.

Figure 1. Overall view of a new pawl. Small arrows are pointing to the welded spots; the long thin arrow is showing the weight and the thick arrow is showing the fulcrum bushing. Mag. 0.6X

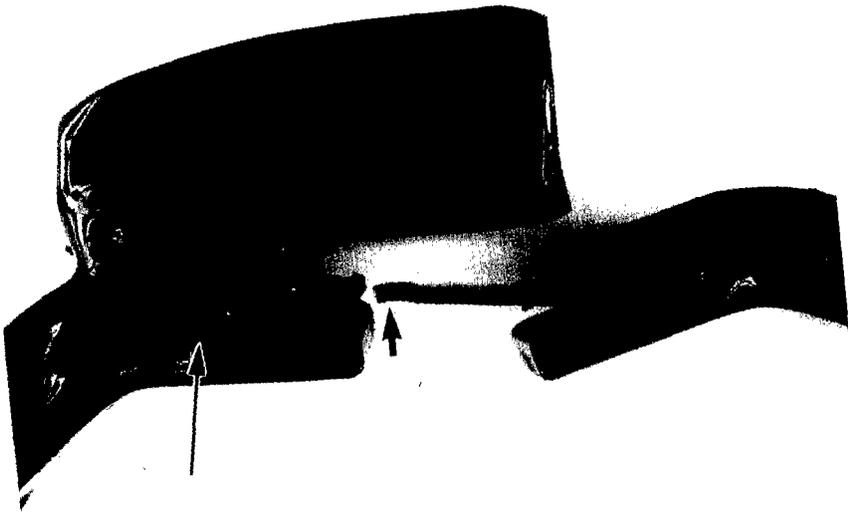
Binocular Microscope Examination: The spring strips always failed in an area that is unsupported by the bracket. Figure 2 presents an overall view of a failed pawl. Some plastic deformation was observed near the fractured surfaces of the spring strips.

Figure 2. A fractured pawl; the smaller arrow is pointing to the plastic deformation and the longer arrow is showing the cracked weld. Mag. 2.2X

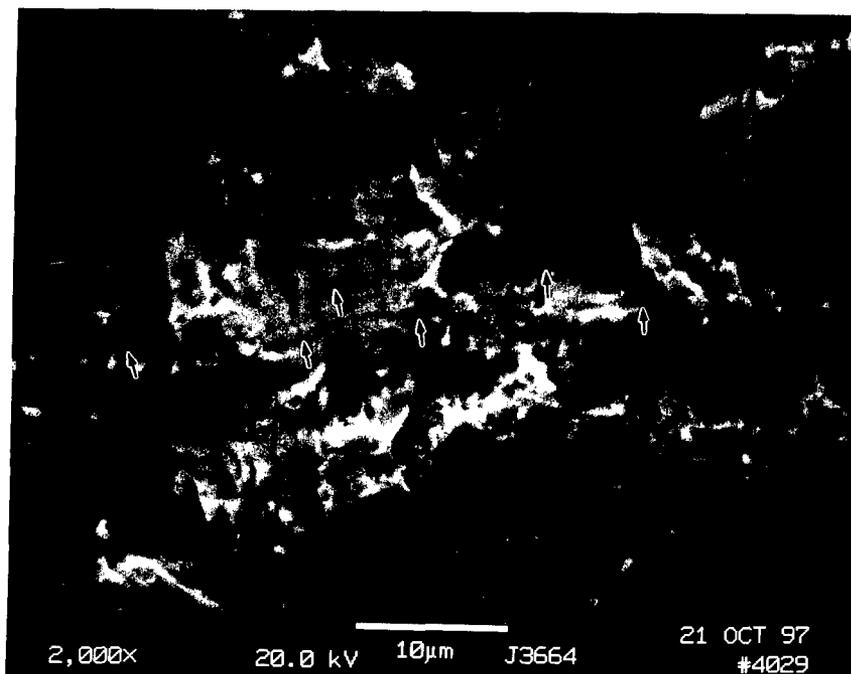
Scanning Electron Microscopy: The fracture surfaces from the samples were examined at higher magnifications for determination of the fracture mode. The origins were always from the same side and from the surface. No anomalies were observed at or near the origins. Fatigue striations were visible emanating from the origins. Figure 4 presents an area with striations. Each striation indicates the position of the crack front after each succeeding cycle of stress or loading and are indicative of fatigue fracture.

Figure 4. Higher magnification SEM photograph revealing fatigue striations (arrows) emanating from one of the origins. Mag. 2,000X

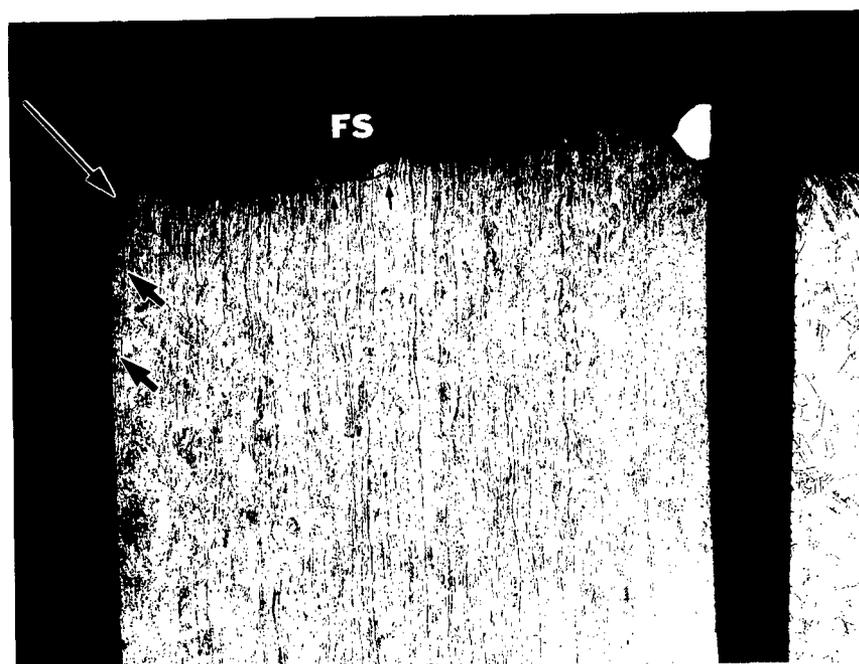
Optical Microscopy: Cross-sections were made through the origins of the two fractured samples. No microstructural anomalies were found in the samples. The microstructure consisted of heavily worked elongated austenite grains, typical of full hard 301 stainless steel (SS). Figure 5 shows an overall view of the mounted cross-section through one of the origins of sample #1. The longer arrow shows the origin. The fracture was predominantly transgranular and showed many secondary cracks (small arrows). The small thicker arrows on the left-hand side of Figure 5 show initiations of other fatigue cracks, parallel to the fracture surface (FS).

Figure 5. Mounted cross-section through one of the origins of sample #1. The longer arrow is pointing to the origin; small arrows are showing the secondary cracks on the FS. Thick small arrows on the left-hand side are showing other fatigue cracks initiating. Mag. 100X

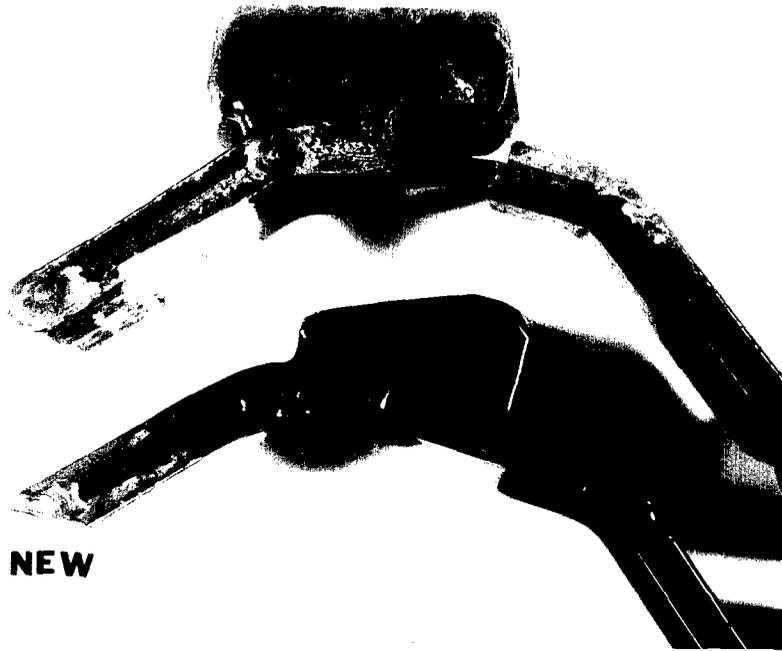
Figure 6. Suggested new pawl tip design for the existing pawls. The upper pawl is showing the tip design currently in use. Mag. 1.25X

Recommendations: We suggest a change in the shape of the tip of the pawl, which would be a retrofit to the existing pawls. Instead of the present rounded tip, the end should be ground so that the inner diameter side of the bracket makes an angle of about 40-45 degrees with the pawl weight side (outer diameter side) of the bracket (Figure 6). This reduces the contact area between the pawl tip and the gear tooth and the angled surface helps the pawl slide down to nest between the gear teeth. There is less chance of the pawl tip to get caught on the gear crest. The crests of the big gear teeth should be smoothed so that there are no burrs.

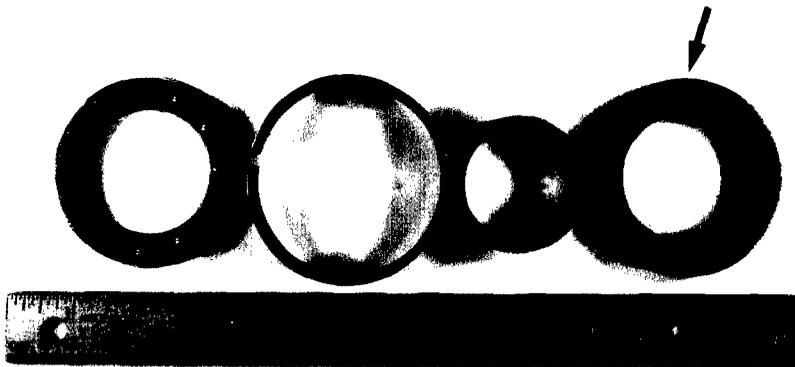
Binocular Microscopy: The Power Lock was disassembled, Figure 7, and examined with a binocular microscope. Cracks were observed on both sides of a drill hole in ring A, at the thinnest section. The arrow in Figure 7 is pointing to the crack. There were no cracks at any of the remaining drill holes.

Figure 7. Overall view of the disassembled "Power Lock". The arrow is pointing to the crack in Ring A.

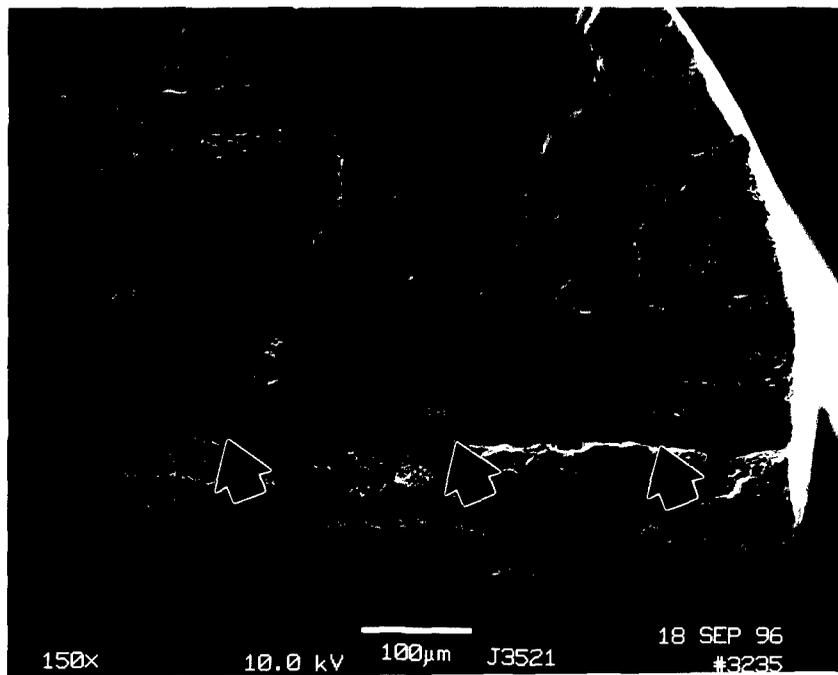
Scanning Electron Microscopy: High magnification examination of the outer radius fracture revealed that the thin end of the fracture had two “smooth” linear regions extending to the tip. Figure 9, at higher magnification, shows the tip of the fracture surface containing one of the smooth features. Energy dispersive x-ray spectroscopy was performed on the smooth linear portion and rough portion of the fracture surface. Analysis of the smooth surface revealed a major concentration of iron, minor concentrations of sulfur and manganese, and a trace of oxygen, indicative of a manganese sulfide inclusion. Analysis of the rough fracture surface revealed a major concentration of iron, and trace amounts of sulfur, manganese and oxygen indicative of the base steel material.

Figure 9. Higher magnification SEM fractograph reveals a long, smooth, flat area

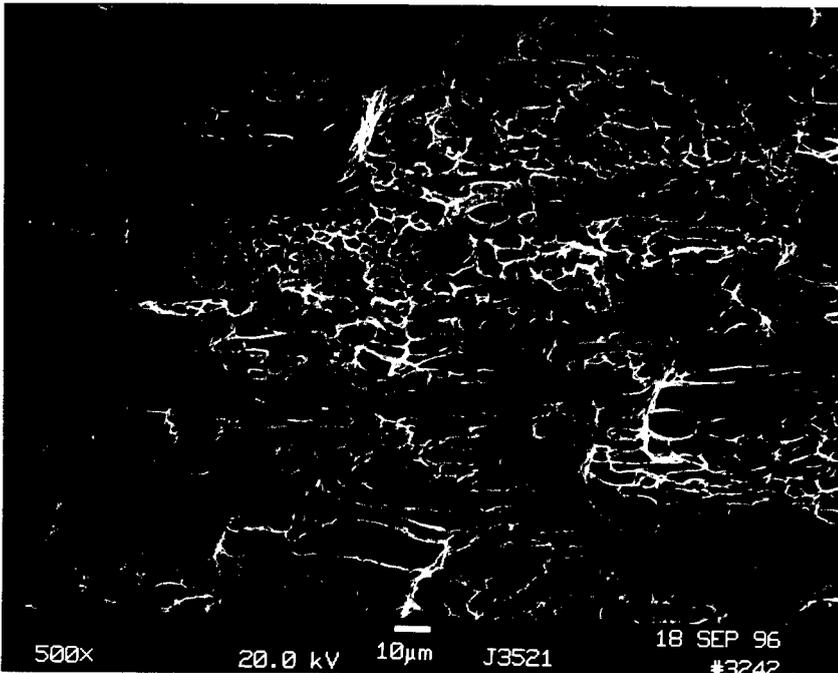
The rough “woody” features on the fracture surfaces are ductile, as shown by the dimple rupture in Figure 10. The thick end of the fracture, which appeared to be shiny and rough in our binocular examination, are “cleavage” facets, indicating a fast fracture, probably the last portion to separate.

Figure 10. Ductile dimple rupture type of fracture observed in the “woody” areas of the fracture surface. Mag. 500X

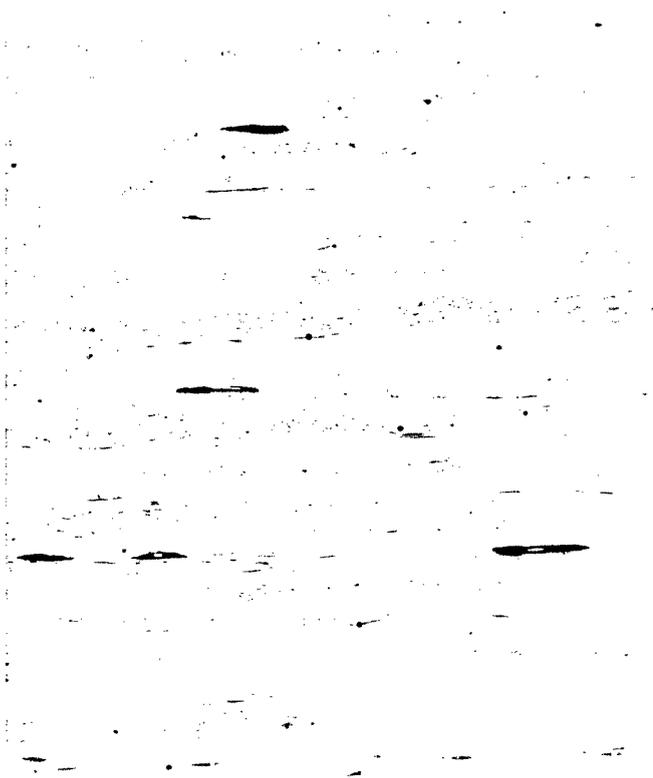
Optical Microscopy: The failed ring was cross sectioned away from the fracture for microstructural analysis. Figure 11 shows the inclusions in the longitudinal cross-section. The inclusion content is quite significant and is typical for a resulfurized steel.

Figure 11. Mounted longitudinal cross-section through ring A showing manganese sulfide inclusions. As-polished. Mag. 100X

Recommendations: Since the tapered rings were stressed circumferentially, (i.e. transverse to the drawing direction), selection of a material with: 1) a low inclusion content, such as a non-resulfurized grade; and 2) fabricated by hot-rolling rather than cold drawing should improve the product.
