Repair of Damage to Marine Sandwich  
Structures: Part I – Static Testing

Rodney Thomson, Raoul Luescher and  
Ivan Grabovac

DSTO-TR-0736

*October 1998*

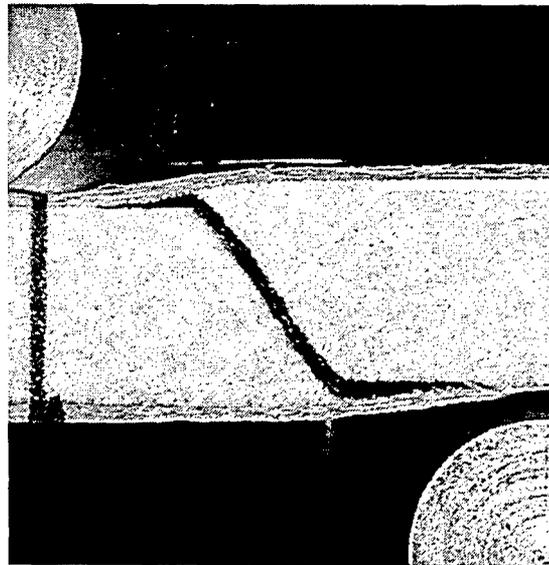
Some variability was observed in the behaviour of the repaired specimens tested in the normal position. The maximum load achieved was influenced by the integrity of the bond between the existing skin and the replacement core. All specimens failed through core shear, which initiated from a defect in the bondline in some of the specimens. The load displacement behaviour of a typical repaired specimen that failed under core shear is shown in Figure 14. The additional ply in the repaired skin in the region under the loading point also helped to prevent local failure through skin wrinkling. As shown in Figure 14, the core shear failure occurred between one support and loading point at a 45° angle (in the direction perpendicular to the maximum tensile stress). Core shear failure was characterised by sudden, catastrophic failure of the specimen. The skin was usually debonded from the core at either end of the shear failure.

Figure 14: Typical core shear failure in the normal position for specimens repaired using the RAN Type B method.

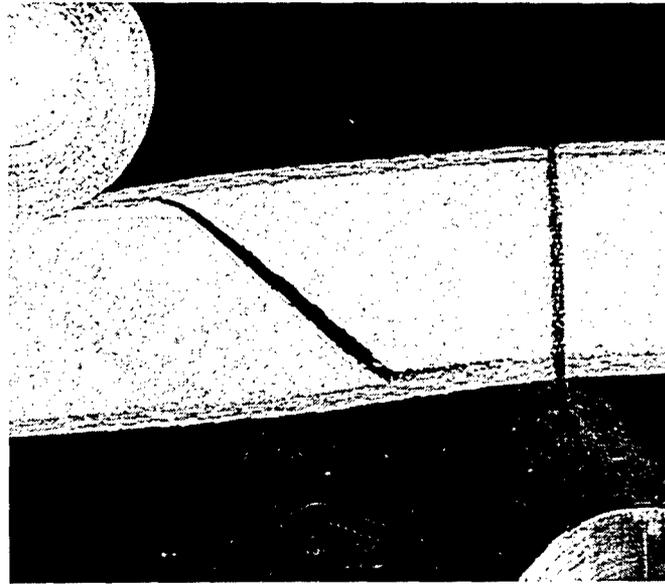
A large degree of variability was observed in the behaviour of the repaired specimens in the inverted position. Most specimens failed through core shear but the maximum load carried depended on the integrity of the bondline. In a number of specimens, shear failure initiated from a visible defect in the bondline, an example of which is shown in Figure 15. One specimen in which the void covered approximately 50% of the bondline carried only 60% of the reference load. The position of the void as well as the void size influenced the load carried by the specimen. Other specimens suffered debonding of the original skin from the replacement core which, being under compression, proceeded to buckle as shown in Figure 16. One specimen failed through local skin wrinkling under the loading points.

Figure 15: *Shear failure of a RAN Type B repaired specimen in the inverted position initiating from a defect in the bondline.*

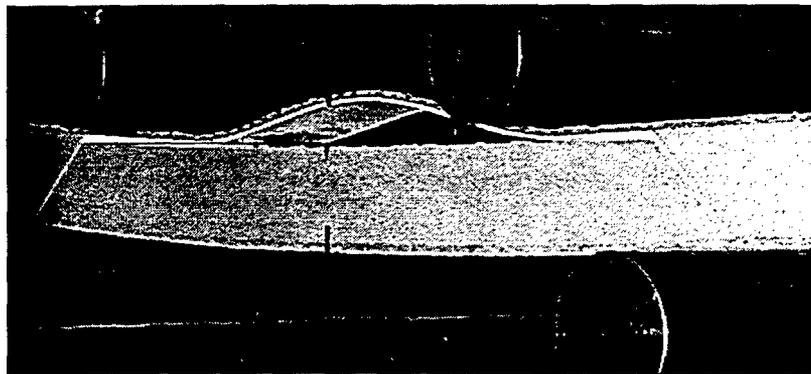
Figure 16: *Typical debonding failure of a RAN Type B repaired specimen in the inverted position.*

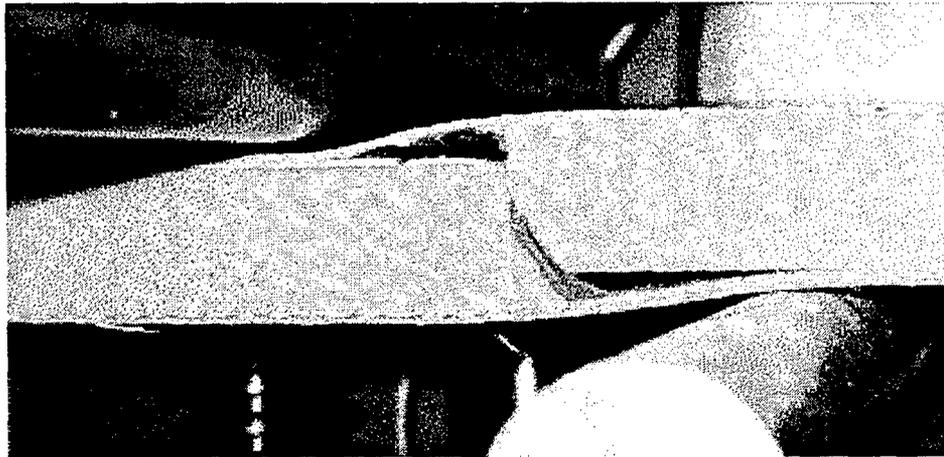
The behaviour of the repaired specimens tested in the normal position was consistent with all specimens achieving a similar maximum load. Two specimens failed through local skin wrinkling while the remainder failed through core shear. The extra ply in the skin due to the repair in the loaded region helped prevent local skin wrinkling failure. One specimen was deemed to fail prematurely due to the presence of a void in the joint between the existing and replacement core, as shown in Figure 17. This specimen failed at a load approximately 10% lower than the average. It was noted that in most of

*Figure 17: Failure of modified Type B repaired specimen from a defect in the bondline.*

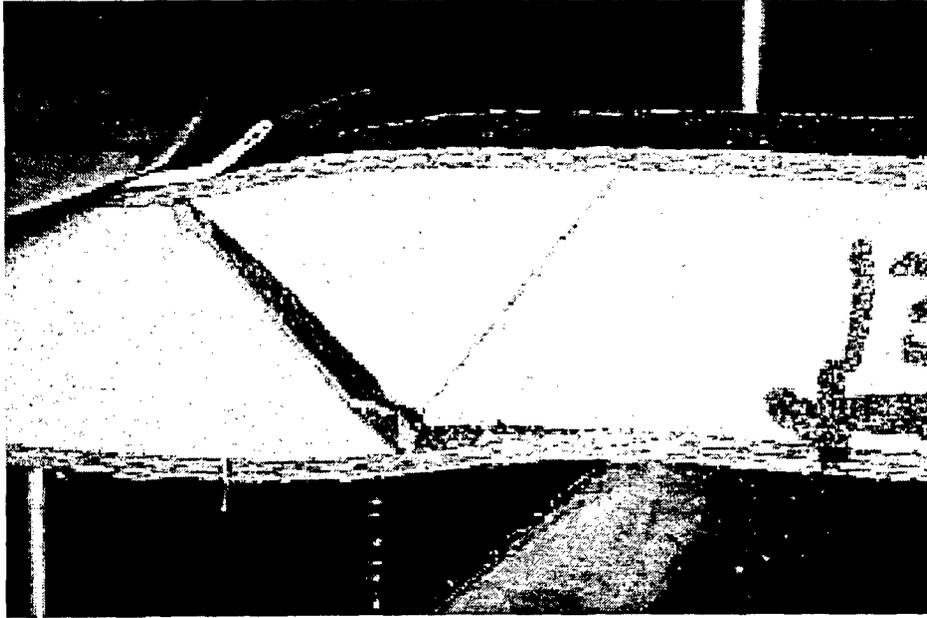
The repair specimens tested in the normal position exhibited consistent behaviour. Just over half of the specimens failed through core shear while the others suffered interface failure between one of the 45° bondlines and the core, as shown in Figure 19. This mode of failure usually occurred in the core directly next to the bondline unless there was a void or porosity in the adhesive in which case it could run through the bondline. In most of the shear failure specimens, failure initiated from a crack in one of the 45° bondlines, as shown in Figure 20. It was observed that the adhesive failed under tension resulting in a crack which then propagated slowly into the core until catastrophic growth and failure occurred. The other shear failure specimens may have failed through a similar means which was not visible on the specimen edges.

Figure 19: Typical bondline interface failure of a RAN Type C repaired specimen tested in the normal position.

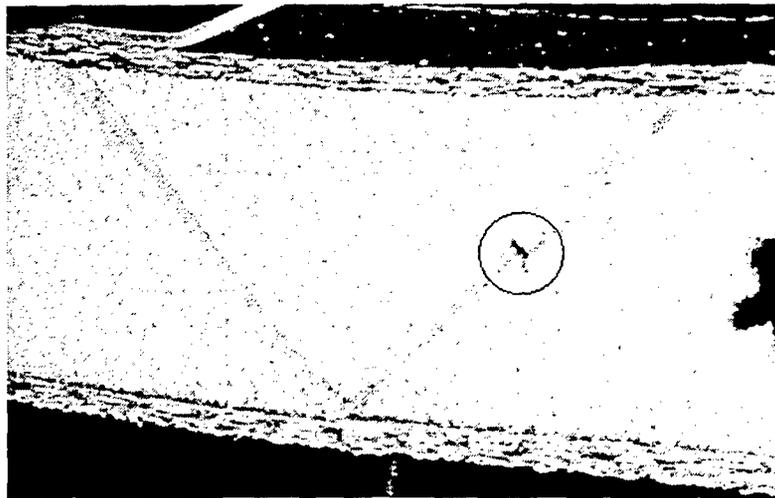
Figure 20: The crack (circled) which developed in the bondline in a RAN Type C repaired specimen tested in the normal position.

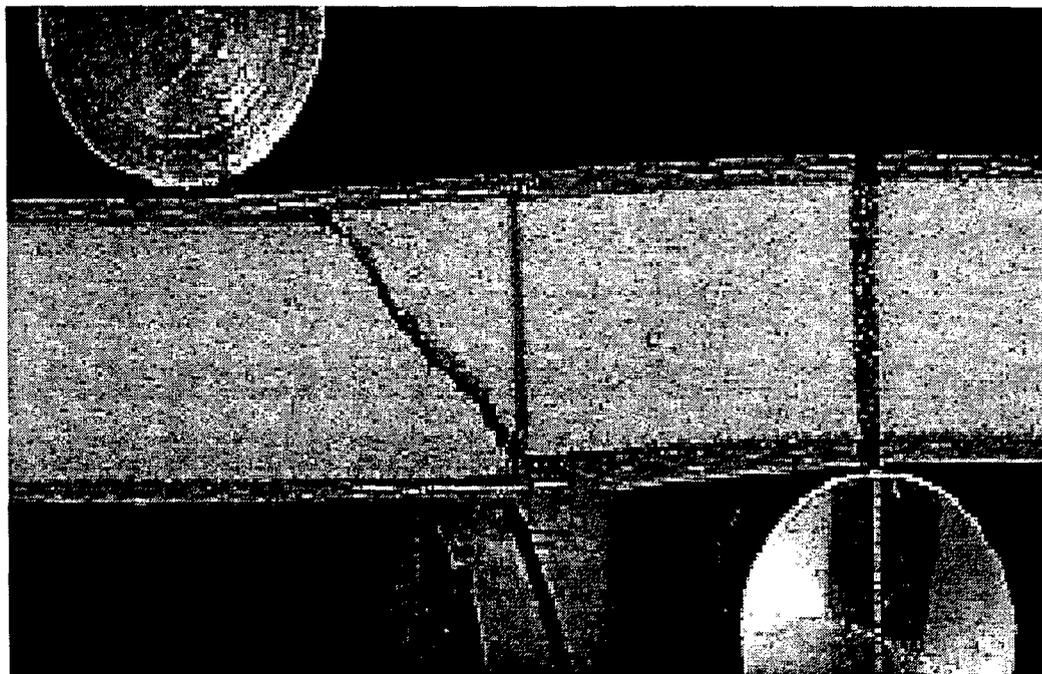
The repaired specimens tested in the normal position reached similar maximum load and failed through core shear which usually occurred as shown in Figure 21, running

through the bottom of the join in the core. One specimen failed through local skin wrinkling under the loading points.

*Figure 21: Typical shear failure of a modified Type C repaired specimen tested in the normal position.*

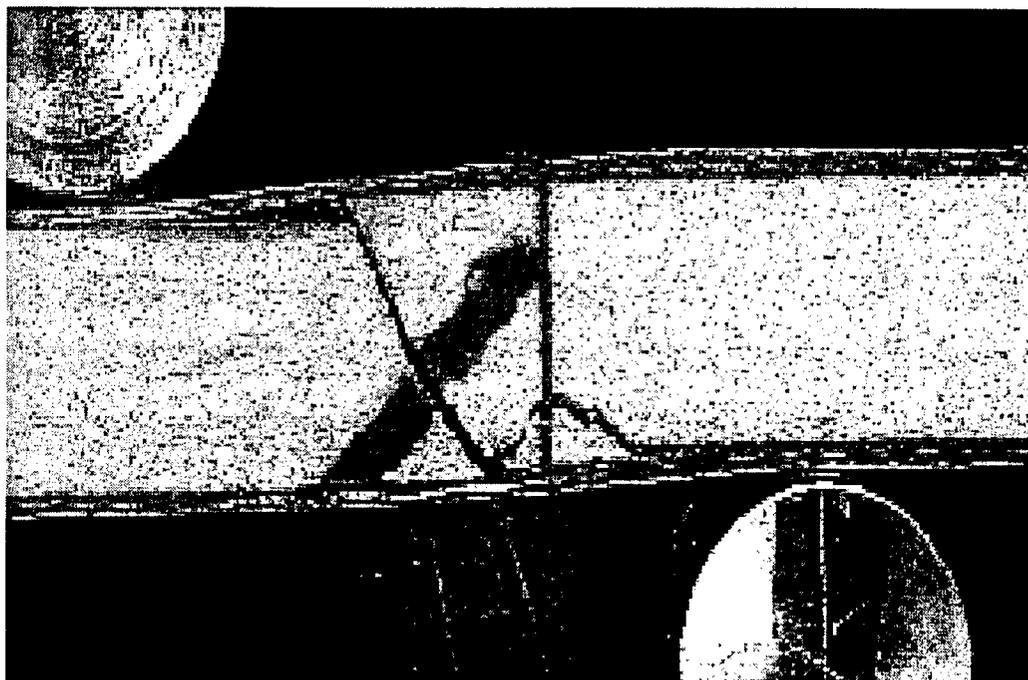
The behaviour of the repaired specimens tested in the inverted position was consistent with all specimens achieving a similar maximum load before failing through core shear. In most specimens, a cracking noise was heard at 85% - 95% of the ultimate failure load associated with a crack developing in the adhesive that had filled the injection hole (refer to Figure 8). When tested in the inverted position, this column of adhesive, which was at an angle of approximately 45°, was loaded in tension. Thus, this adhesive column failed under tension in a similar manner to the 45° bondline in many of the RAN Type C repair specimens tested in the normal position. The presence of the crack created a stress concentration in the foam core which then proceeded to fail. This effect was observed in three specimens in which the column of adhesive was visible on the edge, as shown in Figure 22. It was likely that every specimen would have had an injection point on at least one end since they were at 60 mm spacing and the specimen width was 40 mm.

Figure 22: Typical failure of a modified Type C repaired specimen tested in the inverted position showing failure initiation from a crack in the injection adhesive.
