---TECHNICAL REPORT---

No. 13755

Test and Evaluation of the
LMTV Driveline
1998

By Stephen J. Aamodt

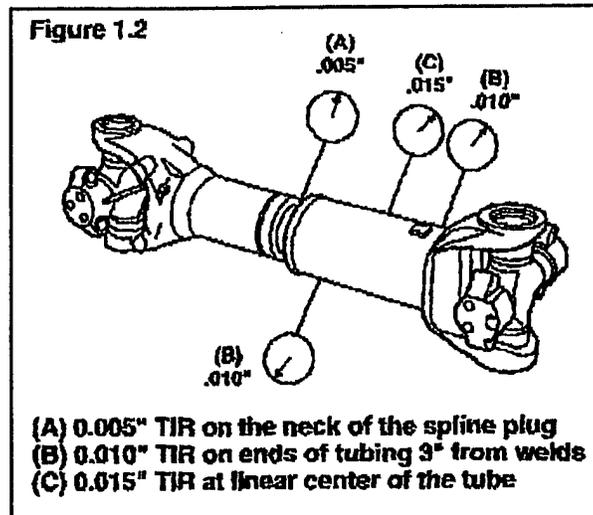
Figure 1 - Driveshaft Runout Specifications

When checking with the PM's office regarding this finding, it was revealed that the shaft did meet the specifications for balance as provided by the manufacturer, Meritor, but did not meet the specification for runout. The Meritor specifications stated for balance that a value of 2.06 inch-ounces is the maximum on the slip end and 1.49 inch-ounces is the maximum on the weld yoke end. Runout values that should not be exceeded are 0.005 inches on the spline plug, 0.015 inches in the center and 0.010 inches on the weld side. Refer to figure 1 for the visual locations of these values as specified by the manufacturer.

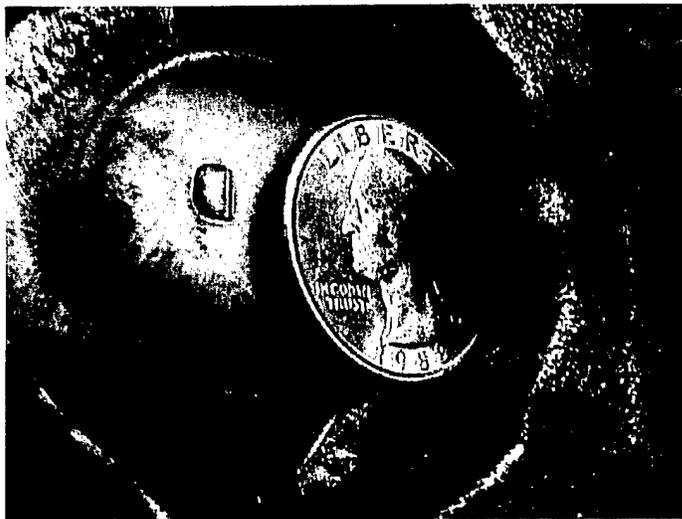
Figure 6 – Play Between the End Cap and Yoke

Once these items were replaced, testing began again only to notice immediately that the rear driveshaft was wobbling. One end cap on the transfer case u-joint had overheated and seized up. Inspection revealed that this failure was typical of those witnessed in the field. It is suspected that the reason this was not noticed before was do in part to thermal expansion that, when the end cap failed, caused the u-joint to be held relatively in place until it cooled off. While the shaft may not have been displaying wobbling that could be visually seen, it was likely causing excessive vibration throughout the rest of the system. It is probable that this extra vibration helped cause the premature failure of the water pump.

The wobbling itself was being caused by the space created between the end cap and the yoke. From figure 6, the amount of play that was discovered was such that a quarter would easily fit in this space. Also visible is the scoring in the metal, caused when the cap overheated, and a slight bulge in the center of the cap. Though some needles were found that were a little squished, nothing was wedged underneath the cap. The space between the yoke and end cap allowed the driveshaft to shift off center which, when spinning, displayed the wobbling motion. This failure occurred while using the Joint Clutch & Gear straightened and balanced shaft. Later analysis of the shaft indicated that it had bent drastically when the failure occurred. Refer to Appendix B for the results.

At this point Joint Clutch & Gear sent a representative out to evaluate the cause of the failure on the driveshaft they had balanced and straightened. Upon inspection of the system, the representative stated that propshaft life cycle prediction with this arrangement was very difficult and failures could occur at any time. This was based on the angle of the shaft and the fact that the transfer case and axle are parallel to each other but have an opposite slope to that of the driveshaft. He also commented on whether a larger shaft was likely to solve the problem. He said that having a bigger shaft, to include a bigger and longer spline, may last somewhat longer but would eventually fail. He recommended tilting the transfer case to a flatter, if not opposite, slope. The axles should remain
