**US Army Corps  
of Engineers**  
Engineer Research and  
Development Center

Technical Report REMR-CS-63  
September 1999

## **Repair and Rehabilitation of Dams: Case Studies**

*by James E. McDonald, Nancy F. Curtis*

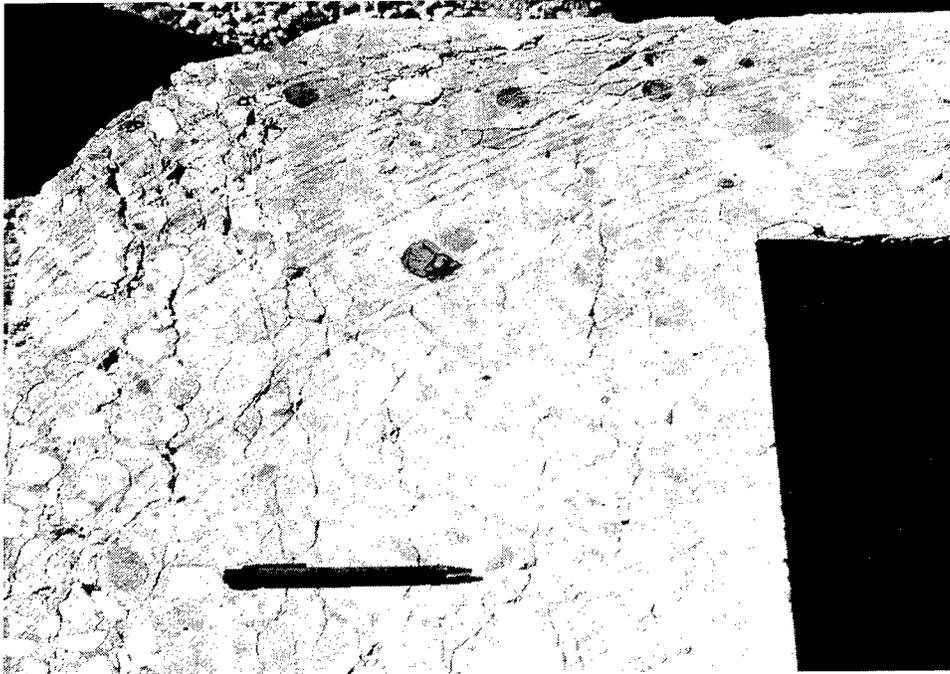
At the time of the Tenth Periodic Inspection (USAED, St. Louis 1997), the removal and replacement of columns on six of the eight bridge piers approved in the 1993 Major Rehabilitation Report were underway. Two of the columns that support the service bridge at Pier 16 had been removed. The periodic inspection team examined them and found excessive cracking, especially toward the top of the columns (Figure 8a). Generally, the concrete in the columns was in poor condition (Figure 8b).

- a. Interior cracking in concrete on Pier 11 removed for replacement, Mississippi Lock and Dam No. 24 (from U.S. Army Engineer District, St. Louis 1997)

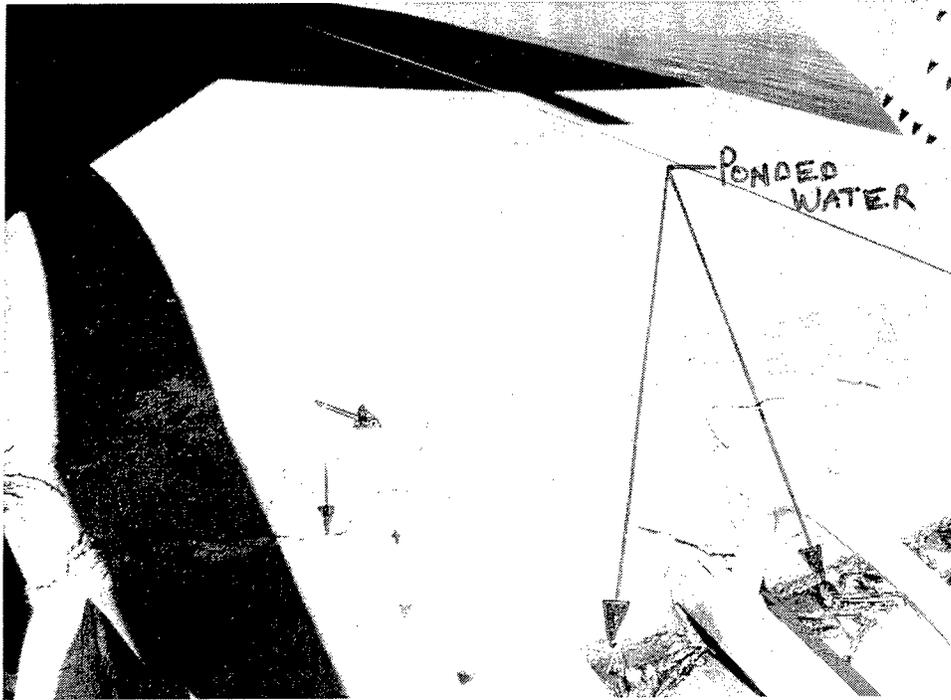
Figure 8c. Lower area of Pier 9 to be capped with floating concrete slab, Lock and Dam No. 24, Mississippi River (from U.S. Army Engineer District, St. Louis 1997)

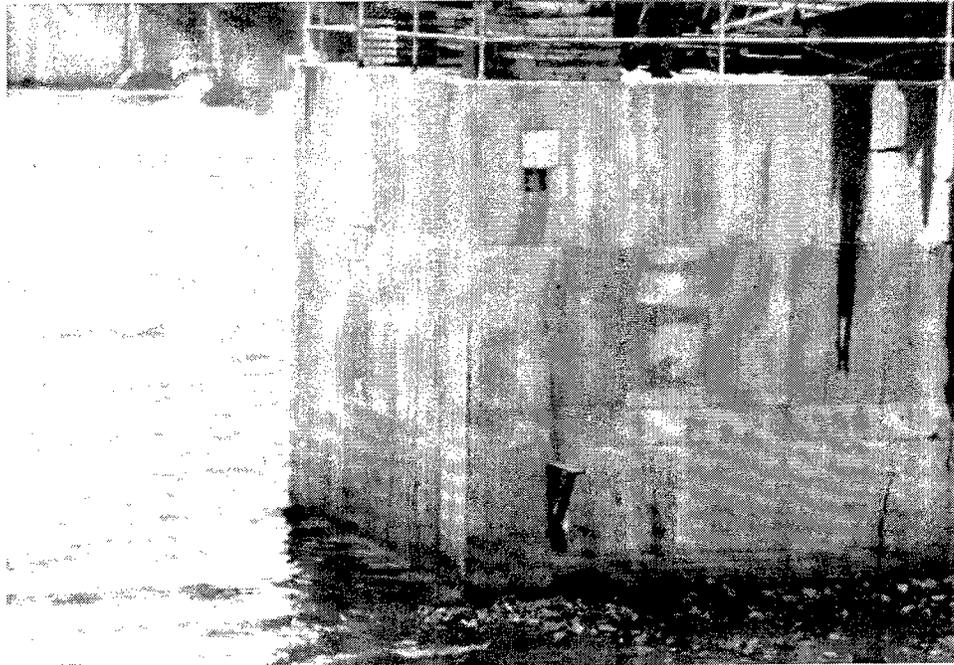
Figure 21. The south abutment of the arch dam after rehabilitation, Dresden Island Lock and Dam

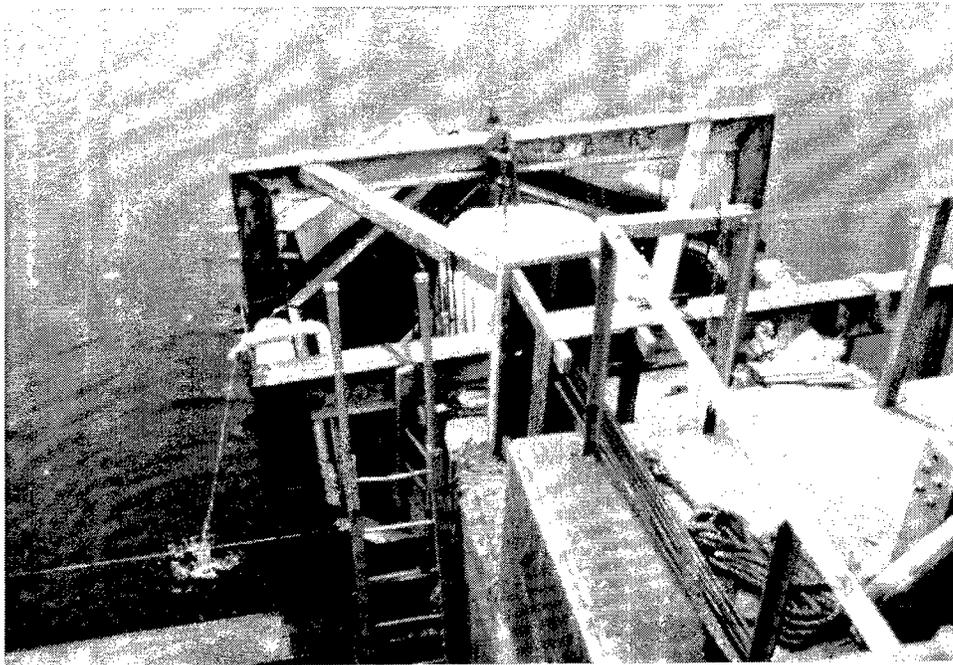
Figure 28. Local cofferdam used to dewater bullnose piers, Marseilles Dam

To replace the gates and complete repair work, it was necessary for the contractor to dewater each spillway sequentially. The contractor was faced with the challenge of constructing a reusable cofferdam that could withstand 6.1 m (20 ft) of water. Bedrock just below the bottom of the reservoir ruled out use of conventional sheetpiling. The solution was a local cofferdam that could be flooded to provide stability (Figure 28) (Stone and Webster).

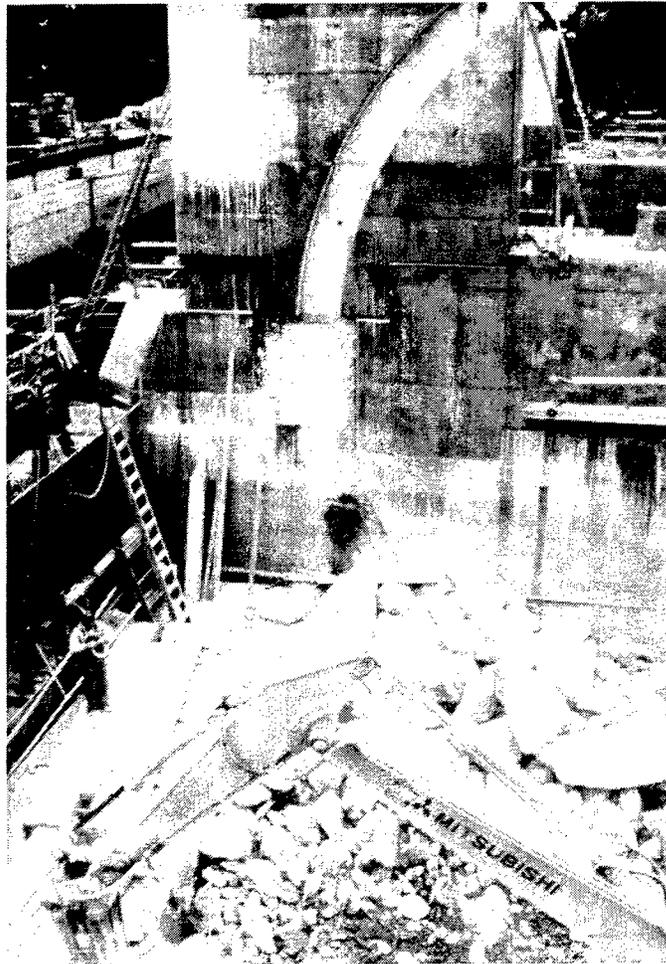
Figure 29. Concrete removal of ogee crest and side of pier to accommodate new gate, Marseilles Dam

Before the new submersible tainter gates could be installed, the piers had to be repaired and modified and the gate sills reconstructed. The ogee crest was removed and some concrete was removed from the side of the pier to accommodate the new gate (Figure 29). Concrete repair consisted of removing the deteriorated nonair-entrained concrete and replacing it with conventional reinforced mass concrete. In addition to visual inspection, concrete in the piers was further evaluated by coring. Concrete cores revealed that deterioration ranged

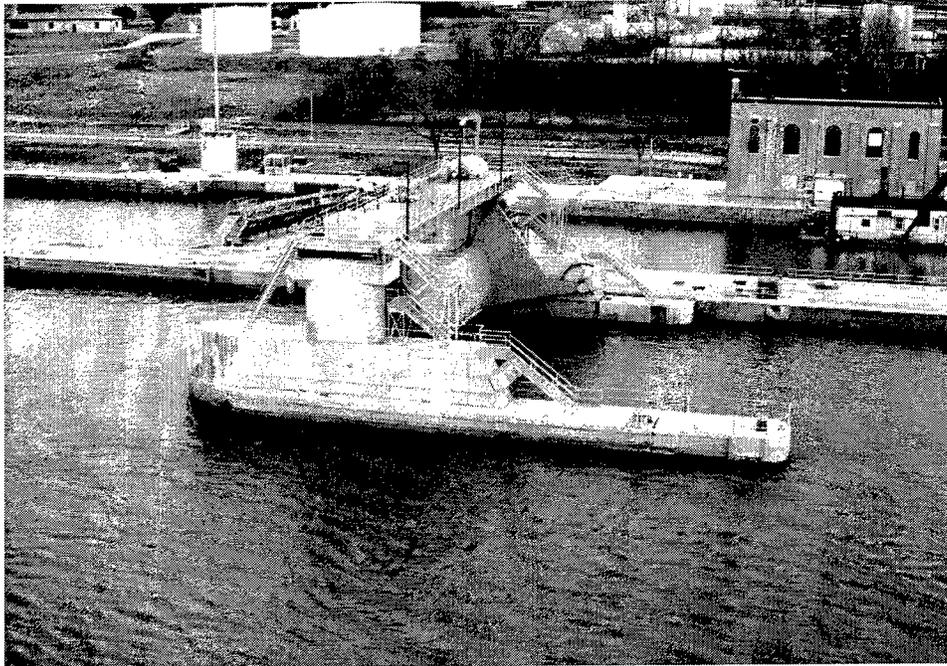
Figure 34. Completed piers and gate constructed at Peoria Dam

Ready-mix trucks were used to transport the concrete from a plant about 20 minutes from the dam. The trucks were loaded onto a barge; concrete was discharged into buckets and transferred by a crane to the forms. Lifts were restricted to 2.3 m (7-1/2 ft). Vibrators were used to consolidate the concrete, which was then moist-cured where possible; curing compound was used where necessary. A high-pressure water jet was used to clean lift joints. The completed piers and gate are shown in Figure 34.

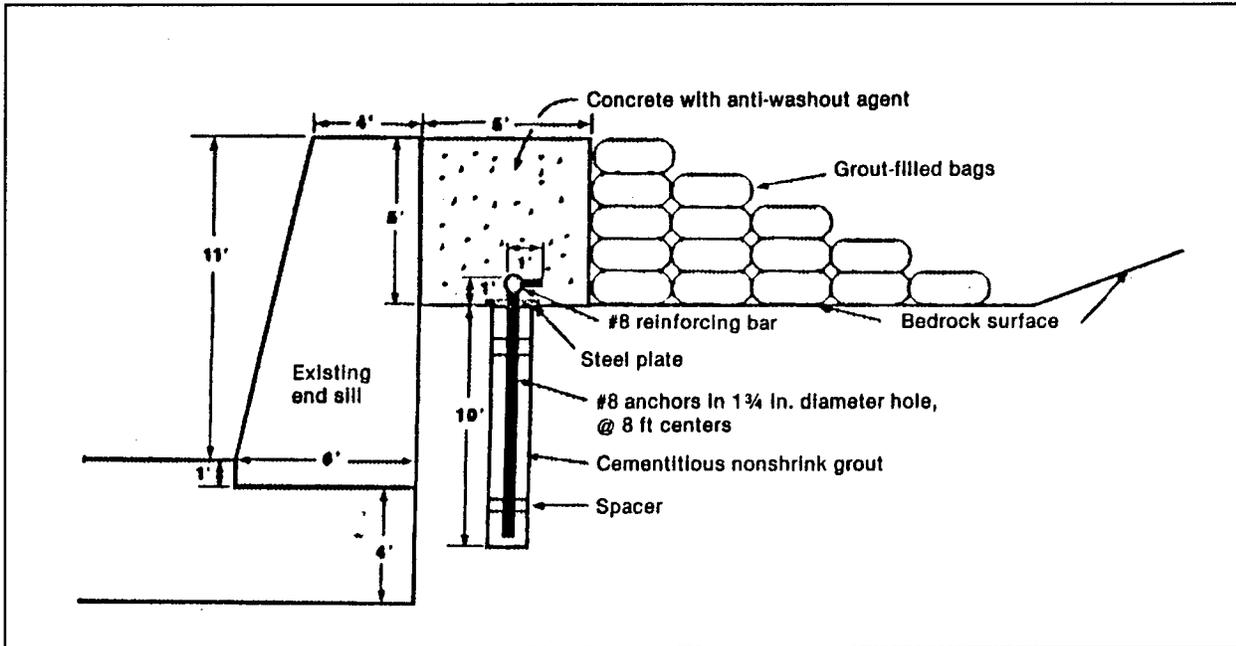
Figure 35. Anchor and concrete placement at the end sill, Red Rock Dam (from Neeley and Wickersham 1980)

Holes for the anchors were air-percussion drilled 3 m (10 ft) deep. Spacers were used to maintain an annular space to be filled with cementitious nonshrink grout. A 102- by 102-mm (4- by 4-in.) steel plate was placed over each anchor to minimize the washing away of the grout. A wall of grout-filled bags with a vertical upstream face and a sloping downstream face was constructed 1.5 m (5 ft) downstream from the end of the sill to help contain the concrete during placement (Figure 35).

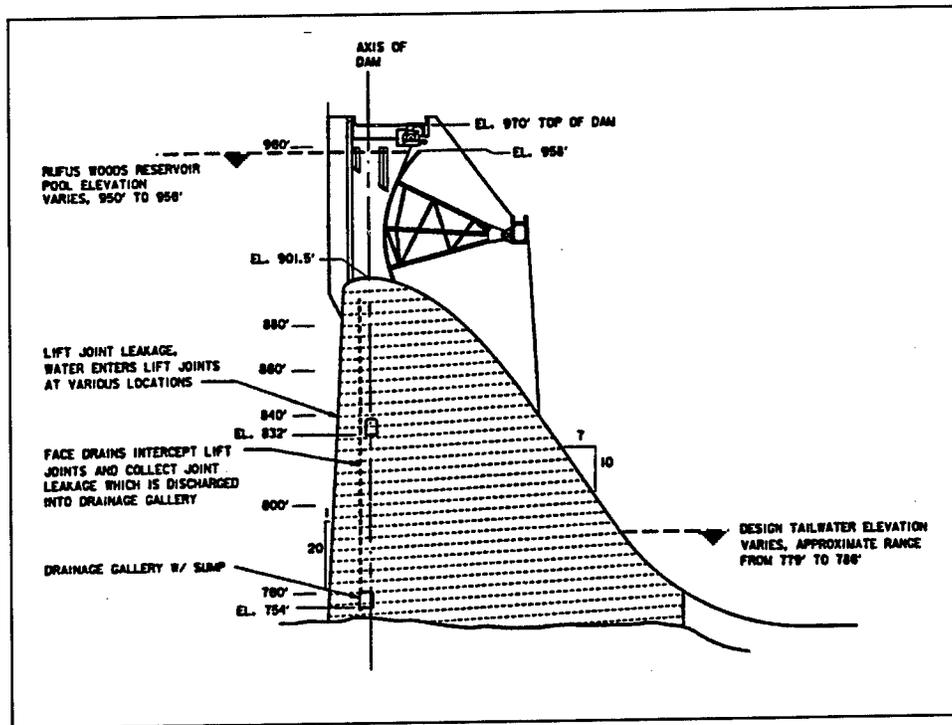
Figure 45. Monolith section showing leakage, Chief Joseph Dam (from Sondergard 1991a) (multiply feet by 0.3048 to obtain meters)

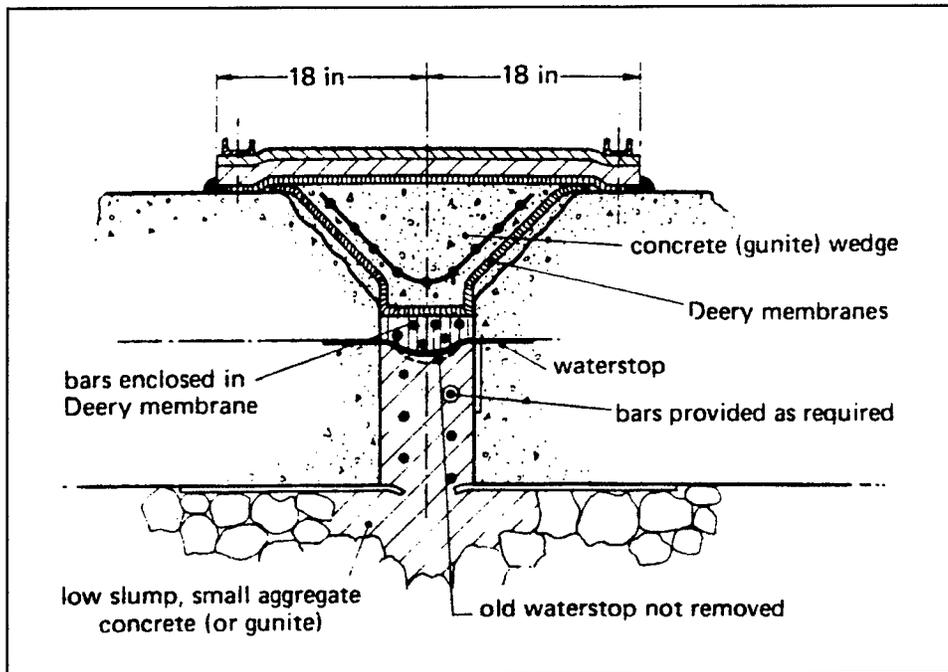
Figure 47. Details of repair for open, leaking joints at New Exchequer Dam (from Brown and Kneitz 1987)

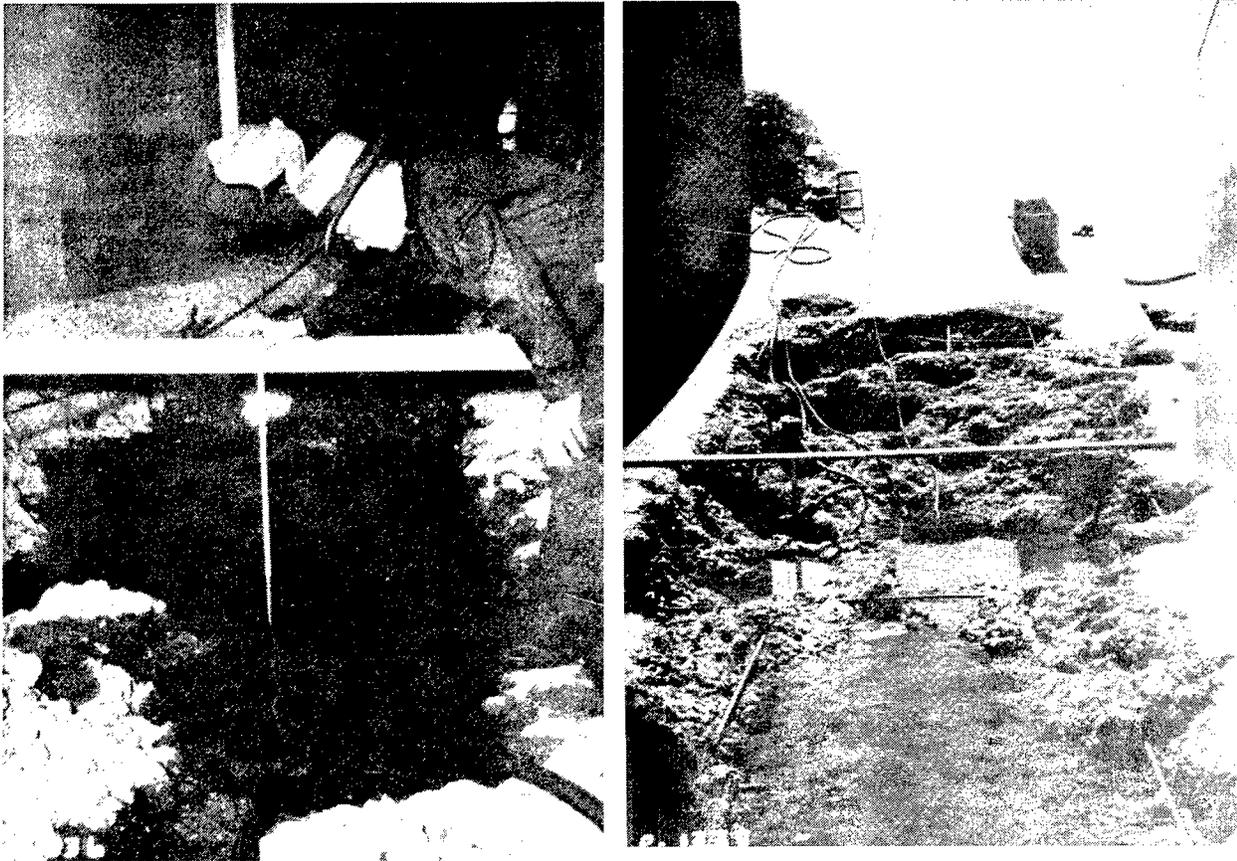
Figure 50. Upstream (left) and downstream views of cavitation in flip-bucket floor in channel no. 1, Luck Peak Dam (from U.S. Army Engineer District, Walla Walla 1983)

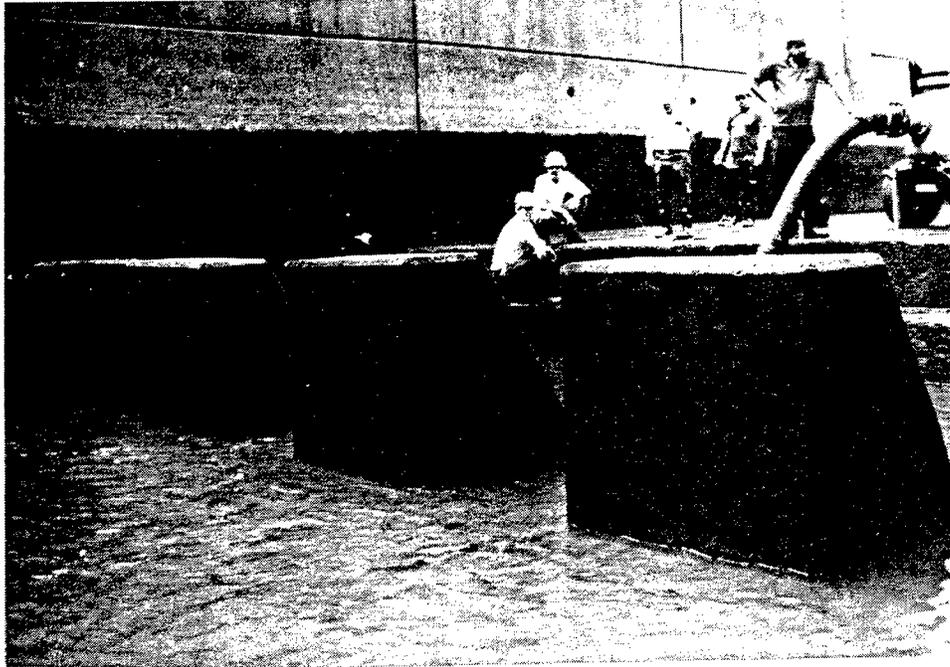
Figure 61. Upstream face and baffles in dewatered stilling basin, R. B. Bailey Dam (from U.S. Army Engineer District, Huntington 1993)

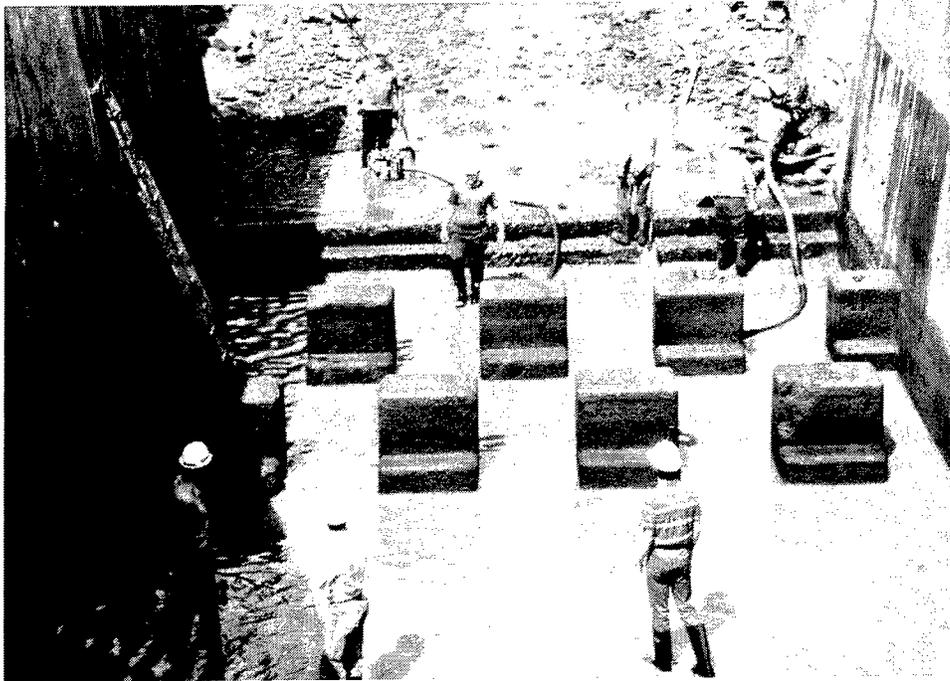
Figure 66. Stilling basin dewatered for fifth periodic inspection, Tom Jenkins Dam (from U.S. Army Engineer District, Huntington 1990c)

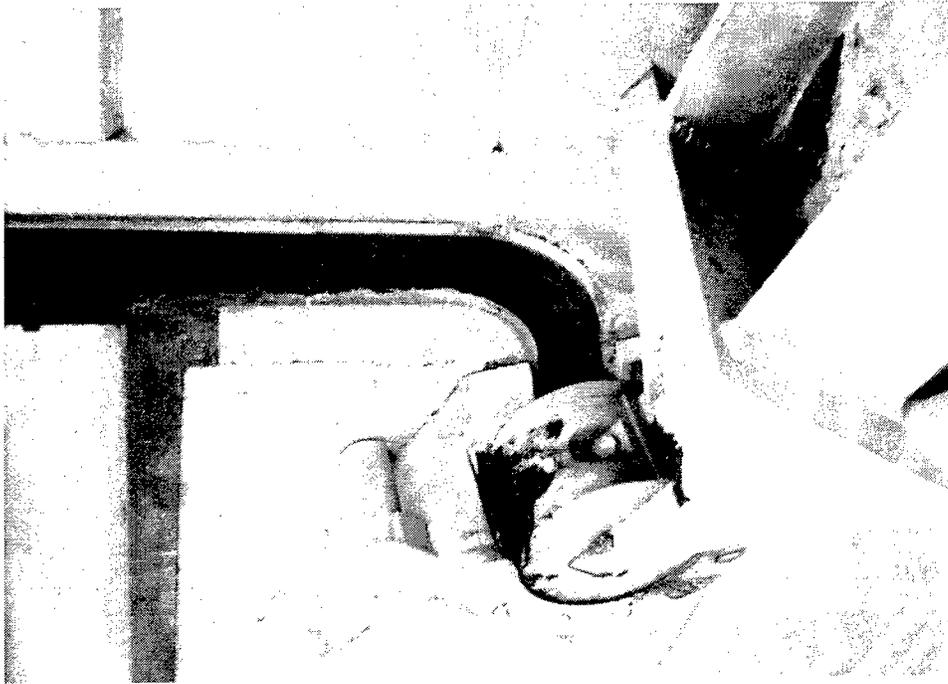
Figure 74. Gate arm and guide slot of tainter gate, Point Marion Lock and Dam (from U.S. Army Engineer District, Pittsburgh 1994)

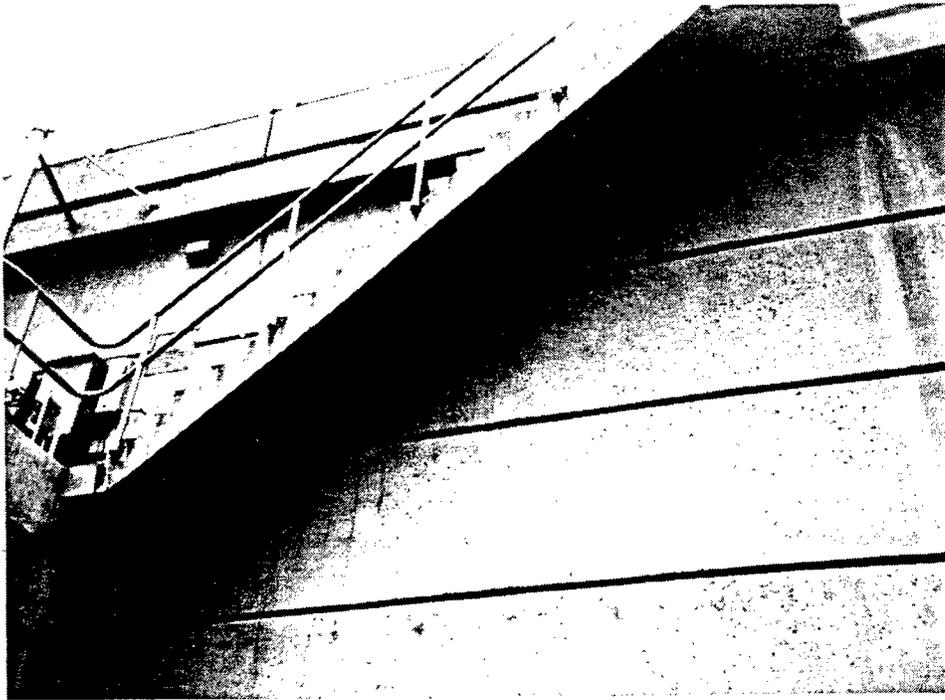
Figure 75. Bug holes on the upstream face of Stonewall Jackson Dam (from U.S. Army Engineer District, Pittsburgh 1989b)

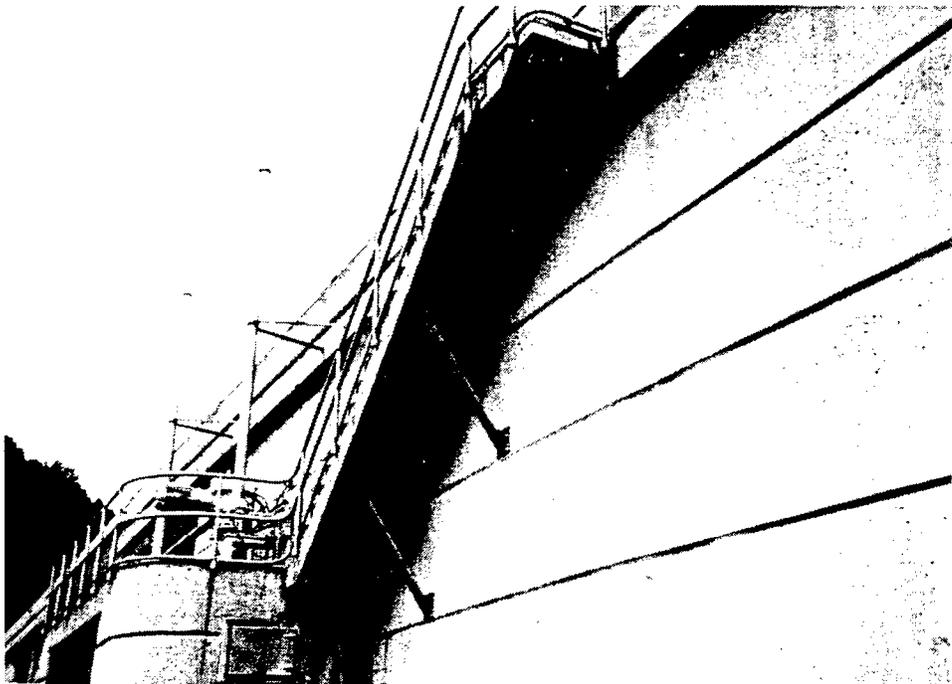
Figure 79. Stainless steel brackets installed to support water quality tower stairway, Stonewall Jackson Dam (from U.S. Army Engineer District, Pittsburgh 1992)

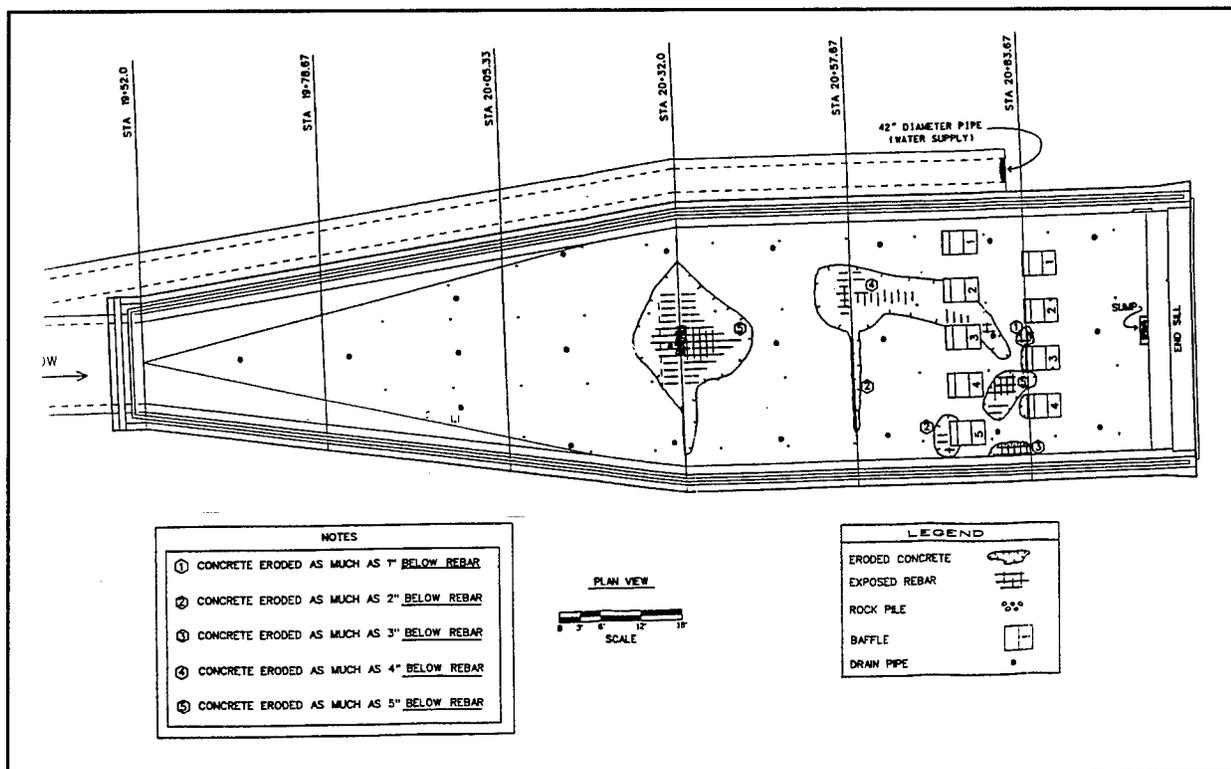
Figure 84. Condition of stilling basin at DeQueen Dam 1993 (from U.S. Army Engineer District, Little Rock 1997a)

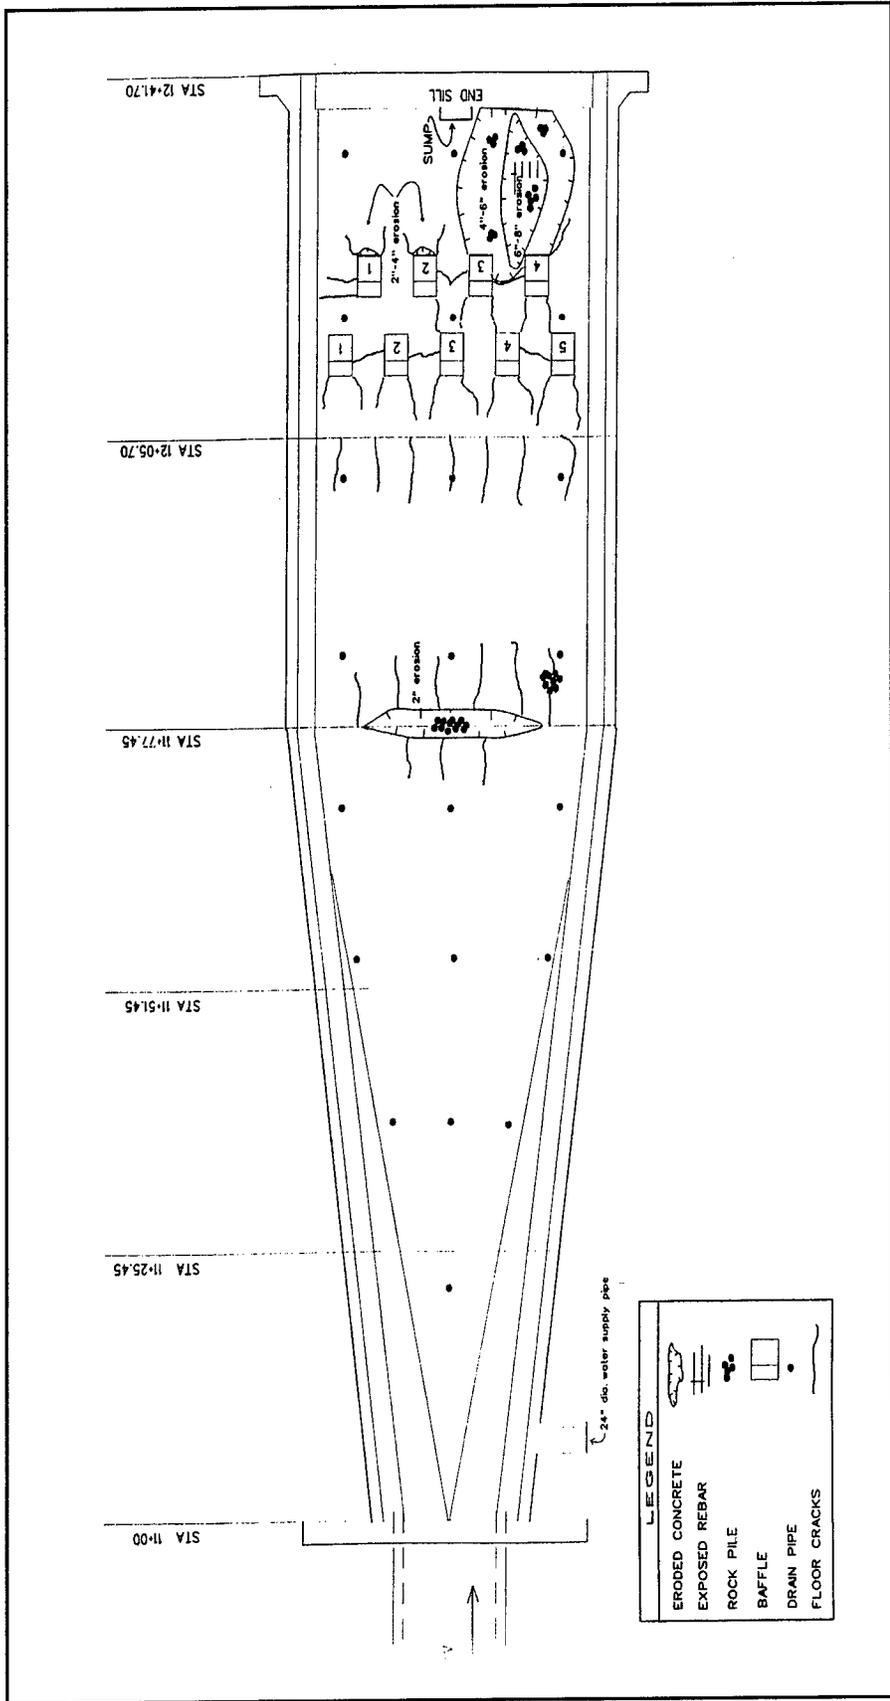
Figure 85. Erosion damage in stilling basin, Gilliam Lake Dam (from U.S. Army Engineer District, Little Rock 1997b)

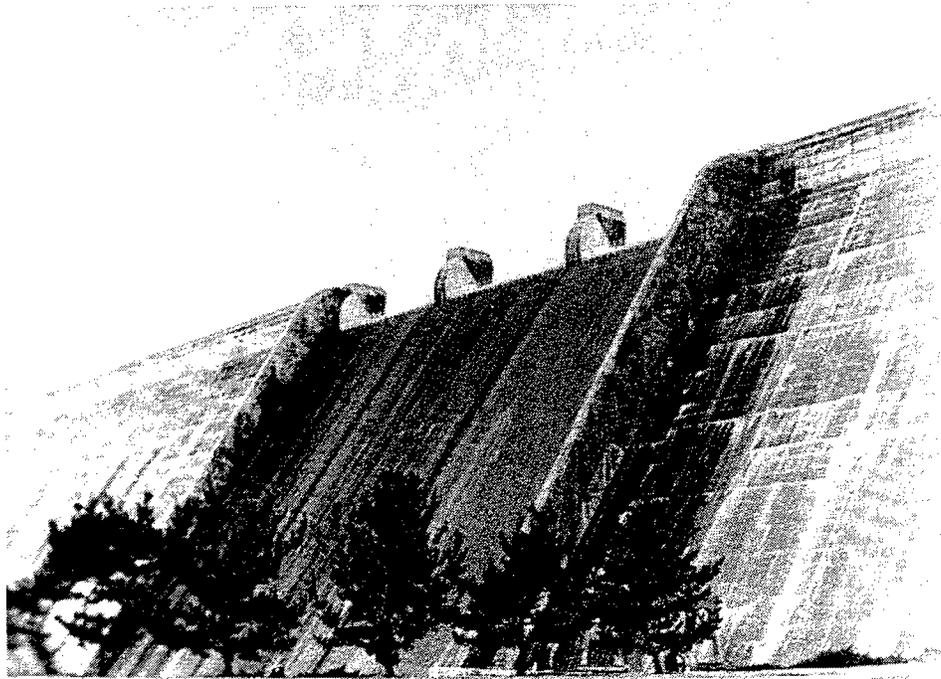
Figure 90. Alkali-aggregate extrusion on the downstream face of Friant Dam  
(from *Hydro Power and Dams* 1997)

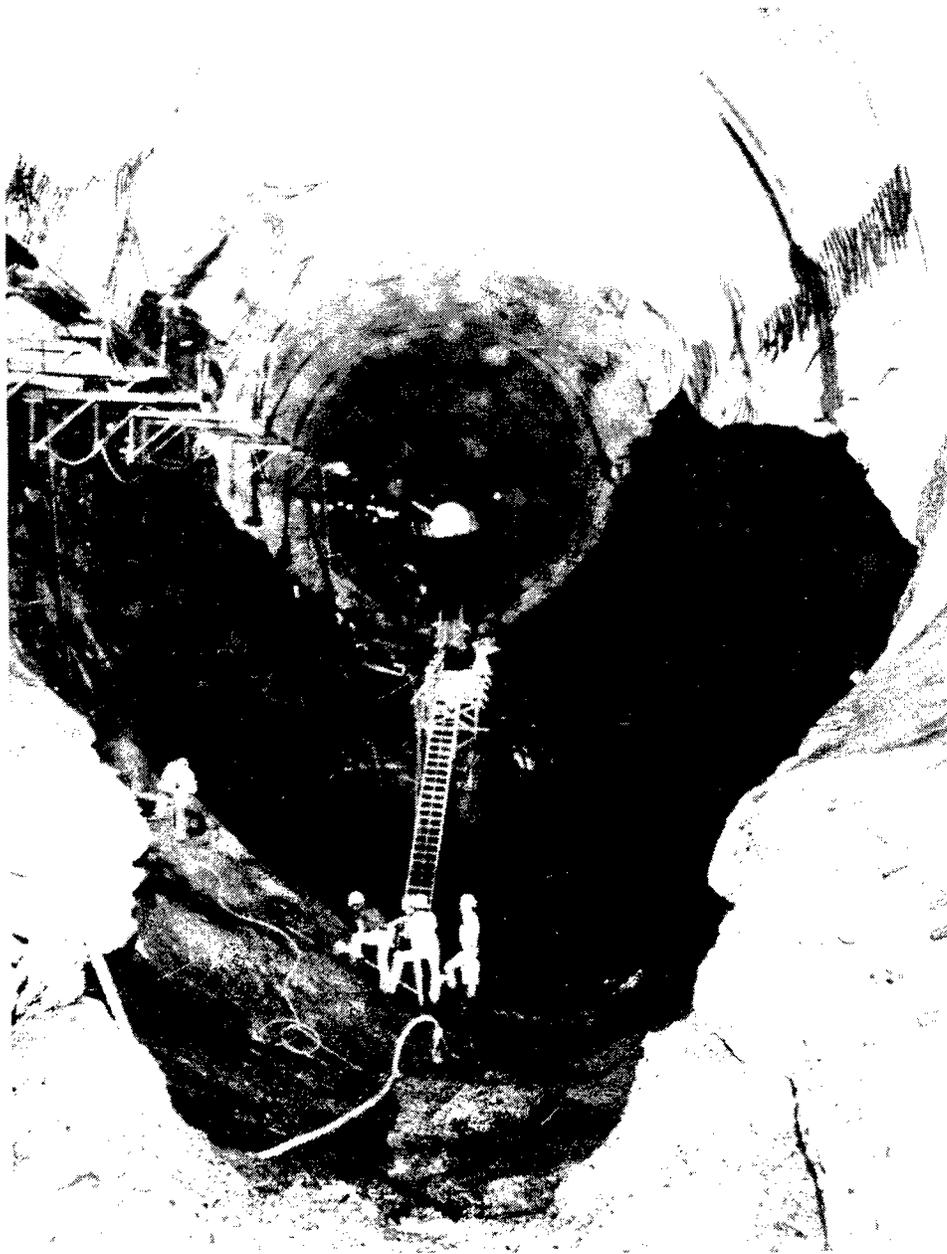
Figure 93. Cavitation damage downstream of the elbow in the left spillway elbow at Glen Canyon (from Burgi and Eckley 1987)

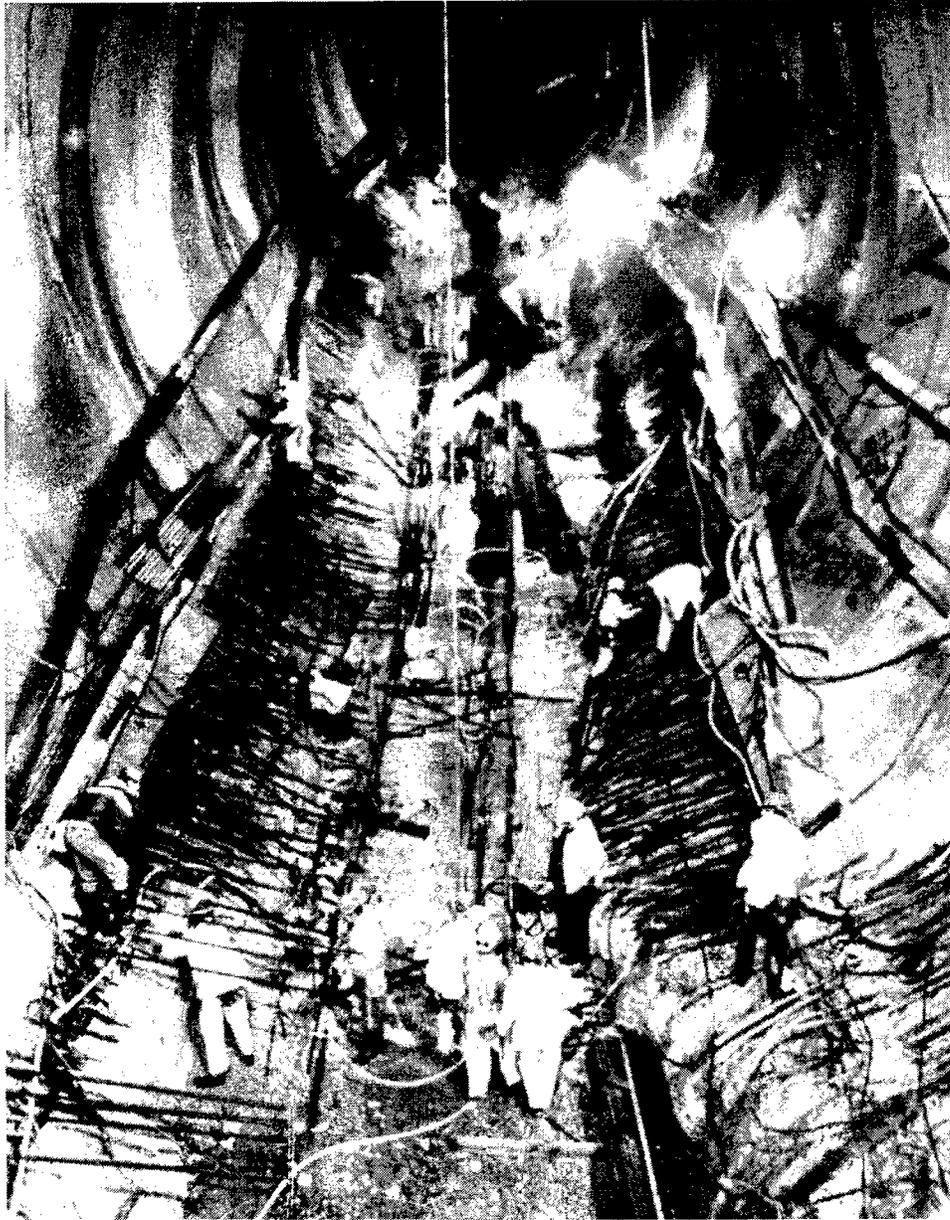
Figure 94. Steel reinforcing steel being replaced in the invert of the spillway elbow at Glen Canyon (from Burgi and Eckley 1987)

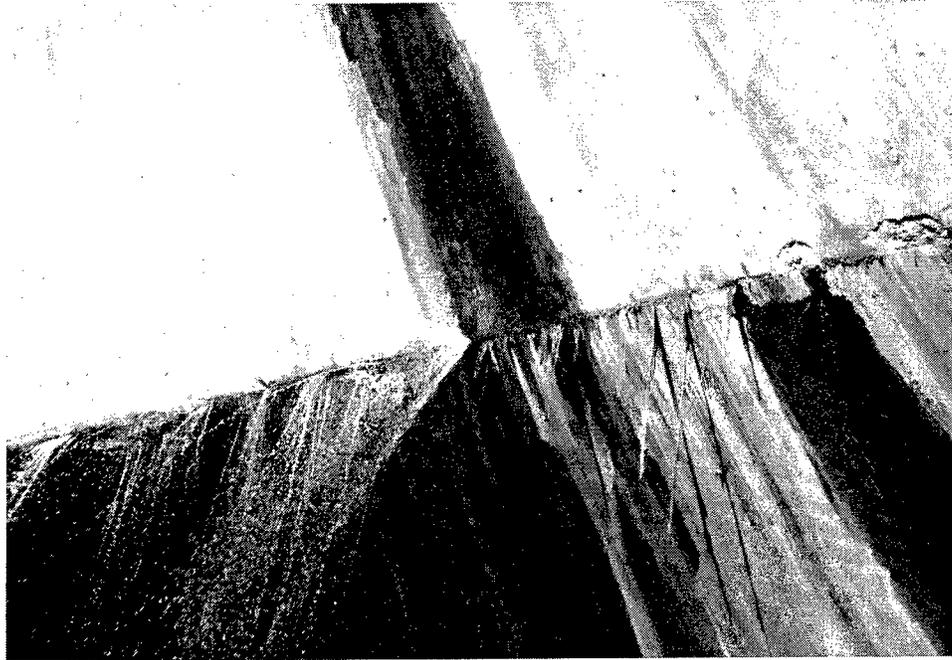
Figure 116. Joint leakage at Buchanan Dam

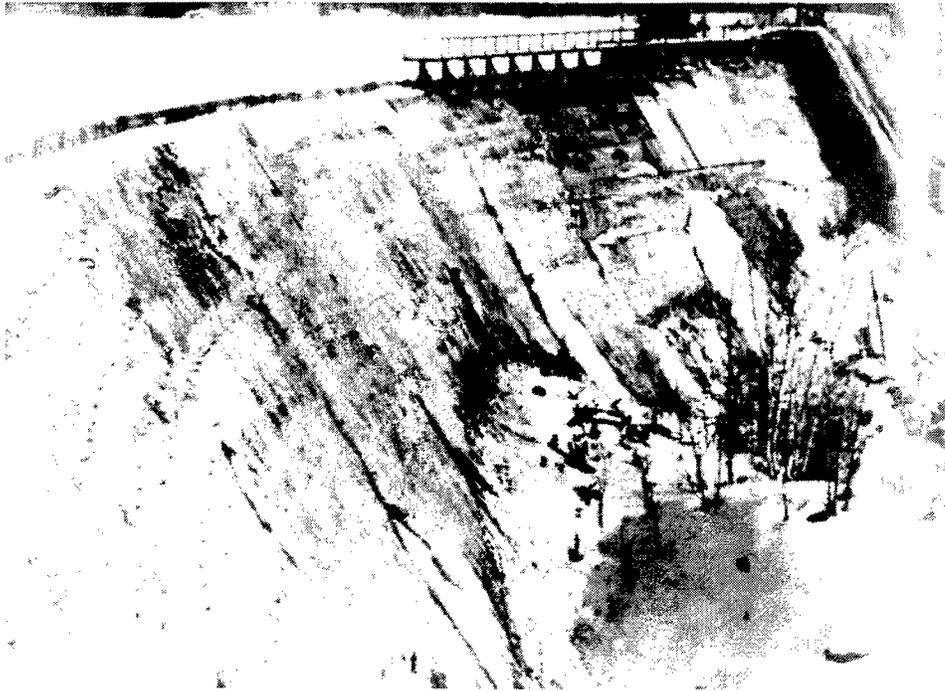
Figure 127. Deterioration on downstream face of Hoist Dam (from Mass and Mier 1980)

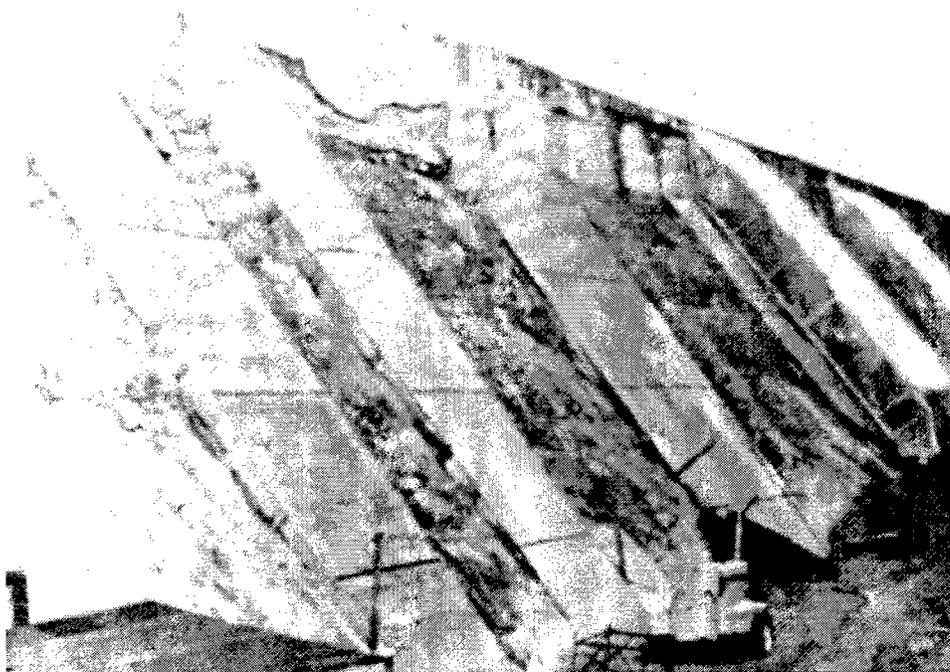
Figure 128. Repair work underway on downstream face of Hoist Dam (from Mass and Mier 1980)

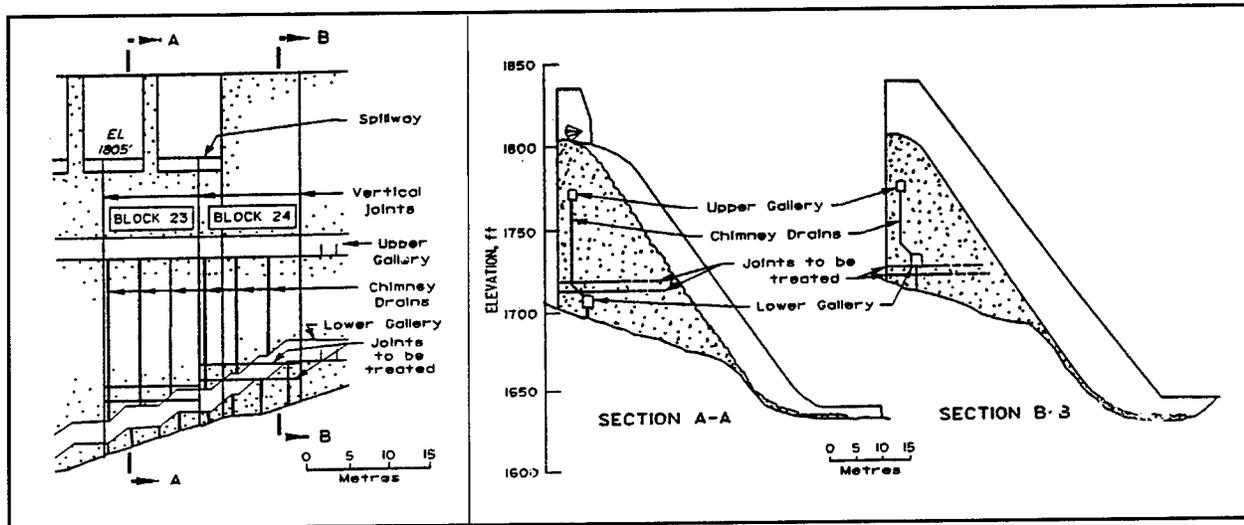
Figure 144. Investigation and treatment plan for horizontal joints in Blocks 23 and 24 at Santeetlah Dam (from Bruce 1989)

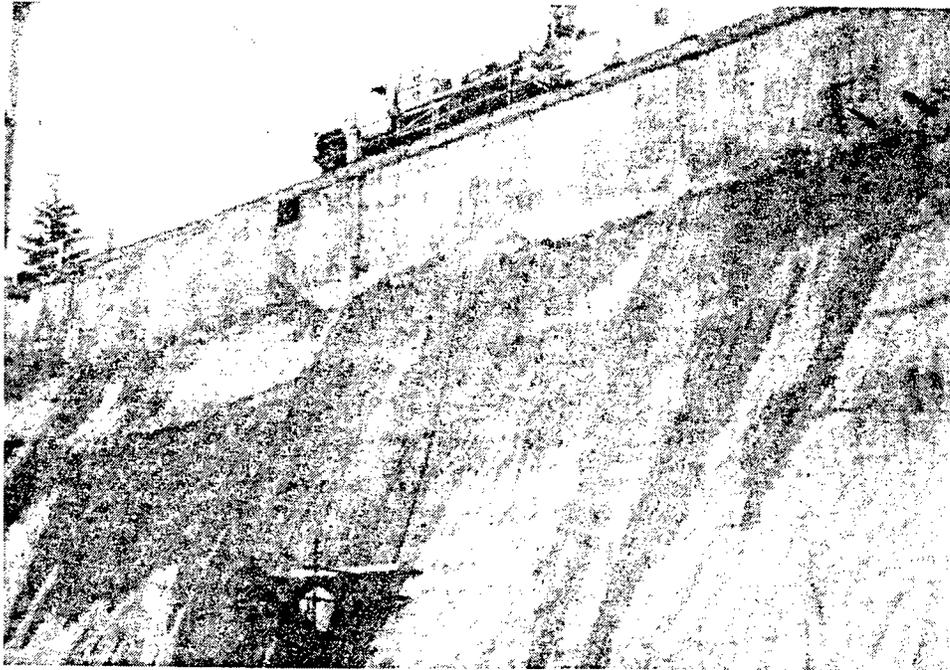
Figure 152. Seepage on downstream face of gravity section of Soda Dam (from Marold, Koniarski, and Bruen 1992)
