# SANDIA REPORT

SAND88-2902 • UC-70

## **Analysis of the Accidental Explosion at Pepcon, Henderson, Nevada, May 4, 1988**

Jack W. Reed

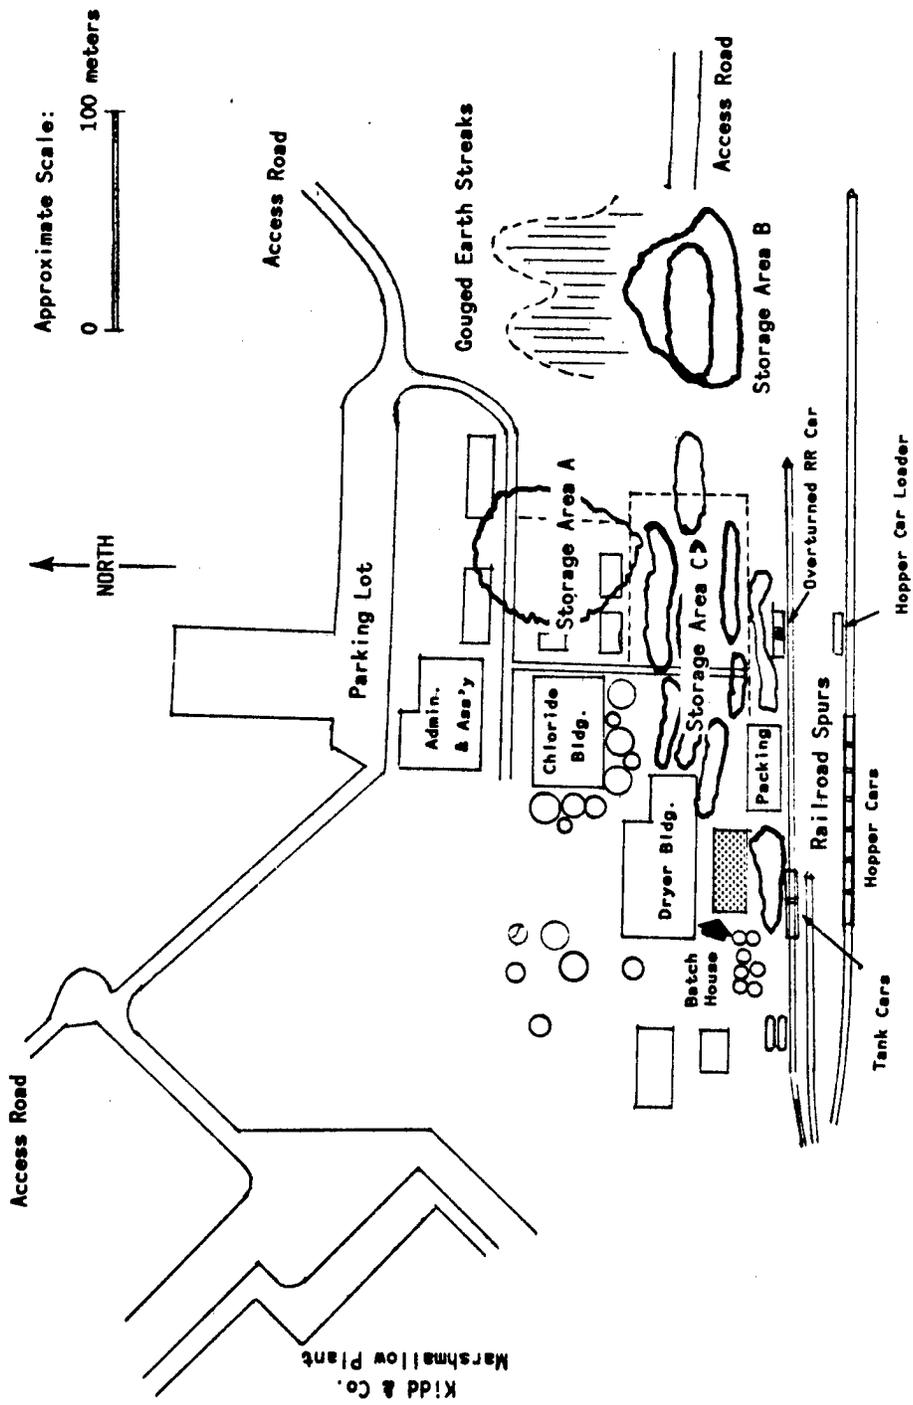
Figure 12. Sketch map of Pacific Engineering Company (PEPCON), Henderson, Nevada, with primary explosion damage features.

Aerial photography was flown over the PEPCON region by EG&G, instrumentation contractors to DOE-NVO, on May 10, 1988. The expectation was that an explosion crater could be dimensioned as an additional yield estimator. Since there was no clear crater formation comparable to ones observed after point explosion tests, no yield scaling was possible. Their photographs did assist in estimating what happened, however, as well as help clear up some map scaling problems that were encountered in connecting the Henderson map in Figure 9 to the Las Vegas map in Figure 11. A sketch of the PEPCON facility in Figure 12, annotated with help from newspaper stories in Appendix B, shows where the initial fire broke out of control in the Batch House, then spread to the Dryer Building and on to the Chloride Building. It is not clear where the first large explosion occurred. What is obvious from these aerial photographs is that the latest and largest explosion occurred in Storage Yard B, nearly 300 m east of the Batch House.

Although it is not important to analysis of damage, overwhelmingly caused by the largest explosion, it might appear that the first explosion occurred at the Batch House and a small adjacent storage area. The east end of the Batch House appears to have been blown away. The second, dark explosion could have been a relatively low-order detonation of the 607-Mg AP in Storage Area A.
