FAILURE OF TUNGSTEN HEAVY ALLOYS SUBJECTED TO DYNAMIC TRANSVERSE LOADING

K. Tarcza^{1,2}, S. J. Bless*¹, and E. Taleff³

¹ Institute for Advanced Technology, University of Texas at Austin

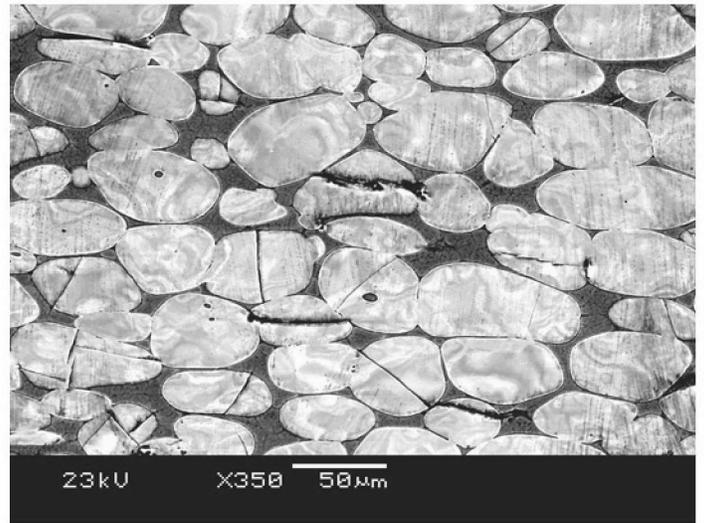
The measured properties of the specimens are summarized in Table 2. It was found that there was a fundamental difference in the nature of the different surface finishes, causing them to fall into two distinct categories: those with processing-induced surface damage and those without. Upon close SEM examination of the EDM, SP, and EP surfaces of both alloys, it became apparent that significant damage existed in the form of extensive microcracking of W grains. EP surfaces offer the best example of this, having effectively removed the EDM residue layer from the surface and revealing the true nature of the base material. In the EP surface micrograph in Fig. 3, fully 33% of complete surface grains in the image (20 out of 60) are either flawed or associated with flaws. The surface flaws were introduced by the EDM cutting. Only the CG and CG-SP-EP finishes totally removed the layer of cracked surface grains. Details of the effects of surface preparation can be found in Tarcza [2004].

Figure 3. SEM surface micrograph of EP WNiFe

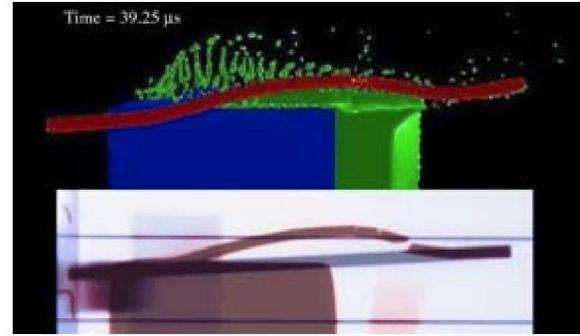
The general response of rods is to be thrown into an arc trajectory. The initial part of the rod that misses the steel block is undeflected. However, the lateral force increases as the rod is more embedded into the plate – giving the back of the rod the highest transverse velocity. The x-rays are taken soon after exit from the plate, so the gentle curvature of the rod shown in the x-rays does not wholly reflect the fact that the back of the rod has experienced a more violent event than the front. This idealized behavior of the rod is most easily shown in a numerical simulations, displayed here in Fig. 5 (from Fuentes, 2003), where it is compared to an experimental result from Shot 717, conducted at 2.3 km/s with EDM WNiFe material.

Figure 5. Upper: CTH simulation of rod showing leading part that missed the block, next part that has been deflected, and trailing part that is still within slot. Lower: Shot 717: x-ray superposition of initial position of rod and dynamic deflection of rod.

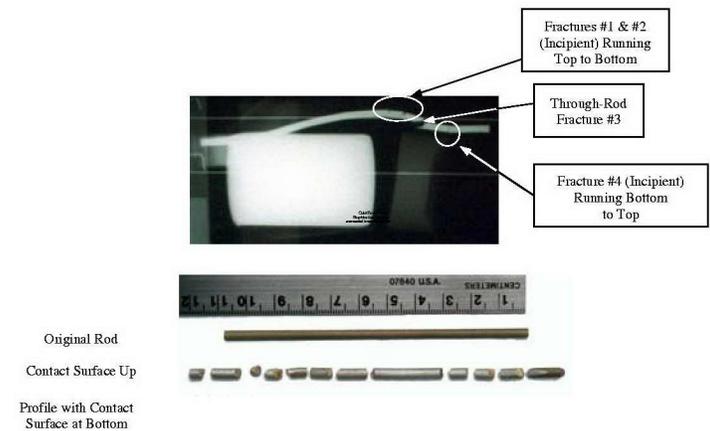
The actual tungsten rods emerged from the target with multiple fractures, as shown in Fig. 6. These fractures are initiated under tensile loading, typically on the side of the rod opposite that interacting with the target. Fractures deflect gradually toward the rod tail, the direction of sliding load motion, developing a characteristic lazy-S shape. The one exception to this is shown in Fig. 6 fracture #4, caused by initial rod-launch package contact in the vicinity of fracture #3, which forced the nose of the rod to whip clockwise. This generated a backwards-fracture running from bottom to top, opposite from the fractures caused by the rod bending in response to contact with the launch package, such as in fractures 1–3 in Fig. 6. The rod segments have a fairly uniform size, with an average mass of 1.0 g as determined from recovered fragments.

Figure 6: Recovered fragments from shot 717.

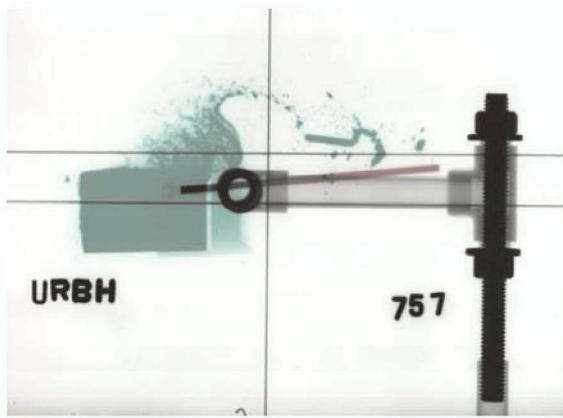
An entirely different failure mode was observed, for example, in Shot 757, shown in Fig. 7. In this experiment, the slot-cutting process has become unstable. There resulted a violent disruption that produced locally very high velocity gradients and very fine fragmentation of the rod. Figure 8 shows the fragments recovered from shot 757. The fractures involve axial splitting of the rod, as opposed to the transverse rupture that occurs normally.

Through examination of the recovered fragments and comparison with flash x-ray photographs, it became evident that the debris plumes were the result of hypervelocity gouging. Gouging has been previously

Figure 7. X-ray of deflected rod in Shot 757.

observed to occur in thin-plate penetration by tungsten rods [Satapathy et al., 2003]. Rod gouges have a shiny, distorted appearance, indicating the extreme loading conditions under which they are created, and the characteristic teardrop shape. They initiated uprange and always resulted in rod failure.

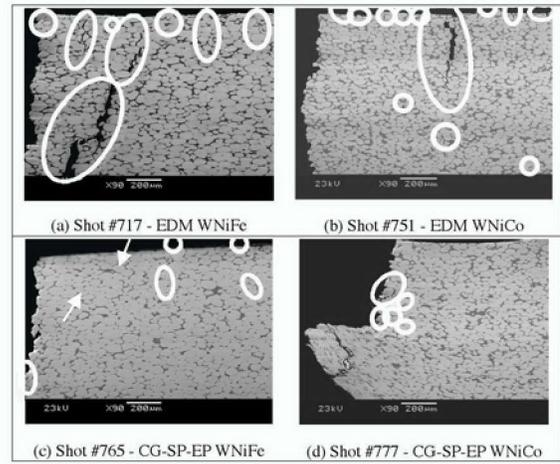
of the distribution of fractures initiated on tensile surfaces after reverse ballistic tensile surfaces show the largest cracks to be uniformly spaced approximately 200 μm apart. In contrast, CG-SP-EP surface improvement greatly reduces the damage visible at a 90x magnification for both alloys, and the largest fractures are linked W grain cleavages nucleated in the interior of the rod segments, as shown in Fig. 10. In the case of the WNiCo specimens, the proximity of internal fractures to the tail end of the segment and the absence of any other incipient fractures makes a strong case for rod failure from internally nucleated damage; this is less clear for the WNiFe CG-SP-EP specimen.

Figure 10. Normal cross sections of specimens with fracture initiation sites identified (tensile side on top).

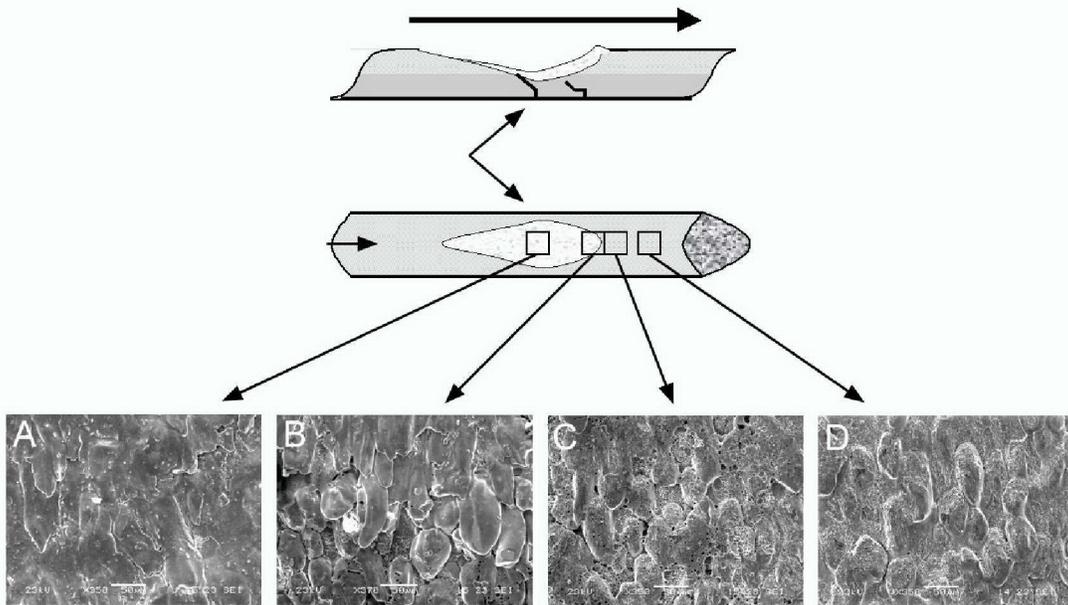
Recovered specimens with gouges were examined. Transient loading induced by high velocity sliding contact acts first at a discrete location, triggering an expanding region of significant plastic surface deformation. Contact conditions become more severe as the gouge region expands, leading to surface melting and material removal, as well as gross W grain deformation. This causes a scaly, smeared appearance as W grains are elongated, flattened, and overlapped, as shown in Fig. 11(a). Contact surfaces on the rod and target are expected to gouge simultaneously, and material from the growing crater(s) is drawn downrange as the transient load begins to diminish. Gouges terminate with a lip of this material pushed up at the tail end of the gouge as shown in Fig. 11(b), followed by the region of gradually diminishing surface melting and solidification seen in Fig. 11(c). As steady-state contact conditions resume, the surface reverts to the more usual, scoured appearance of Fig. 11(d).

Figure 11. Examination of shot 757 gouge crater and nearby surface details. A) Gouge surface interior; B) Downstream gouge lip; C) Near beyond gouge; D) Far beyond gouge.
